December 11, 1936  
WATERTOWN ARSENAL  
WATERTOWN, MASS.

Report No. 710/79  
Watertown Arsenal

The Relation of Microstructure  
to the Ballistic Properties of Homogeneous  
Armor Plate

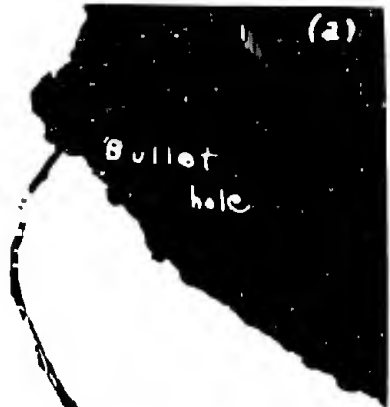
(a)

- a) Shows typical distribution of non-metallics and crack progressing from bullet hole. (Compare with other good plate, Figure 2 (a). There is no indication that the crack has anything but a random connection with the inclusions. See area enclosed in circle, Figure (c)

X100 Round 2 MA 127

Figures 1a, 2a, and 2b illustrate the distribution of non-metallics in plates of high ballistic limit; that is, numbers 29 and WJ2.

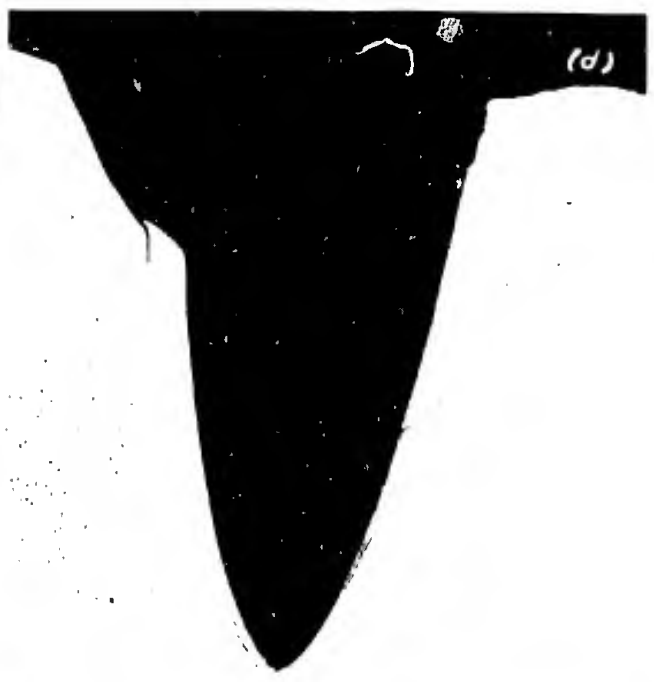
(d)

- d) Partial penetration  
Striking velocity 2540 ft/sec.  
Height of bulge in back 0.06 inches  
Depth of indent 0.96 inches

X3 Round 3 - MA 178

Note: c) and d) show bad etching pits, due to deep etching on specimen before repolishing for these photographs. They were not removed because of the expense involved.

Macrostructures showing the occurrence of cracks resulting from bullet impact in the unetched sections of these high ballistic plates are shown in Figures 1c, 1d, 2f, 2g, and 2h. Although plate WJ2 had a high ballistic resistance, an examination of the unetched cross sections revealed the presence of some internal ruptures near the bullet hole, see Figure 2f. This condition was typical of this plate containing 3.58% nickel and 2.01% silicon. The standard chromium-molybdenum-vanadium plate of high ballistic resistance was relatively free from internal cracks or ruptures as shown in Figures 1c and 1d.

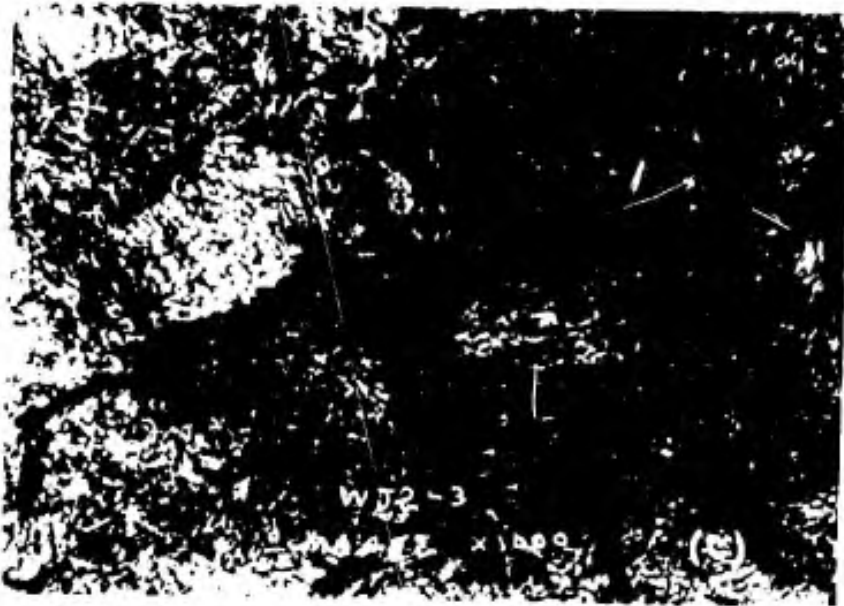
Figure 2

- a) Typical fine unfformly distributed non-metallics.  
Compare with Figure 1 (a)  
X100 Round 9 - MA 125
- b) End of crack progressing from bullet hole see  
Figure (g) #142, which follows grain boundaries,  
a behavior characteristic of cracks in this plate.  
X100 Round 5 - MA 142

- c) To demonstrate that these cracks do follow along  
grain boundaries, this specimen was etched with  
1% Nital to show up the grains, and the crack is  
clearly seen to follow the contours of the grains.  
X1000 Round 3 - MA 402

- d) Typical nitride inclusion. Compare with Figure 1 (b)  
See #154 Figure (g).  
X1000 Round 5 - MA 154
- e) Non-metallic inclusion of the sulphide type.  
Compare with Figure 1 (b). See Figure (g) #147  
X1000 Round 5 - MA 147

- f) Highest velocity not completely penetrating  
Partial penetration  
Striking velocity 2945 ft./sec.  
Height of bulge in back 0.01 inches  
X3 Round 9 - MA 106

- g) Partial penetration  
Striking Velocity 2639 ft./sec.  
Height of bulge in back 0.00 inches  
X3 Round 5 - MA 140
- h) Partial penetration  
Striking velocity 2599 ft./sec.  
X3 Round 3 - MA 139

Figures 1b, 2d and 2e illustrate the characteristic complex oxides and typical nitrides or cyano nitrides found in these plates.

A plate one-half inch in thickness and which contained 3.58% nickel and 2.01% silicon having a high ballistic resistance (highest velocity not completely penetrating with Caliber .30 AP at a striking velocity of 2945 foot-seconds) was free from spalling but contained pronounced irregular cracks or ruptures shown in Figure 2f. The microstructure of this plate

was martensitic as shown in Figure 2c and had a Brinell hardness of 555. Crack systems in this plate were intercrystalline; that is, they followed the grain boundaries, see Figure 2c.

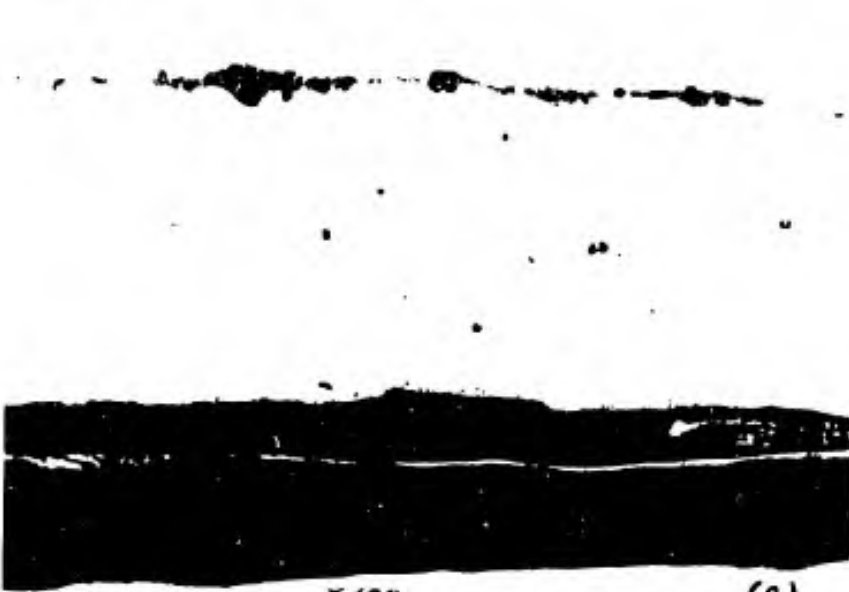
Figure 3 Plate #Ex 36

- a) Showing inclusions elongated by rolling. At the upper left is the end of a wide crack parallel to the laminated inclusions, and which trails off into a thin chain of non-metallics. See (1) below.

X100 Round 8 - MA 124

- b) These titanium nitride, or titanium cyano-nitride crystals occur with the same frequency as in the good plate.

X1000 Round 5- MA 122

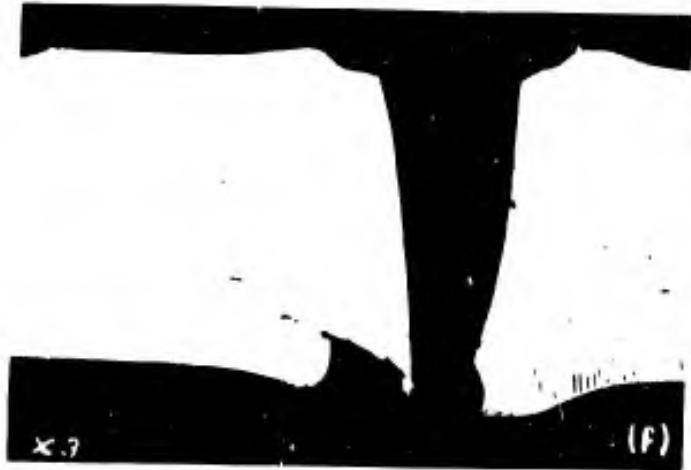
- c) This crack very nearly resulted in a button, see (g) below. Exactly parallel to it is a stringer of non-metallics indicating the probability of this "button crack" having opened up along just such a stringer. A higher power picture of the encircled portion of the stringer follows.

X100 Round 5 - MA 115

- d) Structure of stringer indicated in preceding picture.

X1000 Round 5 - MA 121

- e) Typical portion of a slag segregation showing angular and cubic non-metallics strung in long practically straight lines.

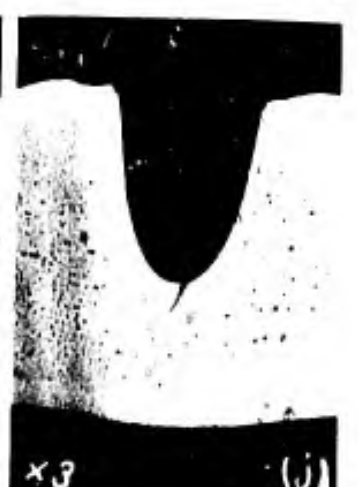
- f) Complete penetration, one petal  
Striking velocity 2704 ft./sec.  
Diameter of hole 0.41 inches

- g) Complete penetration, core in plate removed by machining.  
Striking velocity 2696 ft./sec.  
Core through back 0.55 inches  
Core through front 0.02 inches

- h) Complete penetration, core in plate removed by machining.

Striking velocity 2672 ft./sec.  
Core through back 0.30 inches  
Core through front broken off

- i) Partial penetration, highest velocity not completely penetrating.

Striking velocity 2371 ft./sec.  
Height of bulge in back 0.05 inches

- j) Partial penetration

Striking velocity 2286 ft./sec.  
Height of bulge in back 0.03 inches

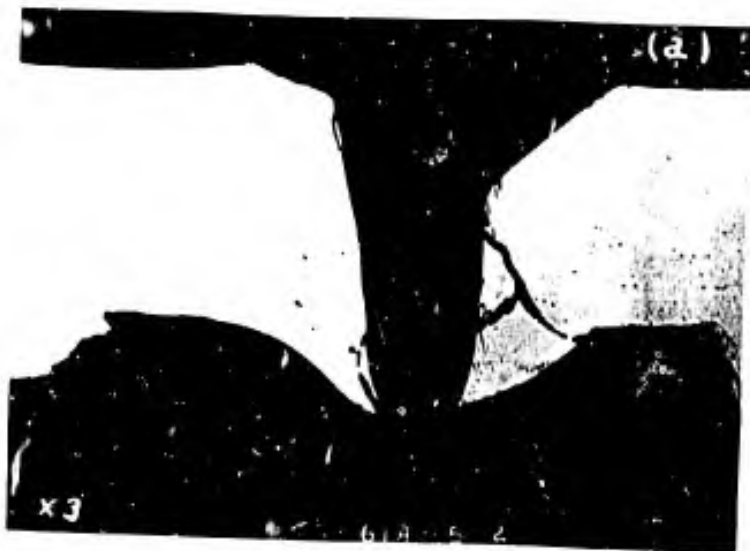
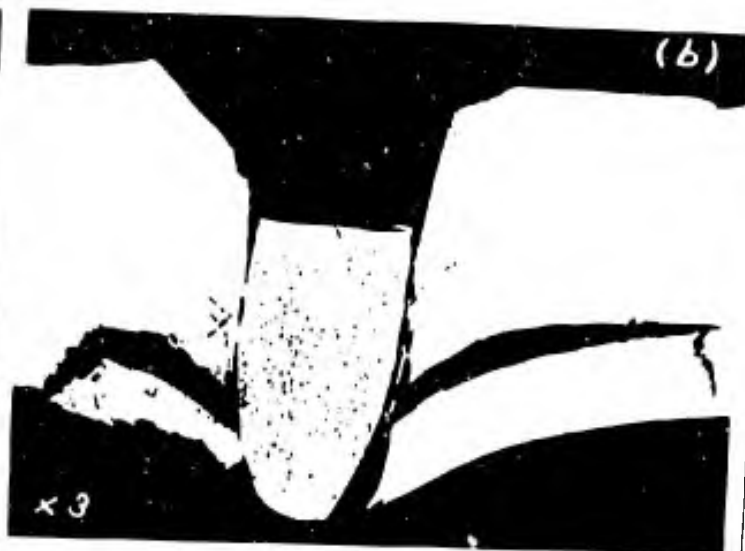
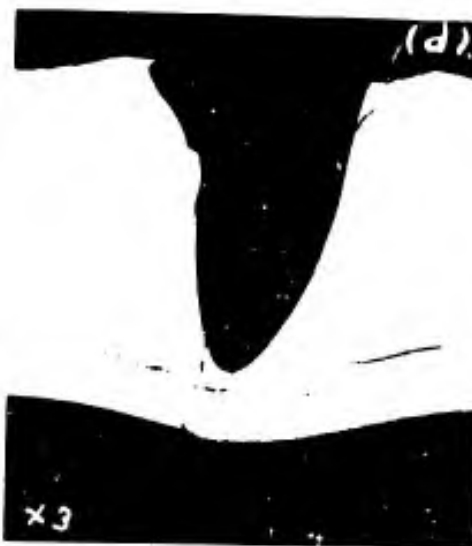
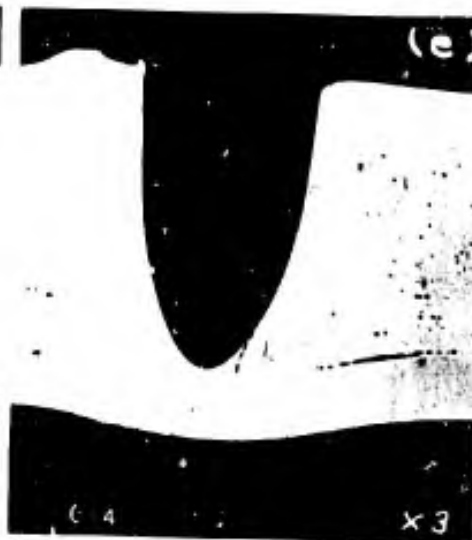
Figure 4

- a) Illustrating a typical behavior of cracks in the steel, this crack progress from the bullet hole parallel to the laminae of non-metallics, following one of them at its end, in this case.  
See figure 5 (d)  
X100 Round 10 - MA 143

- b) This crack again shows itself tailing off into the same direction as the segregated non-metallics in this area. See figure 5 (b) #119.  
X100 Round 3 - MA 119

- c) A series of cracks, progressing along non-metallic segregations parallel to other segregations. For higher power picture of the segregations, see (c) below. Also see Figure 5 (b) #117.  
X100 Round 3 - MA 117

- d) Typical distribution of non-metallics. Compare with good plate in Figure 1 (a) and Figure 2 (a). See Figure 5 (a)  
X100 - Round 2 - MA 145
- e) Non metallic inclusion parallel to crack (upper left corner). High power of area enclosed in Figure (c) above.  
X1000 - Round 3 - MA 118

- f) This is the end of the crack indicated in Figure 5 (f). It is seen to progress along a series of fine non-metallic inclusions, giving rise to the belief that the major portion of the crack may have done the same.  
X100- Round 8 - MA 120

- c<sub>1</sub>) Sectioned off axis of bullet hole  
X3 - Round 5 - MA 113
- d) Partial penetration  
Highest velocity not completely penetrating.  
Striking velocity 2446 ft./sec.  
Height of bulge in back 0.06 inches  
X3 - Round 10 - MA 111

- e) Partial penetration  
Striking velocity 2409 ft./sec.  
Height of bulge in back 0.05 inches  
X3 - Round 9 - MA 112
- f) Partial penetration  
Striking velocity 2391 ft./sec.  
Height of bulge in back 0.03 inches  
X3 - Round 8 - MA 114

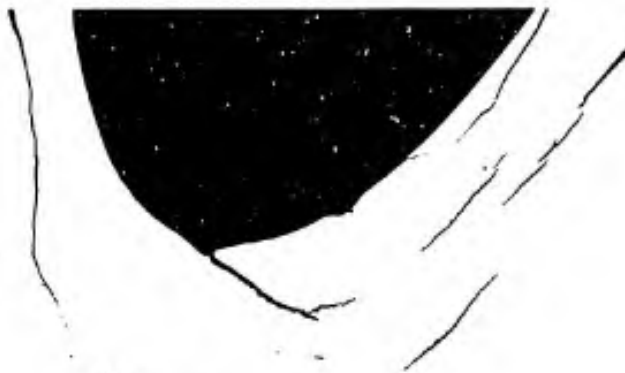
FIG. 6

Partial penetration  
Striking Velocity 2391 ft./sec.  
Height of bulge back .03"  
Showing early stages of development of spall on  
back side of plate.

Plates of medium ballistic limit, numbers Ex 26 and 614-5 of standard chromium-molybdenum-vanadium composition are susceptible to spalling although the ballistic limit is not lowered to a marked degree. It is believed that spalling in these plates is due to the presence of laminations or elongated non-metallic inclusions as illustrated in Figures 3a, 3c, 3d, 3e, 4a, 4b, 4c, 4d, 4e, and 4f. Photographs of cross sections of bullet holes showing the various stages of formation of spalls are illustrated in Figures 5c, 5d, 5e, and 5f. Figure 5b illustrates an armor piercing bullet actually penetrating a plate in the act of breaking off a spall on the back face. Figure 5a shows the result of a button blown off the back face. In many cases it was determined that spalls or buttons separated from the plate along the laminations or elongated non-metallics, see Figure 6.

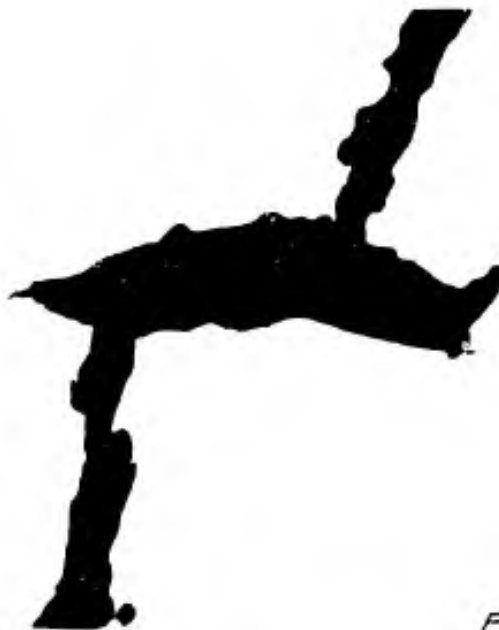
FIG. 7

Same as sample above.  
Illustrating crack deflected by a non-metallic  
This is the only case in which this type of crack  
system was observed.

In Figure 7 it is interesting to note that a crack produced by a bullet impact was deflected by a non-metallic inclusion, in fact the crack

crossed the non-metallic at an angle of about 30 degrees.

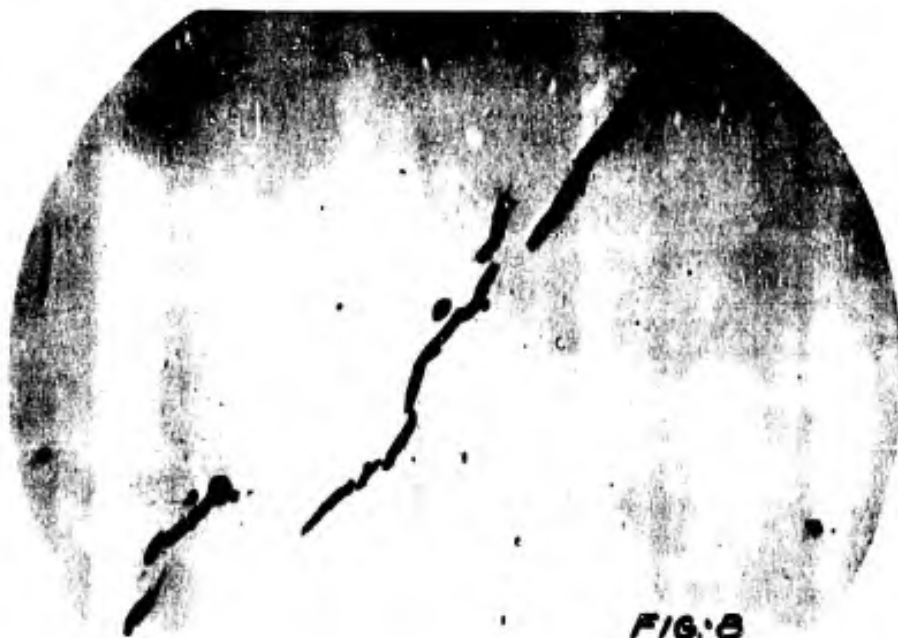
FIG. 8

Illustrating crack originating or terminating  
in a small non-metallic

X1000 unetched - Round 8  
HA1 - 67

Moreover, in several cases, it appeared as though a tiny crack either originated or terminated at a small rounded non-metallic as illustrated in Figures 8 and 9. In the case shown in Figure 9, this particular crack progressed at random for a short distance through several non-metallics found in a segregated area of a medium high ballistic plate. Occasionally cracks resulted from slip along cleavage planes as shown in Figure 10. Some of the non-metallics in the vicinity of impact were shattered as illustrated in Figure 11. Furthermore, tiny cracks were evident at the extreme ends of the non-metallics.

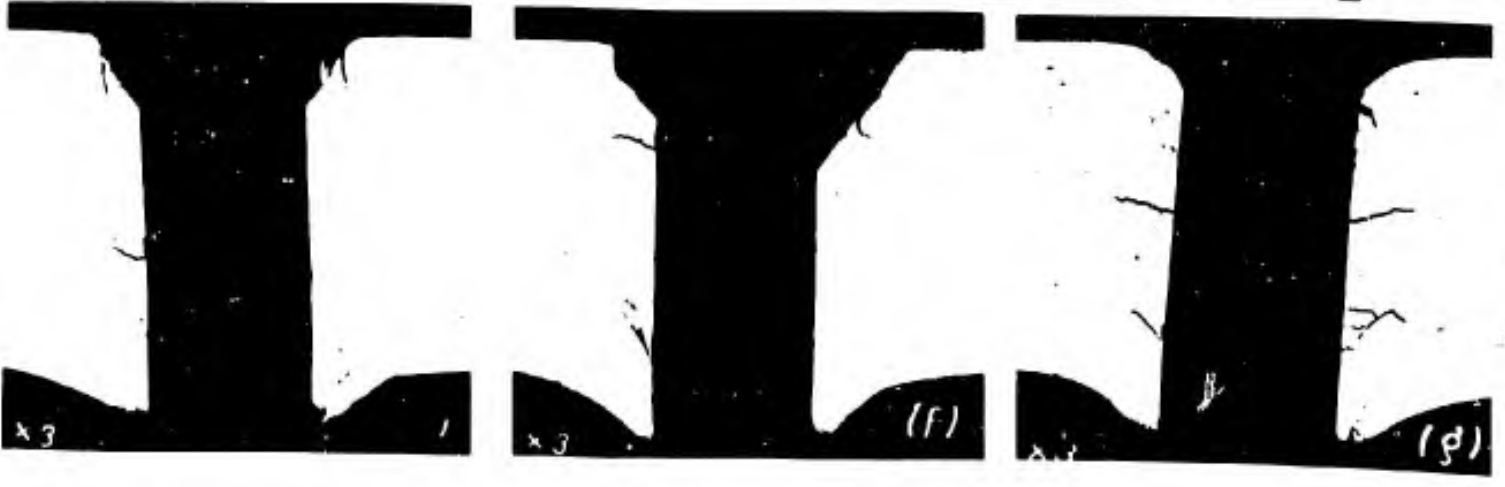
- a) These two parallel cracks apparently have no connection, or no tendency to deviate toward or from the non-metallics. There is however some indication that they follow grain boundaries. See Figure (c) #130

- b) Cracks show no relation to porosity. See Figure (c) #129 below.

- c) Cracks similar to these which follow the contour of the bullet hole were found in practically all castings, although often not so completely surrounding it as in this case.

- d) Crack progressing from bullet hole appears to follow grain boundaries. See Figure (g)

- g) Complete penetration  
Core in plate removed by machining.  
Striking velocity 2215 ft./sec.  
Core through back 0.53 inches  
Core through front 0.07 inches

Crack systems, as the result of bullet impact in cast armor plate, are shown in Figures 12a, 12b, and 12c. The cracks were not closely associated to porosity in the cast plate but closely followed segregated areas; that is, areas between the axes of the dendrites.

Crack systems in the high manganese plate (11.4% manganese and 1.17% carbon) progressed through clear metal. This steel was relatively clean as shown in Figures 12d, 12e, 12f and 12g.

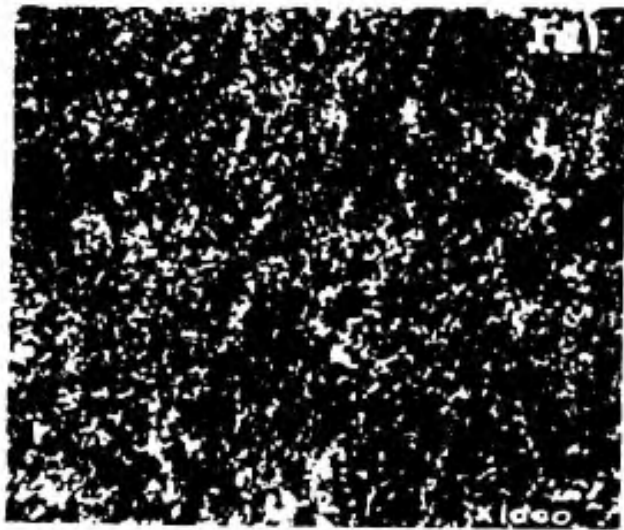
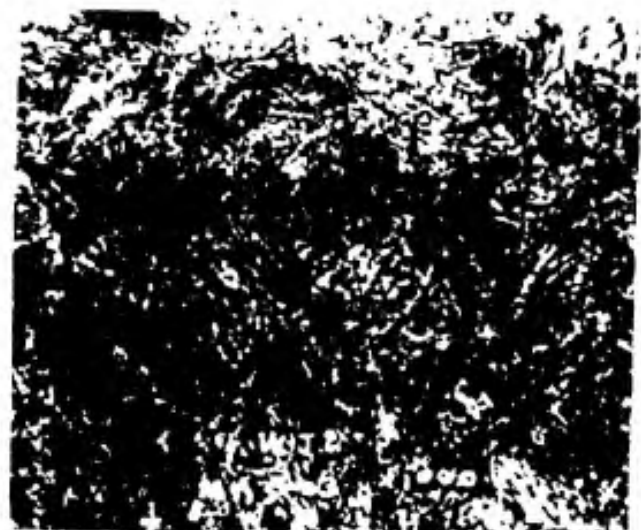
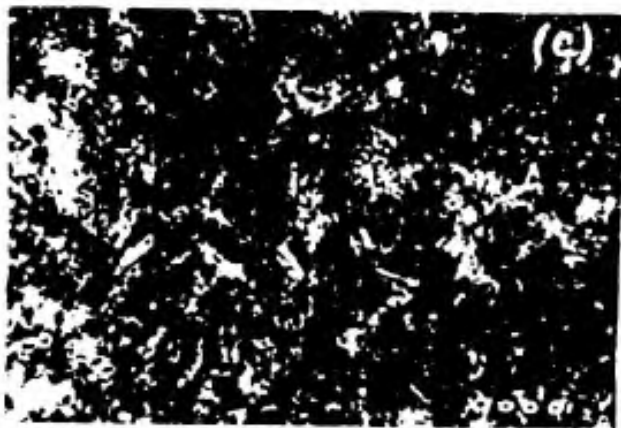
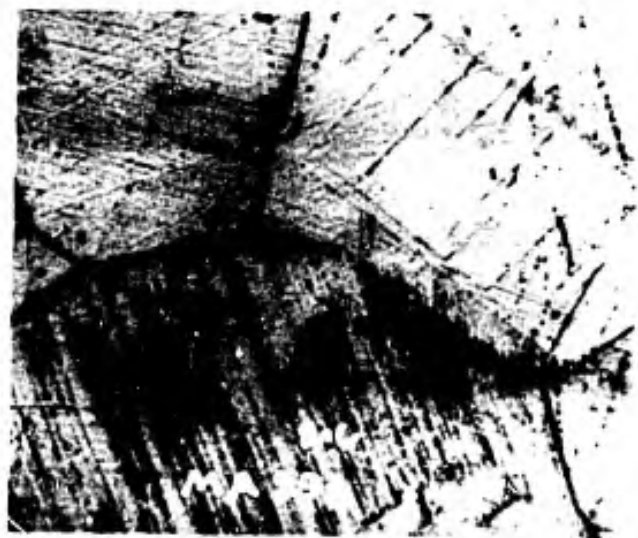
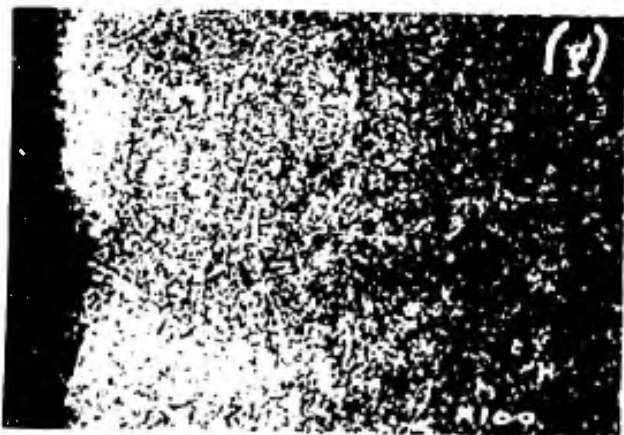
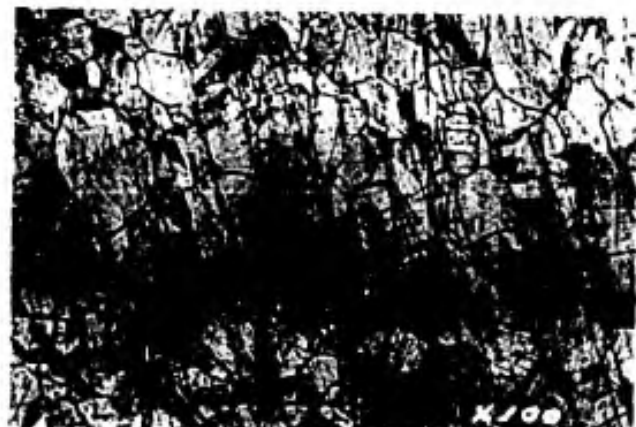
Microstructure of all Plate

- h) #2 Austenite, showing grains with slip lines and twinning. See Figure (f) above.  
X100 - Round C - MA 390

In this investigation it was determined that plate of the standard chromium-molybdenum-vanadium composition having a high ballistic resistance to spalling had a uniform sorbito-troostitic structure as shown in Figure 13a. This particular plate was an inch thick and was not penetrated with a Caliber .50 A P with a striking velocity of 2568 foot-seconds.

Plates of the same composition only one-half inch in thickness which spalled under impact of Caliber .30 A P bullets exhibited a less uniform sorbito-troostitic structure intermingled with ferrite as illustrated in Figure 13c, 13d, and 13e.

In all plates some decarburization was detected, a typical example of which is shown in Figure 13g.

Austenitic manganese steel, the microstructure of which is shown in Figures 13h and 13f are not suitable for good quality armor plate.

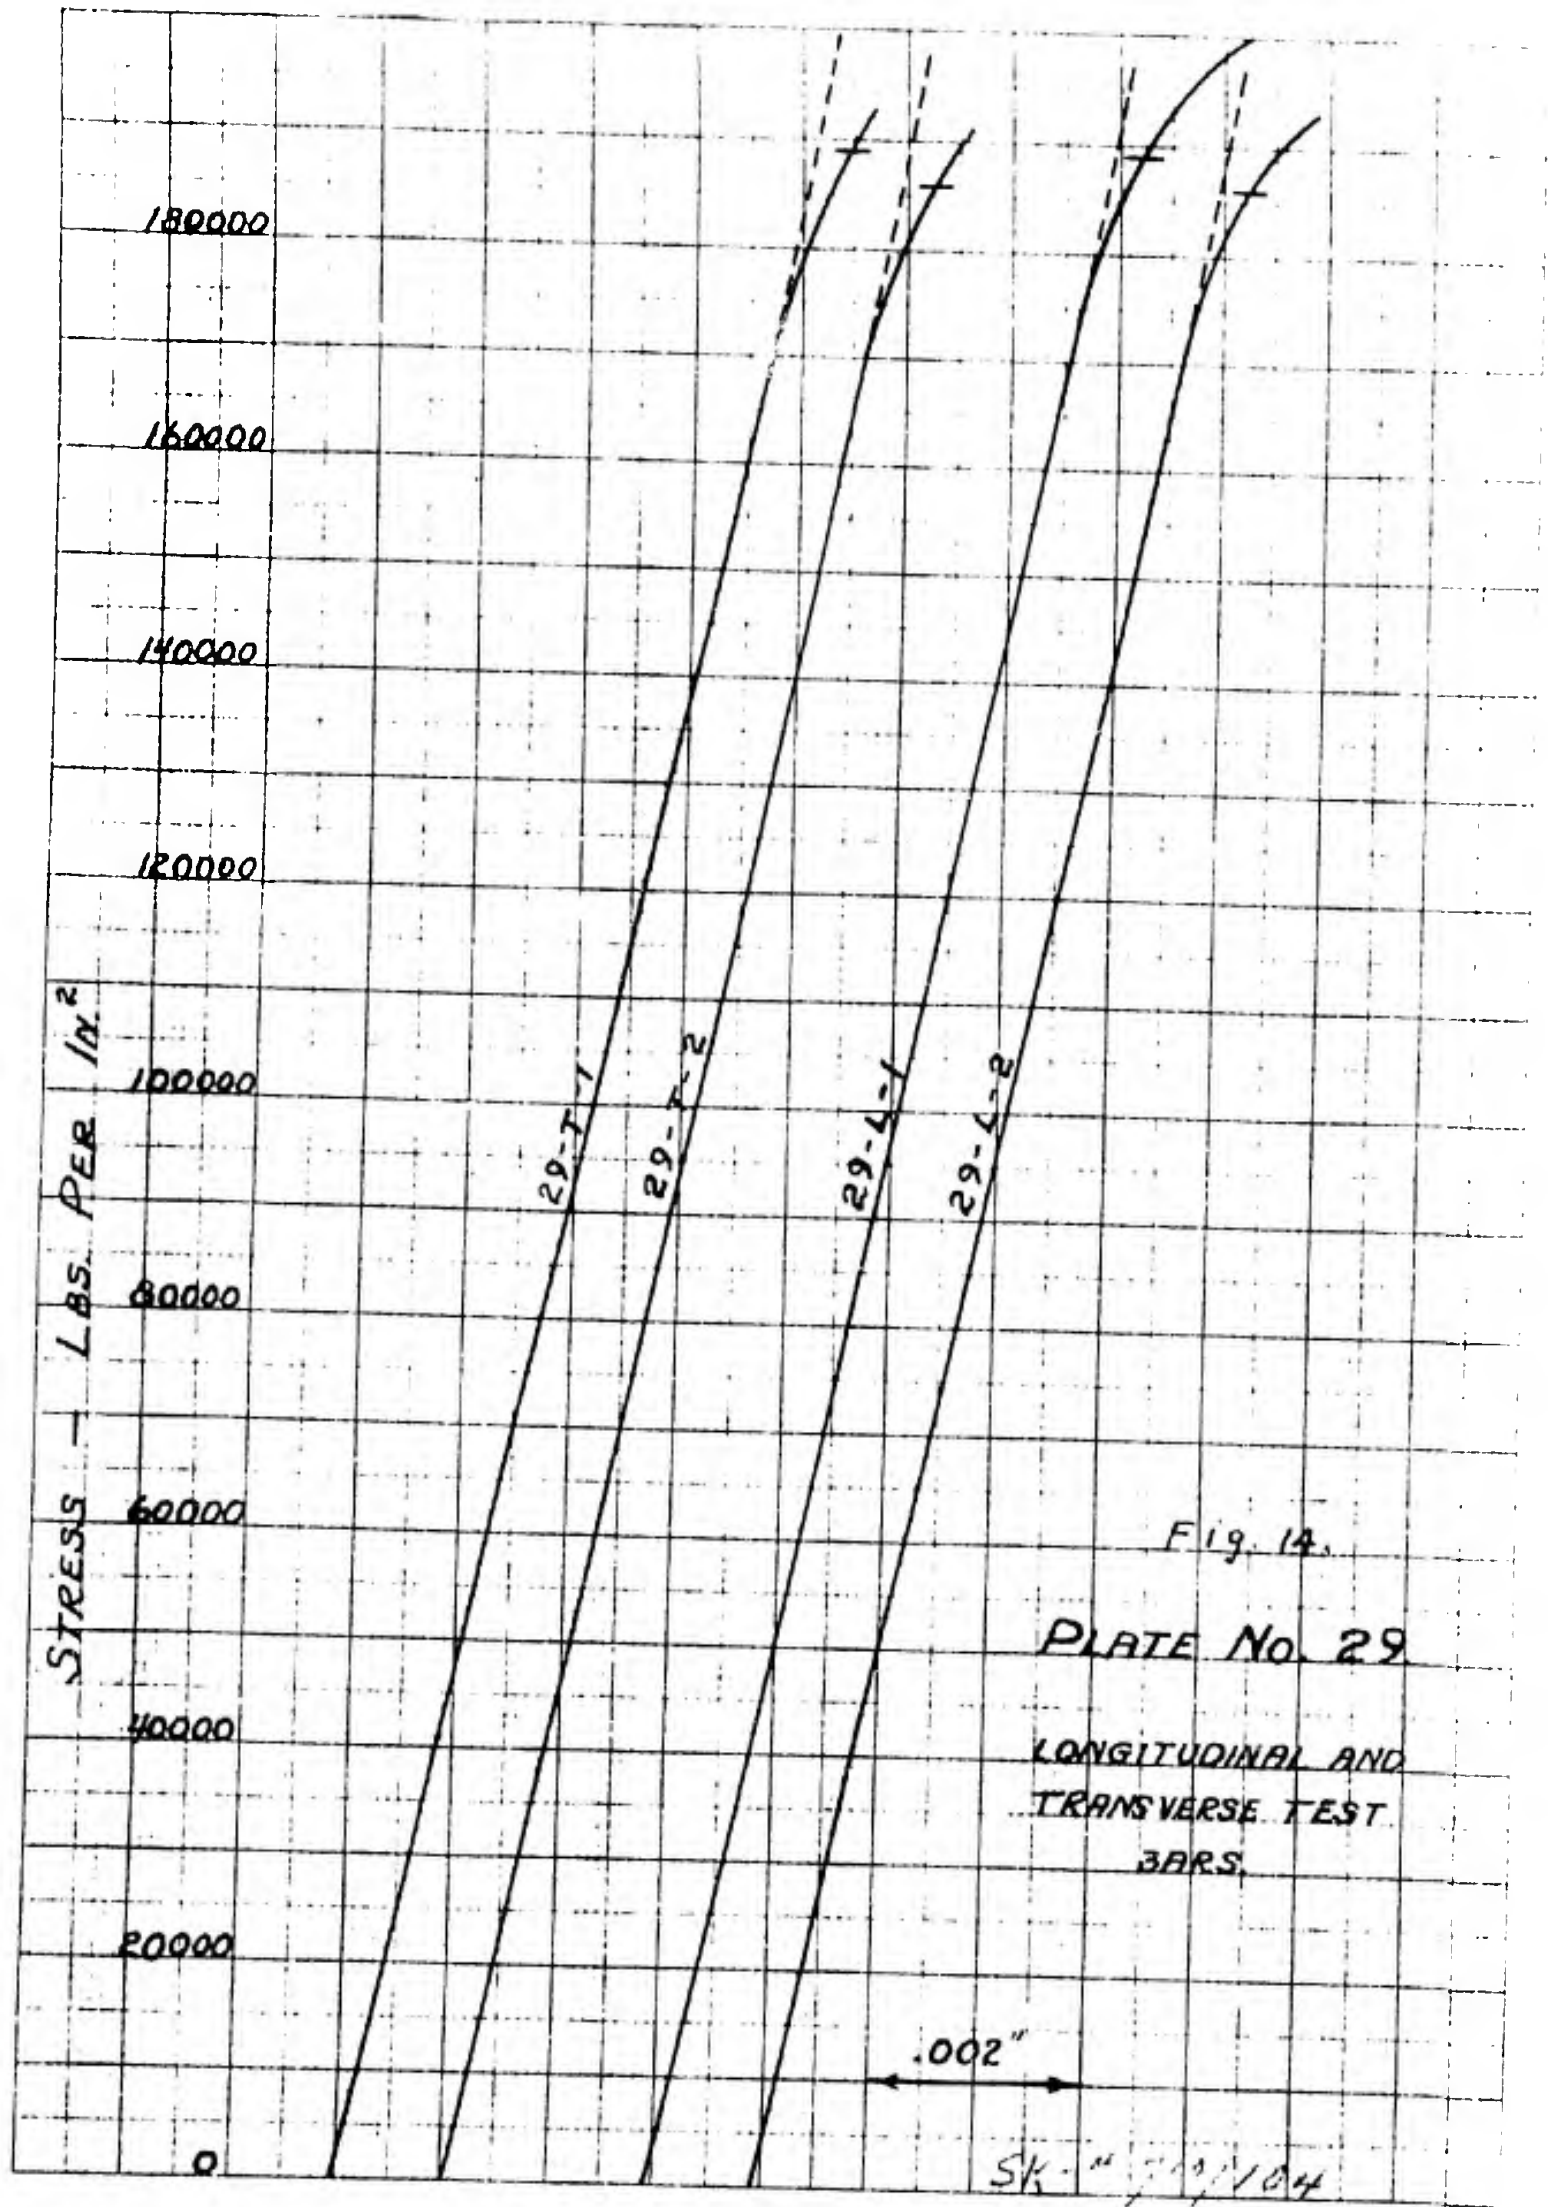
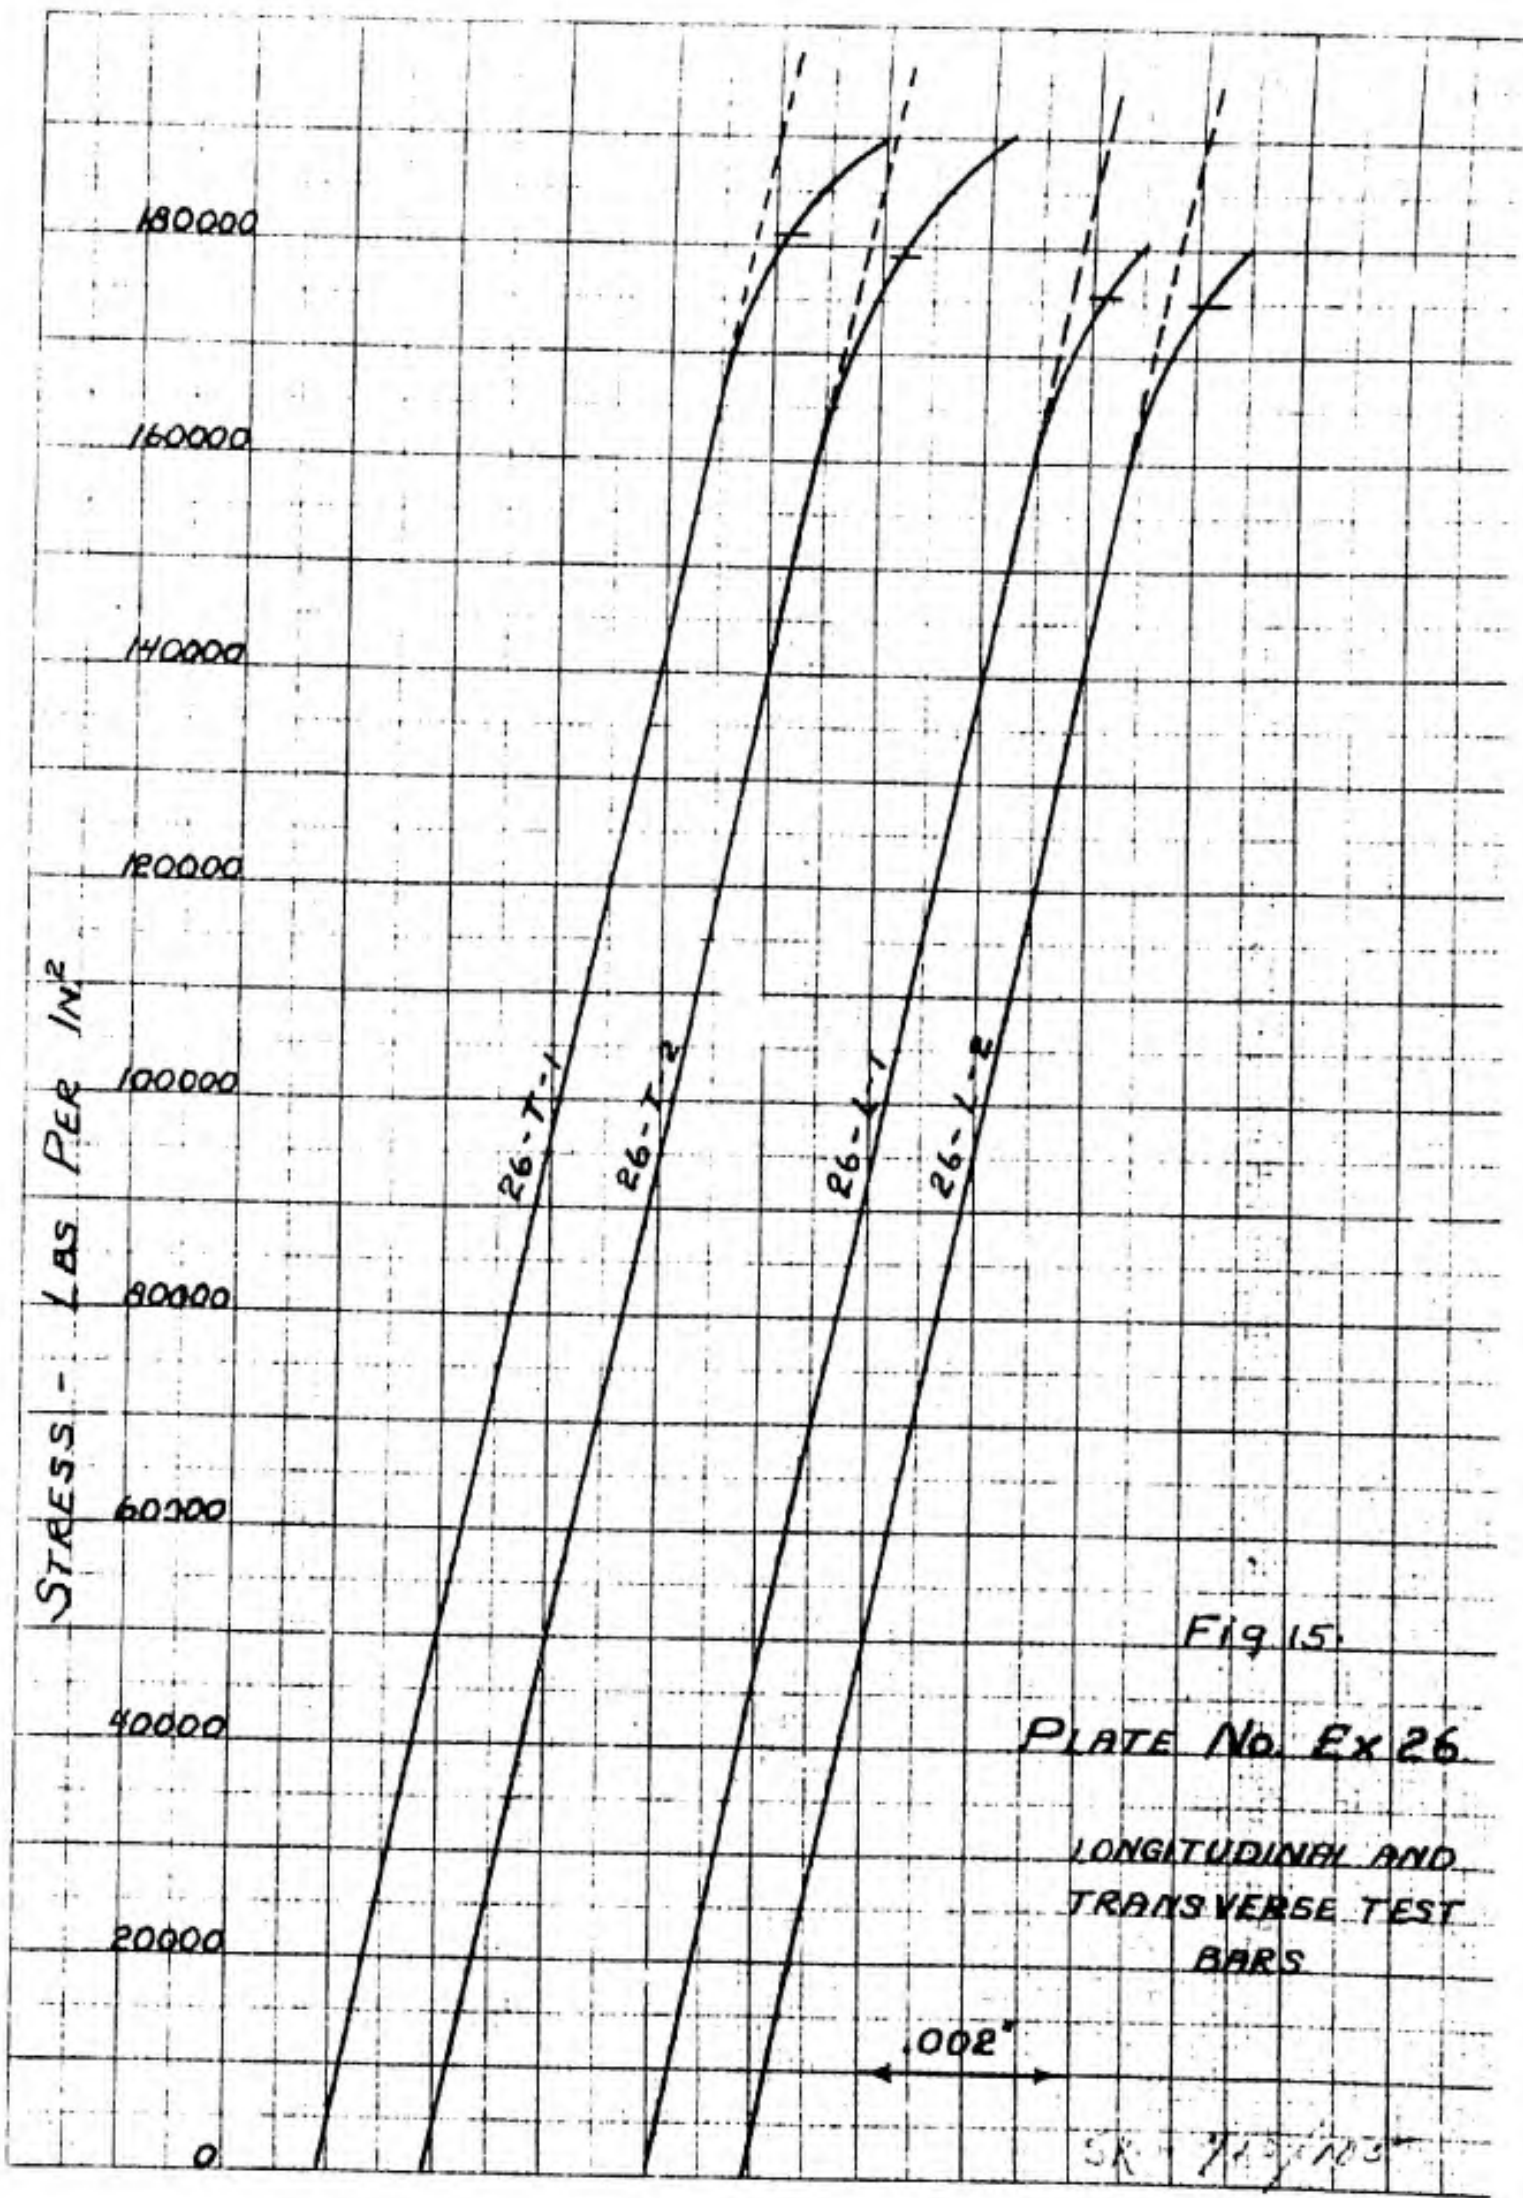
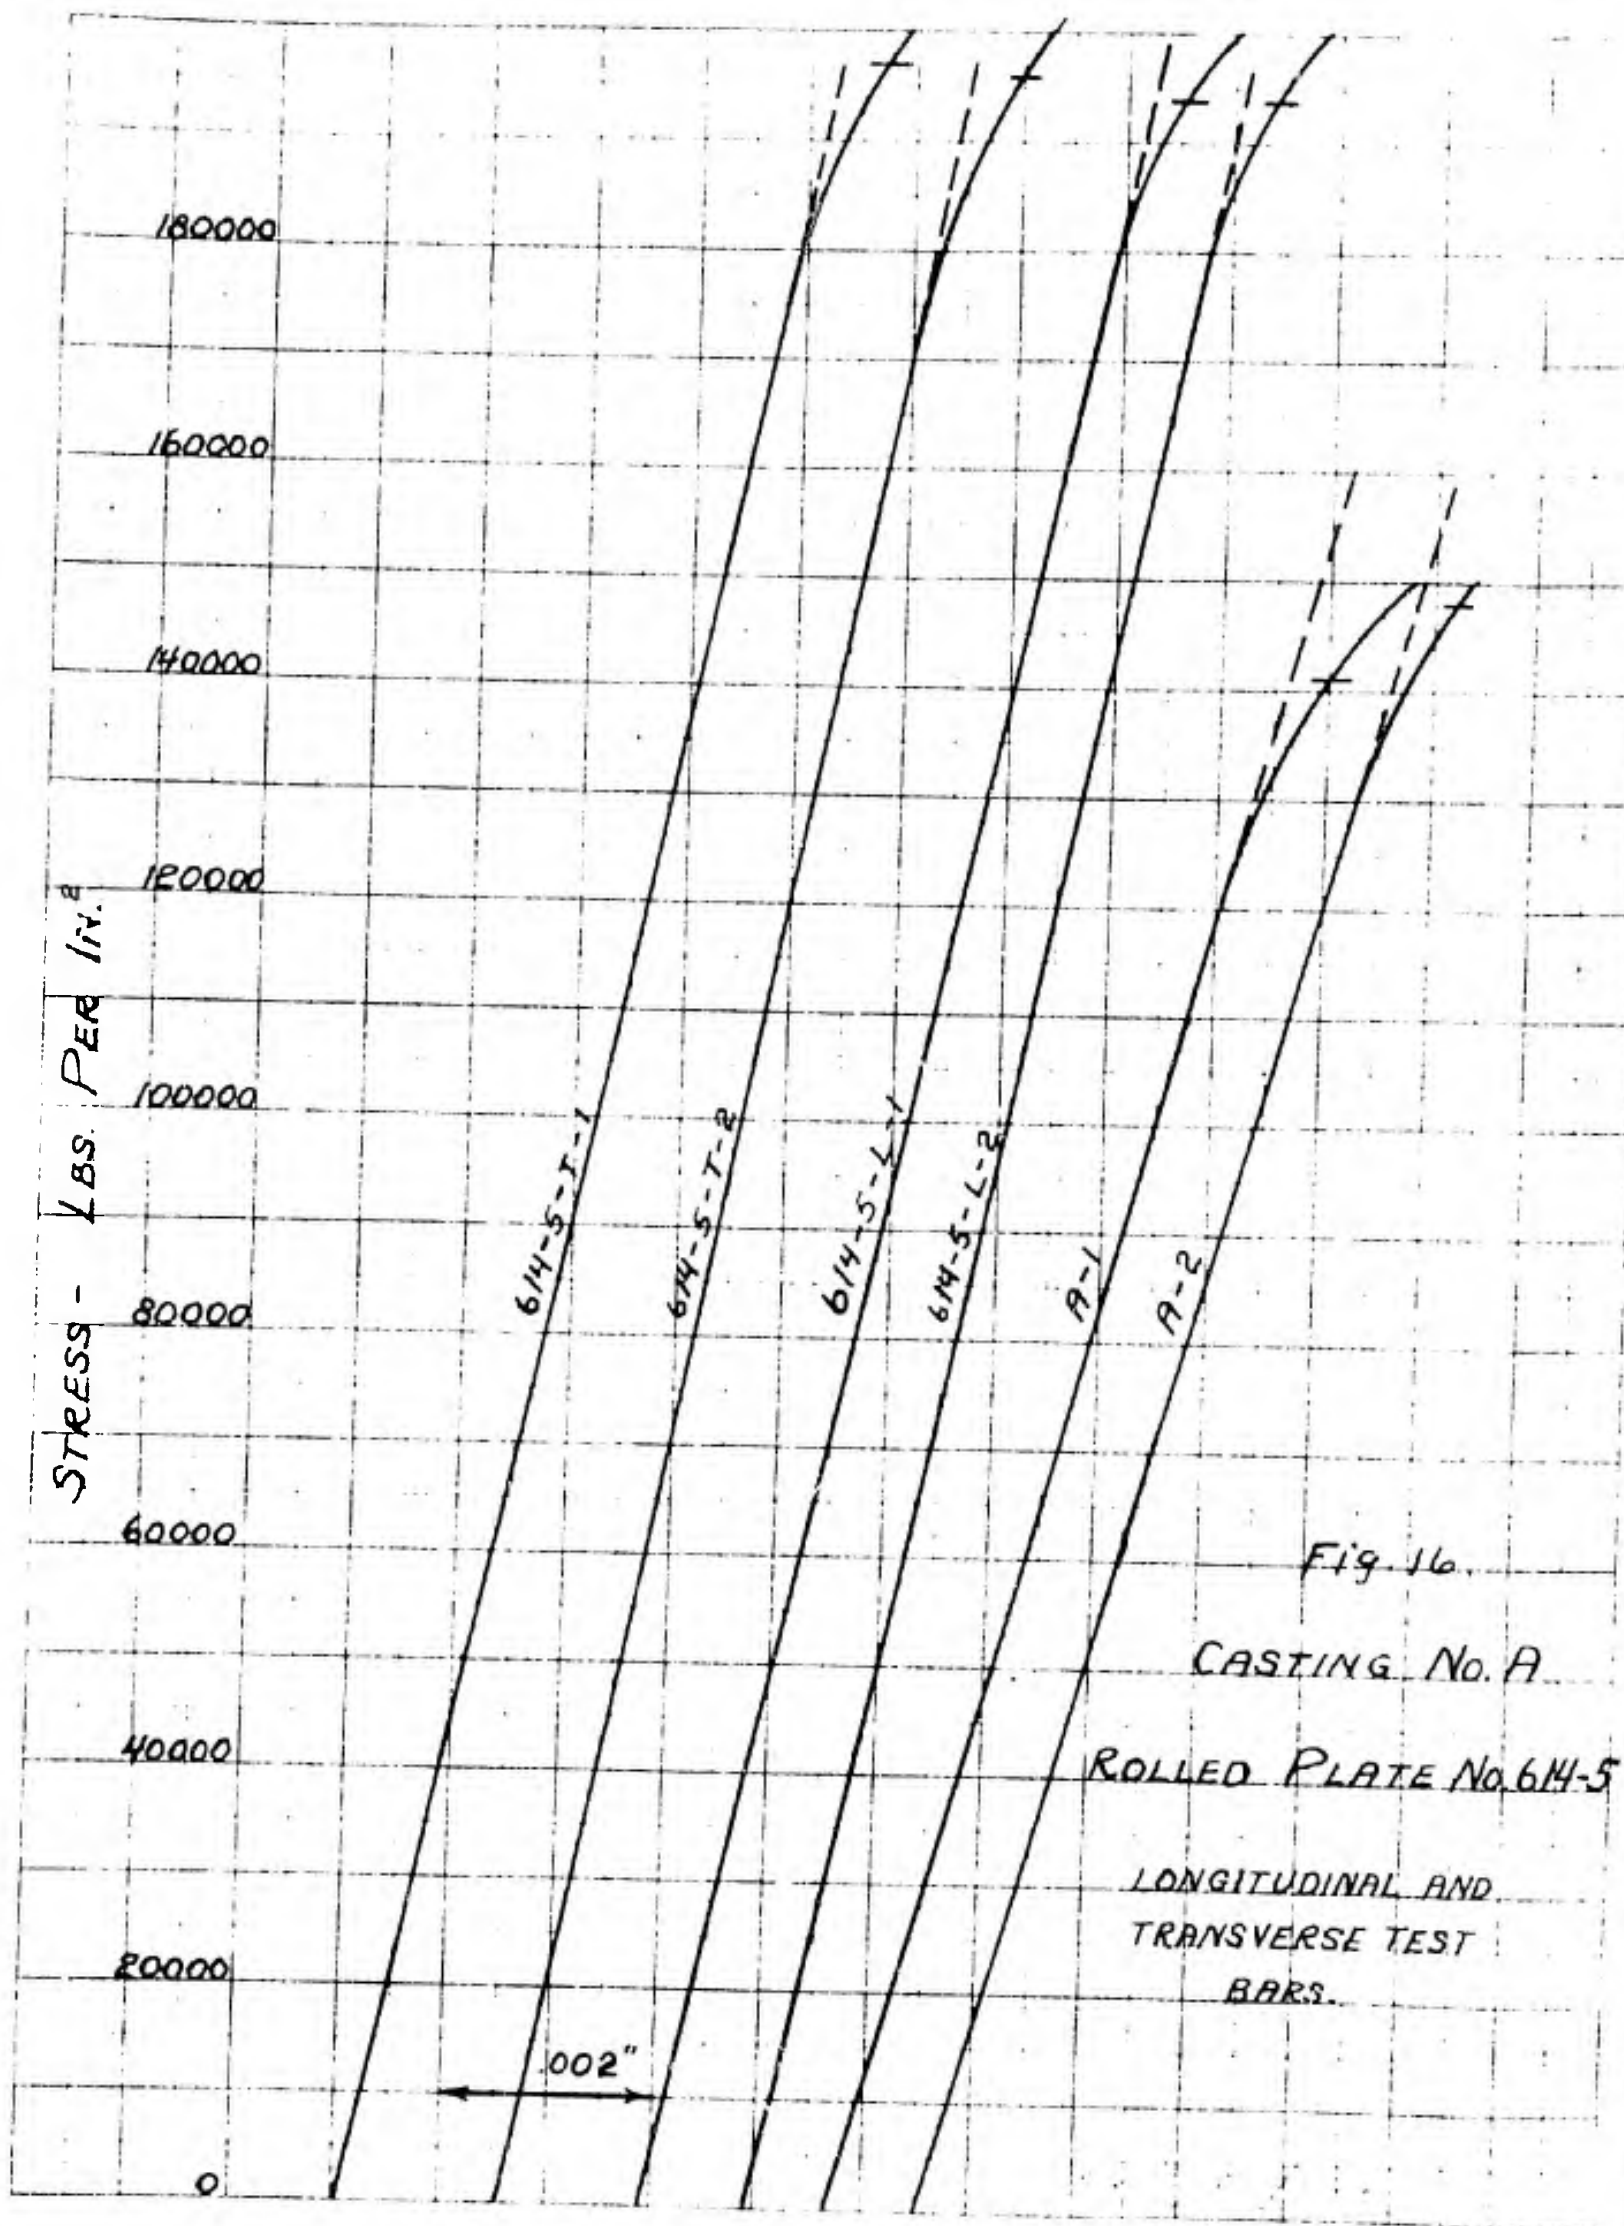
True stress strain curves are shown in Figures 14, 15 and 16.
