# USAAVLABS TECHNICAL REPORT 65-38

## COMPONENT TESTING XV-9A HOT CYCLE RESEARCH AIRCRAFT SUMMARY REPORT

CONTRACT DA 44-177-AMC-877(T)  
HUGHES TOOL COMPANY

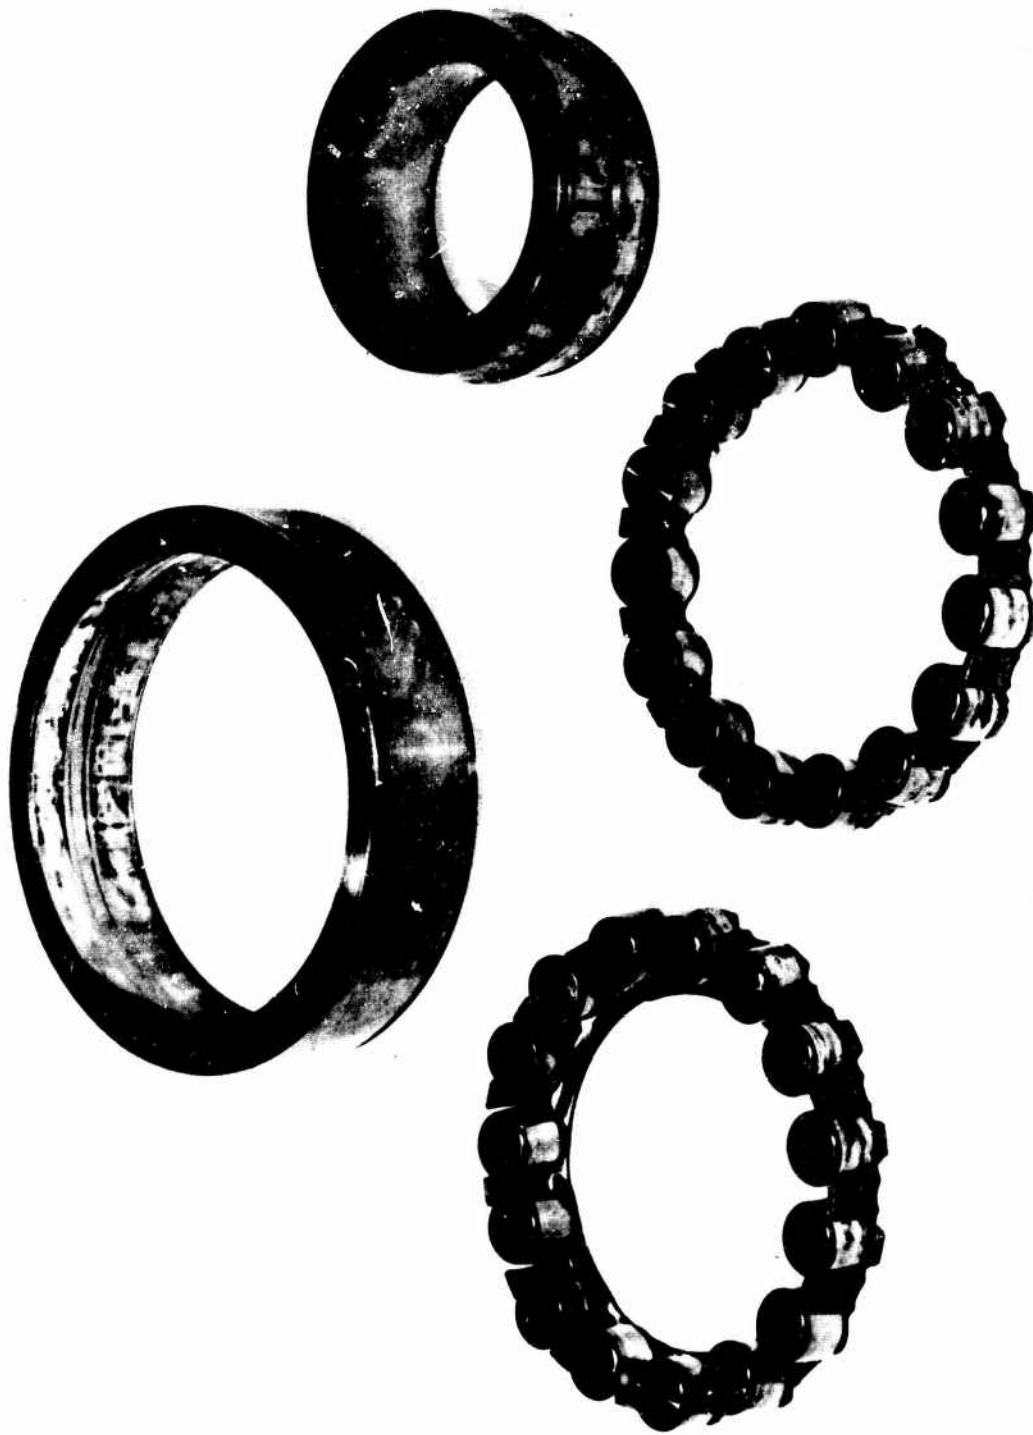
Figure 4. Hub Gimbal System Bearing After Completion of Test.

Figures 4 and 5 show the bearing and hub support structure conditions after the endurance test. The bearing was serviceable at the completion of the test.

1. Fifteen rollers showed evidence of fretting (heavily loaded zone).
2. Seven rollers revealed slight evidence of fretting (slightly loaded zone).
3. Eight rollers showed no evidence of fretting.
4. Mating surfaces on the bearing races also indicated areas of fretting.

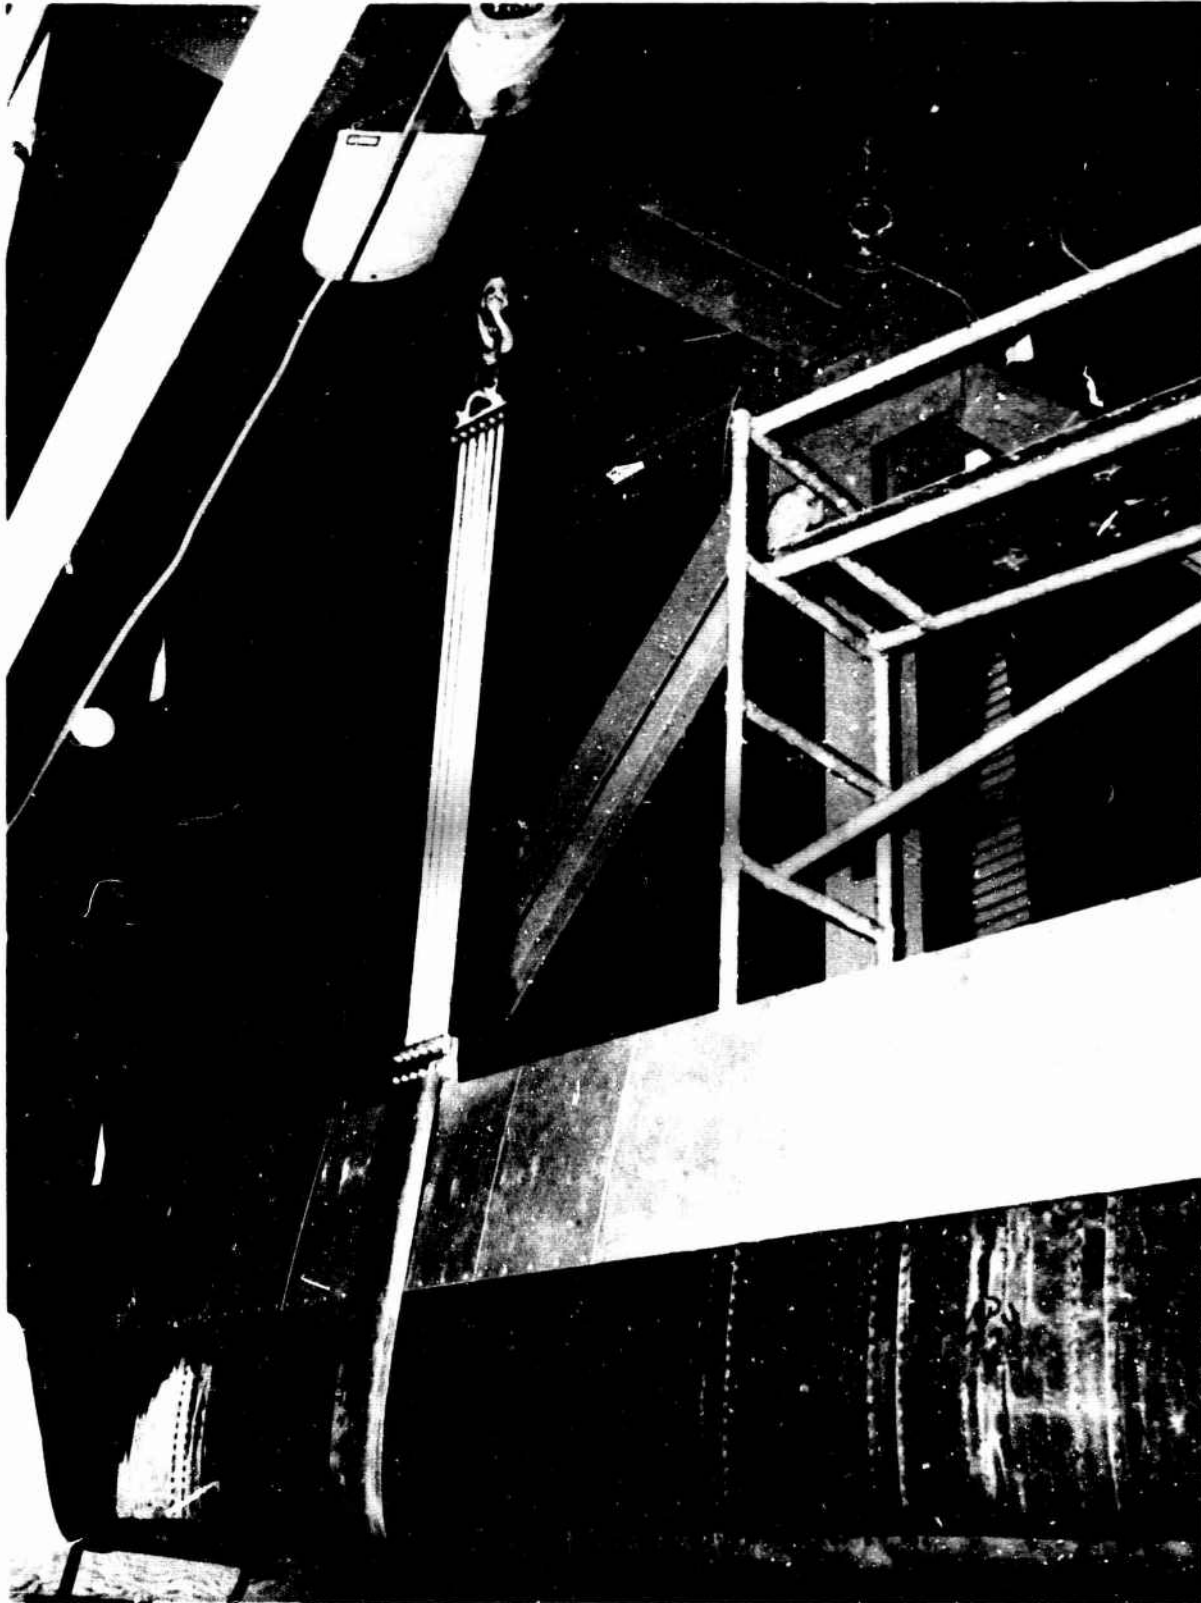
Figure 38. Rotor Blade Shake Test - Bungee Support System.

The bungee support system was later changed to blade station 218 (first mode nodal point), where the natural frequencies were again rechecked and were found to coincide with reported test results.

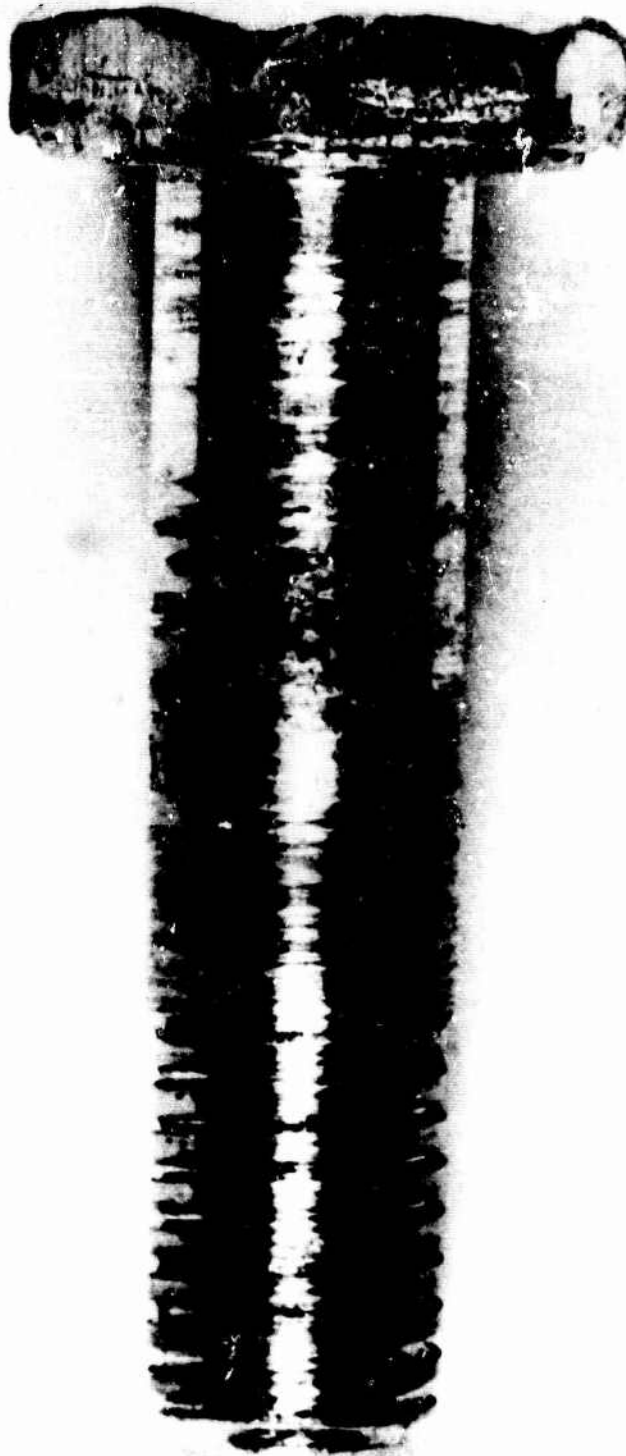
Figure 70. Appearance of Bolt Removed From Station 94. 12,  
Forward Spar, Where Major Cracks Occurred,  
Specimen 2.

3. Cracks in the first lamination on the segment side of the rear spar were minor, and were located at stations 74.62, 94.12, 119.12, and 144.12. They are not shown in detail, because Figure 68 is typical of their appearance.
4. Several spar-to-segment bolts (NAS 464, 1/4-inch dia) broke during the initial 250,000 cycles. They failed in different areas — one at the head, others at the root of the last imperfect thread. Conditions of typical bolts after test are shown in Figures 70 and 71.
