HYDRAULIC-PNEUMATIC FLOATING  
FENDER — ADDITIONAL IN-SERVICE  
TESTS, FIRST SERIES

U. S. NAVAL CIVIL ENGINEERING LABORATORY  
PORT HUENEME, CALIFORNIA

Technical Report R-430

Tests of two experimental hydraulic-pneumatic floating fenders, first in a well-protected harbor (Port Hueneme) and then in a relatively exposed harbor (San Diego), are described. Each fender consists of a 50-foot-long bulkhead fronted by two air-filled and two water-filled rubber bags. Also included is information to aid engineers in increasing the energy-absorption capacity of existing dock fender systems.

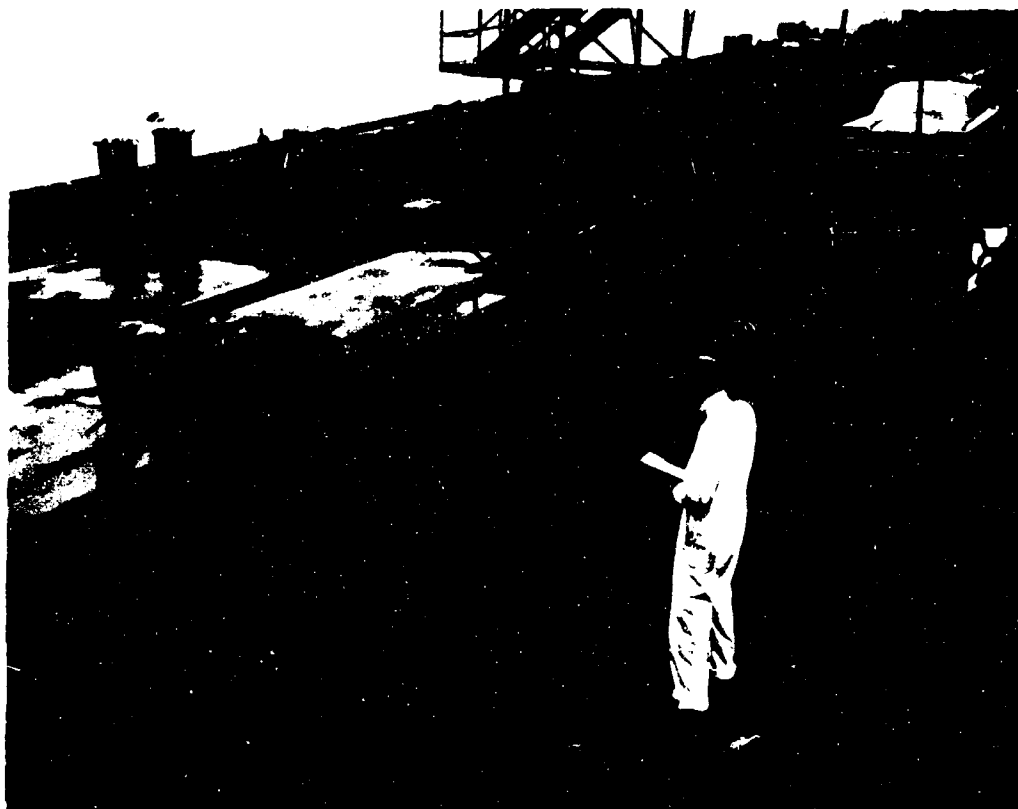
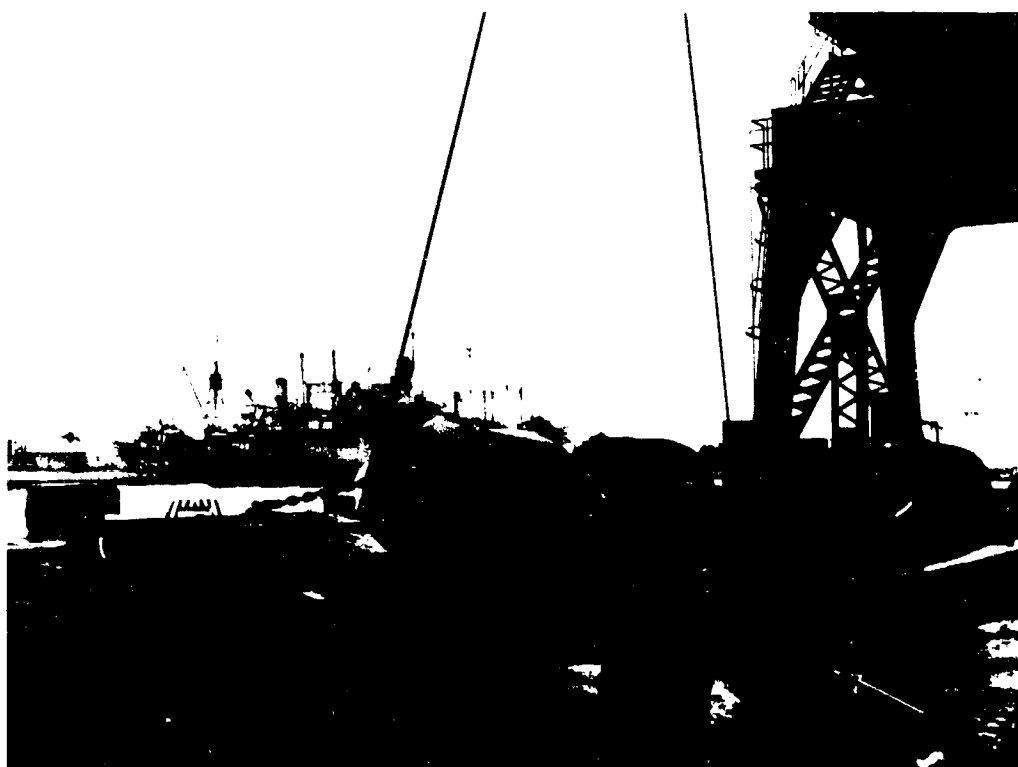
a. Arrow shows hydraulic rubber bag slightly collapsed.

b. Arrow shows separated hose.

Figure 26. Damage to hydraulic rubber bags.

3. Two of the four water-filled bags were found to be collapsed slightly after being lifted from the water (Figure 26). The 2-1/2-inch rubber hose connection at an offshore bag was separated from the bag due to deterioration of the hose clamps. Reconnection of it and reconditioning of two others was routine; galvanized iron seizing wire was used.

8. The concrete mooring weights were about 90% covered by marine algae and barnacles (Figure 26b).
9. The mooring chains showed signs of rusting and about 40% wear at the point where the chain rubs on the 4-inch steel guide pipe. This pipe was broken and flared out at the offshore end.
10. Two bolts holding the closure plate to the ballast pipe were loose. There was rust at the base of all pad eyes where they were welded to the ballast pipe.
