MARINE PHYSICAL LABORATORY
of the Scripps Institution of Oceanography
San Diego, California 92152

MPL PARTICIPATION IN SEALAB II

1 FEBRUARY 1966

SIO REFERENCE 66-3

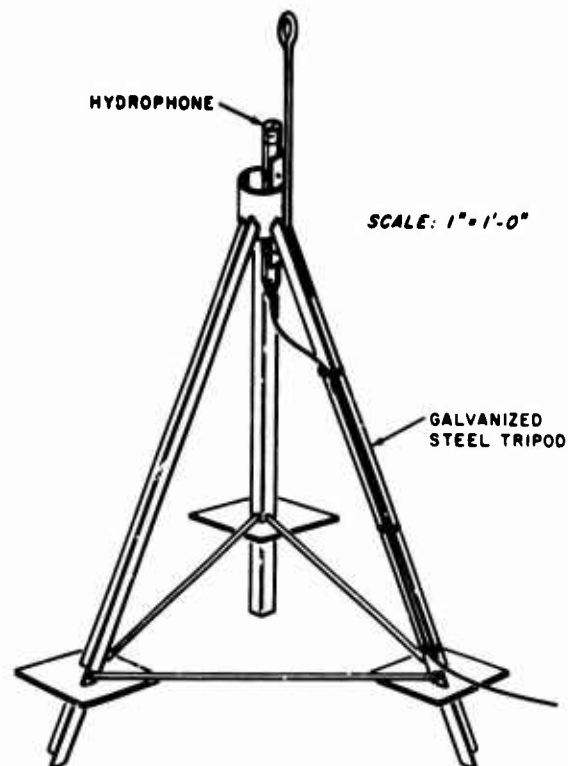
Figure 3. Hydrophone tripod

- (4) After installation and before casting off of the buoys attached to the Manila line and plugs, an electrical check was made from shore, and divers were sent down to make sure the tripods were standing in an upright position.

A third hydrophone was installed in a similar manner at a later date using a small barge for cable laying and hydrophone emplantment. The barge was maneuvered to a preselected position by means of optical sights from shore. At the preselected position the third tripod was lowered into place and connected to its shore cable.

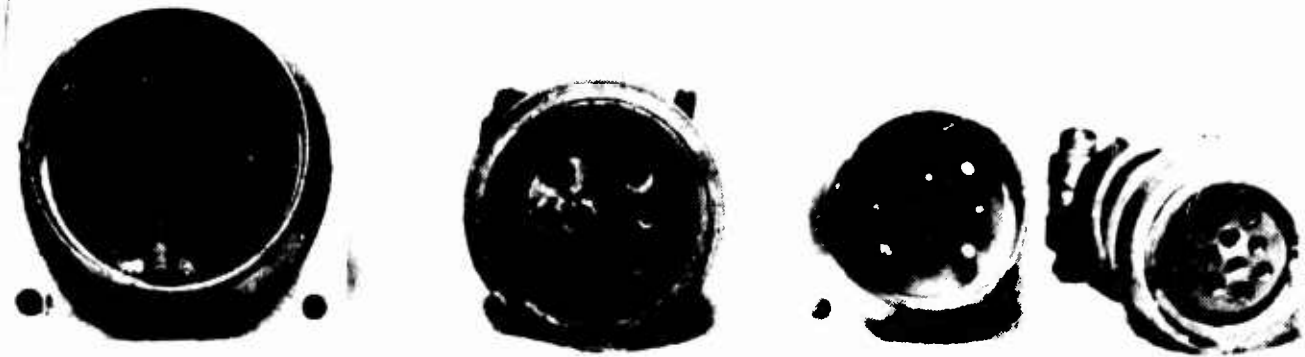
As mentioned previously, the majority of the malfunctions associated with the *SEALAB* project were attributed to connector failure associated with these sea cables. Figures 14, 15, and 16 show various degrees of corrosion and contamination which was observed on these connectors after recovery. In most cases, specific troubles can be traced to a particular connector-pin combination where the corrosion is severe. The cause of this corrosion is unknown; however, three hypotheses are offered:

- (1) Direct contact with sea water sometime during the handling process.
- (2) Pin-to-pin arcing or electrolysis while the connectors were still in the alcohol fluid.
- (3) High ambient humidity and possible salt water splash in the environment near the *SEALAB* trunk.

Figure 14. Connector corrosion and contamination

Figure 15. Connector corrosion and contamination

Figure 16. Connector corrosion and contamination

In considering the above items it is interesting to note that: (1) Corrosion was also evident on the *SEALAB* rack-mounted connectors (see Figure 8b), and (2) the single connector associated with the communications cable, which is terminated only by floating transformer windings, showed no signs of deterioration.
