# USAAVLABS TECHNICAL REPORT 66-27

## AIRCRAFT LITTER RETENTION SYSTEM DESIGN CRITERIA

Langston W. T. Weinberg

April 1966

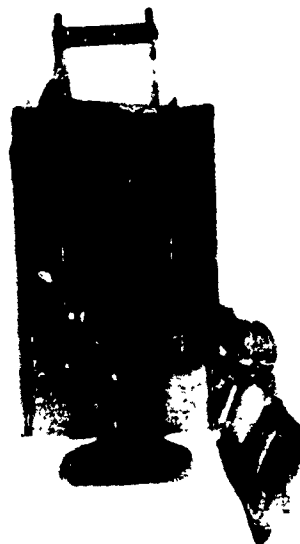
The upper bracket shown in Figure 20 failed owing to combined forward and downward loading. The lower aft side broke, and the lower forward side bent forward and downward. This failure resulted in the complete release of litter restraint in this location.

Figure 20. Upper Bracket, Stanchion Mount.

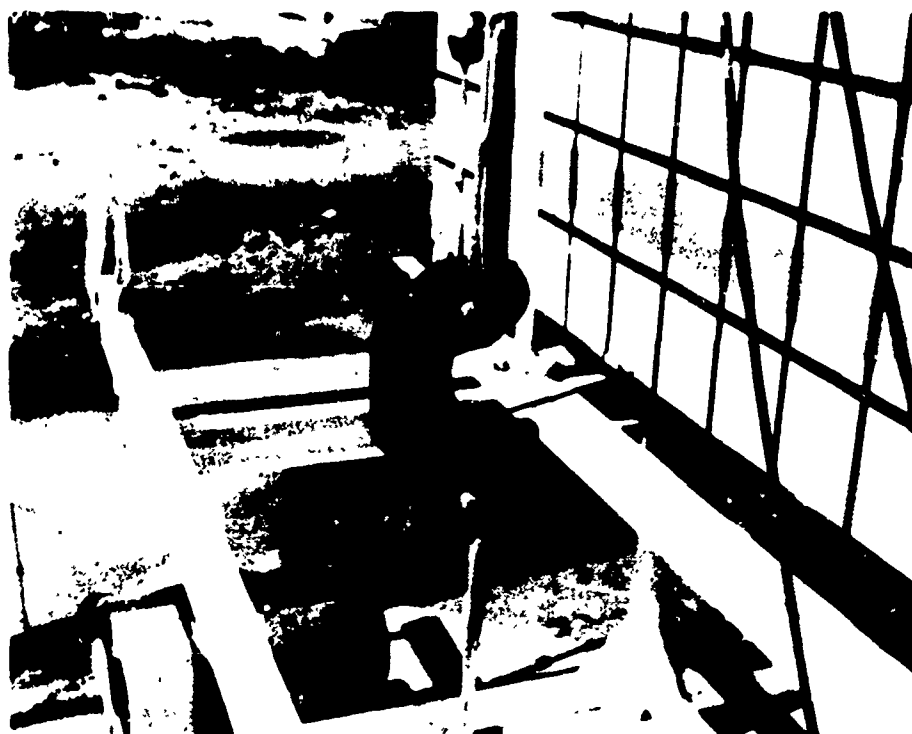
Figure 32. Litter Bracket With Positive Lock.

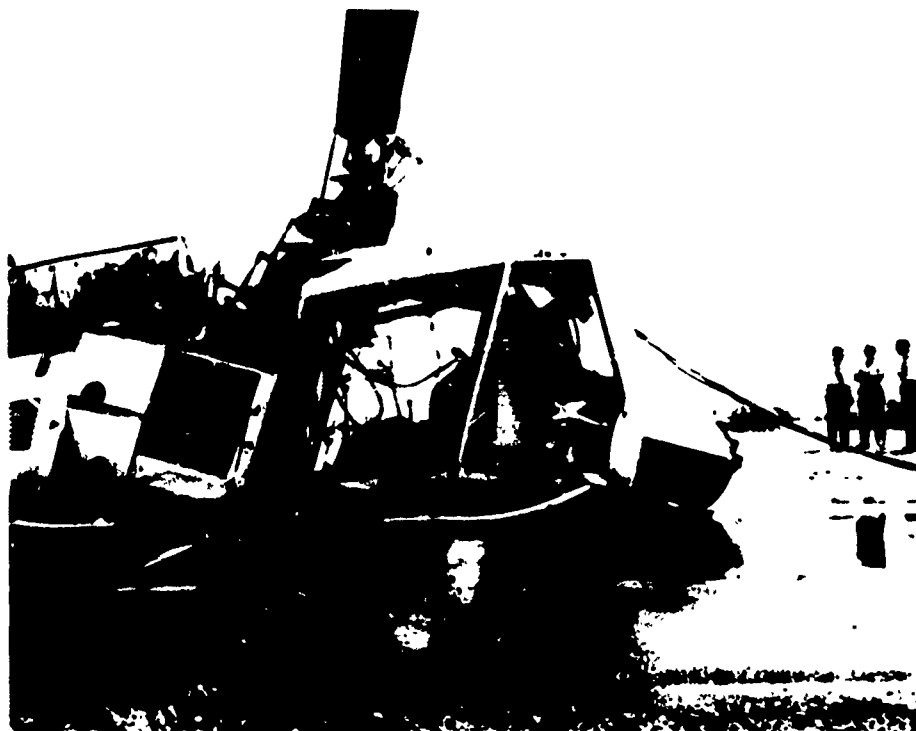
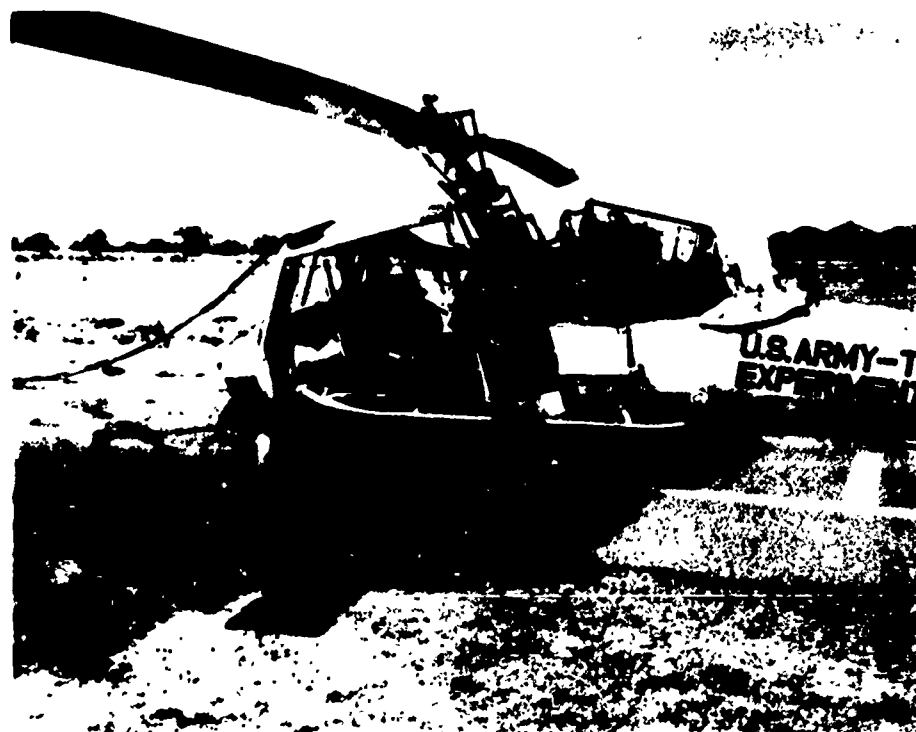
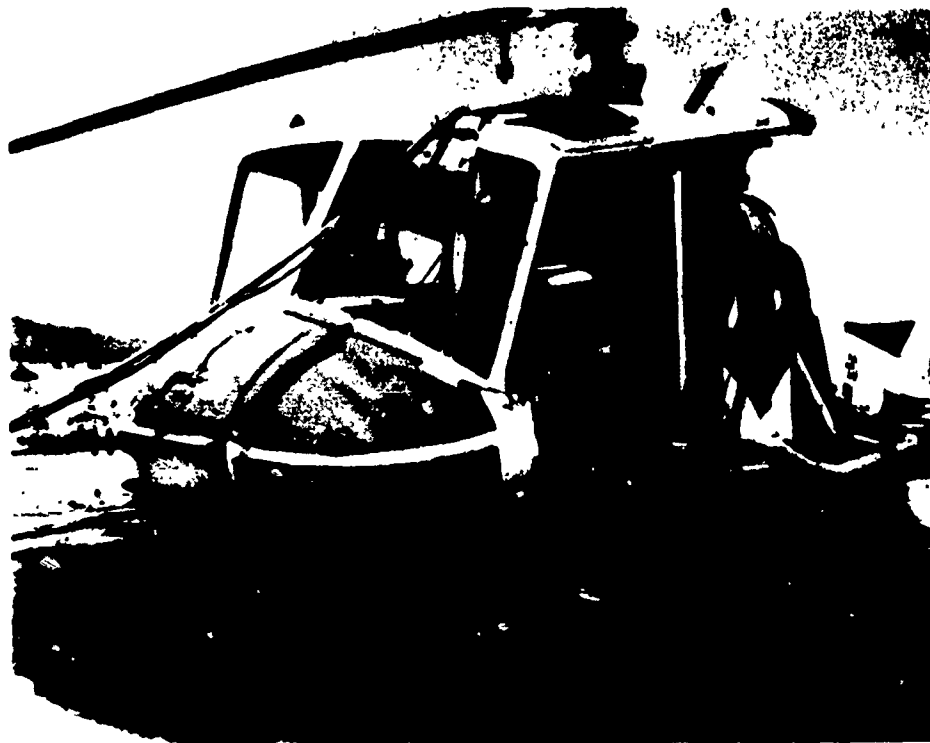
Figure 35. Postcrash XH-40 - Right Side View.

Figure 36. Postcrash XH-40 - Left Side View.

Figure 37. Postcrash XH-40 - Left Front View.

The XH-40 was dropped from a moving crane with impact parameters of 44 feet per second forward and 40 feet per second downward. The litter system did not function as planned owing to failure to the forward litter straps at the stitching. Certain conclusions can be drawn from the test, however, which demonstrate even more the need for the development of a crashworthy aeromedical evacuation system. The litters failed at a G level of approximately 20G. The standard litter system previously failed at approximately 9G. This means that a system of more than twice the strength of the standard litter system still fails with catastrophic results in a potentially survivable crash.
