NRL Report 6387

## Investigation of the Intergranular Corrosion of Lead-Antimony Grid Alloys

A. C. SIMON

April 7, 1966

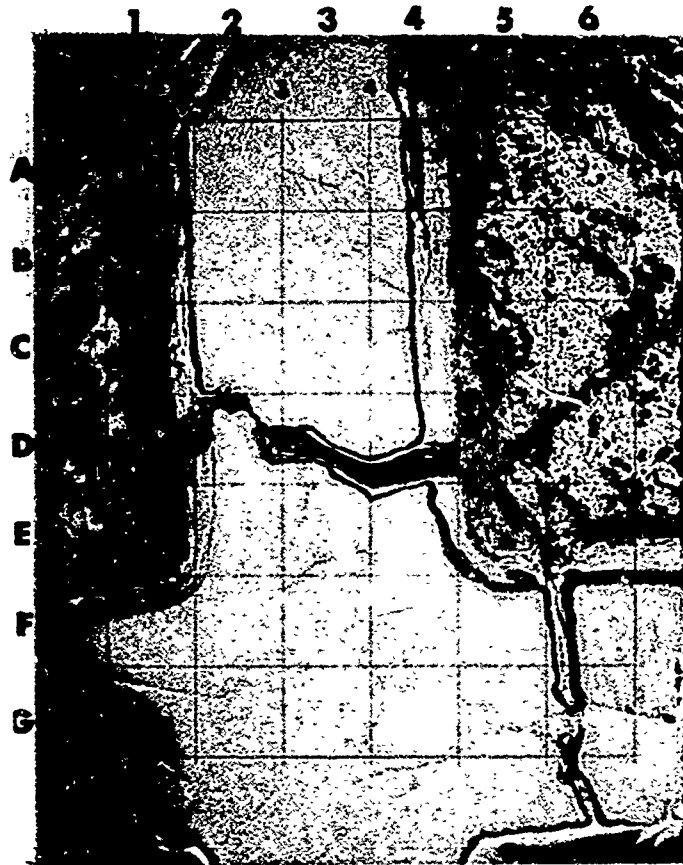
Fig. 1 - A cross section of the junction of two grid members. The photograph shows two major examples of intergranular grid corrosion as found in the 10-year-old battery. A portion of the corrosion layer along the surface of the grid and some of the surrounding active material are also shown. Lines forming the squares are 550 microns apart and the original magnification is 20X.

Figure 1 illustrates several features of this intergranular corrosion that should be mentioned. Although not clearly visible at this magnification, all corrosion resulting in cracking proceeded along grain boundaries, often by rather devious paths. This will be illustrated in later photomicrographs. Although intergranular corrosion cracks could initiate at almost any grain boundary intersecting the surface of the grid, the worst cases were always near the junction of two grid members. At the same time only a small portion of all the grain boundaries that intersected the surface, even at such an intersection of two grid members, showed evidence of such a localized attack.

The crack that crosses the grid at D2, D3, and D4 of Fig. 1 has completely severed the grid, and actual separation has occurred, the space between the two sections being filled with the plastic used in the impregnation. The crack itself extends through the grid, the corrosion product at each side of the grid, and into the active material. There have also been lateral and vertical displacements of the two portions of the grid member. It is concluded that the grid sections were displaced after the plate was removed from the cell and dried, and that this caused cracking of the active material. It seems unlikely that the wet active material would exhibit such a clean fracture. Figure 2 is an enlarged view of D2

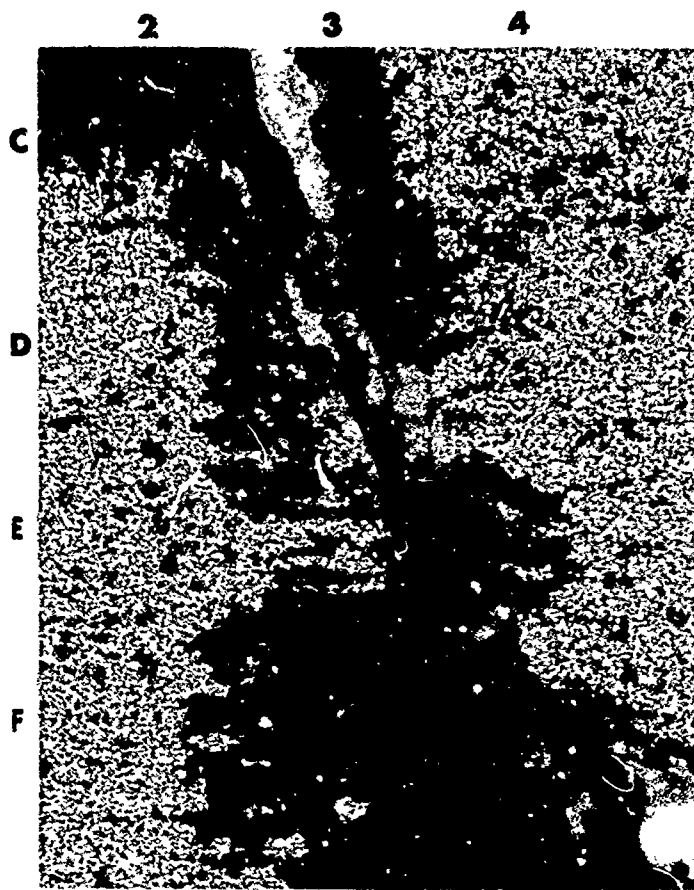
Fig. 4 - Same as Fig. 3 except viewed with polarized light. Lines forming the squares are 60 microns apart and the original magnification is 400X.

the same magnification but illuminated with polarized light. In this picture it can be more clearly seen that extensive lateral corrosion has taken place in a manner that definitely indicates interdendritic corrosion as the dark material in D3, E3, E4, F3, and G3 shows. In addition, comparison of Figs. 3 and 4 reveals that the material along the edge of the crack in F4 and G4 of both photographs differs in appearance from that which occurs in regions of interdendritic corrosion as found in such areas as D3 and E3.

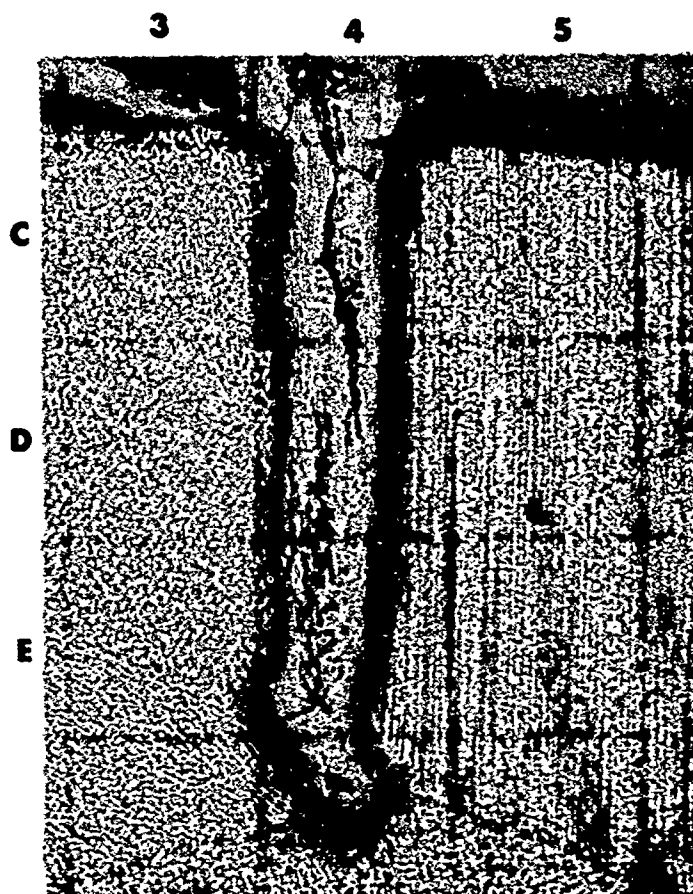
Fig. 9 - The upper portion of the corrosion shown in Fig. 8. The corrosion is intergranular and the grain at the bottom of the photograph has temporarily blocked further extension. Lines forming the squares are 238 microns apart and the original magnification is 100X.

Figure 9 shows the portion of the intergranular corrosion that occurs in C3 and D3 of Fig. 8. It can be seen from the surrounding microstructure that the corrosion has definitely followed the grain boundary between the two adjoining grains and has been slowed against the boundary of a grain at right angles to the path of the corrosion. The obstructing grain offers no boundary for extension of the intergranular corrosion except in a direction nearly parallel to the surface. Throughout this study no cracks proceeded very far in a direction nearly parallel to the surface, and this photomicrograph shows no exception.

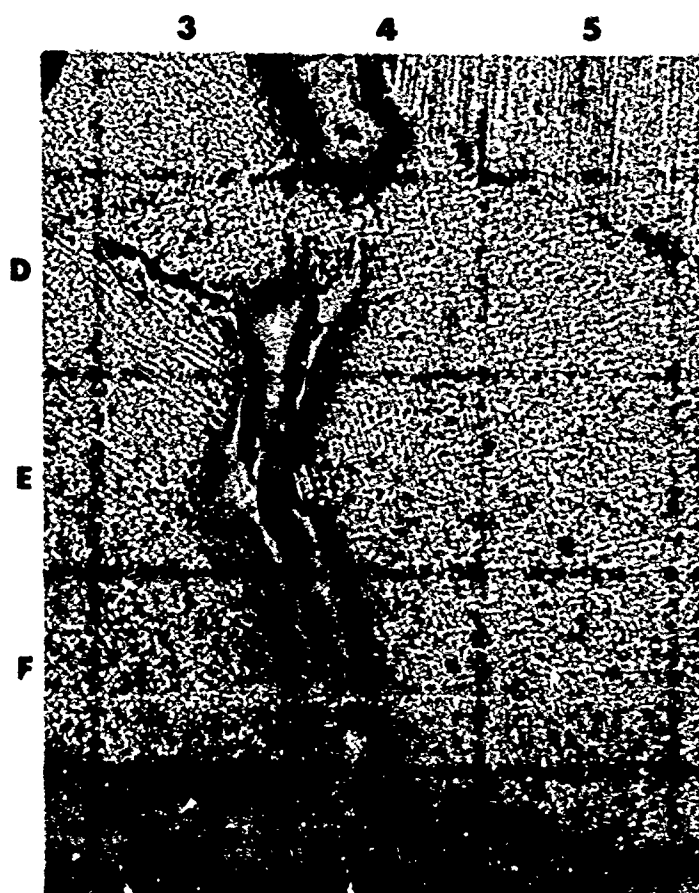
Fig. 10 - The lower portion of the corroded area shown in Fig. 8. Again note the different orientations of the grains bordering the corroded area and the corrosion that has proceeded only a short distance along the grain boundary in D3 that is roughly parallel to the surface. Corrosion has also become interdendritic in several areas. Lines forming the squares are 238 microns apart and the original magnification is 100X.

Figure 10 shows the portion of intergranular corrosion below that of Fig. 9 and represented by D3 and E3 of Fig. 8. Here also the corrosion is proceeding inward along a grain boundary but has also taken a short incursion along another grain boundary across D3 of Fig. 10. At this magnification it may appear that there is also a grain boundary in the upper left-hand quarter of D4 and that corrosion may be proceeding along it to a junction with the corrosion above.

The rather large cracks in the intergranular corrosion of Fig. 10 are somewhat puzzling. Since the corrosion product occupies more volume than the alloy, one would suppose that this space would be completely filled and that the corrosion product would be exerting considerable stress on the surrounding areas. Since no cracks appear in the lower portion nearer to the surface of the grid it is supposed that this portion is exerting pressure that causes the inner portion to crack before it has corroded to the same extent. Notice for example that a quite large crack occurs at the lower right of D3 of Fig. 10, as if the leverage of the corrosion product in F4 might be literally prying out the grain to the left of F4.

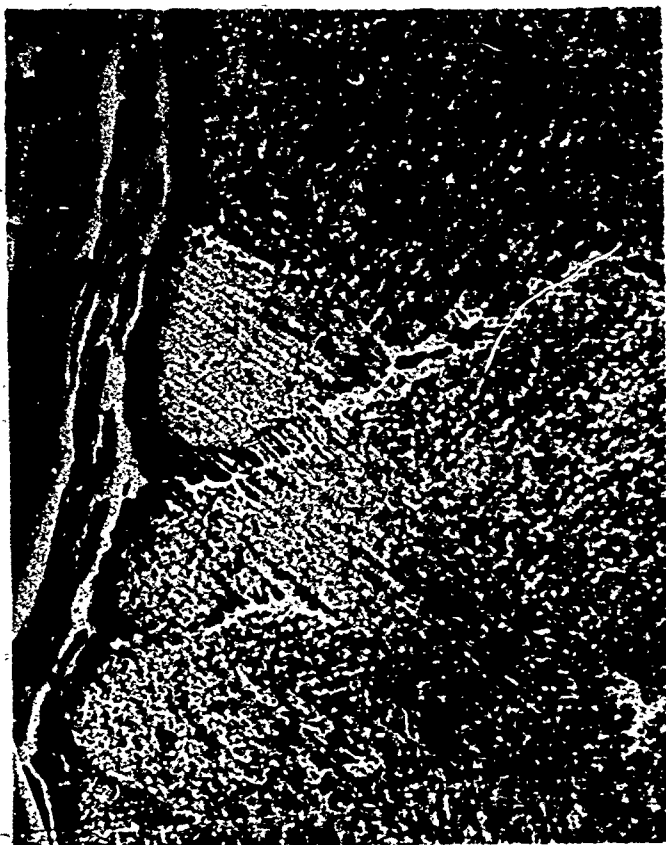
Fig. 13 - An example of interior stress. The wedge-shaped grain to the left of center has developed intergranular corrosion on each side. The increased volume due to corrosion product has resulted in stress cracking at an interior grain boundary (right of center). Original magnification is 100X.

Figure 13 shows a case where corrosion along each side of the wedge-shaped grain at the surface has caused sufficient internal stress so that an actual crack has formed, farther from the surface. The crack does not extend to the surface along either side of the wedge-shaped grain. Also, corrosion has occurred along both sides of the open crack and there seems to be no positive way of telling whether this happened before or after the crack itself developed. There were also cases in which internal cracking at the grain boundary occurred without evidence of corrosion having preceded it in the area. It appears that the internal stress produced by the corrosion in a portion of the grain boundary forms a wedge that is sufficiently strong to pry apart the boundary ahead of its advance. See for example Fig. 14, which shows such a crack that formed ahead of the corrosion or, in other words, developed in the alloy at a point farther than the corrosion had penetrated. This crack was free of corrosion and showed clean separation along the grain boundary. Its terminus, not visible in the photograph, was at the boundary of a third grain which evidently better resisted the internal stress.

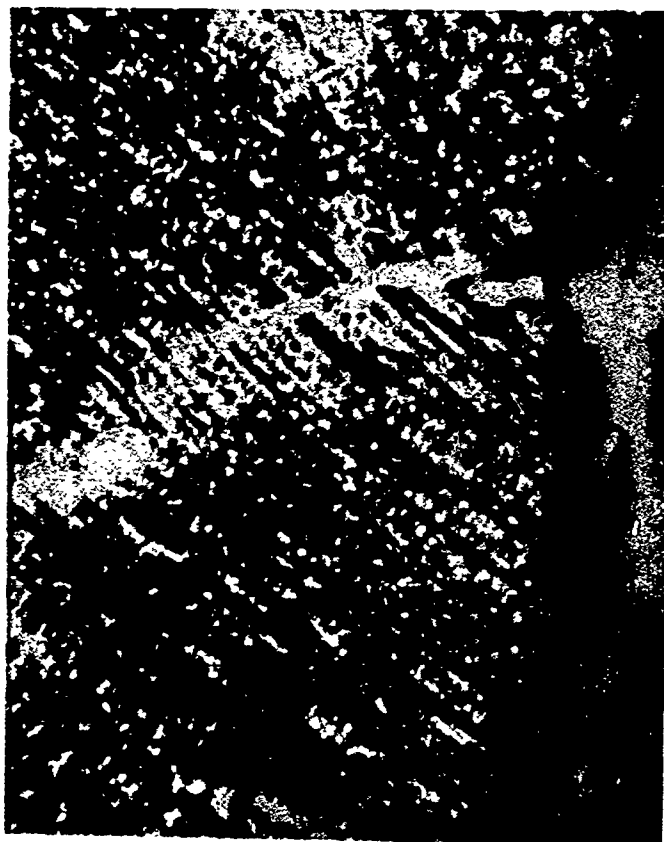
Fig. 19 - Example of an unusually extensive intergranular corrosion in the 7-year-old battery. Even with extensive interdendritic corrosion and consequent increase in volume in this area there has been no actual cracking. The interdendritic corrosion extends much farther between the primary dendrites adjacent to the grain boundary than at the metal surface, although the dendritic branches are all part of the same grain. Original magnification is 250X.

Figure 19 shows another example of grain boundary corrosion in which the penetration and the interdendritic penetration along the boundary are much deeper than in Fig. 17, although there is still no visible cracking. There is also evidence of interdendritic corrosion along the surface of the grid beneath the layer of corrosion product. However, although interdendritic alignment along the metal surface above the crack is the same as at the intergranular boundary, nowhere along the metal surface is there any such penetrating type of attack as that which occurs in the vicinity of the grain boundary. This can also be seen in Fig. 20, a view of the same area by polarized light. Near the surface
