MISCELLANEOUS PAPER NO. 4-804

ROCKET - BLAST - RESISTANT MATERIALS

ROCKET ENGINE BLAST TESTS ON EXPEDIENT SURFACING MATERIALS

U. S. Army Engineer Waterways Experiment Station
CORPS OF ENGINEERS
Vicksburg, Mississippi

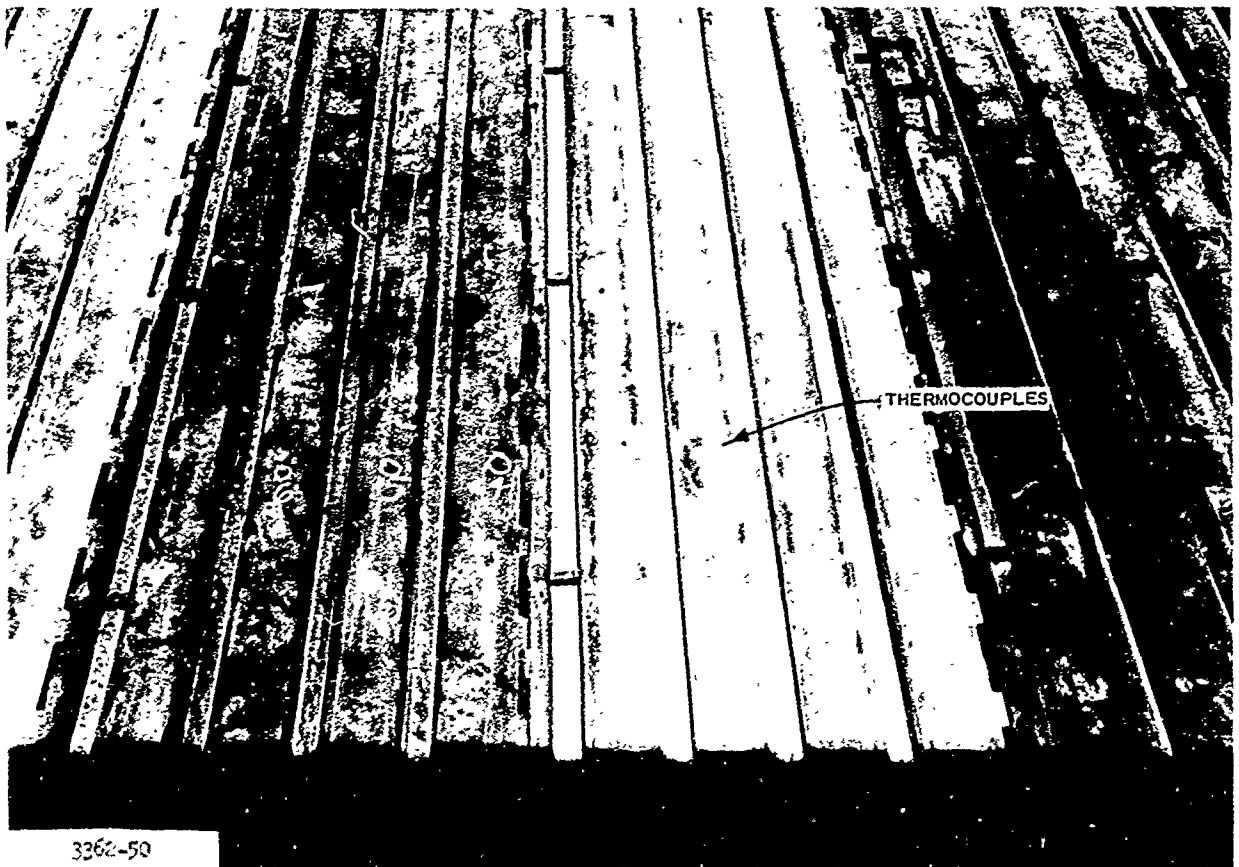
3362-50

Photograph 7. Steel panel test area, first test

differential amplifiers, and continuous recordings were made during the test. The test area and the location of the thermocouples as viewed from the rocket engine exhaust nozzle are shown in photograph 7.

18. During the test, temperatures on the surface of the panels were recorded from thermocouples 1, 2, 4, and 6. Thermocouples 3 and 5 were damaged by the blast force and did not function properly. Thermocouple locations can be seen in photograph 7. The following maximum temperatures were recorded.

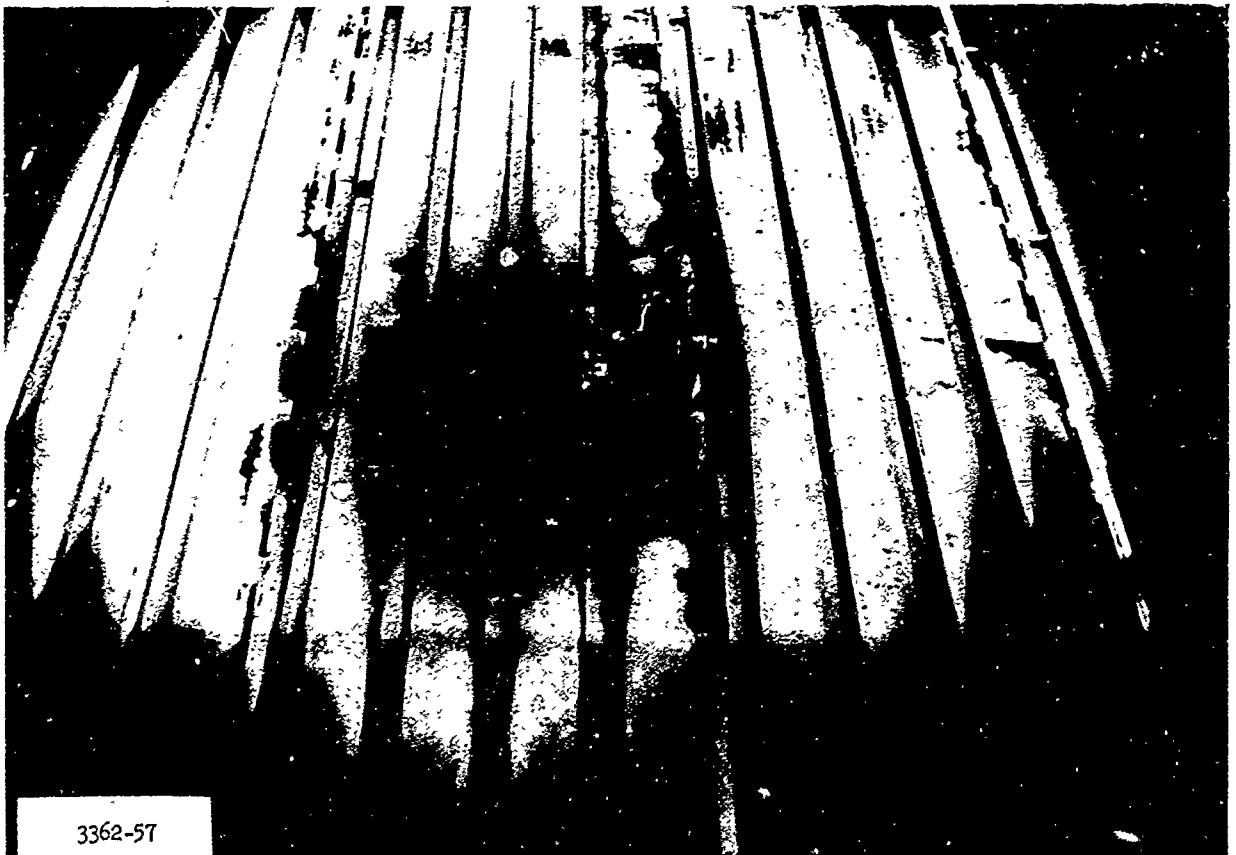
3362-57

Photograph 9. Steel panel surface after first test

15. Photograph 8 shows the blast test in progress, and photograph 9 shows the condition of the panels after test. Only the side connector that presented a surface discontinuity to the flow of the hot, high-velocity gases was damaged. The maximum temperature recorded during the test was 3200 F, but the center of impingement was slightly to one side of thermocouples 1 and 2 (see photograph 7). Photograph 10 is a close-up of the damaged area.

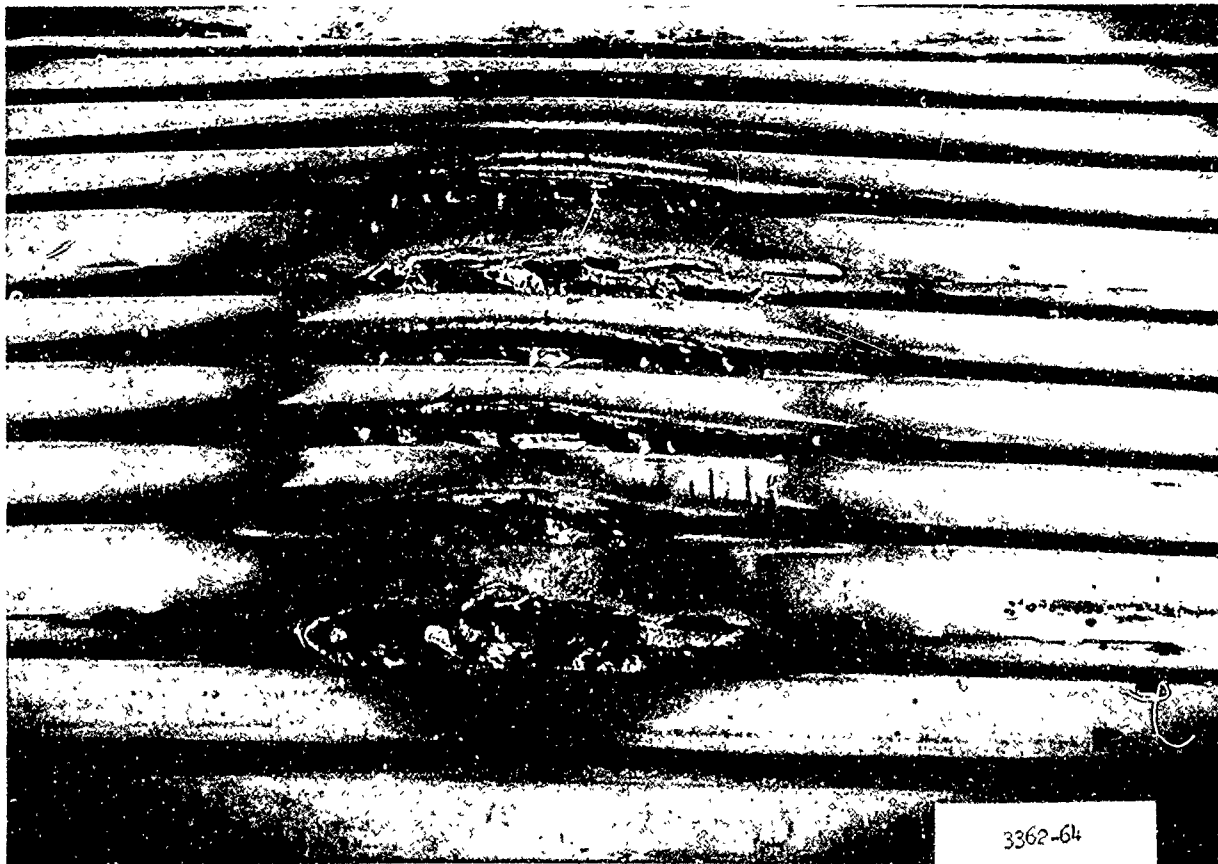
Photograph 12. Steel panel surface after third test

20. Photograph 12 shows the blast impingement area of the steel panels after the third test as viewed from the rocket engine exhaust nozzle. Considerable damage was done to the panel as the hot exhaust gases impinged against the rib sections. The abrupt change in surface at the edge of each rib of the panel apparently caused concentration of heat which in turn burned the steel at these points. A comparison of photographs 9 and 12 shows that the blast along the panel ribs caused less panel damage than that across the ribs.
