COMPACTED-SNOW RUNWAYS
IN ANTARCTICA
DEEP FREEZE 65 TRIALS

NAVAL FACILITIES ENGINEERING COMMAND

U. S. NAVAL CIVIL ENGINEERING LABORATORY

Technical Report R-480

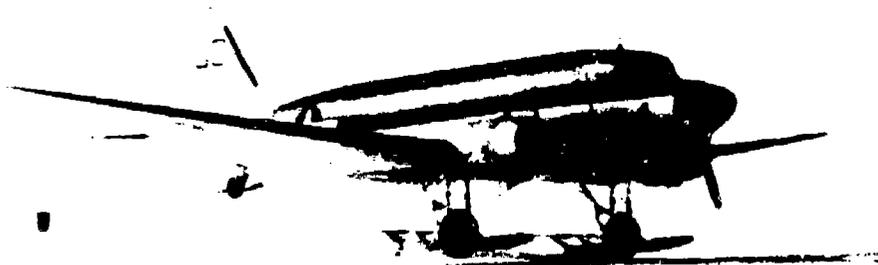
Figure 16. C-47 aircraft making a wheel landing on the 10-70 test area on 3 December 1964.

The C-47 aircraft landed on skis on the 10-70 area at 0900 hours. The tires on its two main wheels were inflated to 60 psi and its tail-wheel tire to 30 psi. Because of the prevailing wind, the aircraft landed on the shelf or east end of the area (Figure 2). It touched down near Station 60+00 and came to a stop near Station 20+00, where the pilot turned it around on skis and taxied back to Station 30+00. After a slight pause, he lifted the skis and slowly taxied on wheels to Station 65+00 and back to Station 15+00. He then made a high-speed serpentine taxi test run back to Station 60+00. Starting at Station 60+00, he took off on wheels in 1,500 feet, circled the area, and made a wheel landing (Figure 16), a second takeoff and a second landing. The copilot then made a wheel takeoff and two touch-and-go wheel landings and takeoffs to complete the test.
