RADC-TR-67-138
Final Report

RELIABILITY TEST PROGRAM OF ULTRASONIC
FACE DOWN BONDING TECHNIQUE

Robert P. Moore
Univac Div. of Sperry Rand Corp.

TECHNICAL REPORT NO. RADC-TR-67-138
June 1967

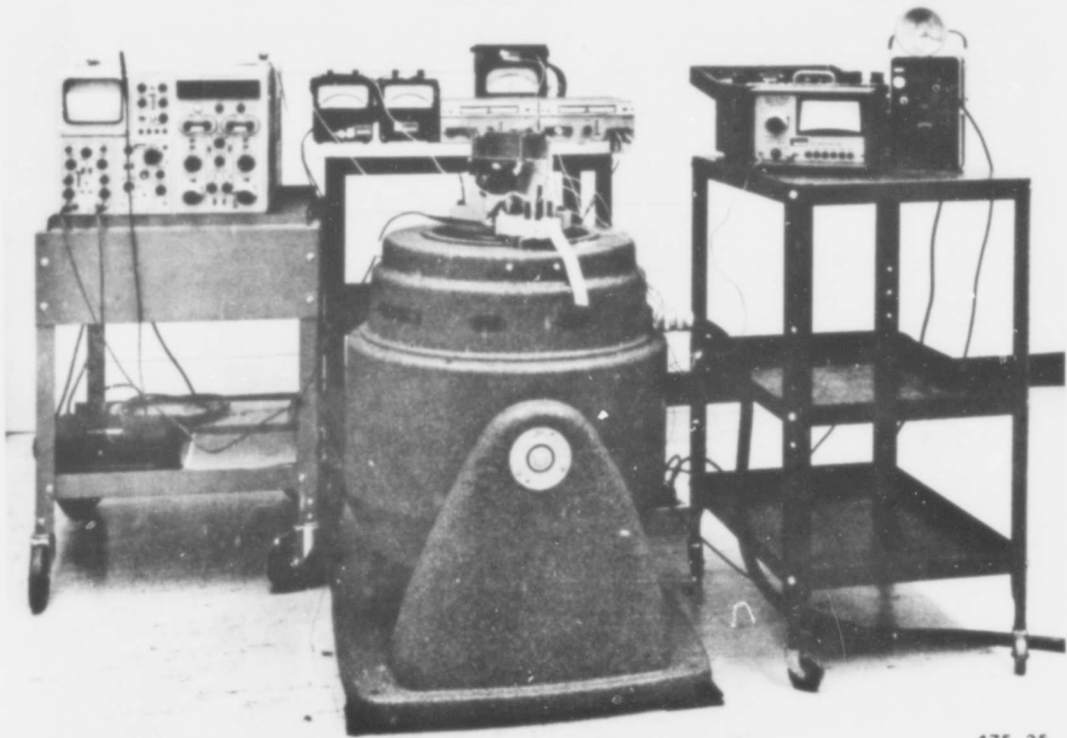
Figure 23. Vibration Test Equipment

Thirty group I, 30 group II, and 31 group III bonded chips were subjected to the vibration test. Paraffin was used to attach the test substrates to aluminum plates mounted on the test equipment. The test equipment is shown in Figure 23, and the aluminum mounting plate and test substrates are shown in Figure 24.

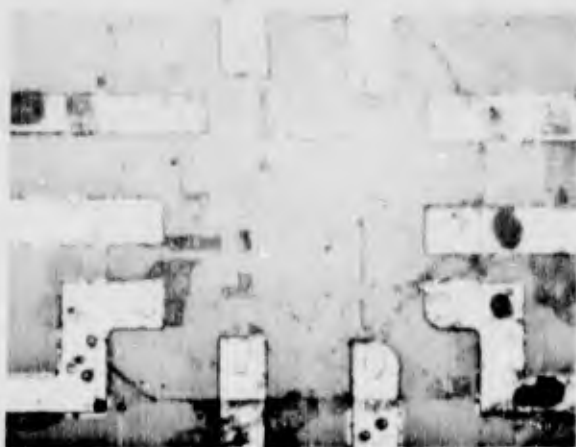
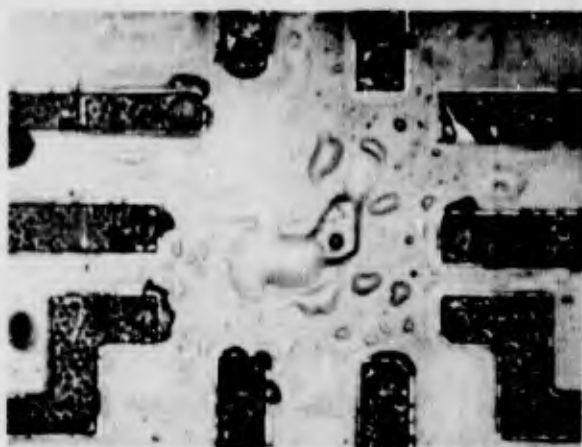
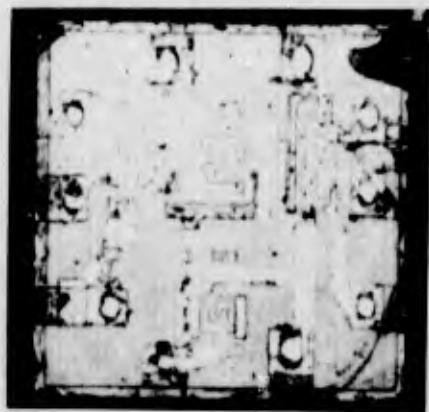
Figure 31. Temperature and Humidity Failures Showing Corrosion

The aluminum substrate wiring was severely corroded in this test, as shown in Figure 31, which shows photographs of actual failures. Even the potted units were damaged. The aluminum metalization on the chips was appreciably corroded; corrosion was observed in the pad areas as shown in Figure 32.

A thorough examination of the failures was made. It was obvious that a major cause of failure was the corrosion of the aluminum on the substrates, although some failures were attributed to the corrosion of the metalization on the chip in the pad area. Samples were chosen from each failure group, cleaned, and then rebonded to new substrates. These samples tested functionally good, indicating no chip damage due to the bonding process.

The observed corrosion may be due to the formation of chromium-aluminum electrolytic cells, to the presence of organic contaminants, or to large numbers of pinholes in the aluminum. It was evident that when there was misalignment of the chromium and aluminum in the evaporation the wiring was severely corroded. The misalignment allowed the chromium to be

The corrosion only occurs when the sample is exposed both to high temperature and to high humidity. The substrate wiring did not corrode in the high-temperature storage test, and substrate wiring deposited under similar conditions has shown no signs of corrosion after exposure to 100-percent relative humidity at normal room temperature.

The test results clearly indicate that some method must be devised to prevent the substrate interconnect wiring from corroding. The corrosion of the metalization on the chip pad areas could have been induced by the substrate wiring corrosion. It was evident that the glass passivation prevented corrosion of the circuit metalization.

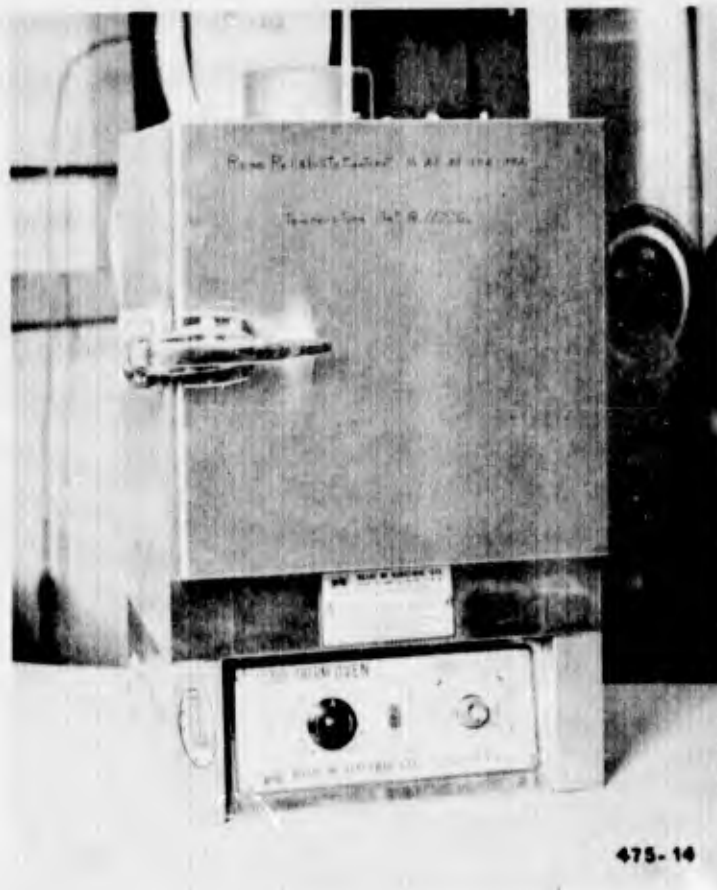
Figure 33. High-Temperature Storage Chamber

Thirty group I, 30 group II, and 30 group III bonded chips were stored at 150°C for 1000 hours. All the samples were operable after this test, and no bond failures occurred. The test chamber used for this test is shown in Figure 33.

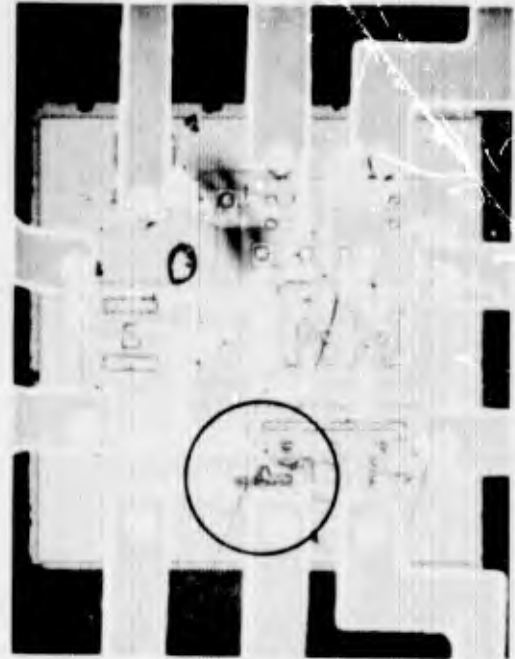
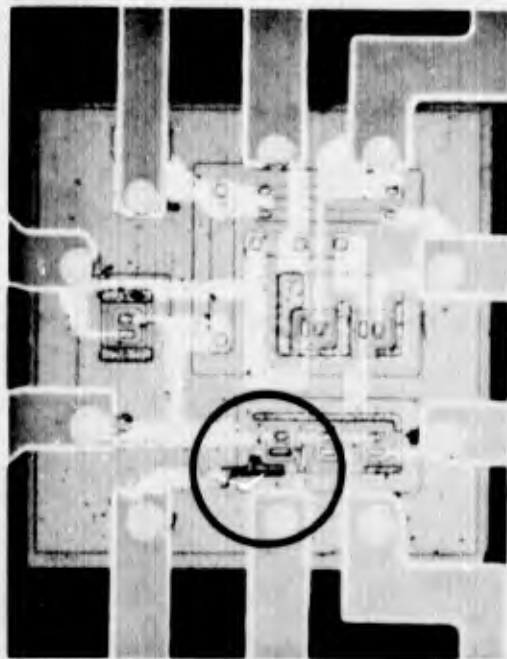
Figure 36. Photographs Showing Metalization Failure on Chip

Under high magnification all the failures that showed an open pin No. 9 were of the same nature. The metalization on the chip which connects the pad associated with pin No. 9 to the rest of the chip circuitry is a very thin line, and the failure occurred on the chip, as shown in Figure 36.

Because of the nature of the power dissipation circuitry, it was necessary to use pin No. 9 in a manner which is uncommon to the general use of this type of chip. The metalization on the chip was not meant to handle the load that this test put on it, and, therefore, it was very prone to failure.

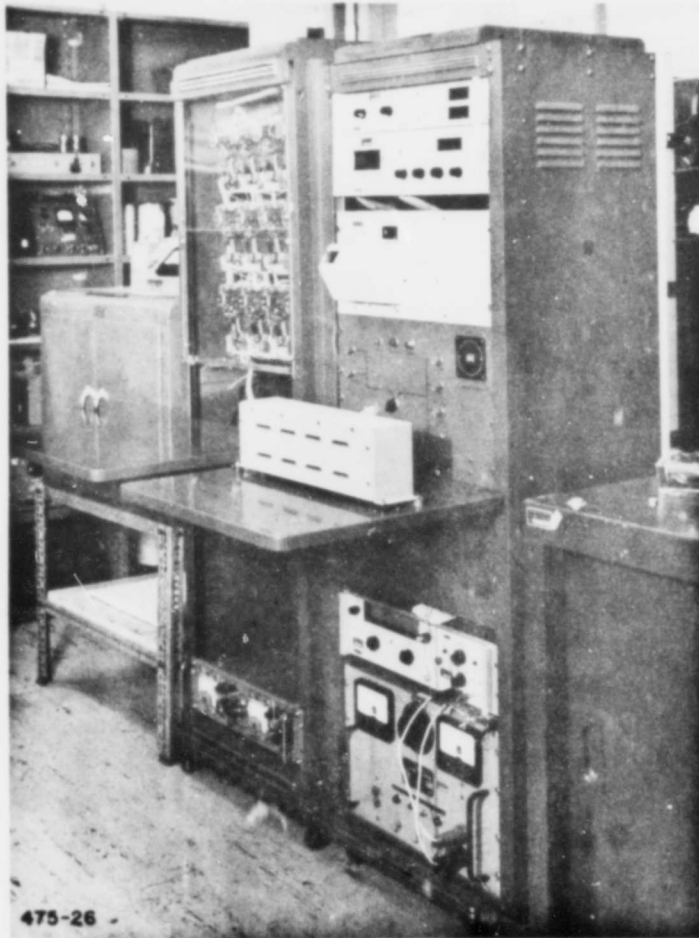
Figure 37. Elevated Temperature Back-Bias Test Chamber and Automatic Tester

The samples were tested at 24-hour intervals during the initial burn-in period, and weekly thereafter. The automatic chip tester was built for performing functional tests on the chips in the temperature chamber. The chips were automatically disconnected from the back-bias test and were

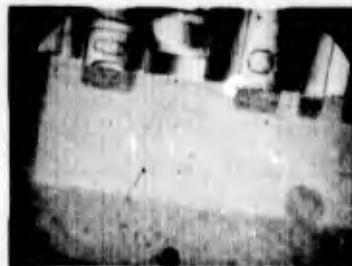
No. 31 130X
Resistor Diffusion Depth
~2.7 μ

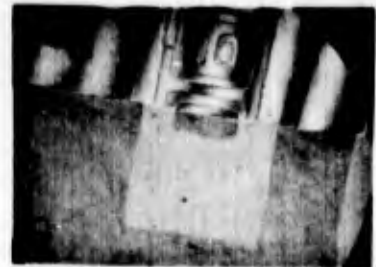
No. 31 130X
"Island" Depth
~16.5 μ
