Document D6-60083  
September 1967

**Some Characteristics of  
Aqueous Stress  
Corrosion in Titanium Alloys**

D.N. Fager and W.F. Spurr

The **BOEING** Company  
Commercial Airplane Division  
Renton, Washington

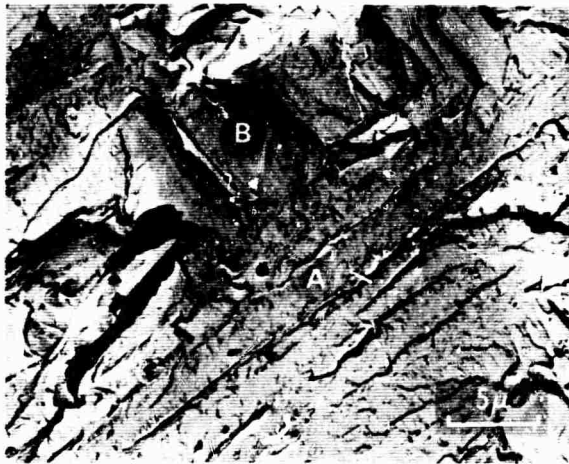
Fig. 3. Fractograph showing cleavage (A) in the single-phase hexagonal martensite of Ti-5Al-2.5Sn (2000 F/15 min/NQ). Ductile failure occurred at B.

Figures 1 and 2 show the transgranular fracture paths typical of aqueous stress corrosion in high- $\alpha$  alloys. The brittle fracture mode (cleavage) is shown at A in Fig. 3, along with ductile failure (B) due to unfavorable grain

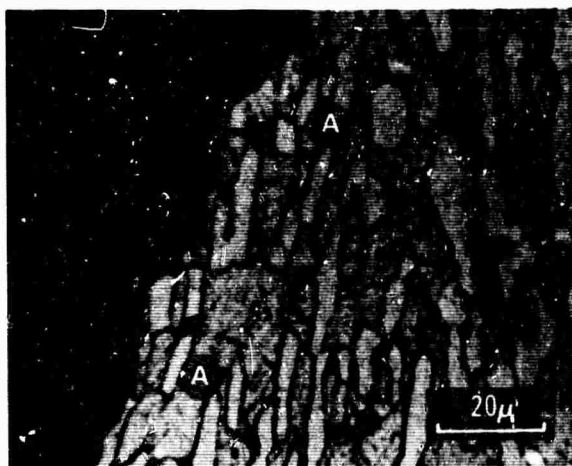
a. Viewed parallel to propagation direction.

b. Viewed normal to propagation direction.

Fig. 5. Stress corrosion cracks (A) in  $\alpha$  inhibited by  $\alpha''$  of Ti-8Al-1Mo-1V (1875 F/WQ).

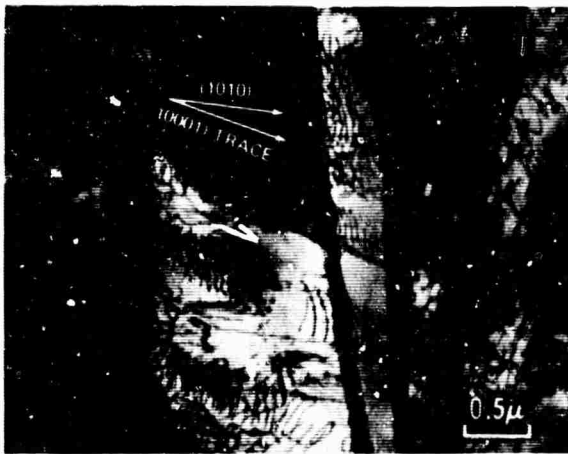
Fig. 25. Transmission electron micrograph of dislocation structure after ~2% plastic strain in the  $\alpha''$  phase of Ti-8Al-1Mo-1V.
