FINAL REPORT

SUBARRAY E3 EXPANSION

PHILCO-FORD CORPORATION
MONTANA LASA

An expansion and reconfiguration of a Montana LASA subarray was performed during the period October-December 1966. A description of the construction and installation of that subarray is presented. The evaluation of the array is reserved for a subsequent report.

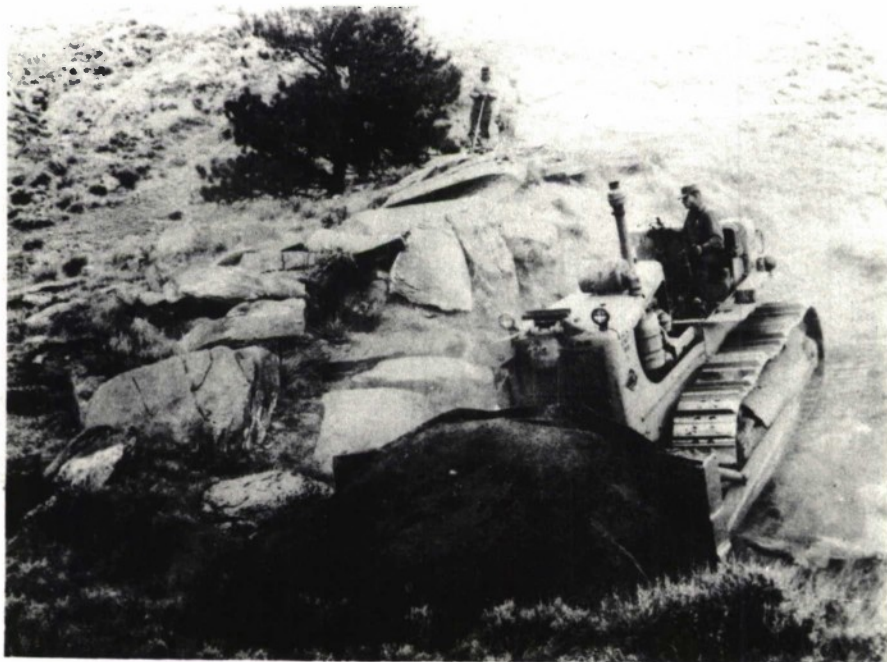
Figure 5 Cable Route Preparation at E3 Leg 1

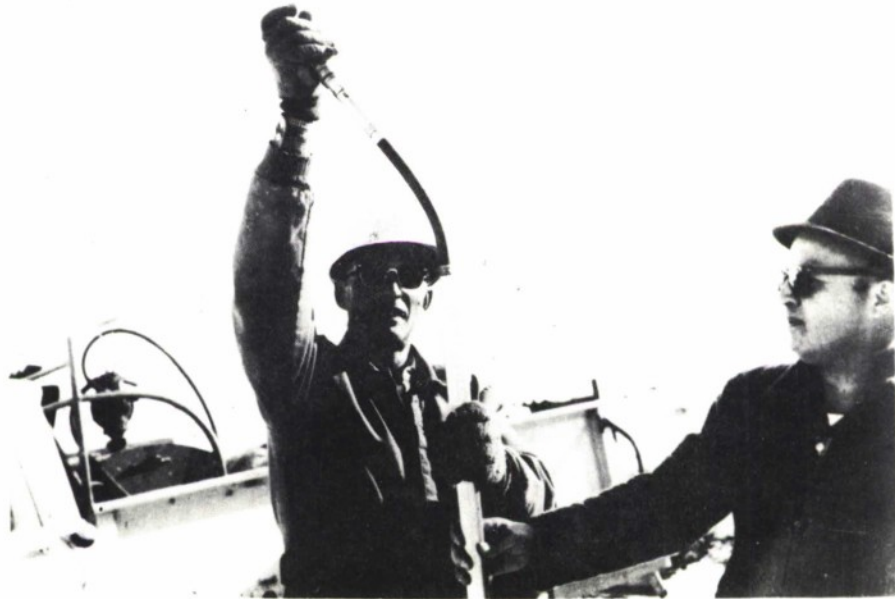
Figure 7 Eastman Drift Indicator Being Prepared For Use

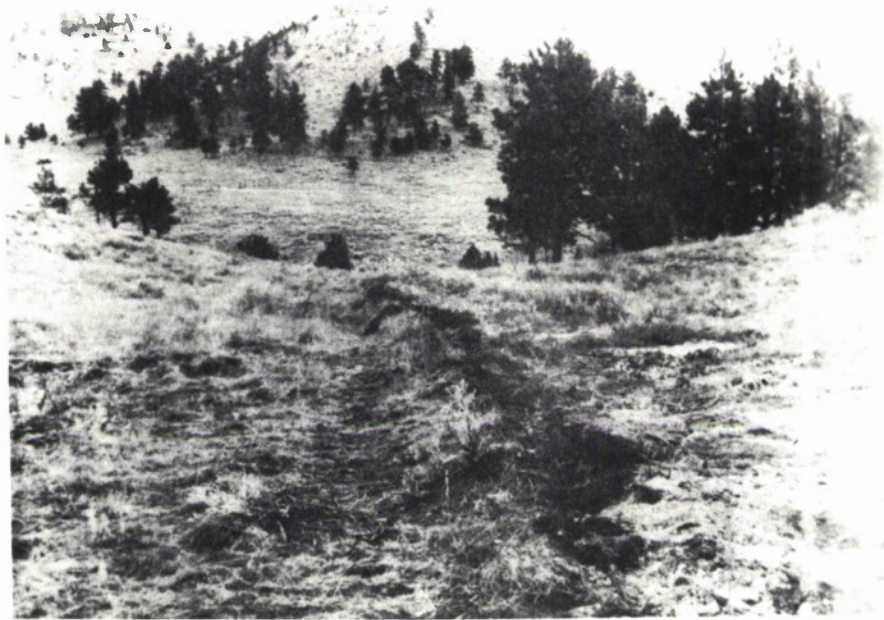
Figure 8 Completed Cable Trench at E3

Cable was trenched (Figures 8 and 9) into the ground by means of a ripper tooth (Figures 10 and 11) through which the cable was fed. The cable was buried to a depth of 36 inches. Some of the ground had to be pre-ripped prior to laying the cable. The trenches were partially leveled by dragging two sections of railroad track behind the cable-laying ripper tooth. The trenches were not "back-dragged" with the dozer blade as in previous construction since this completely destroys the grass coverage allowing erosion to take place. These trenches were inspected and restored in the spring of 1967. The cost per mile to restore the cable trenches was less than had been incurred prior to this time. In certain areas, some leveling of terrain (Figure 5) was necessary before the trencher could lay cable. This work was held to a minimum to reduce land damage.

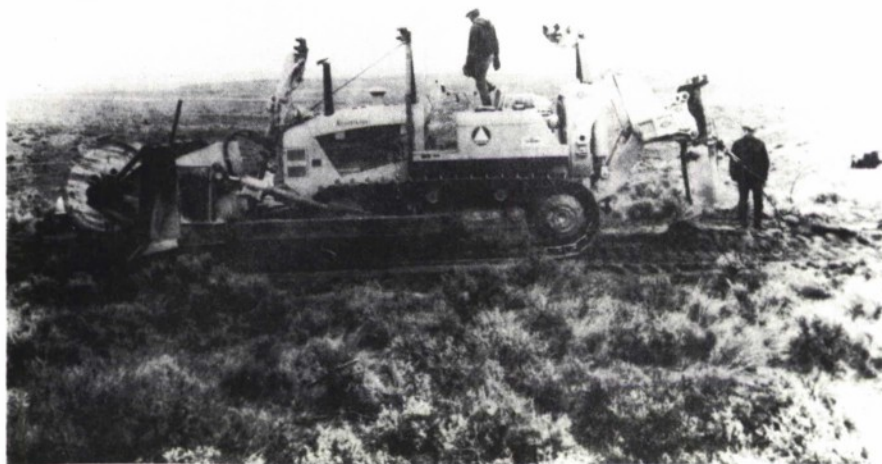
Figure 9 Trenching Rig in Use at E3

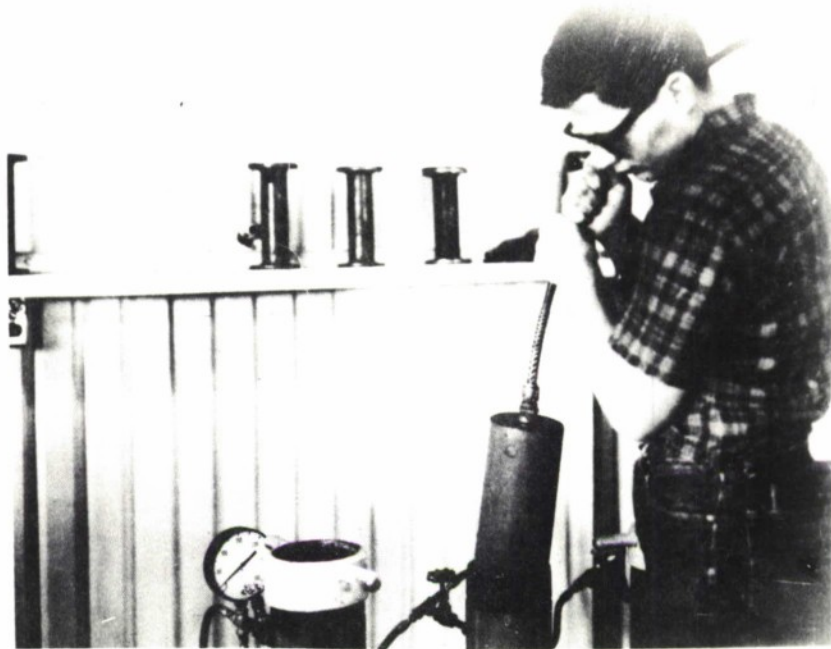
Figure 16 Seismometer Being Placed in Pressure Test Chamber

Electrical tests made consisted of resistance measurements of coils, high-potential test of case insulation (500 volts), natural frequency and damping measurements (Appendix III). The units were then subjected to water pressure (Figure 16) of 250 psi for one hour while resistance checks were taken again to determine if any signs of moisture leakage were present.

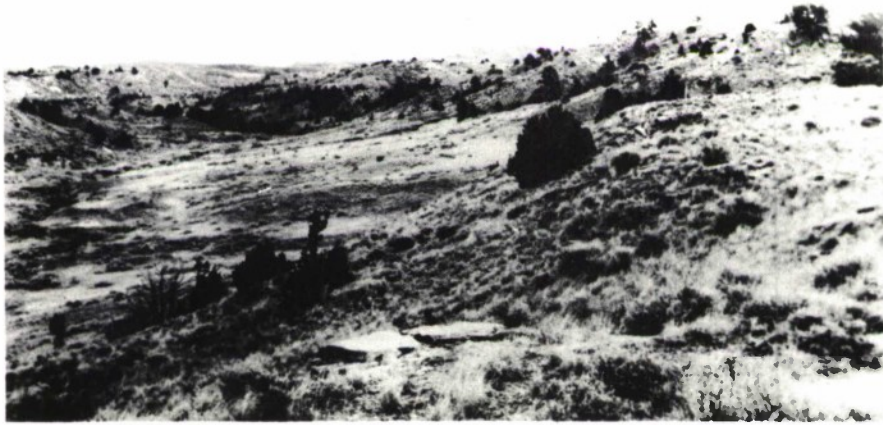
Figure 18 Typical Terrain Encountered at E3

Due to the rough terrain (Figure 18), 4-wheel-drive pickup trucks were used. These trucks are specially equipped for LASA operations of this sort. Two-way radio telephones and EE-8 field phones were used for communication between the WHV, CTH, LMC and LASA Data Center (LDC). Near blizzard conditions were encountered during the latter days of this installation. During this time these improved vehicular and communication facilities proved essential.
