Technical Note

TN 1968-7

Haystack Antenna  
Reflector Surface  
Improvement Program

D. G. Stuart

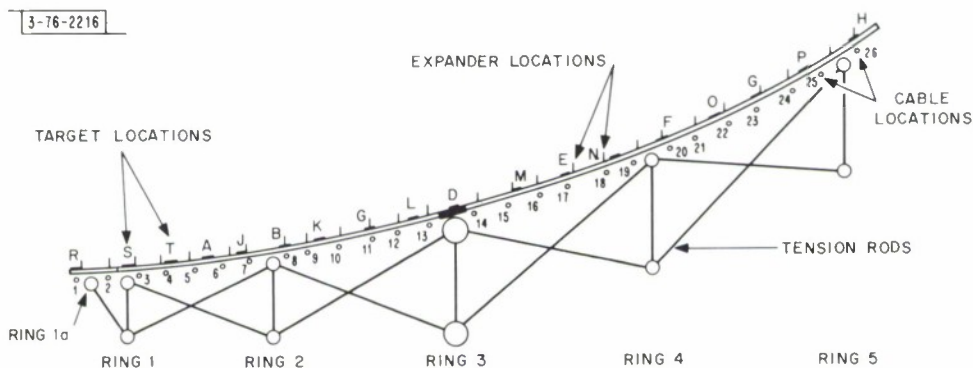
Fig. 1. Typical section through reflector.

The back-up structure is composed of five annular ring trusses made of aluminum tubing. These five ring trusses are fastened to each other by aluminum tension rods in a pretensioned configuration (Fig. 1). The design is such that the tensions are maintained for all loadings of the reflector. Reflector loads are removed from the structure through the central and heaviest ring truss, ring 3, close to the 60-foot diameter of the reflector. These loads are carried from ring 3 to the elevation trunnions by tubular truss trunnion beams, one on each side of the reflector. The ends of the beams fasten to ring 3, the main support of the reflector structure, at approximately its quarter points. All inboard structure, such as the RF box and its supporting structure, is fastened directly to ring 3. The reflector itself grows inward and outward from the ring 3 truss.

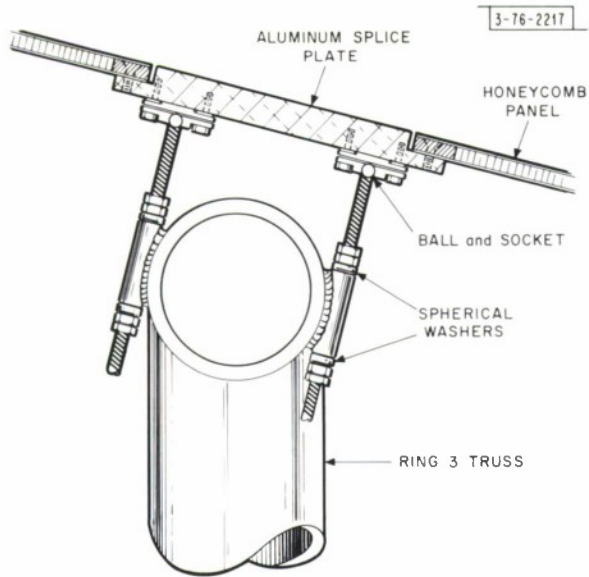
Fig. 2. Detail at splice plate showing typical stand-off stud connections.

Directly above the ring 3 truss, and fastened to it by means of stand-off studs, is the ring 3 splice plate which is made of aluminum approximately 1 inch thick by 1 foot wide. This serves as the "backbone" of the surface. All the surface panels are connected firmly to the splice plate at one end, and the surface panel loadings are brought out of the reflector through the splice plate and down into ring 3 (Fig. 2).

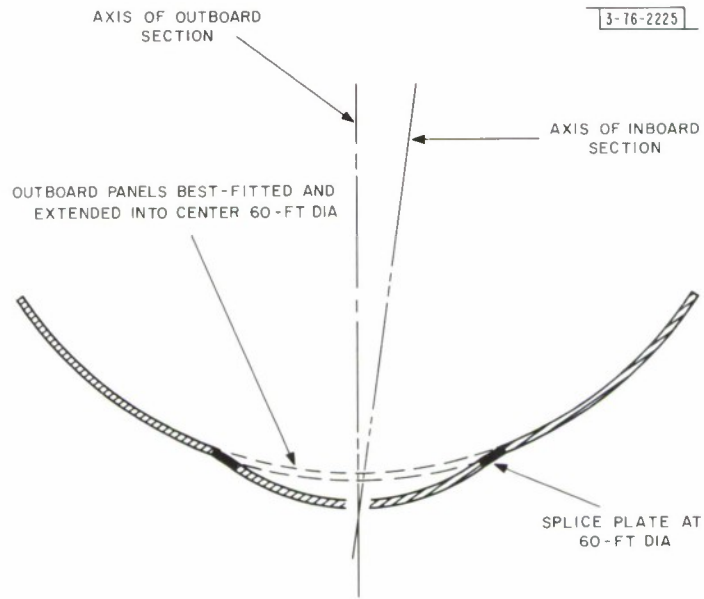
Fig. 13. Exaggerated sketch of reflector shape.

Plots of the deviations from the best-fit paraboloid resulting from the series of measurements taken showed some interesting characteristics. The shape of the reflector surface could be visualized as two separate reflectors separated by the splice plate (Fig. 13). The inner reflector, or inner 60-foot diameter, was deeper in curvature than the best-fit paraboloid, and had the largest deviations from the best-fit. The outer portion of the reflector more nearly matched the curvature of the best-fit paraboloid. In addition, the inner 60-foot diameter appeared slightly tilted with respect to the outer portion of the reflector. Rms calculations were made for both the inner 60-foot portion and the outer portion, as separate entities. After inspection of these results, a best-fit was made to the outer portion of the reflector and then extrapolated toward the center of the reflector. Values were then assumed for the center 60-foot portion, assuming reasonable tolerances for adjusting to the contour of the extrapolated best-fit parabola. The resultant rms calculated for the whole reflector was most encouraging, and from this was derived the idea of adjusting only the center 60-foot diameter to the paraboloid which best fit the outer portion of the reflector. This in effect increased the errors in the center 60-foot diameter while it reduced the errors in the outer panels. The advantage of this approach was the considerable reduction in area that must be considered for readjustment. The inner section was only one-fourth of the area of the reflector and therefore required only one-fourth of the number of adjustments. In addition, the center 60-foot diameter was an easier area in which to perform adjustments than was the outer section of the net access system.

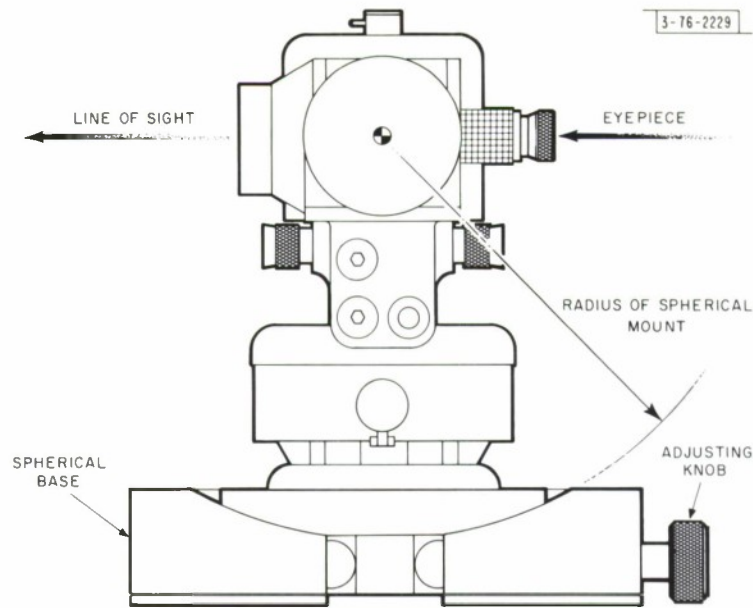
Fig. 17. Theodolite mounted on "flying saucer."

Performance of the theodolite on this project indicated that a "soak time" of about 36 hours was required for the instrument to produce consistent results. Once the instrument was initially set up, its illumination system was turned on and left on, at the same voltage, for the entire project. Any large changes in the radome thermal environment resulted in the necessity for another "soak time" of about the same length. It should also be noted that it is important to protect the instrument as much as possible from the body heat and exhaled breath of the operator. The operator's awareness of these facts was considered sufficient protection without resorting to shielding or insulation.

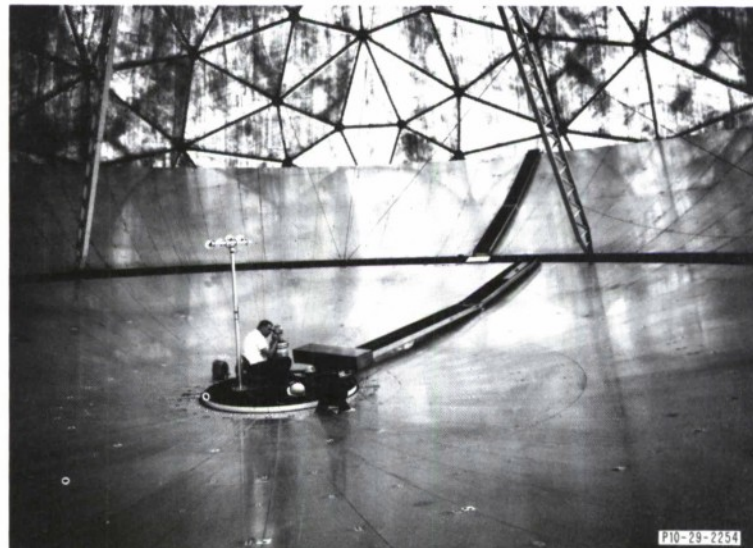
Fig. 18. Photograph showing instrument and stanchion, front access catwalks, operator's chair, platform and lights.

Other items installed at this time were the illumination system, radial catwalks, extra lead bars to bring the optics box up to standard weight, various items of measurement equipment, temperature recording equipment, telephone communications, and assorted tools (Fig. 18).

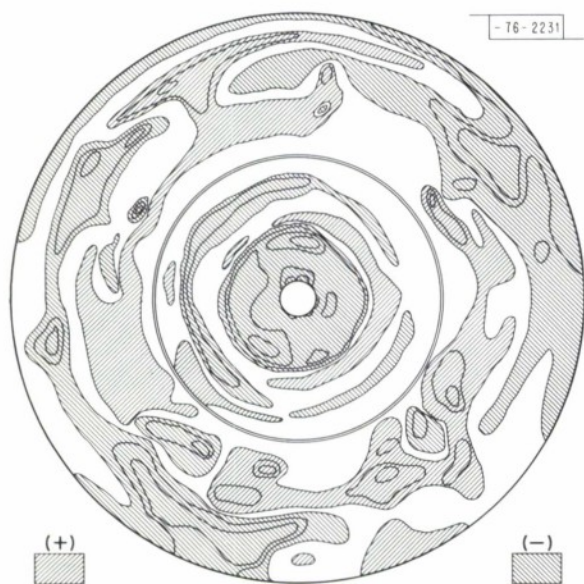
The first data set taken best-fitted to an rms deviation of 0.037 inch. This was the first data taken since the study program of a year ago. The reduction of the data taken at that time was not as refined as in the current program. Since the targets sampled were different from those of the previous year, the agreement of error for the two sets of conditions was a re-assurance that the reflector was not changing shape over a period of time. The consistent rms value for nighttime readings demonstrated that most of this error had been built into the reflector and was not the result of any degradation over a period of time.

Fig. 20. Deviations from best-fit paraboloid before adjustment (rms = 0.037 inch; contours of deviation at 0.025-inch intervals).

When the reflector was first considered for an adjustment program, the daytime rms of the best-fitting paraboloid was 0.055 inch. This was reduced during the study phase of the program, by the painting of the splice plate, to about 0.044 inch rms. The adjustment program then reduced these values to 0.017 inch rms for nighttime conditions, and, except for very extreme summer day conditions, the rms is not expected to exceed 0.025 inch for the sunny day condition (Figs. 20 and 21).
