**SNOW MOVEMENT-DRIFT CONTROL FOR
AT-GRADE CAMPS**

May 1968

NAVAL CIVIL ENGINEERING LABORATORY

Technical Report R-578

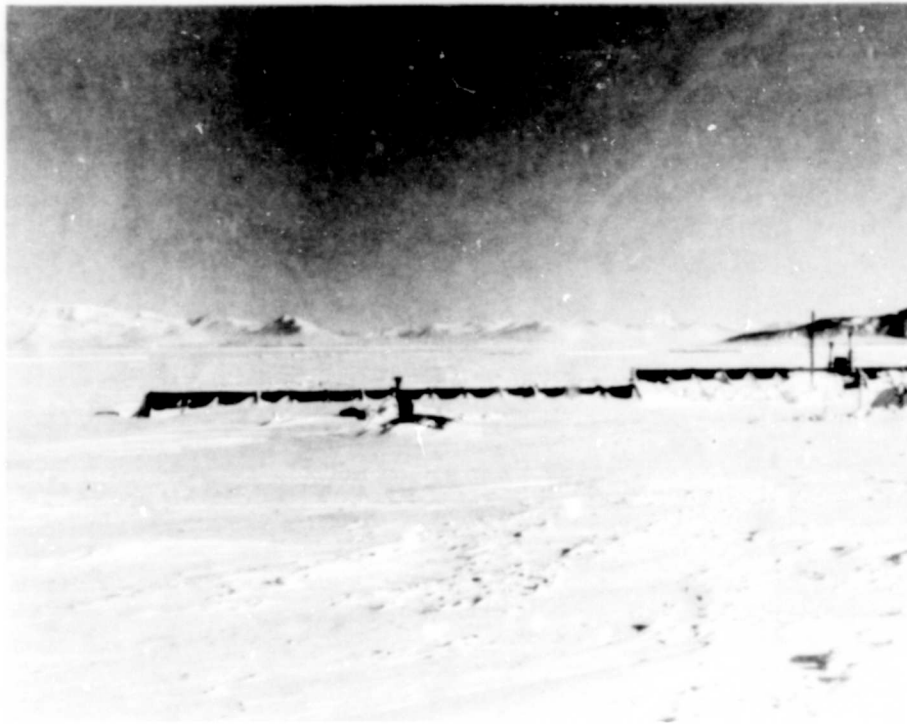
Figure 5. NCEL camp after 3 years of drift accumulation (looking west).

After 3 Years. By November 1965, at the end of the third year, snowdrifts 6 to 10 feet deep covered the courtyard formed by the three Jamesways. The snow surface was 18 to 24 inches below the tops of the Jamesways (Figure 5) and completely covered the head. The 1964 snow walls were only faintly visible to the east of the camp. A small, relatively deep depression was cleared in the courtyard by the removal of 3,000 cubic yards of snow. Each storm drifted this depression with as much as two-thirds of what had originally been removed. Although the area cleared was smaller than the previous year, drifting during summer storms deposited more snow.

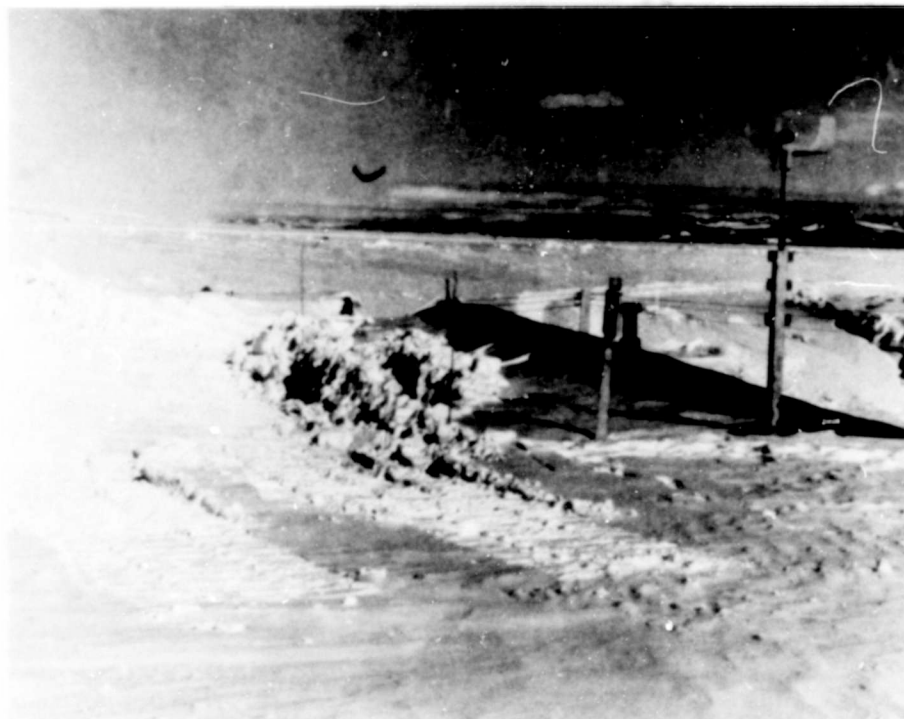
Figure 7. NCEL camp after 4 years of drift accumulation; note upwind portion of the trench to right of Jamesway (looking south).

After 4 Years. At the end of the fourth year in mid-October 1966, the NCEL camp was inundated with snow to the ridge of all three Jamesways in the main camp complex, a depth of about 10 feet. To open the camp for the DF-67 season, a north-south V-shaped trench parallel to the storm wind was cut level with the floor line between the two facing Jamesways: Quarters 2 and the utility building. Each end of the V-shaped trench extended up and out of the camp a distance of about 100 feet. The snow from the trench was feathered out around the camp area. Although succeeding storms deposited drift in the upwind end of the trench, none was of sufficient duration to cause drifting in the camp courtyard. Following each storm, the drift was dozed out of the upwind portion of the trench and feathered over the surface around the camp. Figure 7 shows drift around the camp buildings and storm drift in the upwind end of the trench prior to clearing.

After 4 years of exposure the NCEL camp and the T5M were completely covered with snow (Figures 7 and 14), although only about 4 feet of snow had accumulated on the surrounding natural surface. From Figure 15 it is apparent that the drift accumulation around the T5M during the fourth year was as great as that of the first 2 years combined, but the rate of accumulation during this time around the initially protected cluster of buildings was quite uniform. Even though the T5M shop building was 4 feet higher than the buildings in the NCEL camp, it was nearly covered with snow in the same 4-year period.

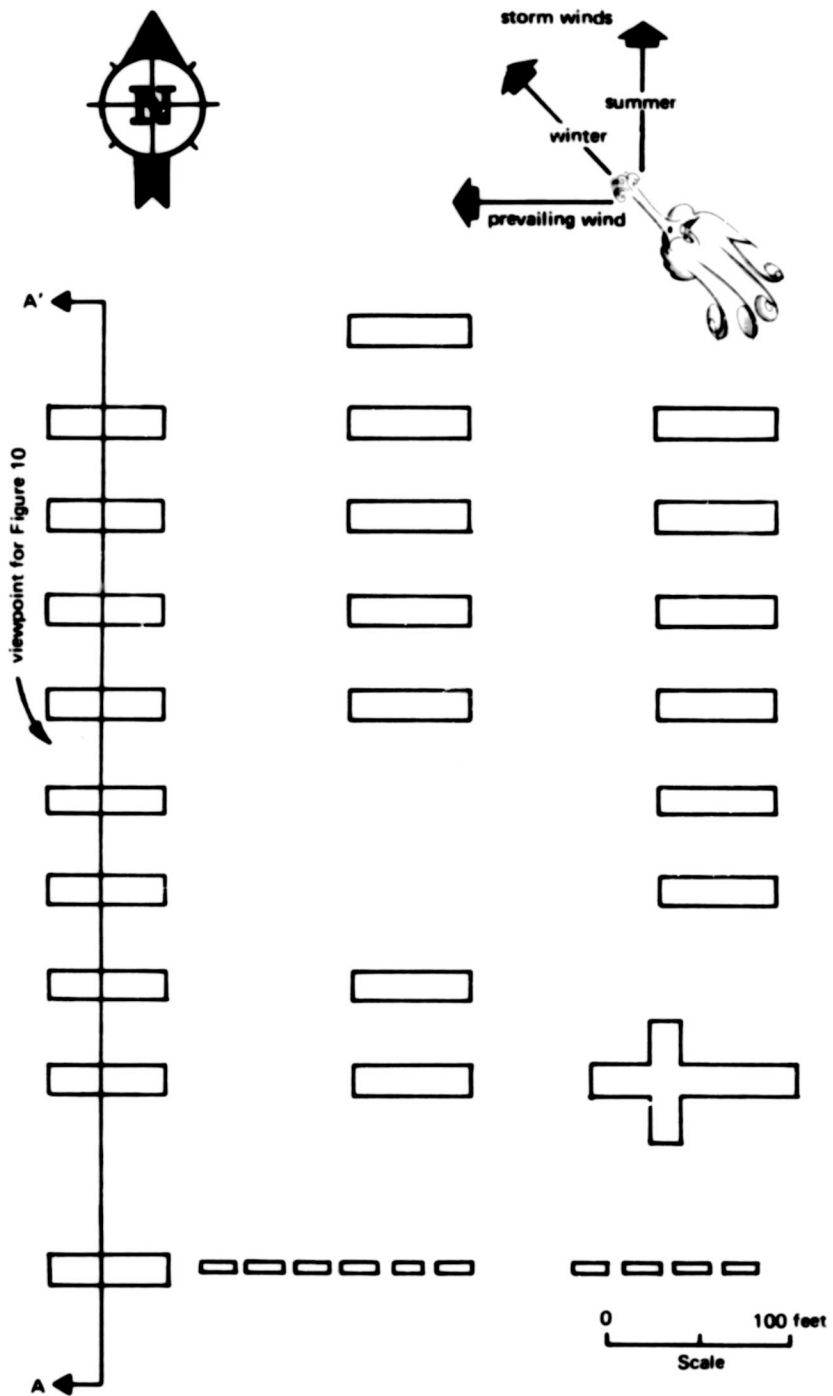
Figure 8. Plan view of Williams Field camp as of October 1965. Cross section A-A' shown in Figure 9.

The Williams Field camp, which was erected in its present location (Figure 1) in September 1965, consists of three rows of Jamesways, with 8 to 10 Jamesways in each row (Figure 8). All buildings are oriented with their long axis perpendicular to the major storm winds. In late February 1966 all of the buildings in the Williams Field camp were 1 to 2 feet above the surrounding surface due to ablation of the surrounding snow.

Drift accumulation in the Williams Field camp also was accentuated by arrangement of buildings (Figure 8). Nearly complete burial of the windward buildings occurred because they were placed with the long axis perpendicular to the storm winds. Distance between buildings was such that the short, deep leeward drifts from the upwind building coalesced with drift on the windward side of the downwind building (Figure 9).

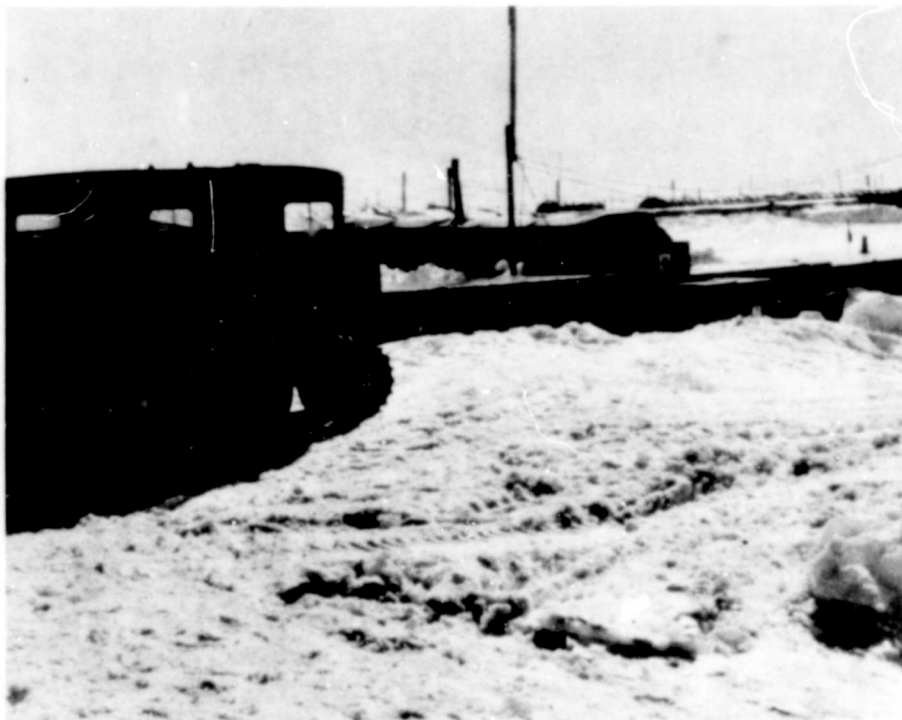
Figure 10. Drift snow in Williams Field camp after 2 years of accumulation; looking northeast along western edge of camp. (See Figure 8 for location.)

After 2 Years. By the end of the second year, October 1967, the buildings along the storm-wind side were covered with drift snow to within a foot or less of the ridge line (Figure 9). The other buildings in camp were 3 to 6 feet below the snow surface. Depth of burial of the camp averaged about 6 feet (Figure 10).

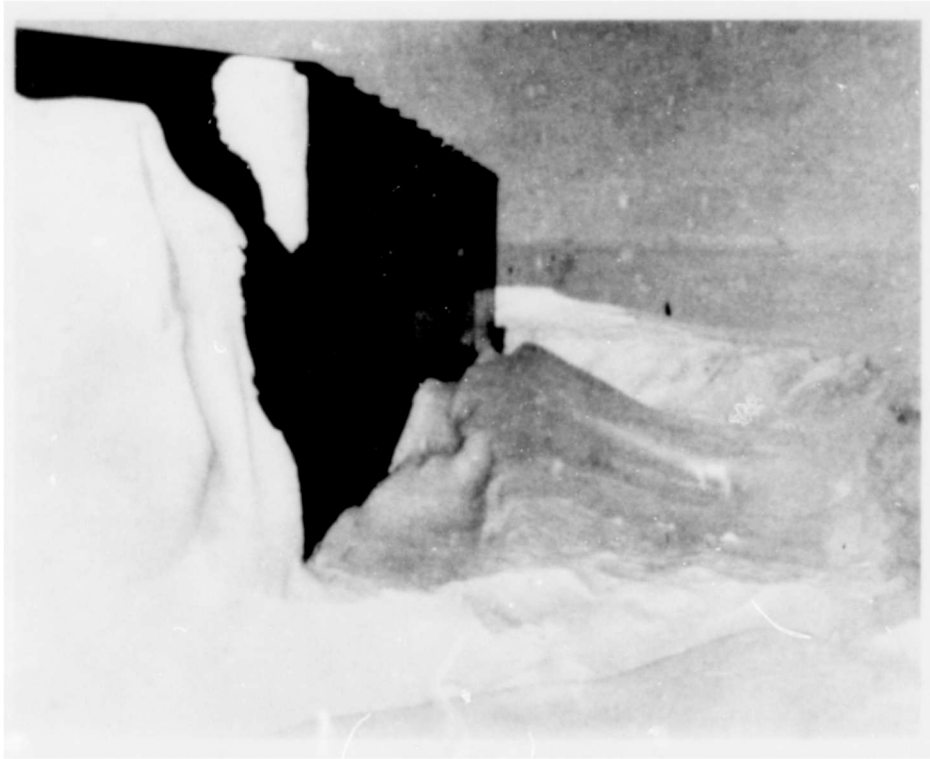
Figure 11. Drift snow around the NCEL T5M shop building after 1 year of accumulation (looking south).

After 1 Year. Maximum drift accumulation occurred during the winter on the north, or leeward, end, and on the west side. At the end of the first year, November 1963, the north end was drifted to roof height for about 8 feet from the building (Figure 11). Drifts formed 3-1/2 feet high on the west side, 2 feet high on the south end, and 1 foot high on the east side, up to 10 feet from the building. By February 1964 only the snow from the north end had been removed and feathered out to provide access to the building.

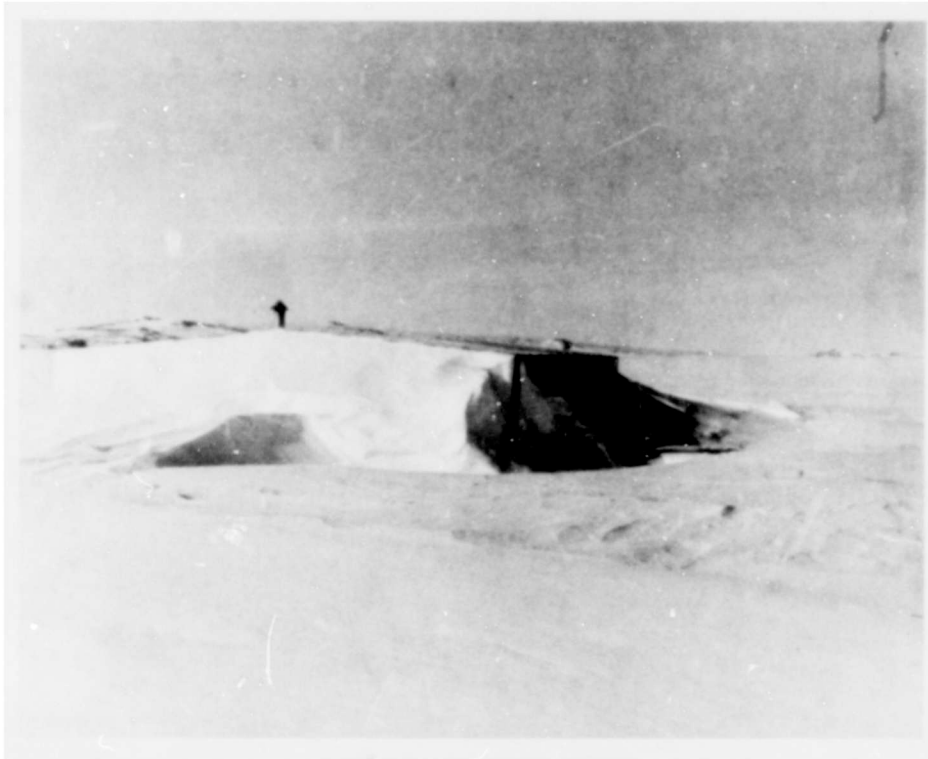
Figure 12. Drift snow around the T5M shop after 2 years of accumulation (looking south).

After 2 Years. By November 1964, at the end of the second year, drift snow on the north end and west side had increased to the roof, filling the previously drift-free space between the 1963 drift and the building (Figure 12). All of the previously drift-free areas next to the building were filled with snow except for a small area near the southeast corner. In February 1965 all accumulated drift snow was cleared from around the T5M and was feathered out across the surrounding surface, leaving the building in a depression about 6 feet below the adjacent surface.

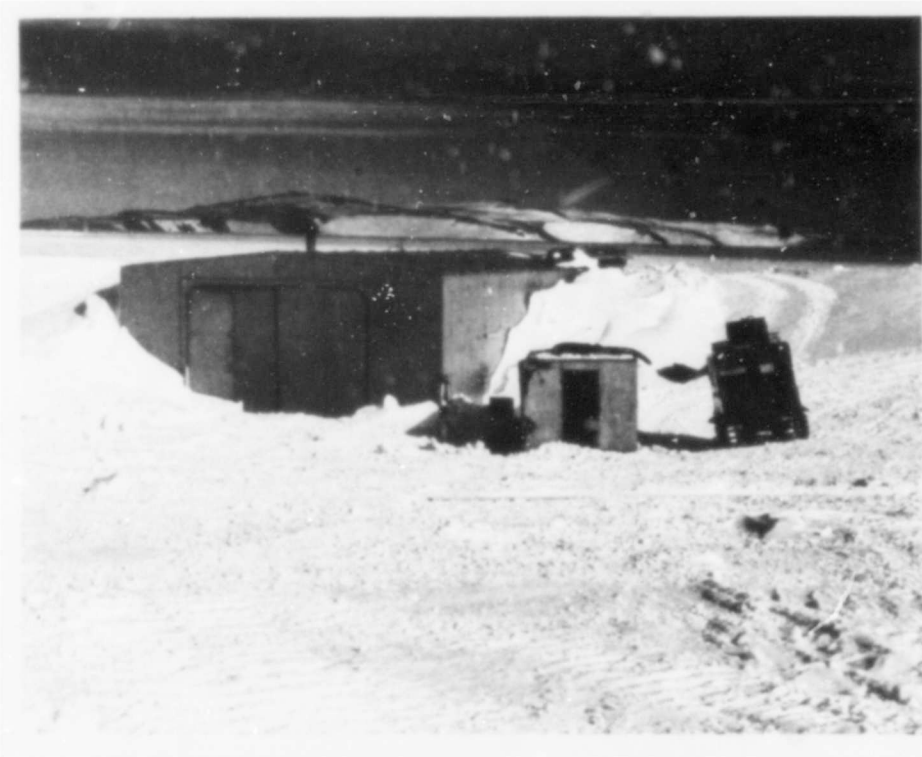
Figure 14. Drift around T5M after 4 years of accumulation; the area in front of the doors has been cleared (looking south).

After 4 Years. By mid-October of the fourth year, 1966, the T5M was inundated with snow to the eave line, a depth of about 14 feet (Figure 14). The north, or down-storm wind, end was cleared of snow, which was feathered out.

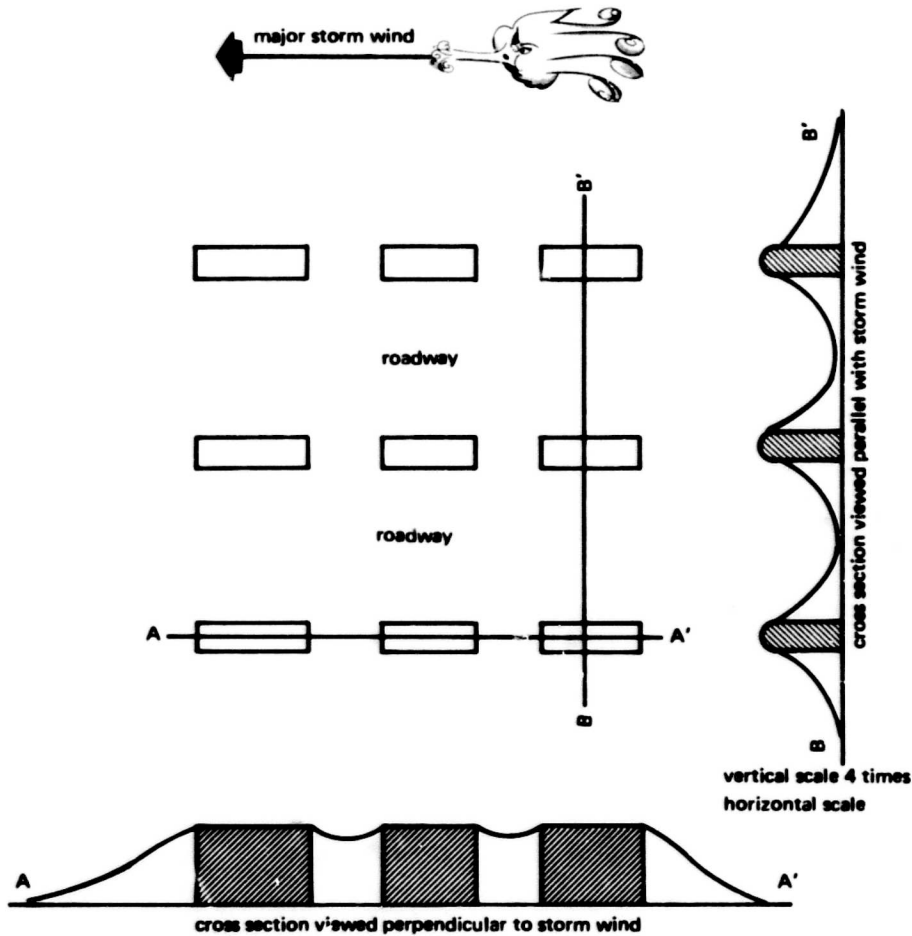
Figure 16. Illustrative layout of multi-building camp and expected drift pattern.

The amount of drift accumulation could have been decreased considerably at Williams Field by rotating the camp layout 90 degrees (Figure 16). With such a layout, the three long rows of buildings would be perpendicular to the storm winds, with the long axis of each building parallel with the storm wind. In addition, the ends of the buildings in each row should be placed close together as in a train, and the camp roadways should parallel the long axis of the buildings. To provide access with such a plan, all buildings would need sidewall entries, since the ends would be drifted in.
