EVALUATION OF  
DIESEL ENGINED JEEP (JAPAN)

Job Order No. 318  
Contract No. DA-20-113-AMC-08571(T)

January, 1967

**MICHIGAN TECHNOLOGICAL UNIVERSITY  
HOUGHTON, MICHIGAN**

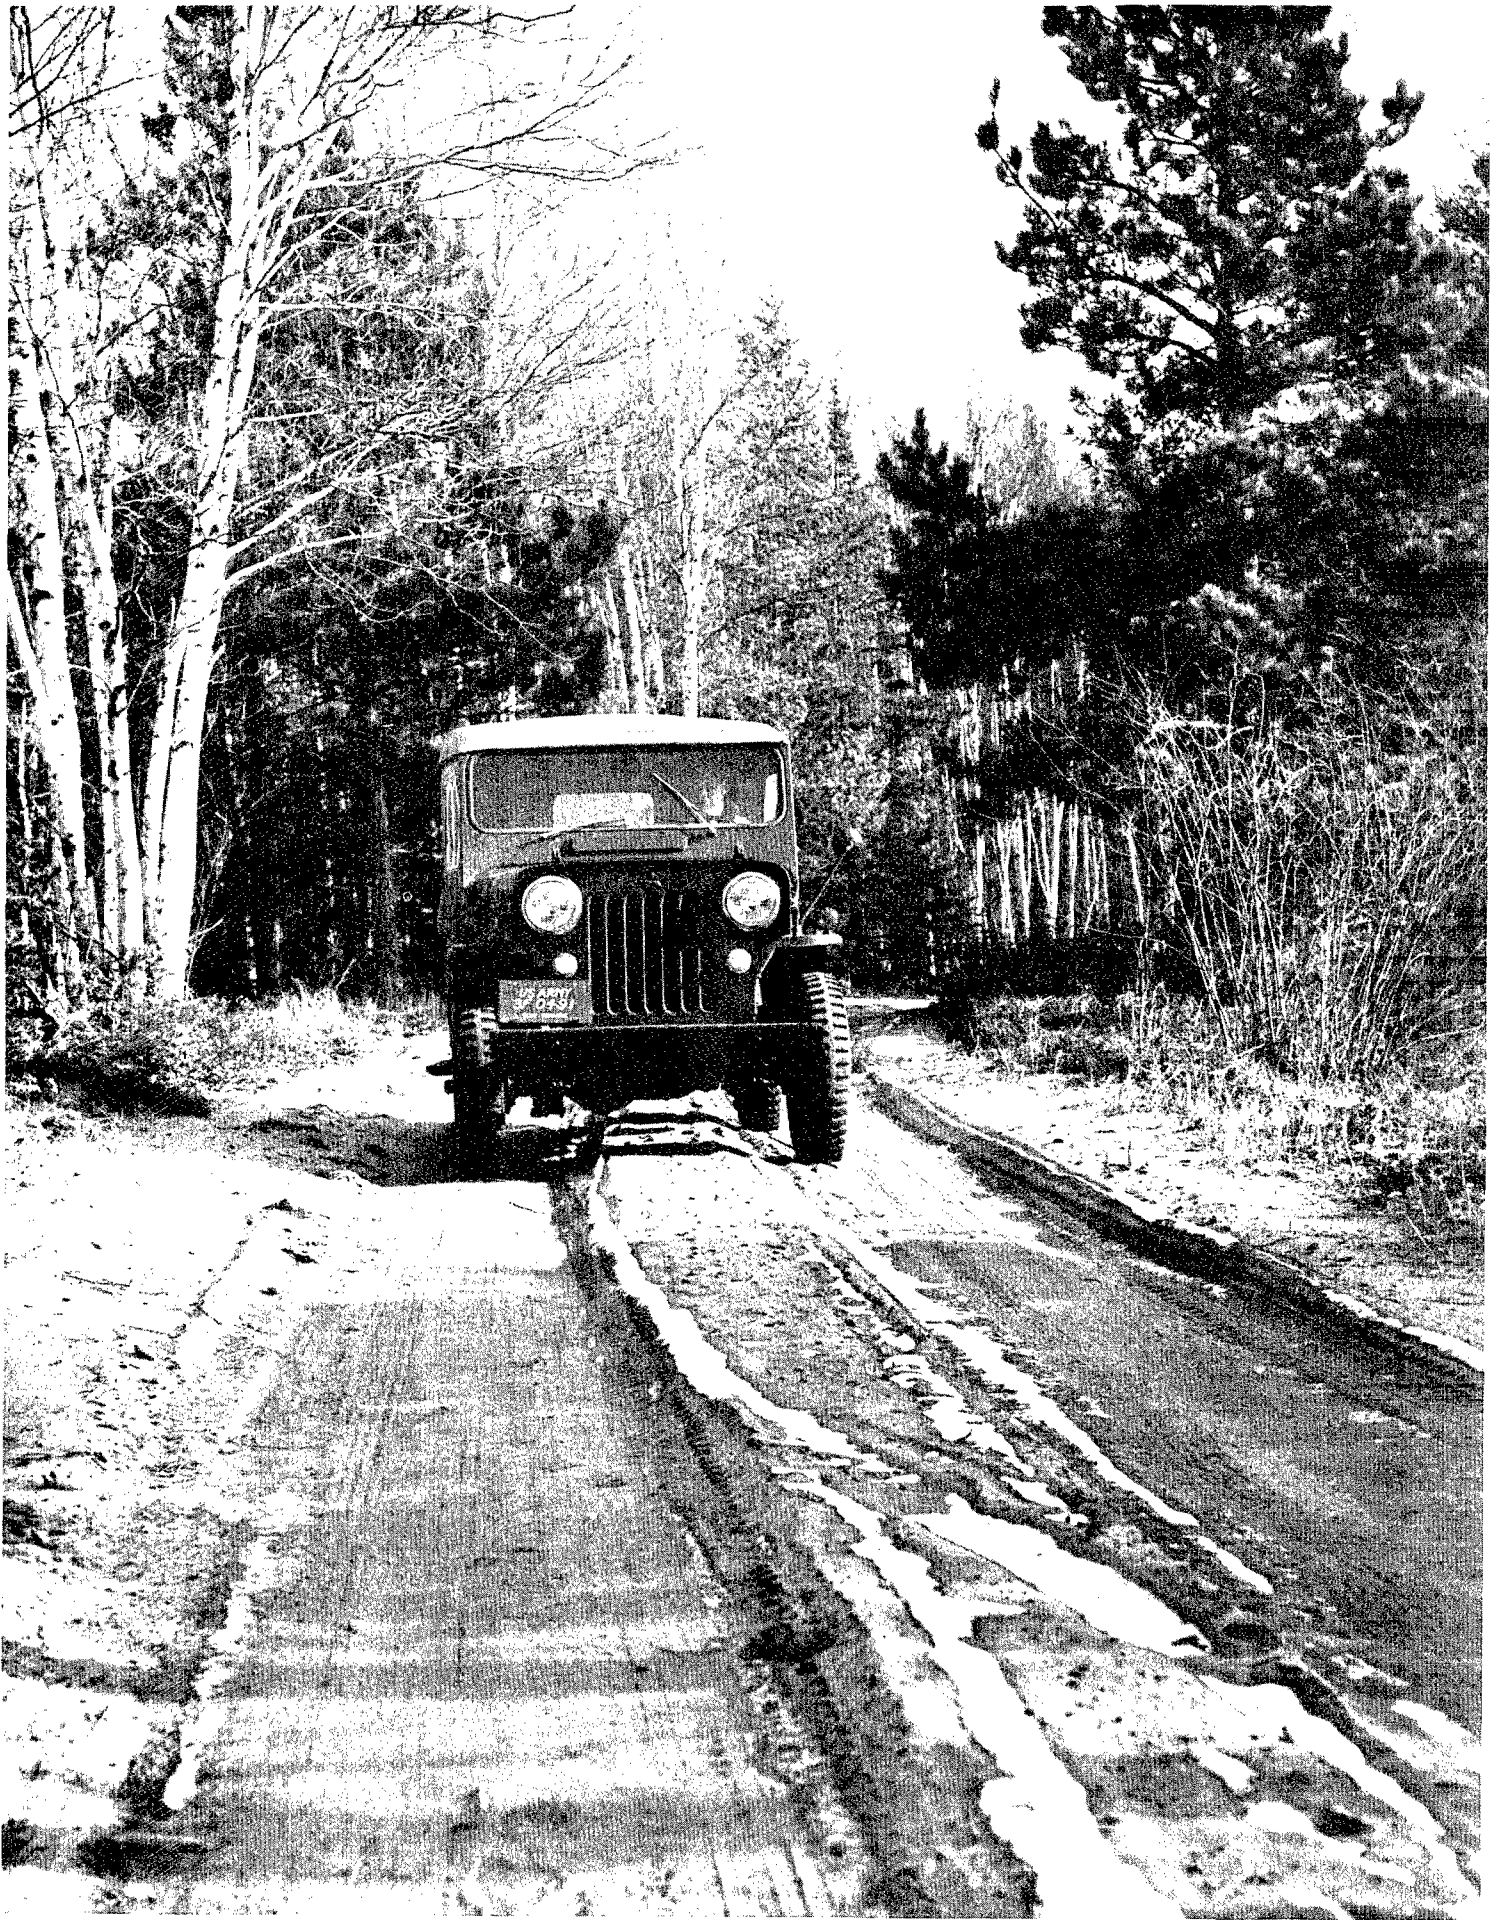
Figure 2  
Japanese Jeep - Secondary Road  
- 2 -

The vehicle is shown in several views in Figures 1 to 4, (detailed specifications are listed in Table I). The vehicle, as tested, had a total weight of 3,750 pounds, including the driver and one passenger plus 550 pounds of payload; a rated engine horsepower of 61 at 3,600 rpm; and a maximum governed vehicle speed of 55 mph.

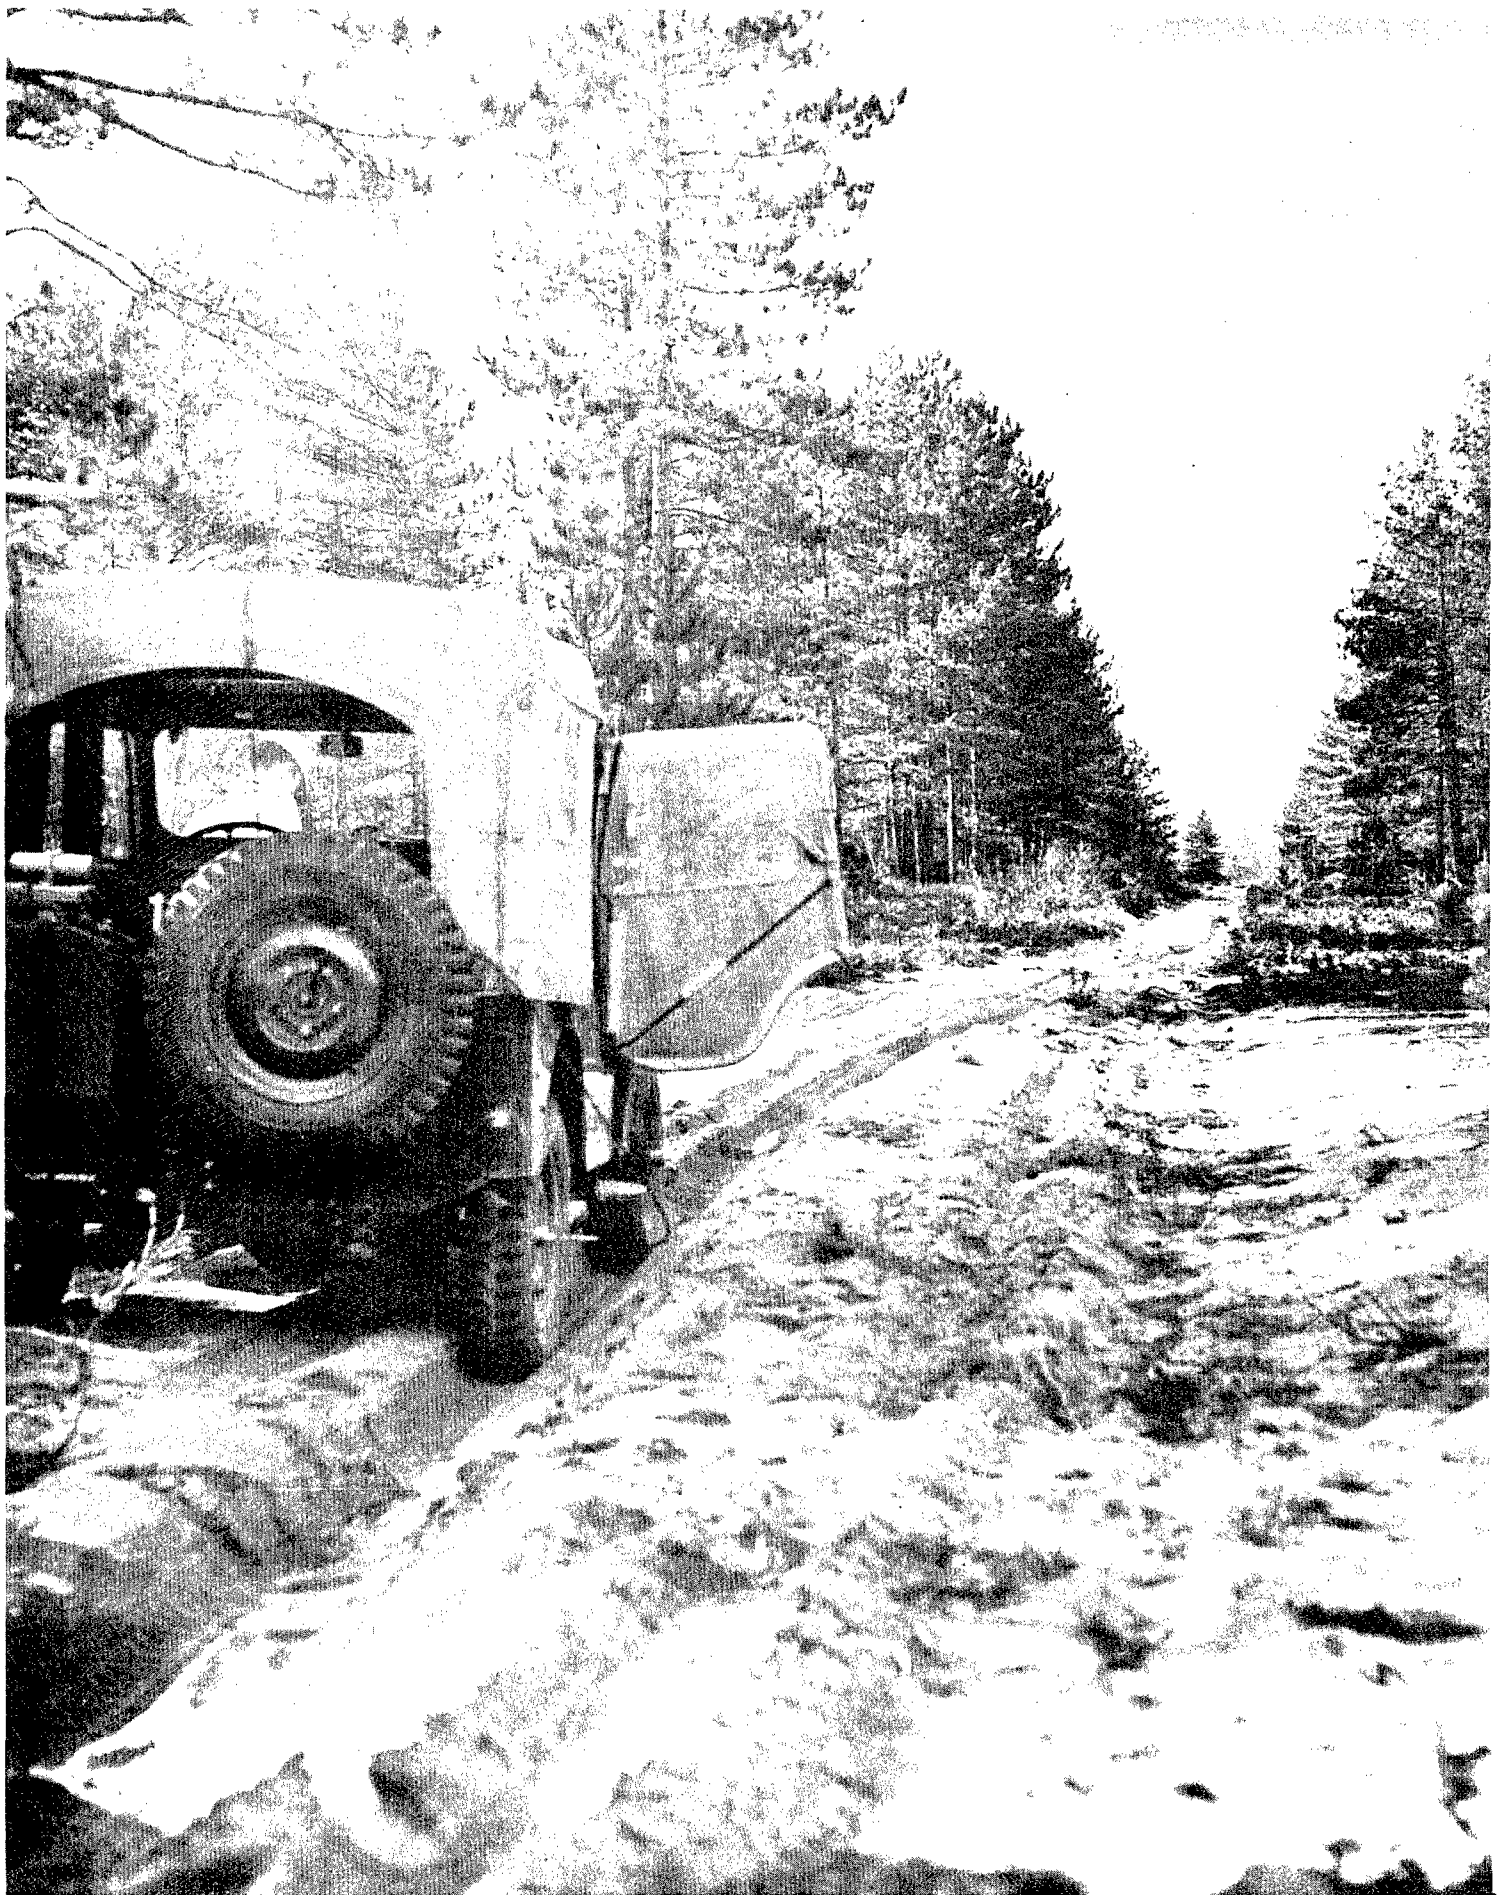
Figure 1A  
Drawbar Test in Sand

Jeep to the Military M38 Jeep. On no occasion was power limitation a cause of immobilization. A series of photographs, Figures 1A to 12A, inclusive, shows the vehicle on various test courses, both on summer and winter terrain.

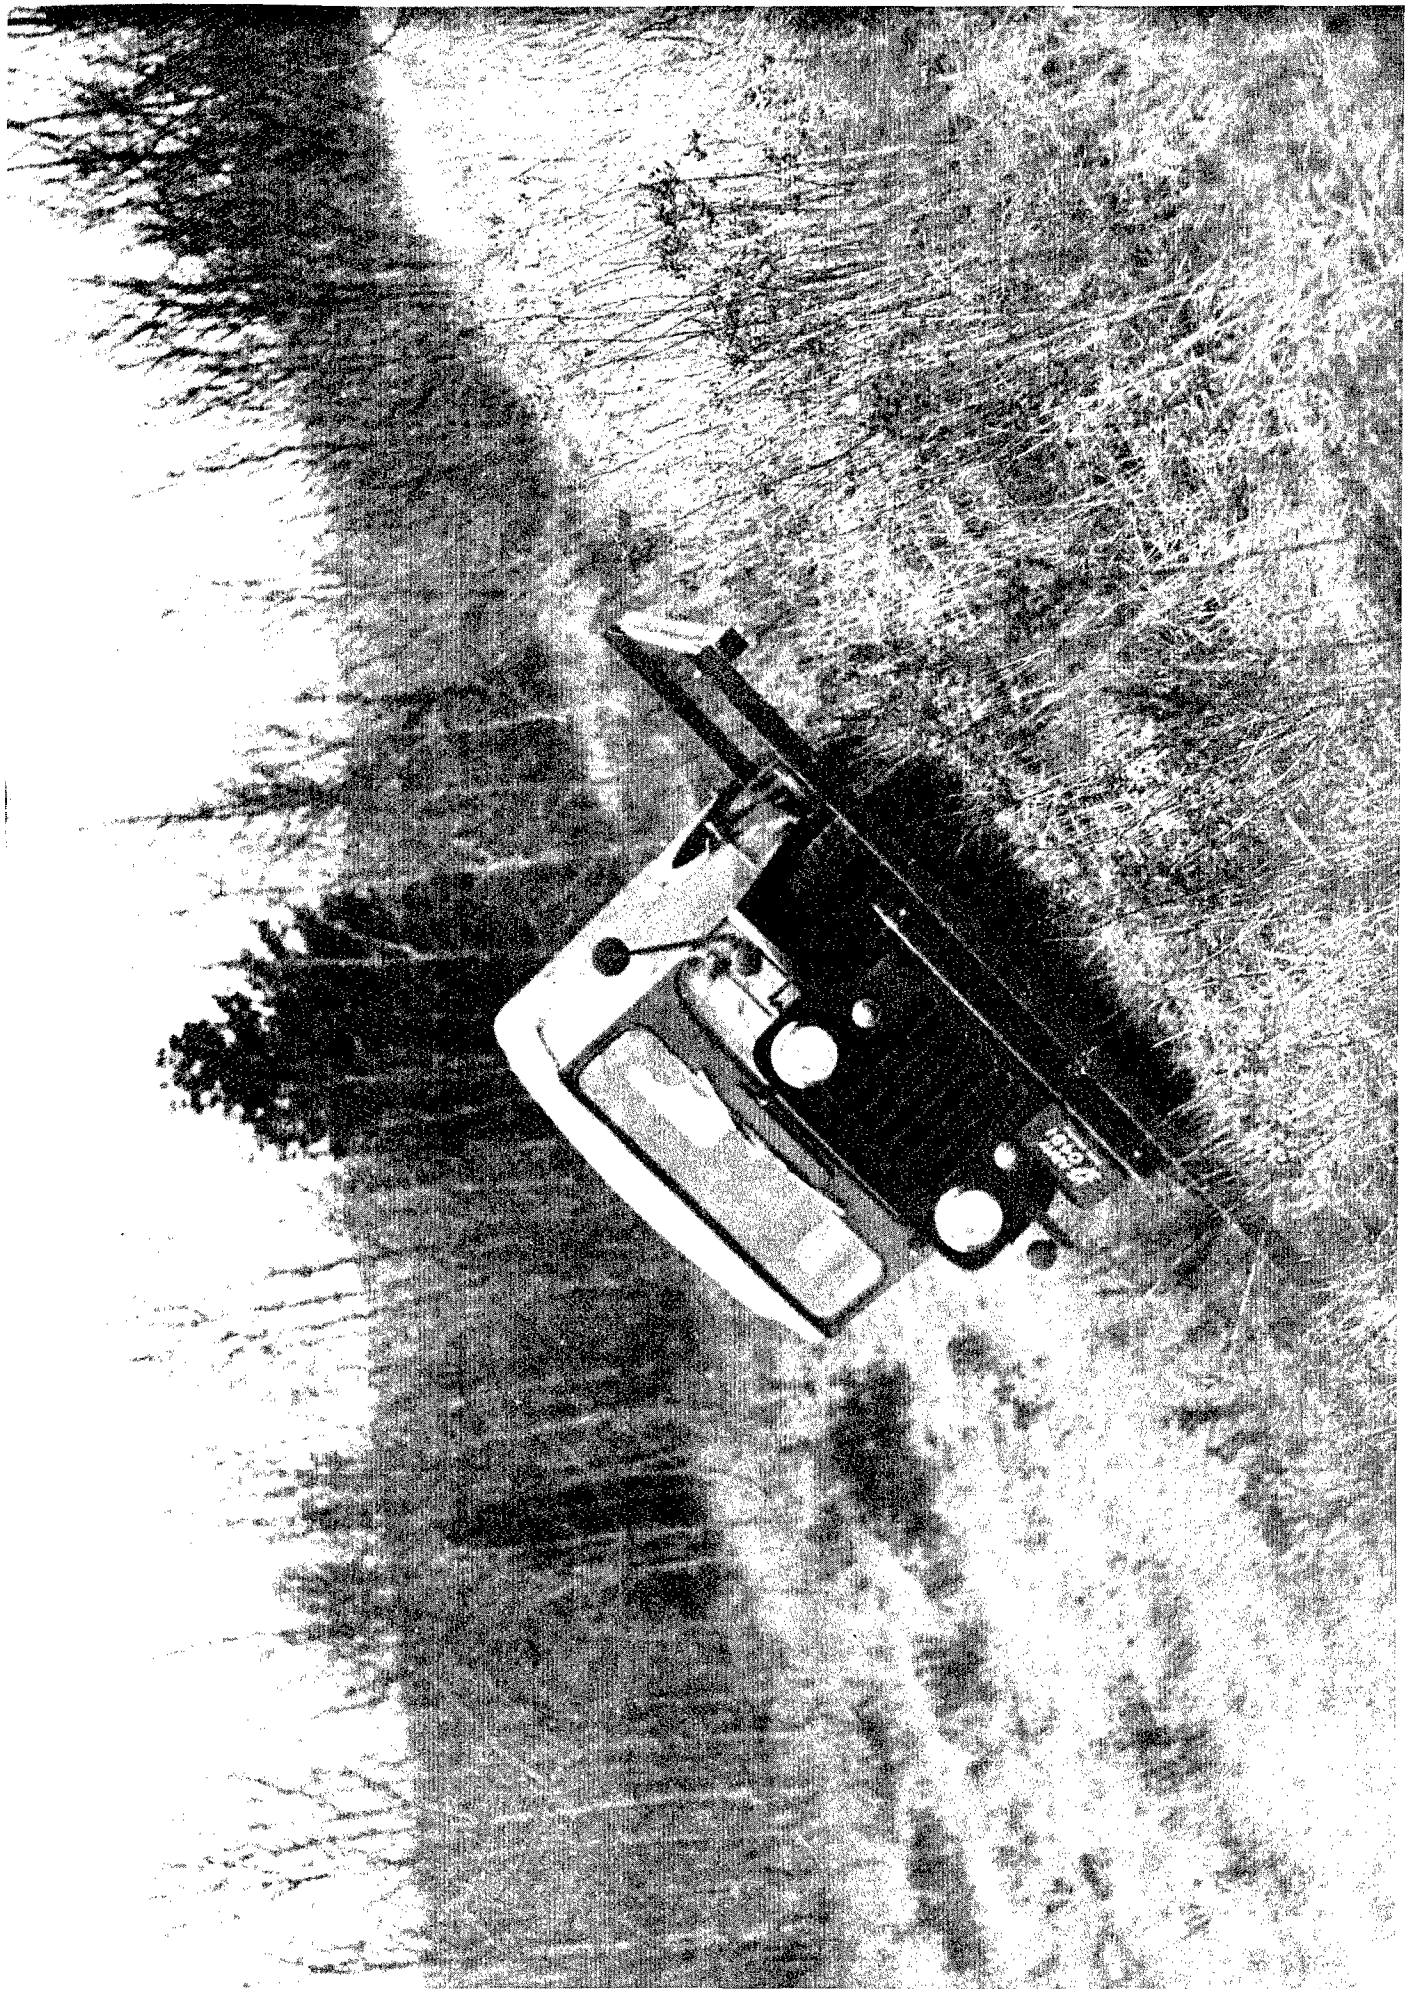
Figure 3A  
Side Slope Stability Test on Packed Dirt

but rather by the limited shear strength of the soil conditions specified in the test procedure. On "packed dirt" the maximum side slope negotiated approached  $35^{\circ}$ , and even in this success was marginal. On sand the maximum slope was limited to less than  $25^{\circ}$ . Both of these figures are considerably less than the maximum safe tilting angle of  $44^{\circ}$  specified by the manufacturer.

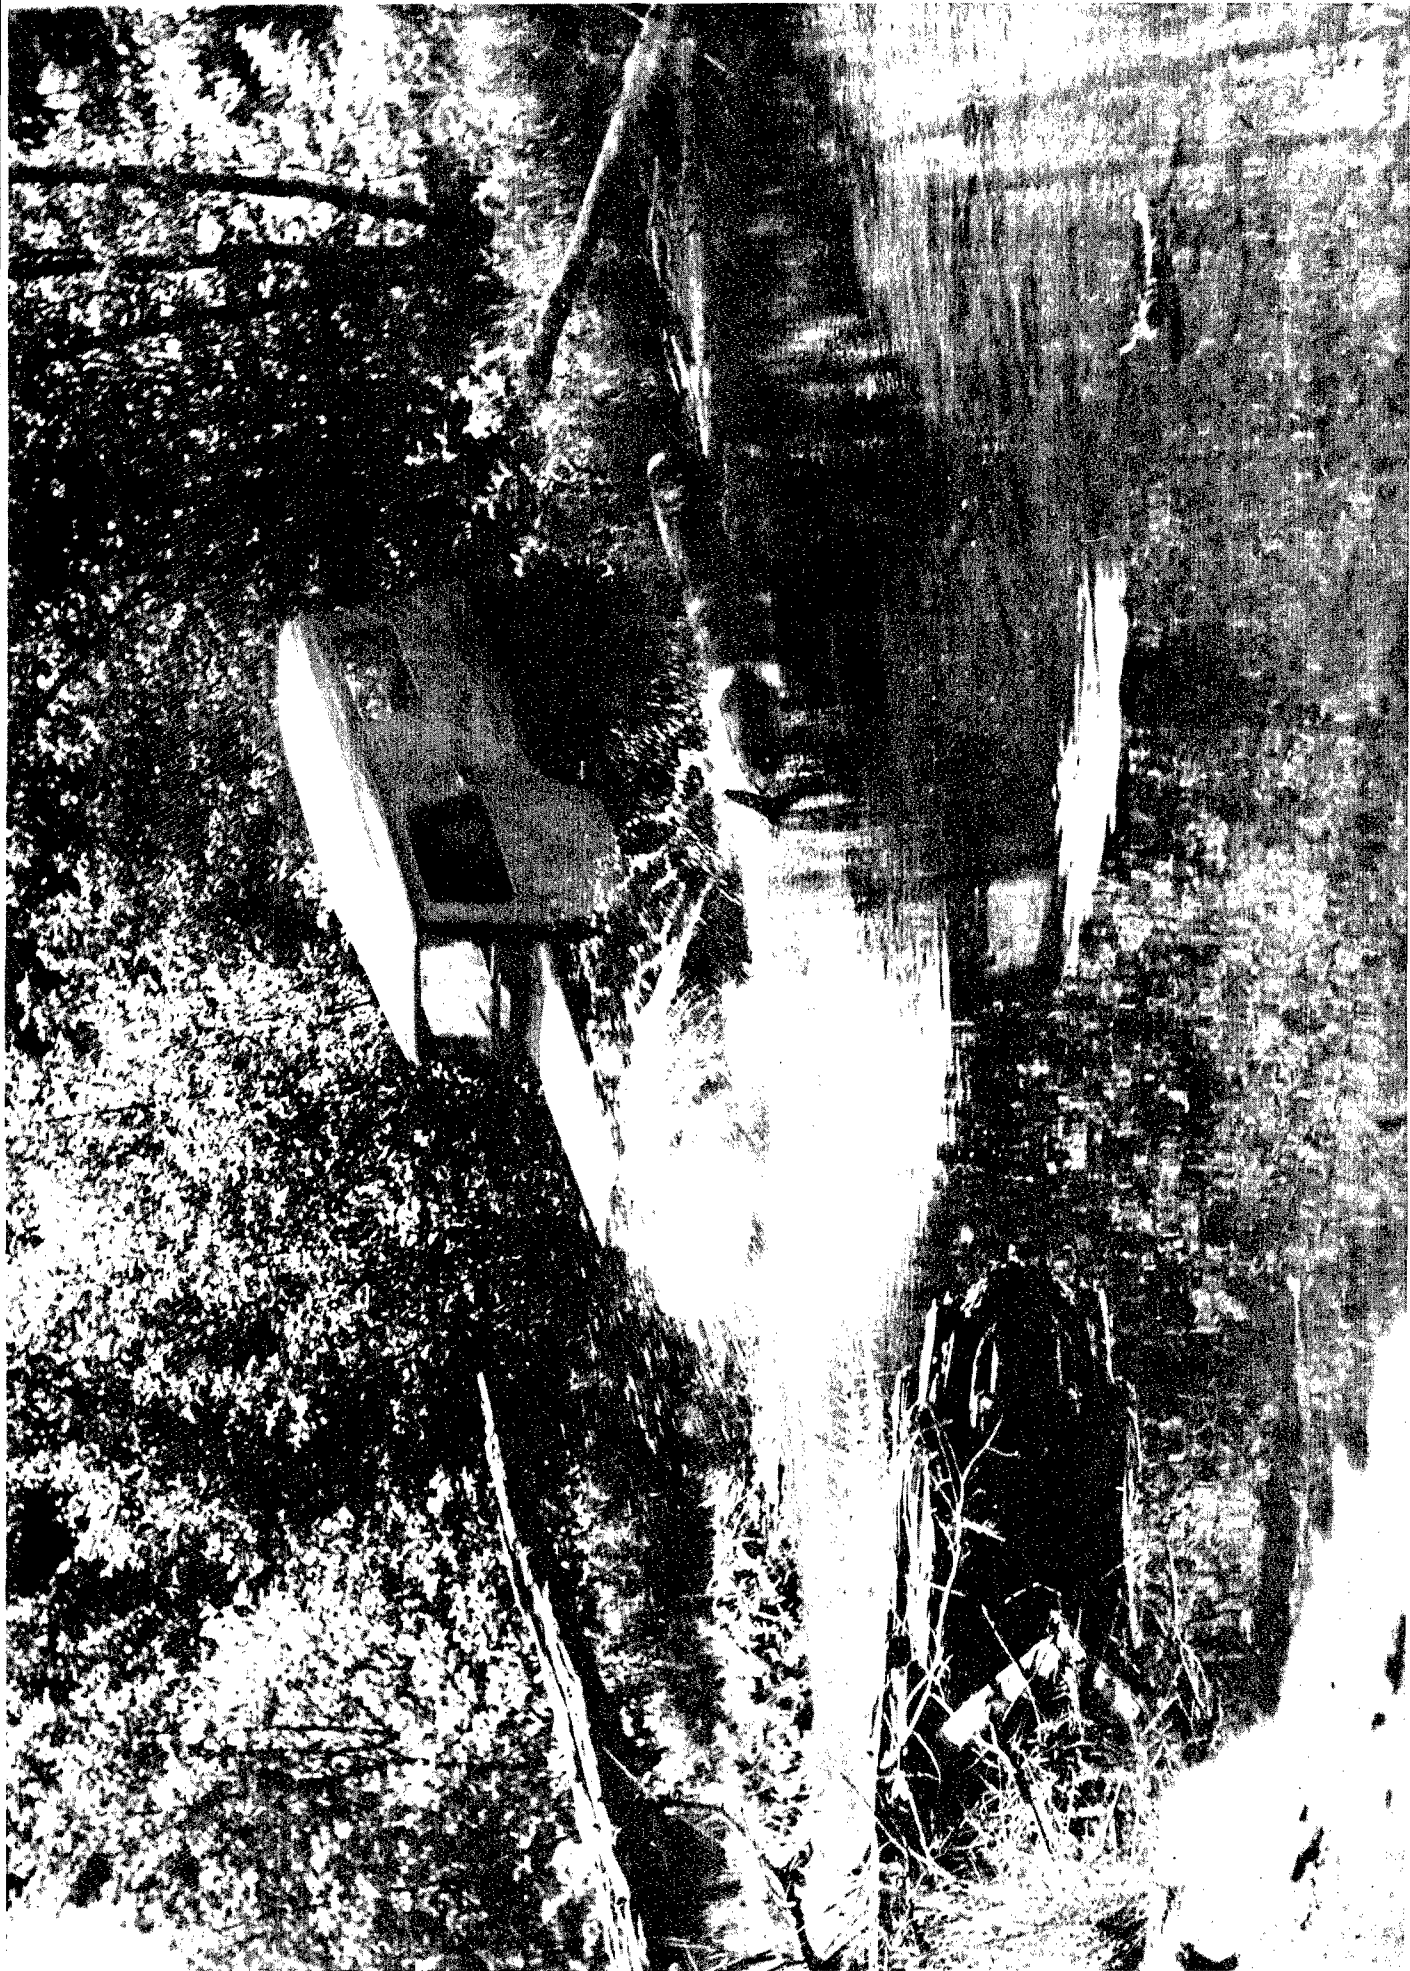
Figure 6A  
Creek Crossing on Cross Country Course

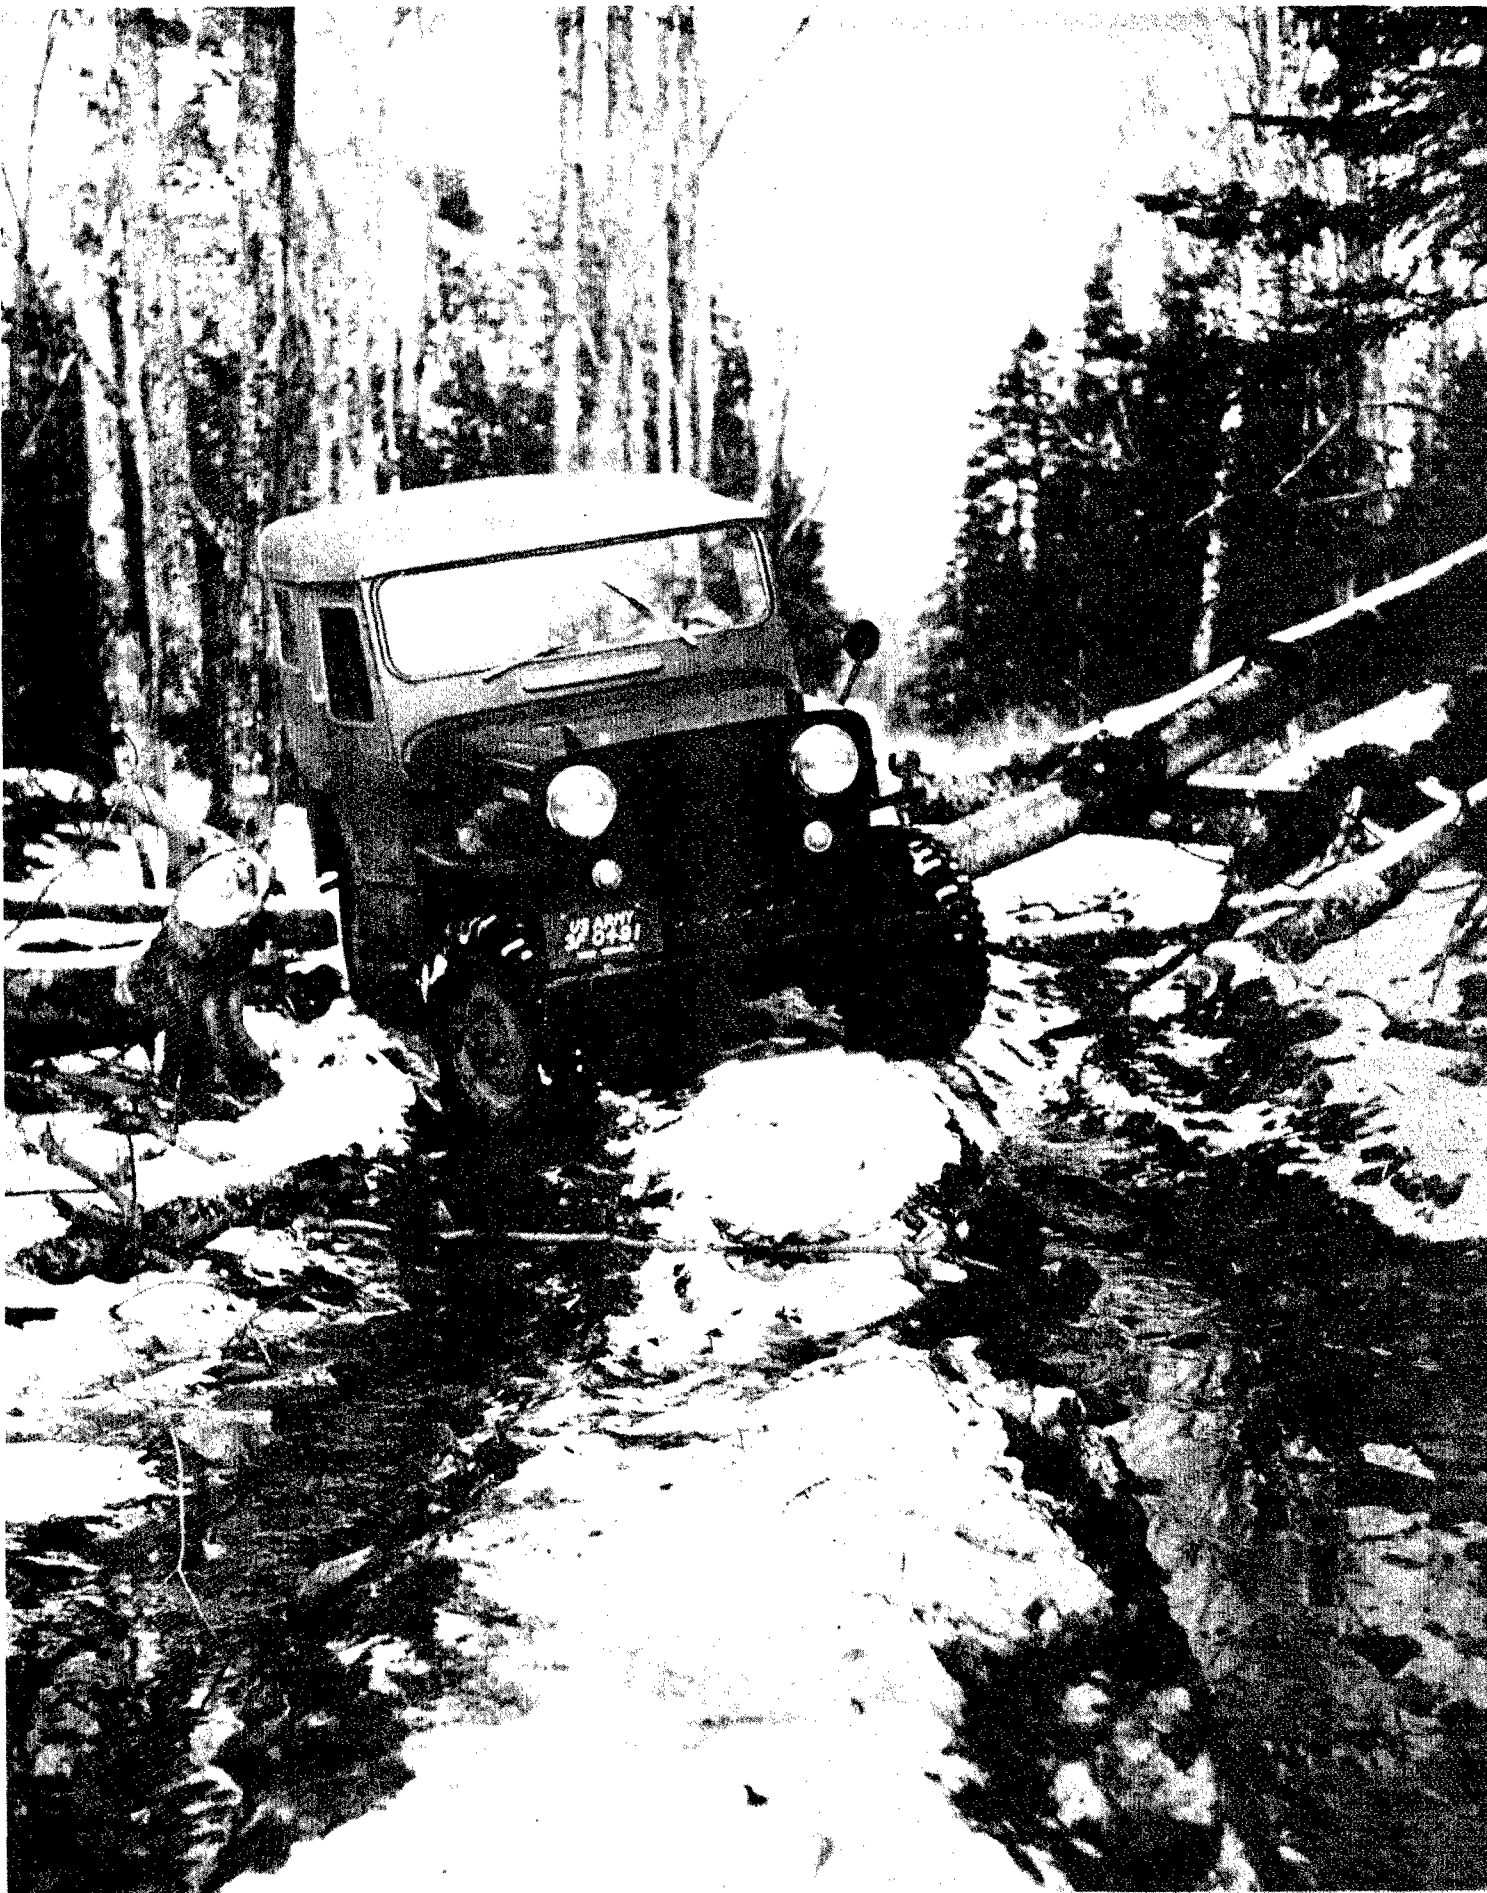
Figure 7A  
Rough Cross Country Course with Snow

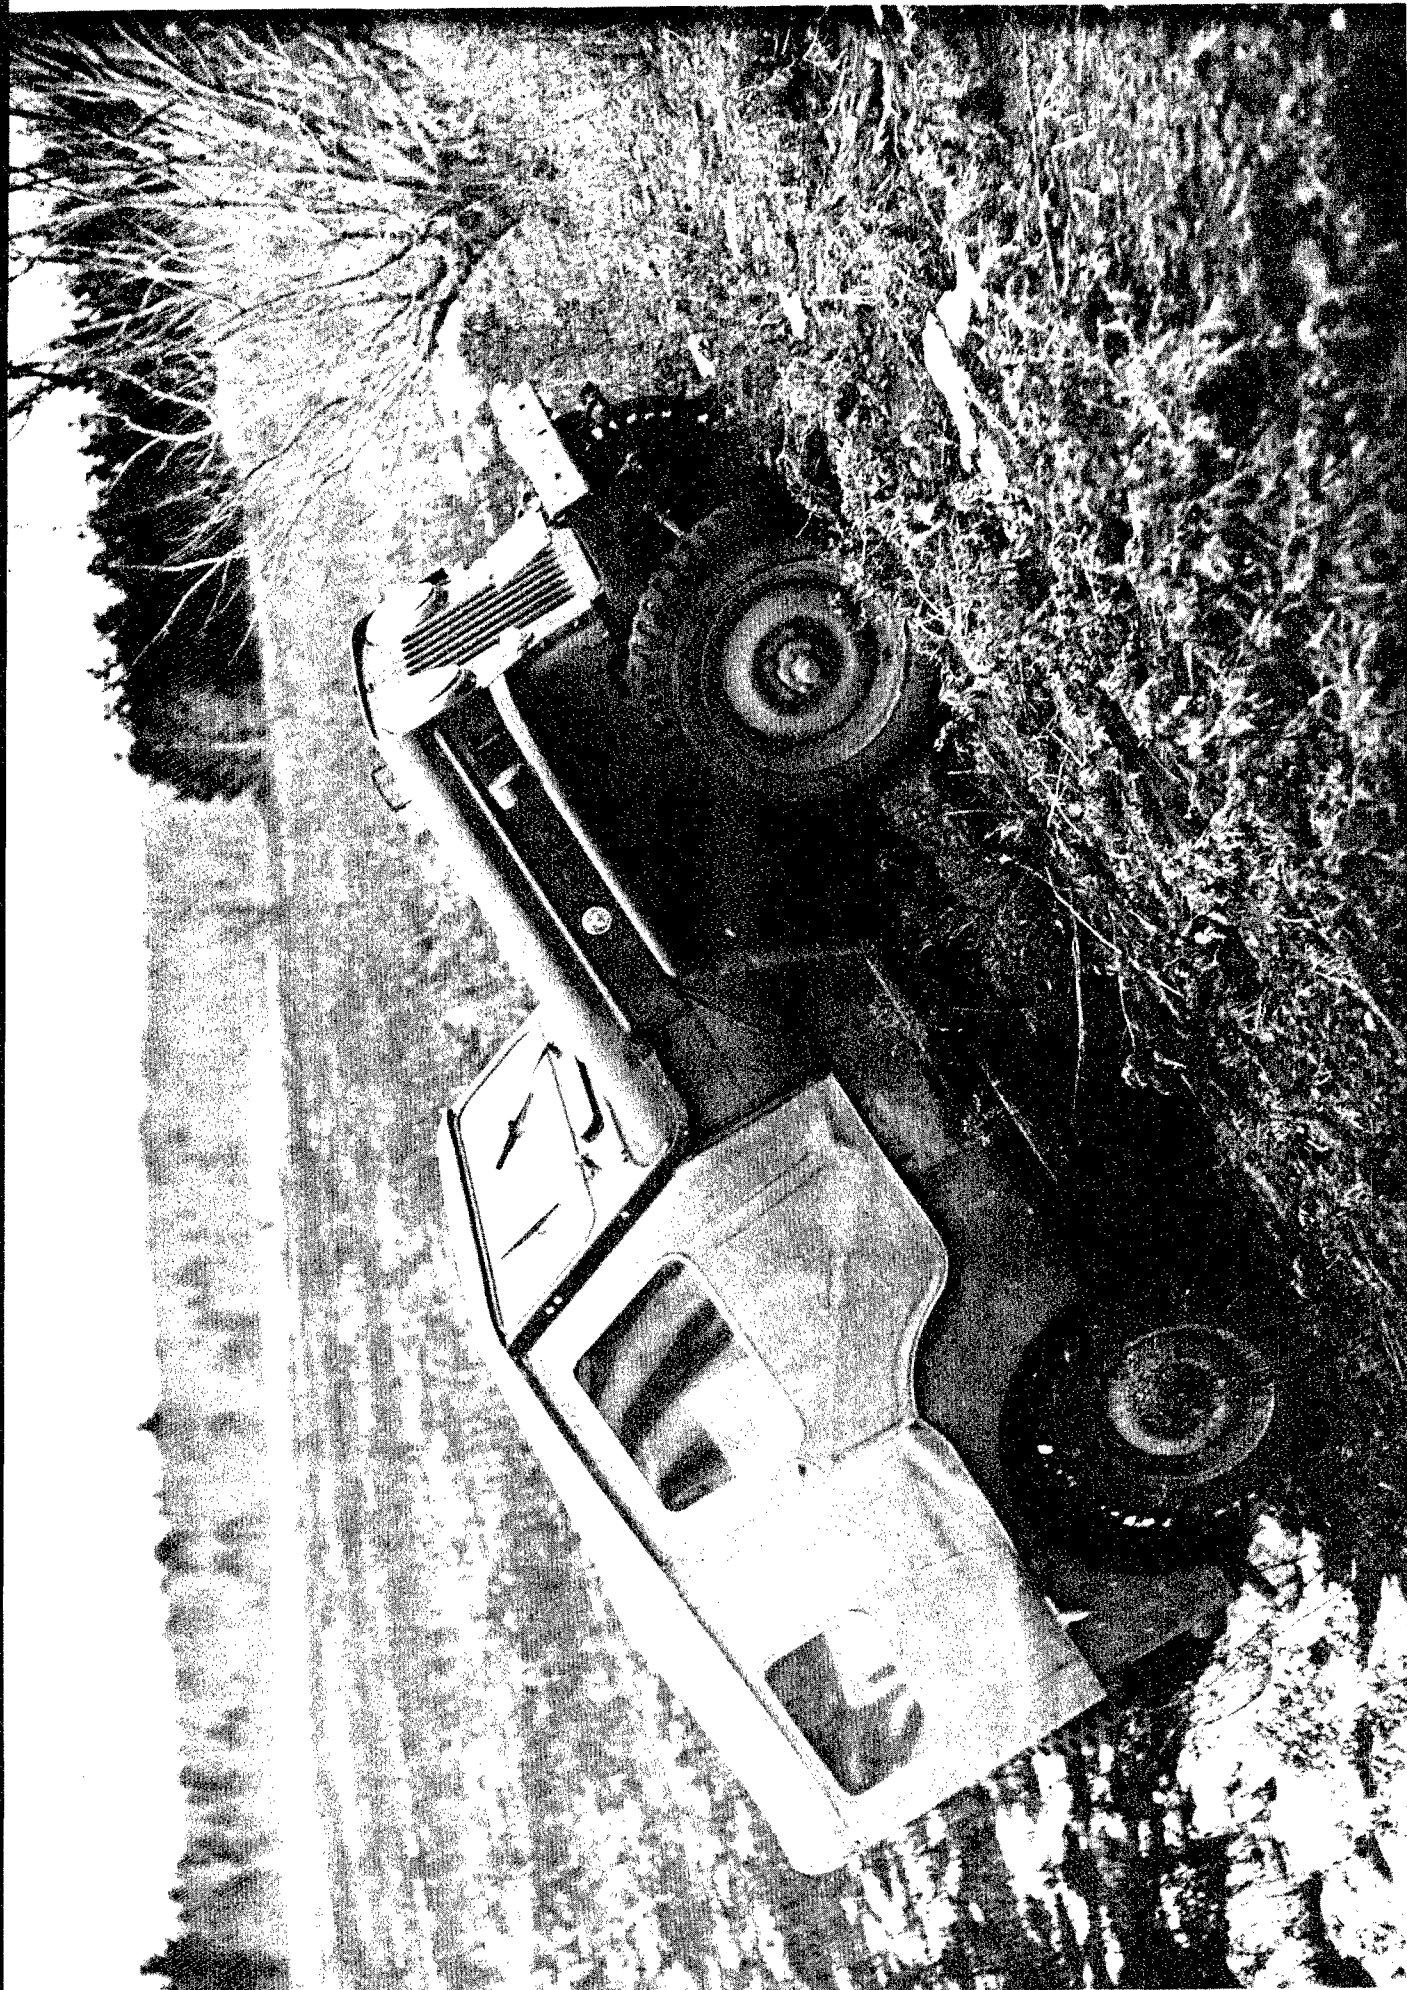
Figure 9A  
Gradeability Test on Packed Dirt

Table II lists the actual Vehicle Performance Factors as measured under test conditions in the Keweenaw Field Station area. Gradeability ranged from 35% on soft sand up to 60% on hard sand, 55% on loose soil, and 65-70% on packed dirt.

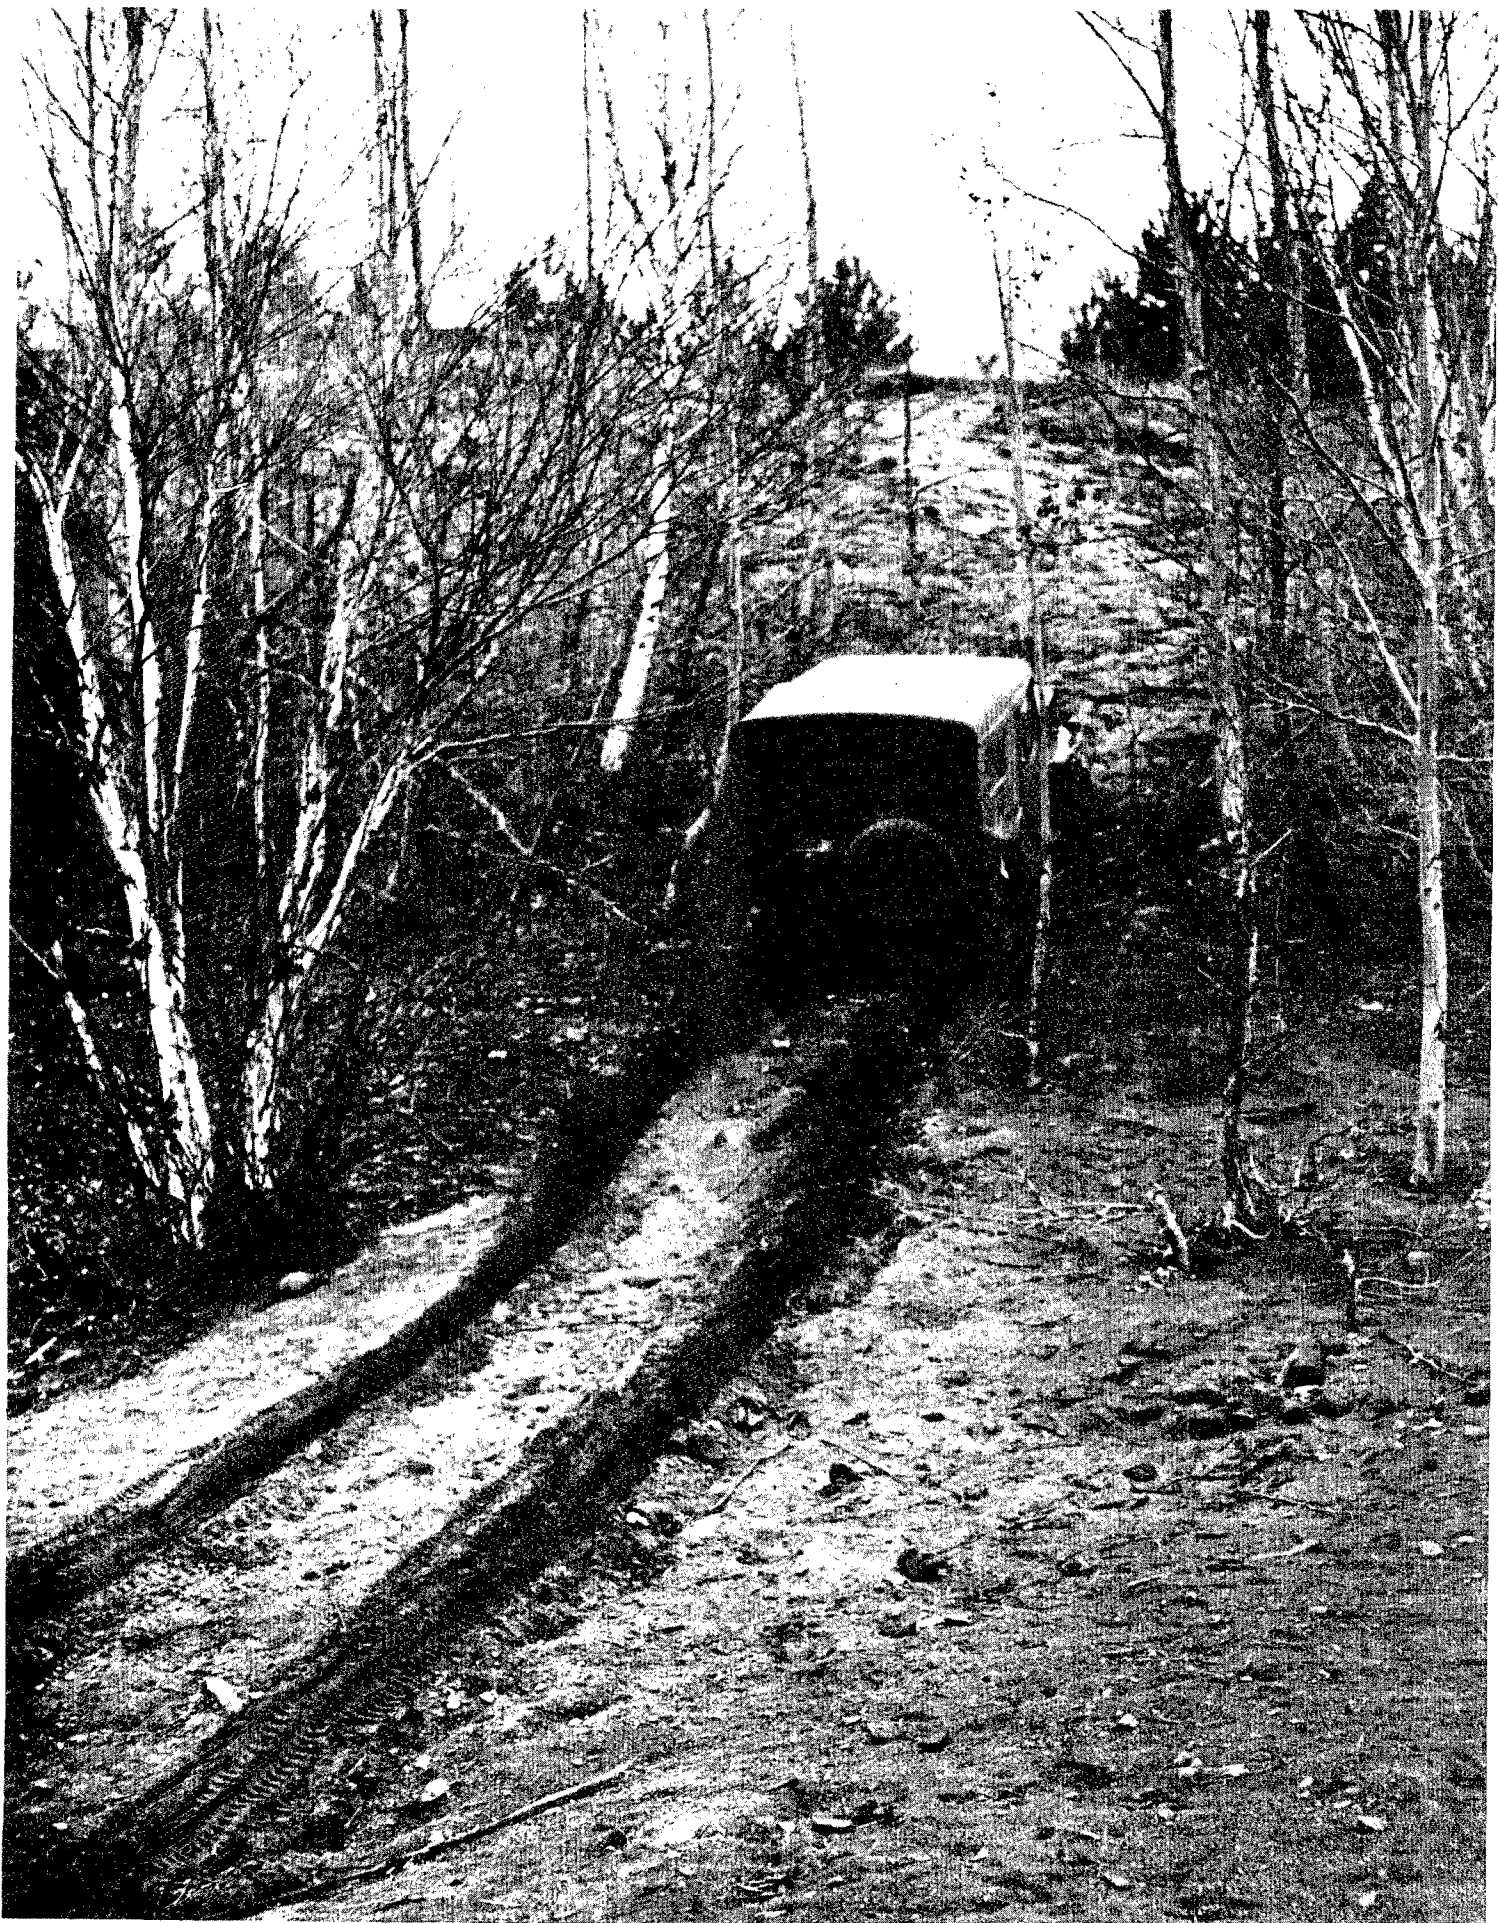
Figure 10A  
Gradeability Test on Packed Dirt

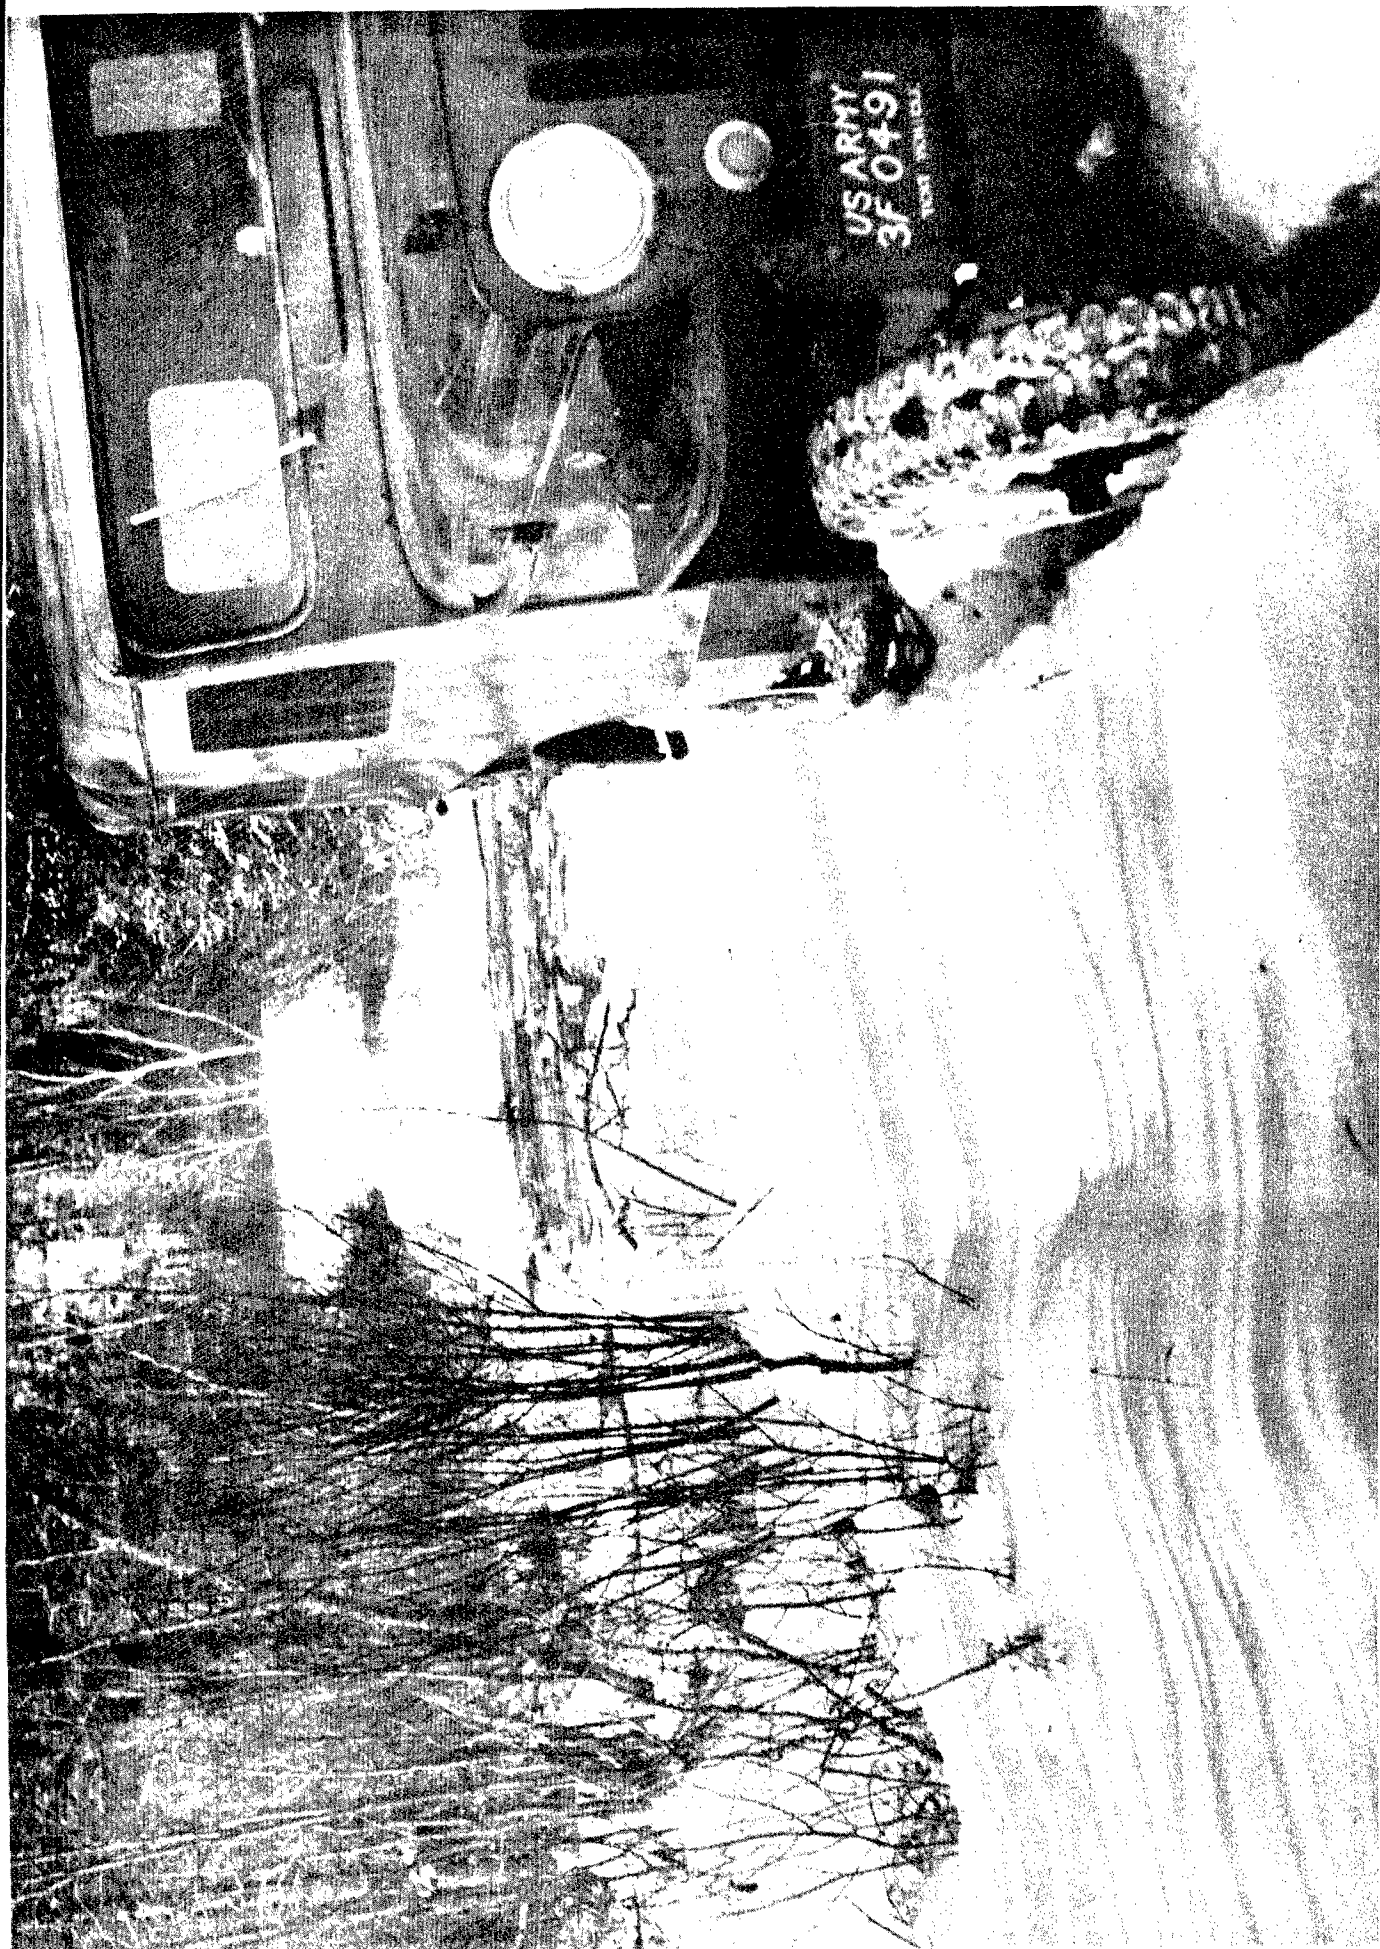
Figure 11A  
Mobility Test in Snow

Vehicle mobility limits usually involved getting "hung-up" on the under carriage. This occurred in soft soil and also in snow which was encountered at the end of the vehicle test. In several instances the vehicle became hung-up on protruding obstacles; and in other cases, on ordinary soft soil surfaces, after the wheels dug themselves into soft ruts. A similar problem was encountered when snow accumulation caused decreased traction and high resistance to motion, and finally hanging-up on the underbelly. Mobility limiting snow conditions finally required sending in a track-laying tractor into the test area to retrieve the vehicle when it became immobilized in snow.
