# A RESEARCH STUDY ON INTERNAL CORROSION OF HIGH-PRESSURE BOILERS

## FINAL REPORT

**ASME - EEI CORROSION SEMINAR**

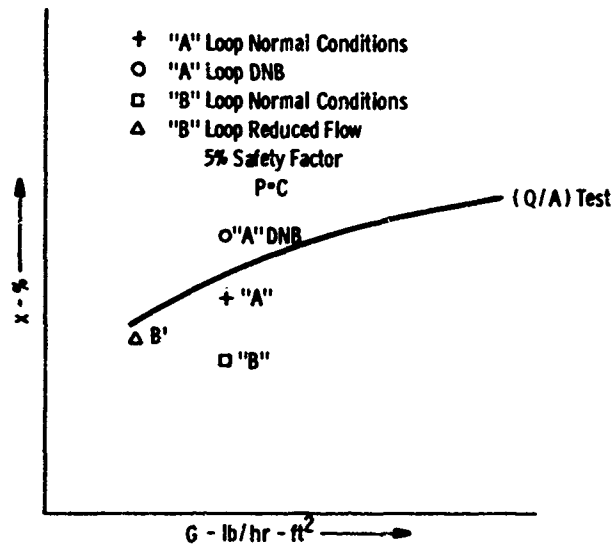
Fig. 5: Loop test conditions shown on a plot of critical parameters

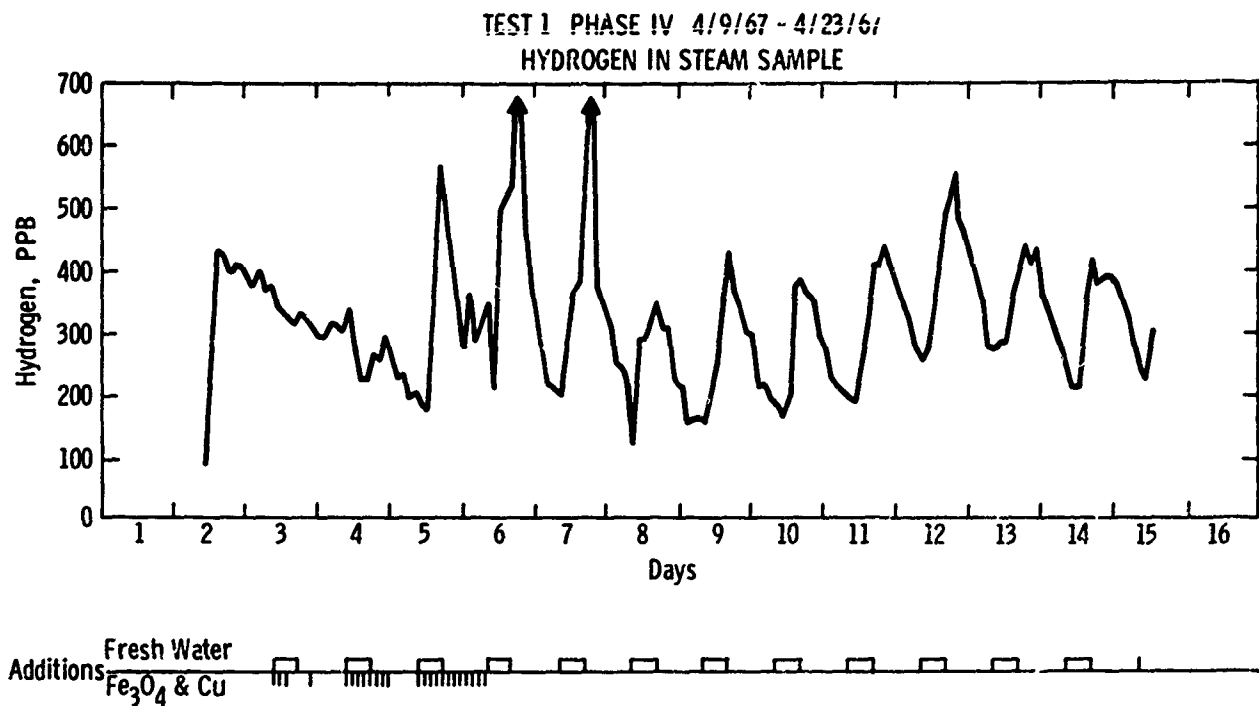
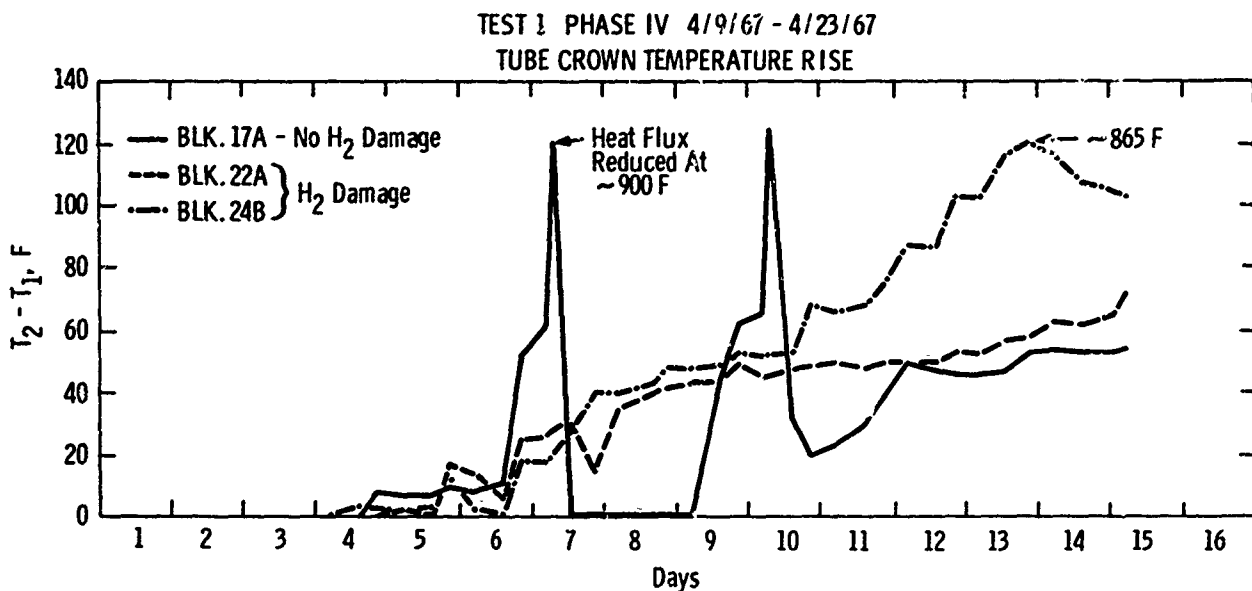
Fig. 7

Figure 7 shows the response of hydrogen concentration to the injections of condenser leakage which were started on the fourth test day and continued throughout the remainder of the test. During the first three days of condenser leakage addition, hydrogen values exceeded the 570 ppb full-scale capability of the analyzer, and hydrogen gas bubbles were noted in the reflux condenser sample. Although subsequent daily values were less than full scale, the variations in hydrogen concentration reveal an interesting upward trend of both the minimum peak and maximum peak values for each cycle. Injection of condenser leakage resulted in a reduction in boiler water pH to values of approximately 4.0 to 4.5 as shown in Fig. 8. During the last few days of operation, the boiler water pH

Increases in tube-metal temperature were noted (Fig. 7) with the injection of condenser leakage throughout the duration of the test. The greatest rate of increase was noted in the 150,000-Btu per hr-sq ft

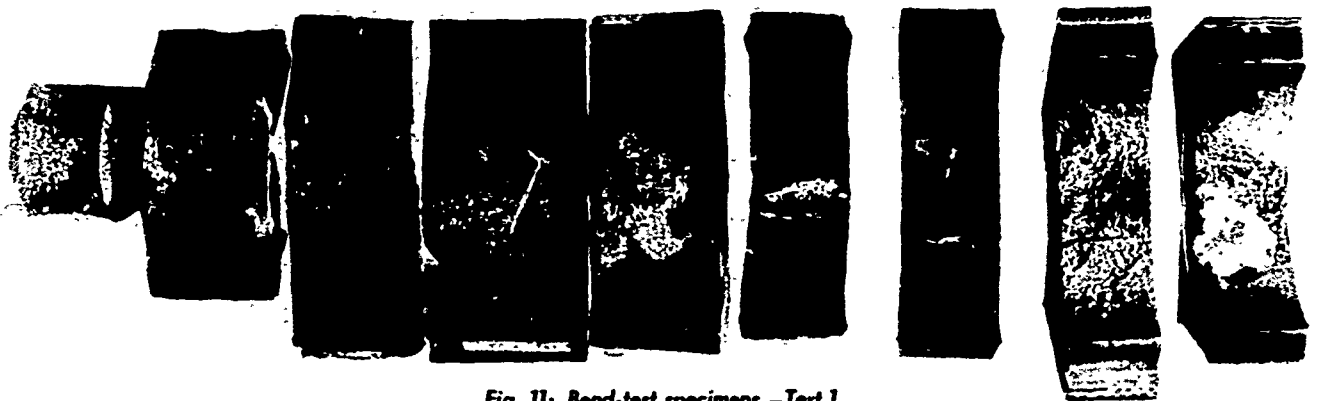
Fig. 11: Bend-test specimens—Test 1

hydrogen damage (Fig. 11). Figures 12 and 13 illustrate the cracking of a bend test specimen and the ductility of normal tube metal, respectively. Hydrogen-damaged metal was noted at blocks 21B, 24B, 19A, 19B, 21A, and 22B. The most severely damaged specimens appeared to have occurred in the low-heat-flux region of the B test loop.

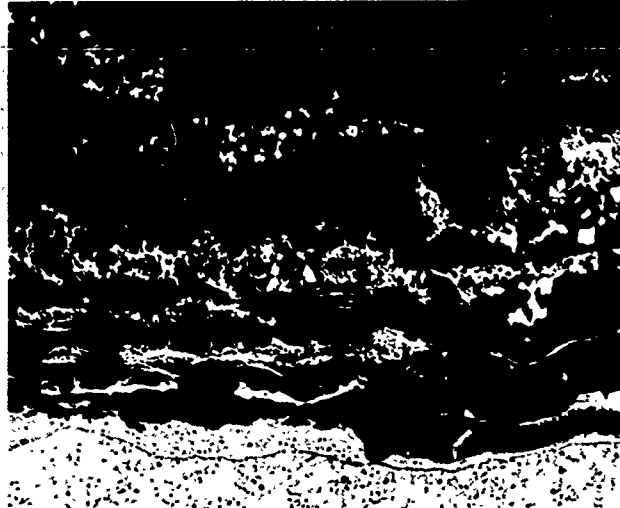
Fig. 21: Photomicrograph of deposit cross section—Test 2—unetched (original mag = 100x)

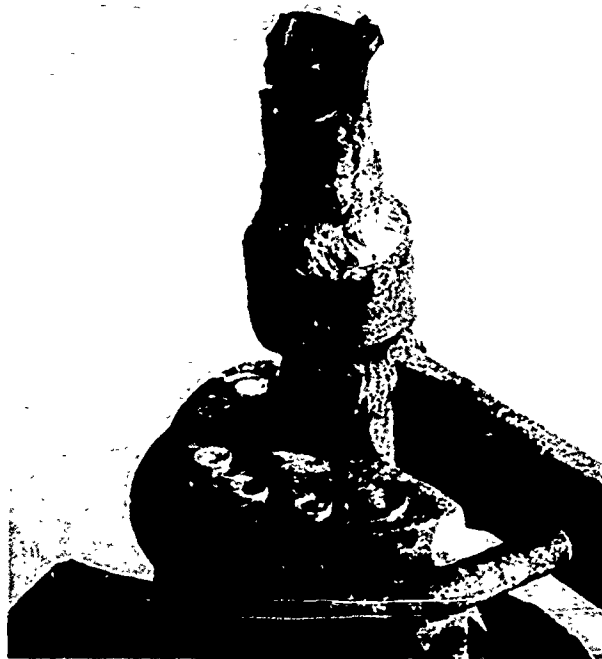
Fig. 32: Close up view of tube end at site of brittle failure—Test 4

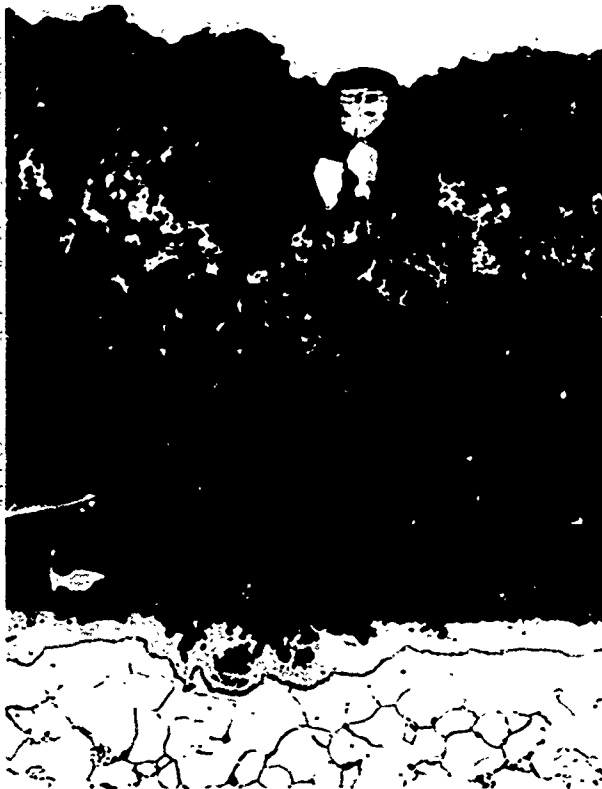
Fig. 36: Photomicrograph of deposit cross section—  
Test 4—(original mag = 250x)

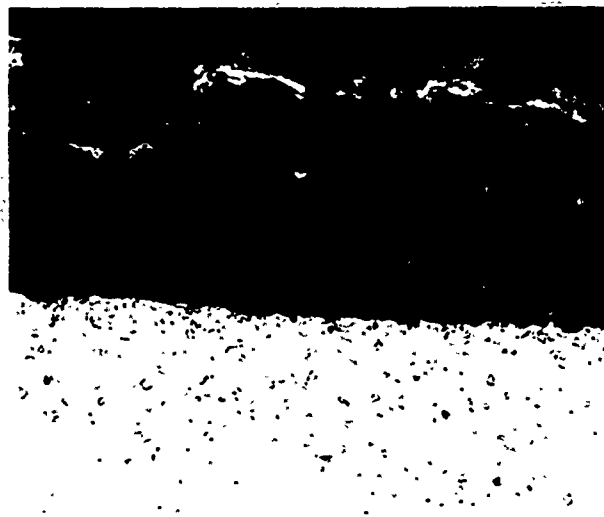
Fig. 44: Photomicrograph of deposit cross section—Test 5—unetched (original mag = 100x)
