AEDC-TR-68-194

**EFFECTS OF MONOMETHYLHYDRAZINE
ON CRYOPANEL MATERIALS
FOR SPACE SIMULATION CHAMBER
PROPULSION TESTS**

P. G. Waldrep and D. M. Trayer

**AEROSPACE ENVIRONMENTAL FACILITY
ARNOLD ENGINEERING DEVELOPMENT CENTER
AIR FORCE SYSTEMS COMMAND
ARNOLD AIR FORCE STATION, TENNESSEE**

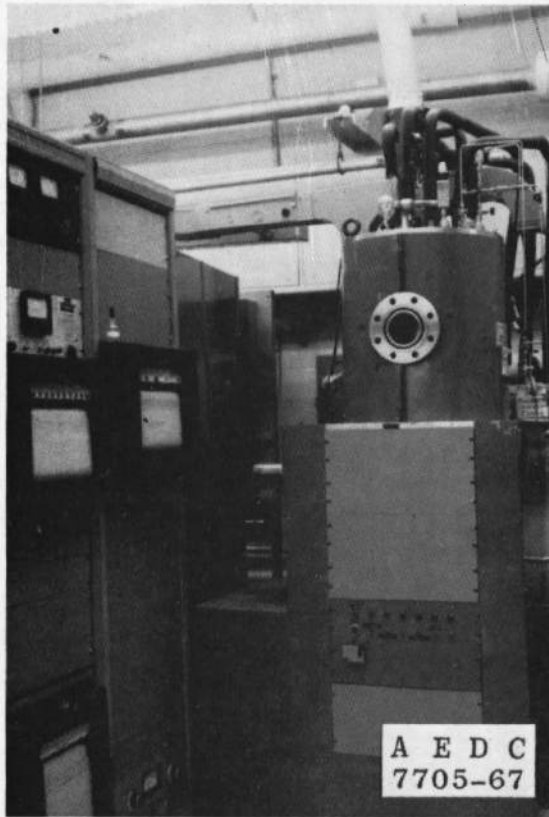
Fig. 1 1.5- by 2-ft Research Vacuum Chamber

The 1.5- by 2-ft Research Vacuum Chamber was used. The chamber is pictured in Fig. 1, Appendix I, and shown schematically as it was used for this test in Fig. 2. The chamber is a stainless steel cylinder, 1.5 ft in diameter by 2 ft high and has an operational free volume of 103 liters. A port is provided in the top for introduction of the test specimen holder, and a viewing port is located on the side. The primary chamber components are vacuum sealed with Buna-N[®] O-rings.

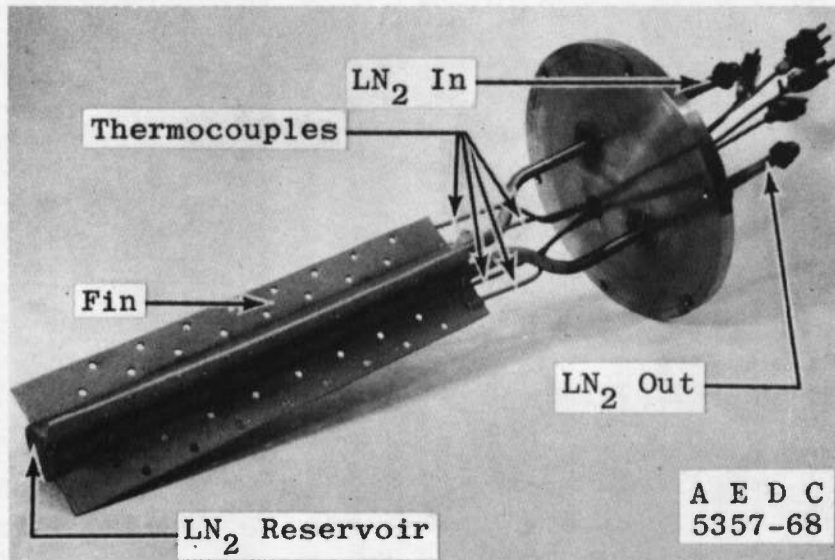
Fig. 3 Specimen Holder for MMH Test

The specimen holder, Fig. 3, consists of a stainless steel cylinder 1.25 in. in diameter by 1 ft long to which four longitudinal metal fins were welded. The test specimens were bolted to these fins. Three of the fins were copper and one was aluminum. Test specimens were mounted by bolting one end between a fin and a metal clamping strip which was cut and drilled to match the fin (Fig. 4). Liquid nitrogen circulated through the central cylinder during cooling cycles. Stainless steel sheathed thermocouples were attached to the base of each fin for temperature measurements.

The holder was inserted through the top of the chamber and vacuum sealed with Buna-N O-rings. The holder was situated inside the LN₂-cooled shroud during testing.

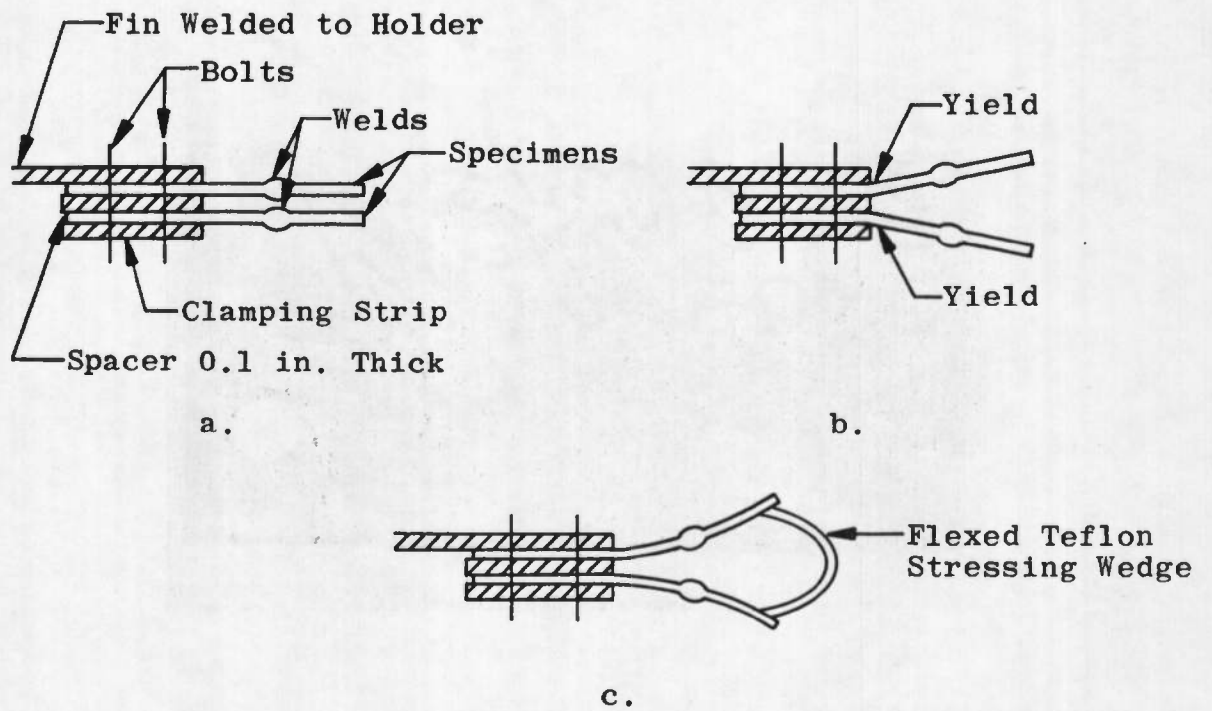
Fig. 5 Method of Stressing Test Specimens

Ten specimens were tested with an imposed external bending stress of just under the yield strength at the edges of the welds. This was done as shown in Fig. 5. Specimens were stressed in matching pairs. A pair of specimens were clamped into the holder at the same point with a metal spacer 0.10 in. thick separating their clamped bases (Fig. 5a). The tips were then separated until the calculated stress level at the edges of the weld was near yield strength (Fig. 5b). Finally, a Teflon[®] wedge was inserted between the tips to ensure this stress level would be maintained (Fig. 5c).

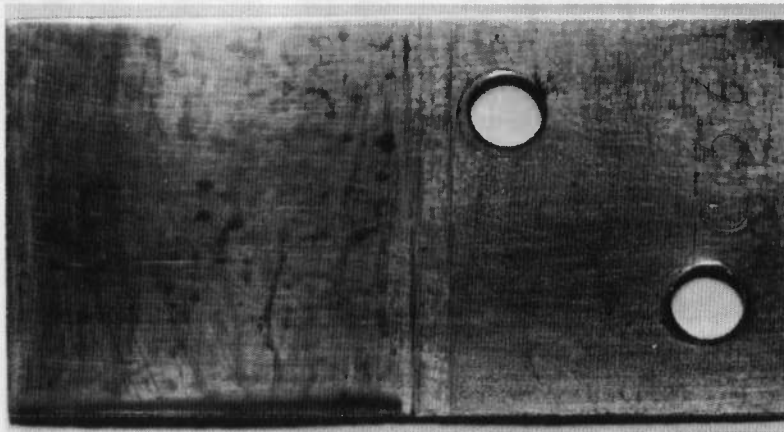
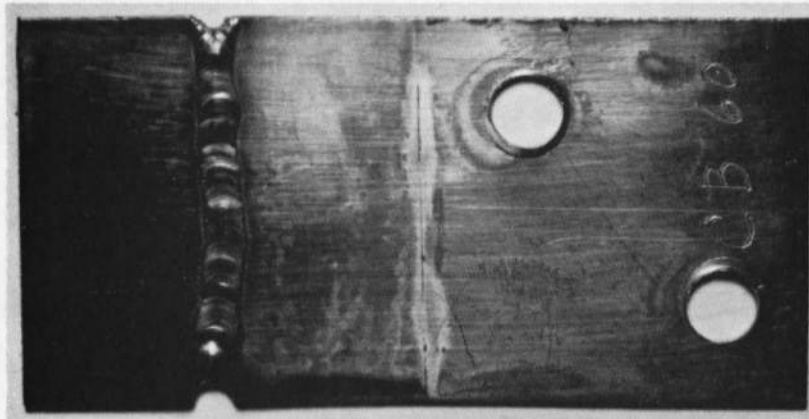
All uncoated copper specimens, including the brazed ones, were tarnished from the MMH exposure, Figs. 6 and 7. The tarnishing was not uniform but had a pattern suggesting that it was formed during melting and runoff of the MMH deposited on the surface. The tarnish film was soft and easily removed from the specimens by rubbing. Microprobe analysis of the film along the lower edge of a specimen indicated the presence of carbon, leading to the belief that the deposit consisted of MMH decomposition product.

Fig. 6 Copper Exposed to MMH, 2X

Fig. 7 Brazed Copper Exposed to MMH, 2X

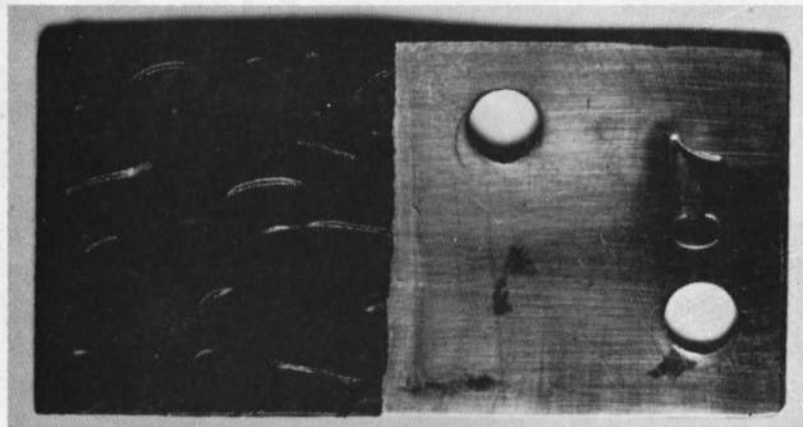
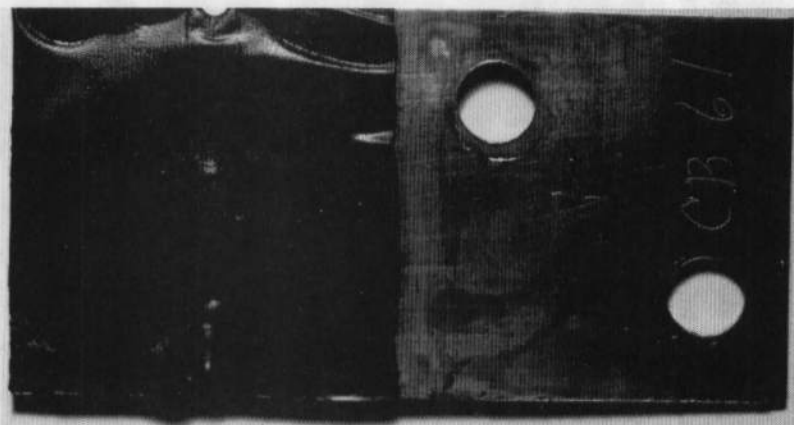
The black epoxy coating had separated from the copper surfaces, Figs. 8 and 9, and was easily removed. Apparently, the decomposition of absorbed MMH into volatile substances at the copper surface resulted in fracture of the metal-to-coating bonds, followed by blistering during subsequent pumpdown. The metal surface under the coating, Fig. 10, showed tarnishing similar to that observed on the unprotected copper surfaces.

Fig. 8 Coated Copper Exposed to MMH, 2X

Fig. 9 Coated Brazed Copper Exposed to MMH, 2X

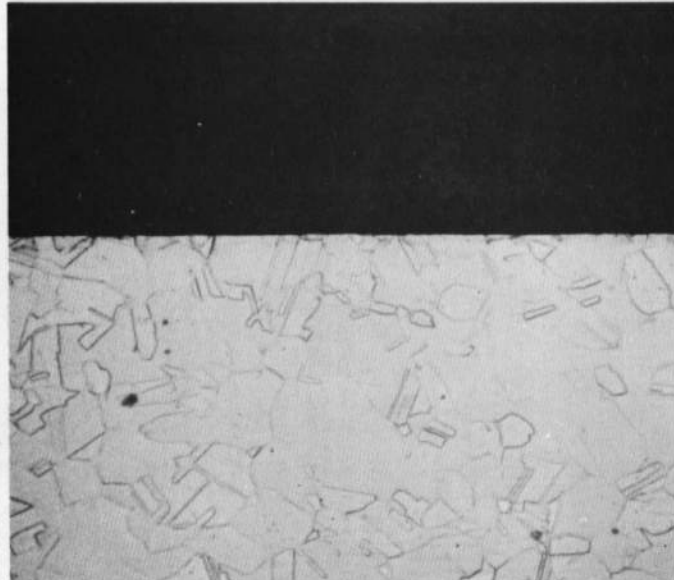
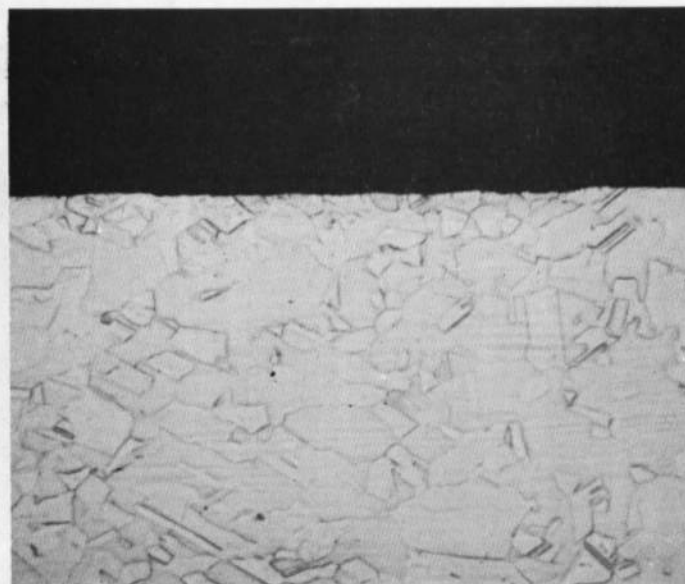
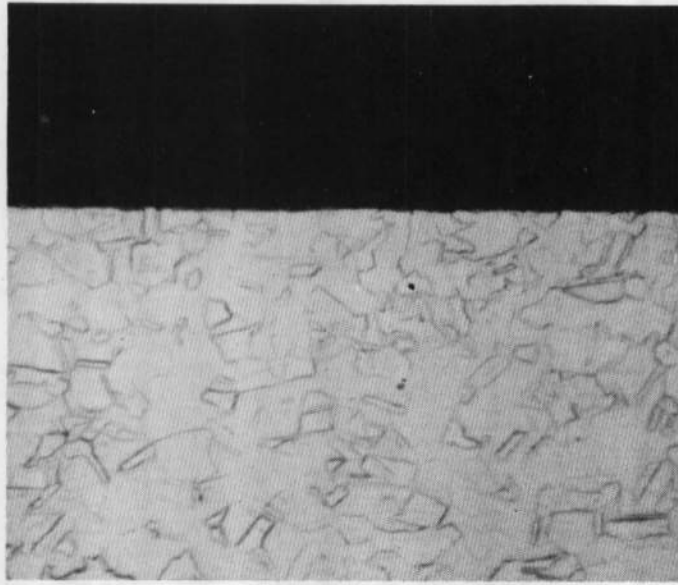
Metallographic examination of the copper specimens revealed no evidence of pitting, intergranular corrosion, or stress-corrosion cracking. A photomicrograph of an unexposed copper control specimen is shown in Fig. 11. Figures 12 and 13 show test specimens tested without black epoxy

coating and with the coating, respectively. No corrosive attack is evident in either case. Brazed and stressed specimens showed no evidence of corrosive activity as can be seen in Fig. 14. Weldments were likewise unaffected in a structural sense by the exposure. Cross-sectional photomicrographs of a control and a stressed test specimen at the welds are shown for comparison in Figs. 15 and 16.

Fig. 11 Copper Control, Unexposed, 500X

Fig. 12 Uncoated Copper Exposed to MMH, 500X

Fig. 13 Coated Copper, Exposed to MMH, 500X

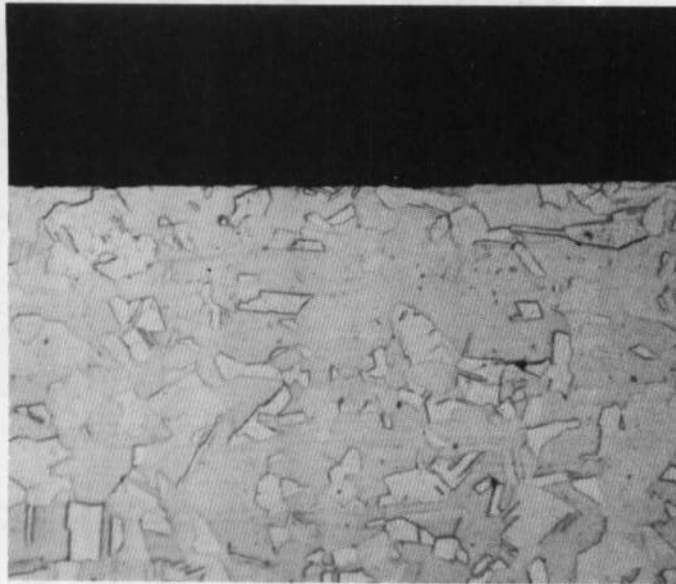
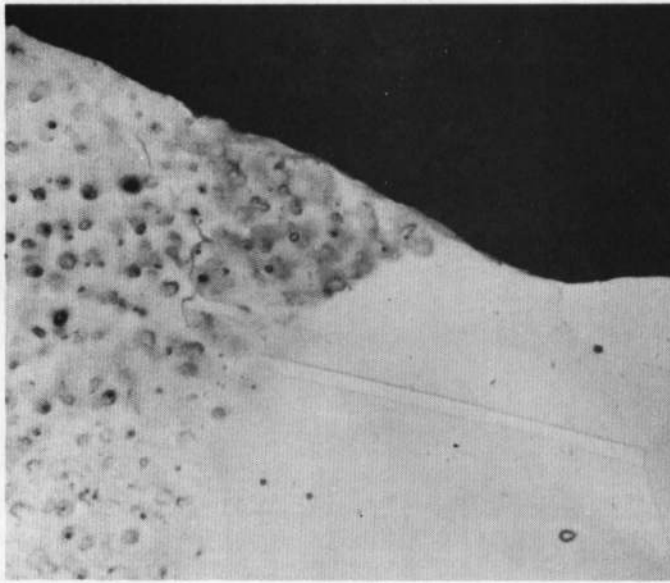
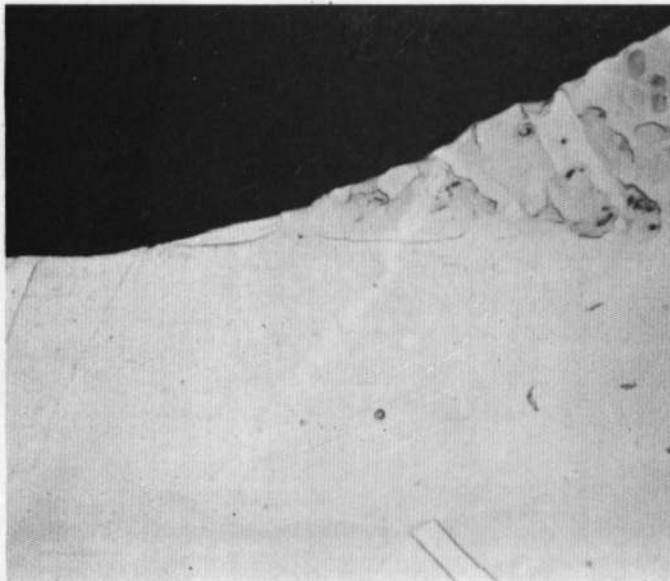
Fig. 14 Brazen Copper Exposed to MMH, Stressed, and Uncoated, 500X

Fig. 15 Control Specimen, Brazed Copper (ot Weld), Unexposed, and Unstressed, 500X

Fig. 16 Brazed Copper Exposed to MMH, Stressed (At Weld), 500X

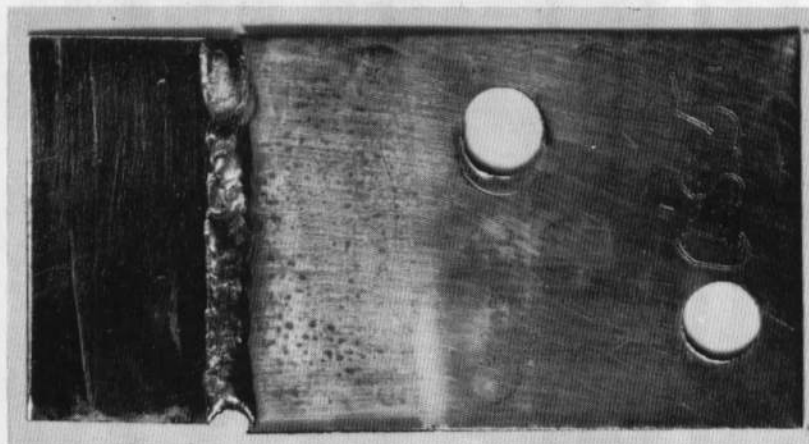
Fig. 17 Composite Exposed to MMH, Uncoated, 2X

The copper portions of the composites were tarnished in the same manner as the copper specimens discussed in Section 6.1. A typical, uncoated specimen is shown in Fig. 17. The stainless steel portions showed only discoloration caused by welding.

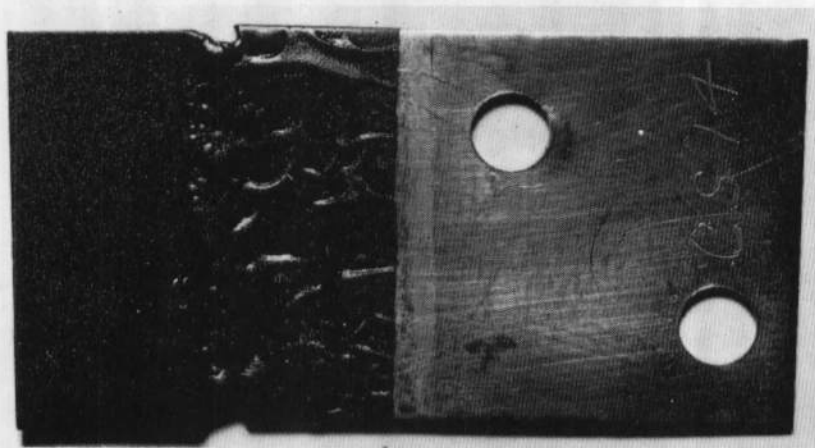
Fig. 18 Composite Coated and Exposed to MMH, 2X

The black epoxy coating had separated from the copper portion of the coated specimens, Fig. 18. Although the coating at first appeared to be well bonded to the stainless steel portion, close microscopic examination of cross sections indicated that it was separated from a large portion of the steel surface. There was no evidence that the coating on the steel had blistered as it had on copper.

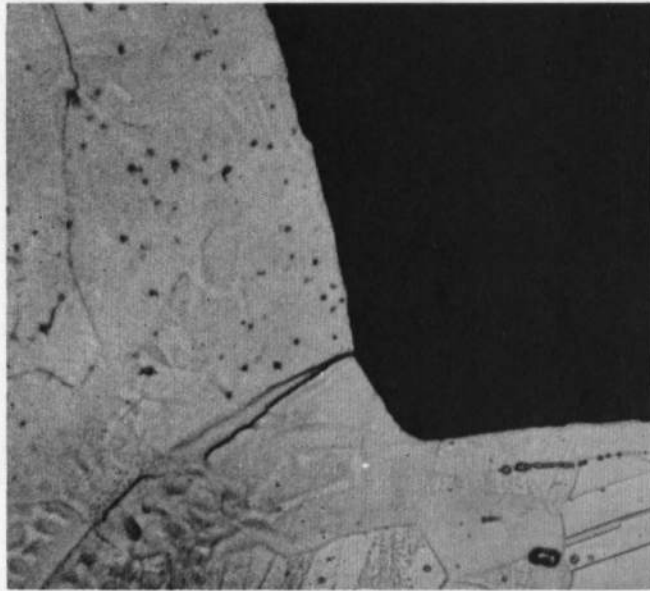
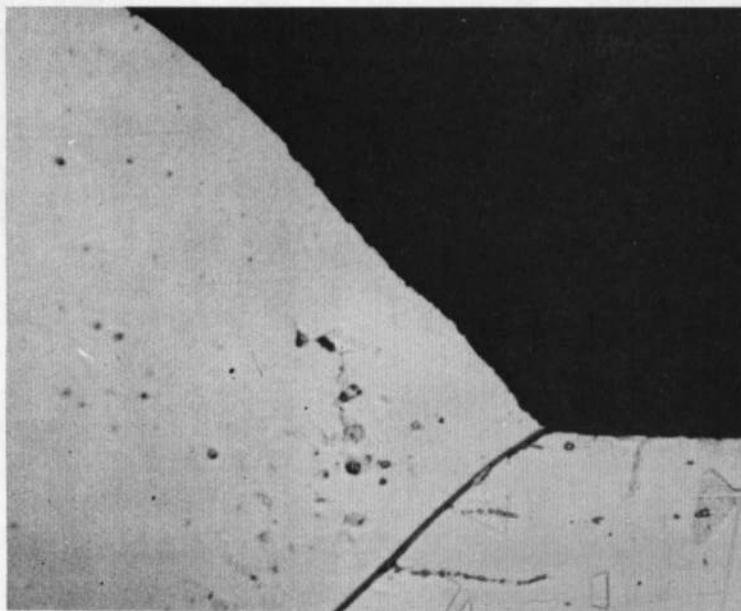
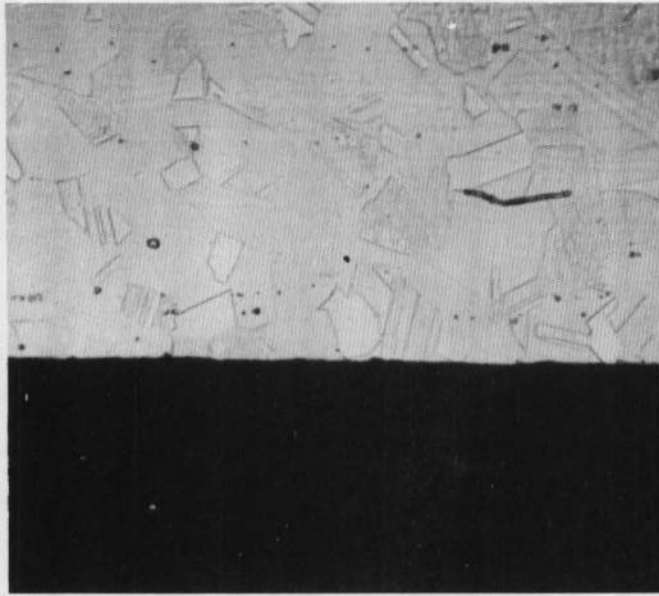
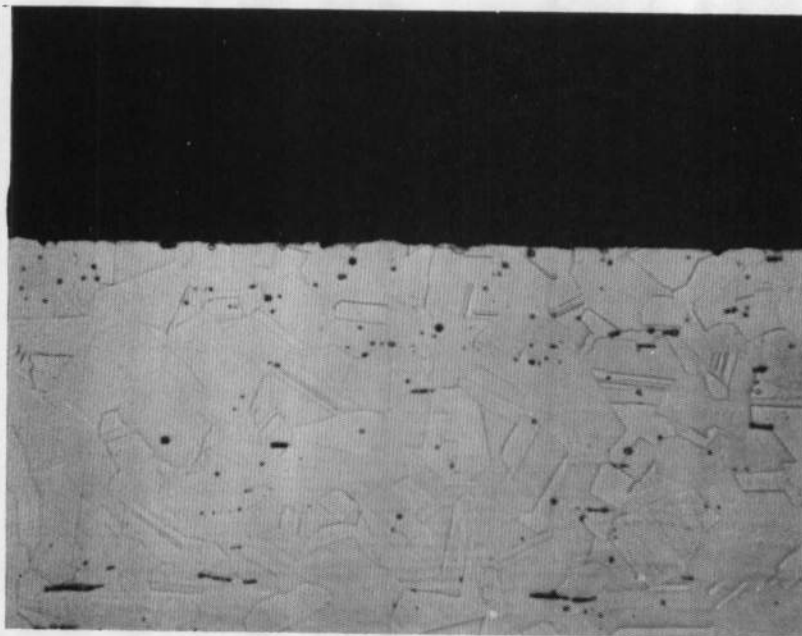
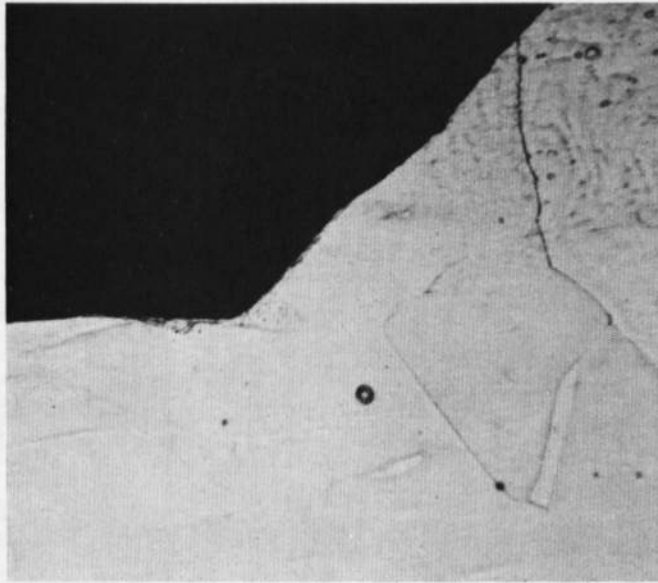
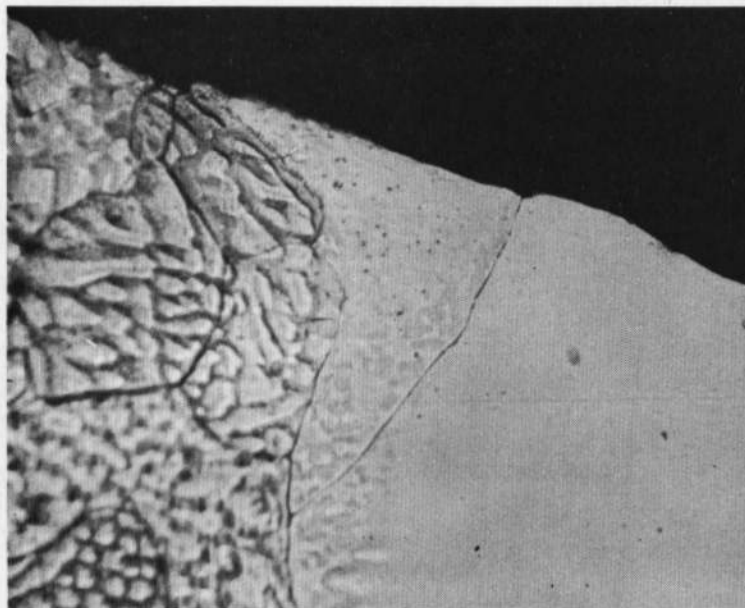
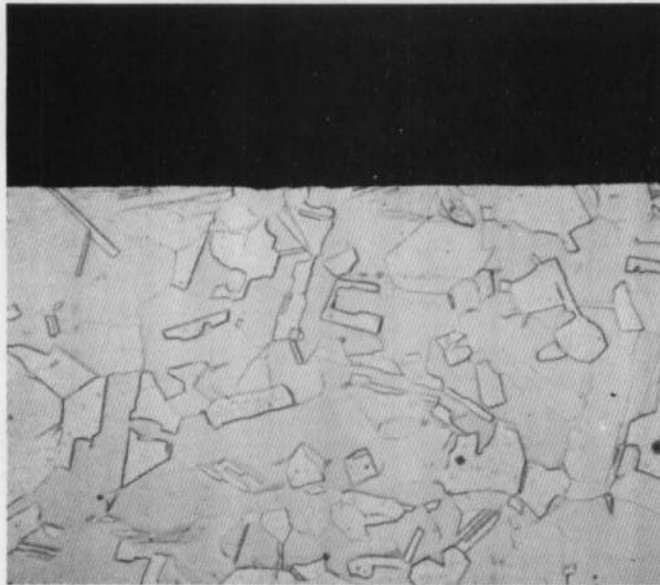
Neither the copper, the stainless steel, nor the nickel weldments showed evidence of corrosive attack on the metal itself. No pitting or intergranular corrosion was discovered. The stress imposed on several specimens did not result in detectable stress-corrosion. Photomicrographs of test and control specimens are shown in Figs. 19 through 25. A control specimen for comparison with the copper portion shown in Fig. 25 may be seen in Fig. 11.

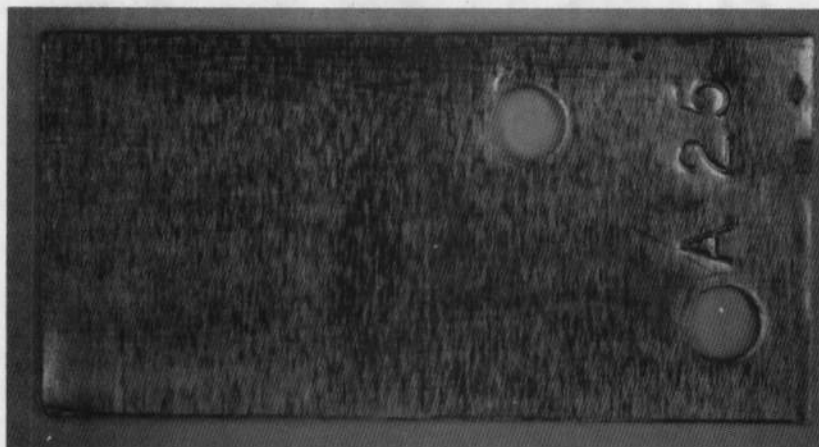
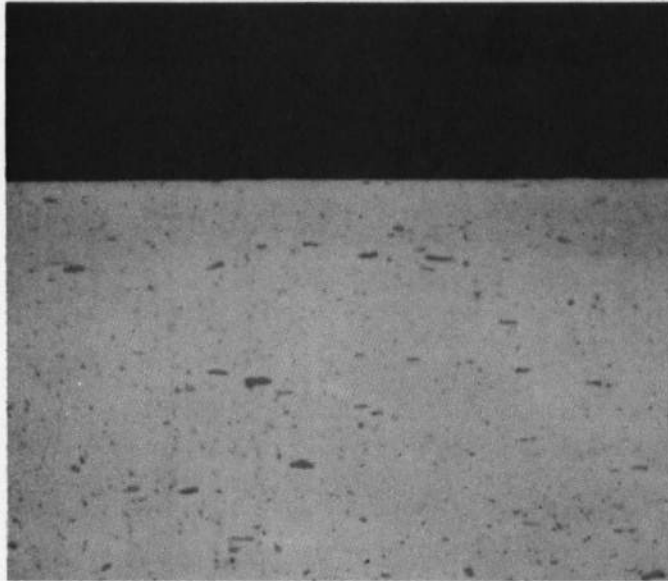
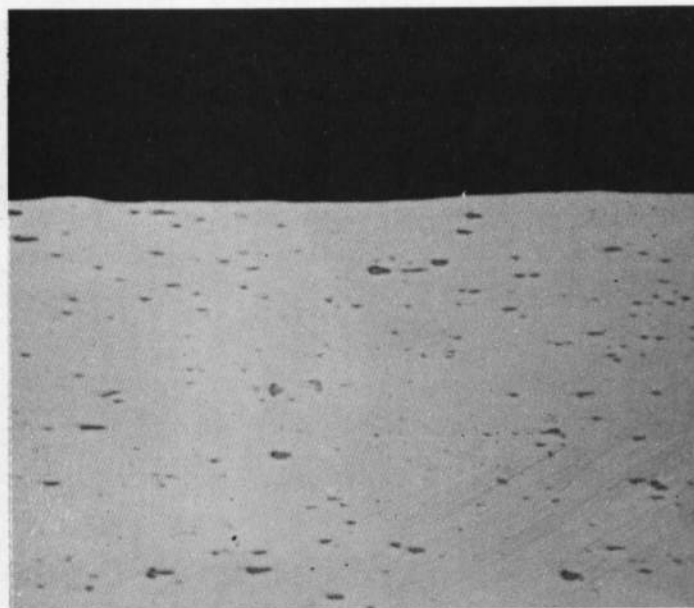
No corrosive effects of any type were found in the aluminum specimens. The specimens retained their original metallic luster, Fig. 26, and microscopic examination revealed no microstructural damage, Fig. 27. A control specimen is pictured in Fig. 28.

Fig. 26 Aluminum Exposed to MMH, 2X

Fig. 27 Aluminum Exposed to MMH, 500X

Fig. 28 Control Aluminum, Unexposed, 500X

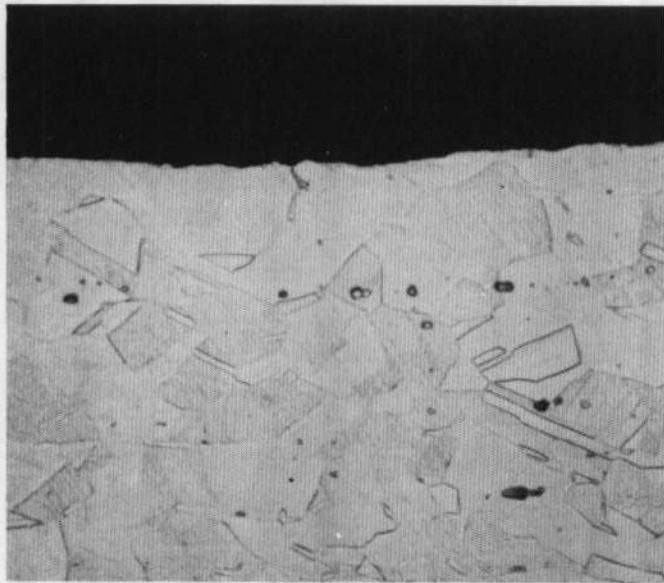
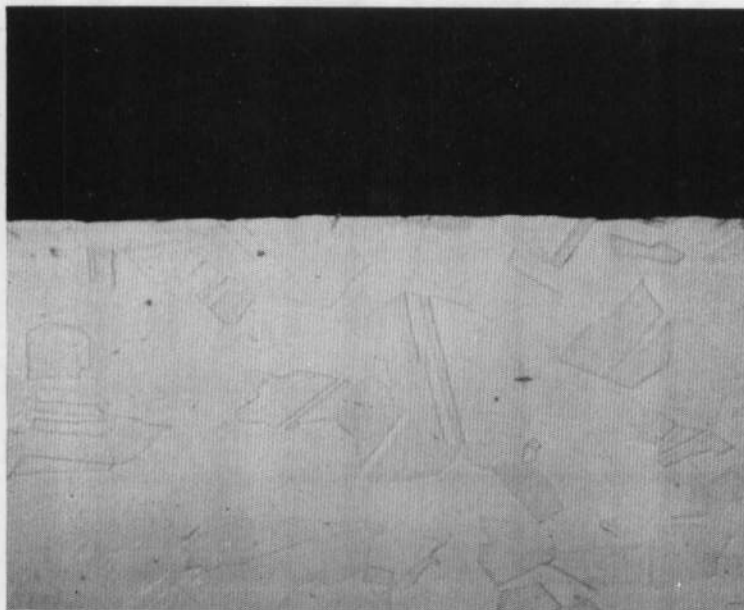
No indication of corrosive attack, general or localized, was found in this specimen. There was no visible surface deposit. The weld regions were closely examined and there was no evidence of damage. A cross-sectional photomicrograph is shown in Fig. 29. The slightly roughened surface is a characteristic of the metal and was not caused by corrosive attack. A control specimen is shown in Fig. 30.

Fig. 29 Stainless Steel Cryopanel Exposed to MMH, 500X

Fig. 30 Control, Stainless Steel Cryopanel, Unexposed, 500X
