USAAVLABS TECHNICAL REPORT 68-50B

**SMALL GAS TURBINE ENGINE
COMPONENT TECHNOLOGY - TURBINE
VOLUME II
PHASE II SUMMARY REPORT**

August 1968

**CONTRACT DA 44-177-AMC-182 (T)
CURTISS-WRIGHT CORPORATION
WOOD-RIDGE, NEW JERSEY**

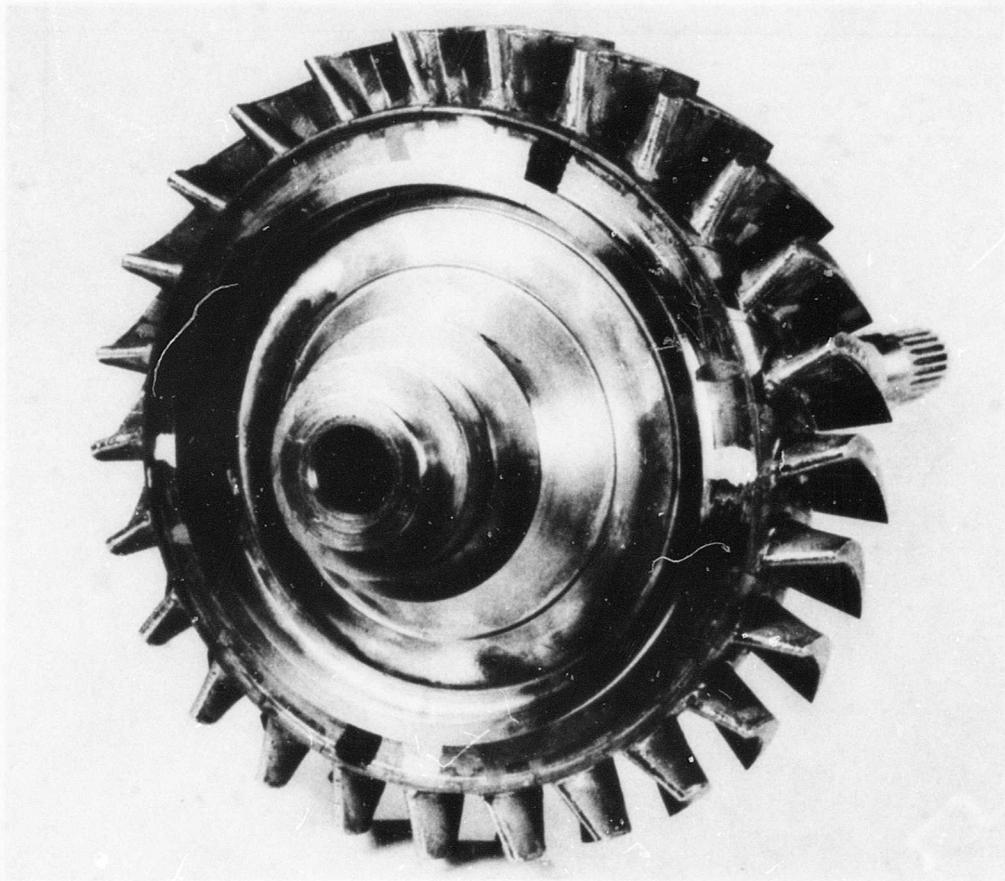
Figure 23. Turbine Rotor Assembly.

(This Figure Shows the Leading-Edge Pressure Side Panels After Replacement on the Completed Rotor Assembly by Electron Beam Welding.)

cooling air passage through the shaft center was bored to dimension. The finish machined rotor assembly is shown in Figure 23. This figure shows the leading-edge pressure side panels after replacement on the completed rotor assembly by electron beam welding.

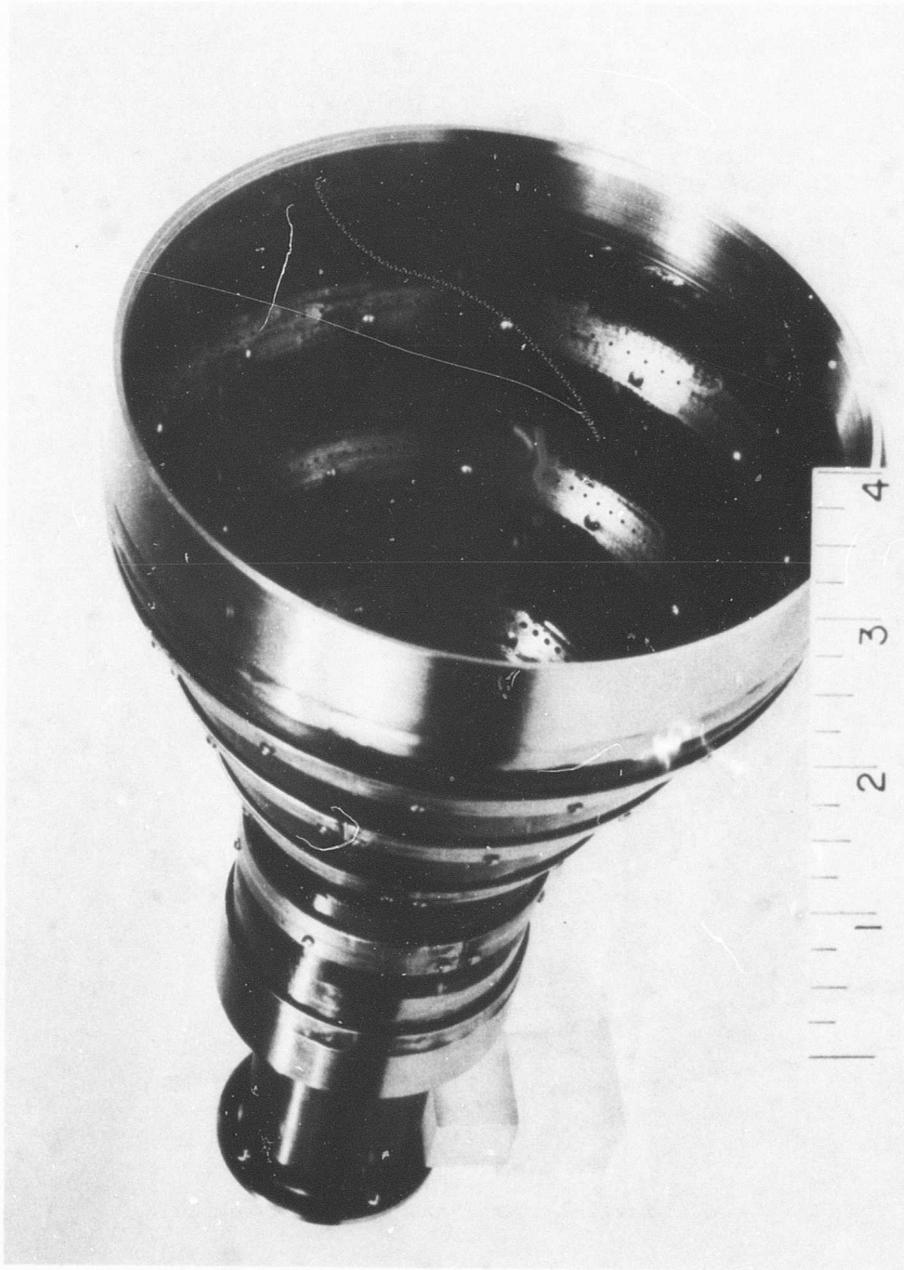
Figure 41. Combustor Inner Liner.

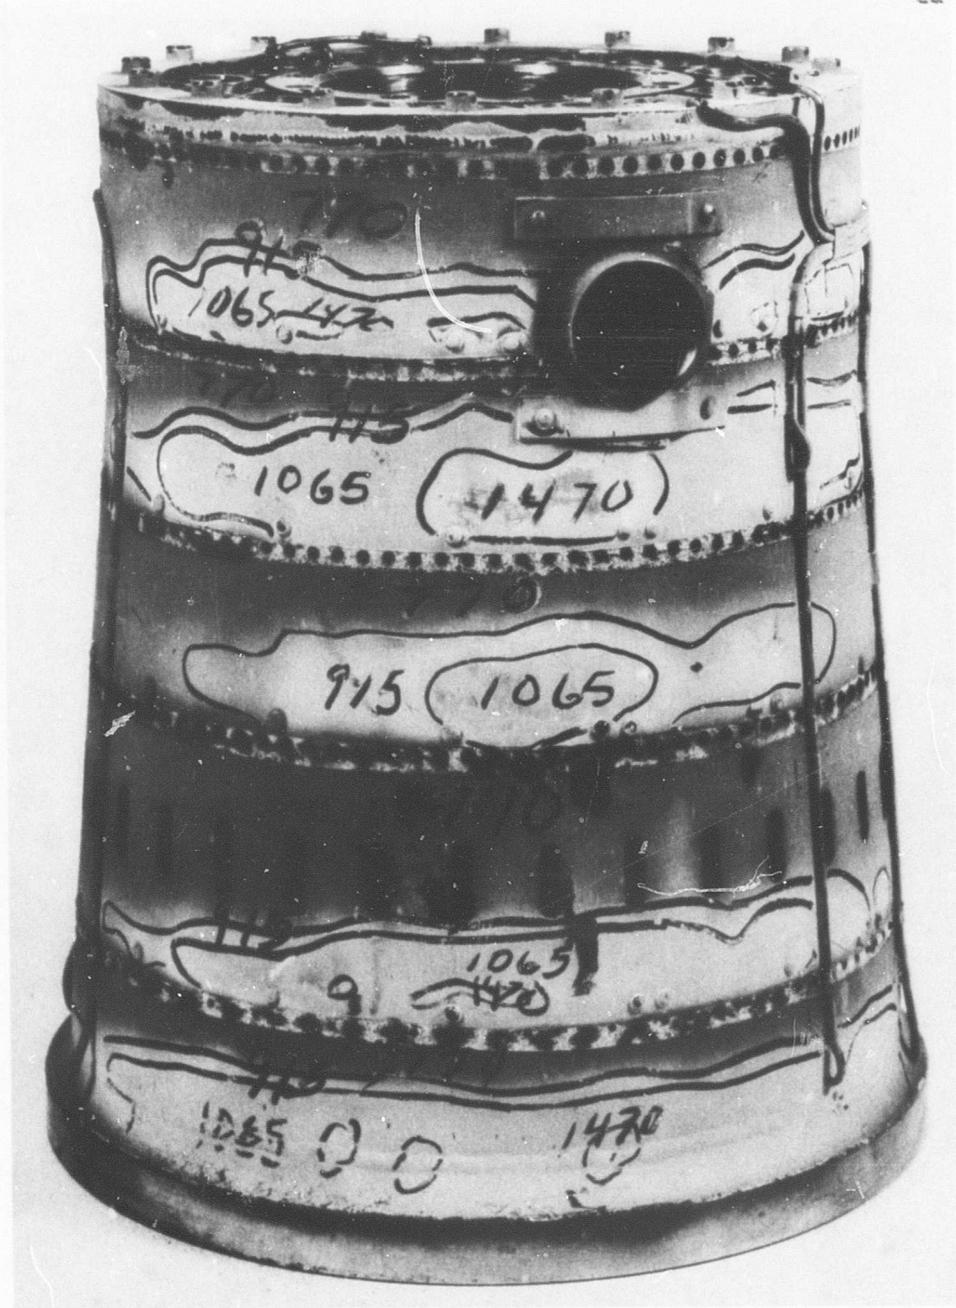
Figure 70. Outer Liner, Posttest

After completing the initial airflow checks and establishing a configuration for stable combustion, effort was concentrated on evaluating liner durability. Figure 68 shows the combustor assembly with temperature paint and thermocouples installed. Figures 69 and 70 show the inner and outer liner after testing to an F/A ratio of .030. Figures 71 and 72 translate a portion of this temperature paint to a schematic of the liners for easy study. It is to be noted that the figures represent liners that were reworked as compared to the initial design as follows:

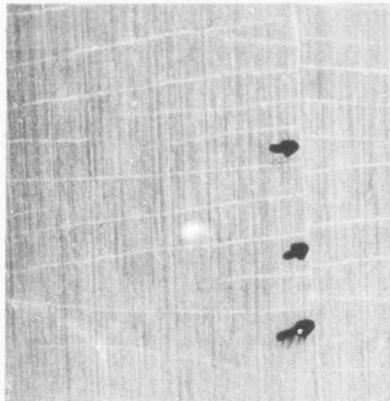
Figure 118. Interconnecting Shaft ID.

A close-up of the shaft ID showing the axial cracks interrupted and displaced across the circumferential crack, indicating that the circumferential cracks occurred first.

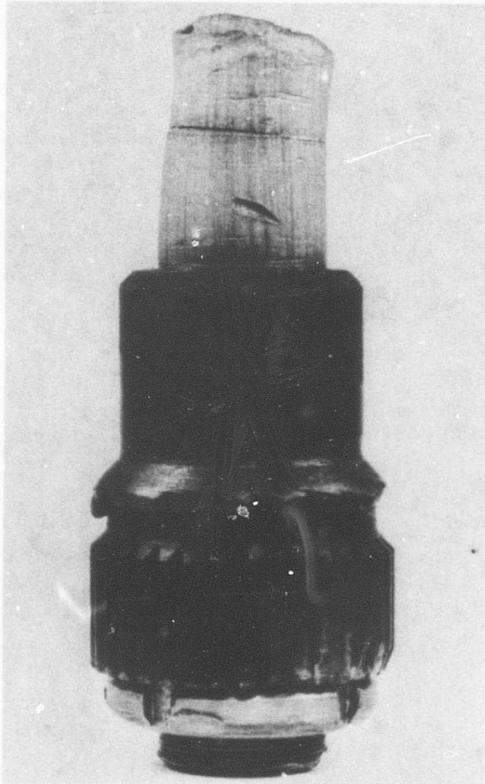
Figure 119. Gearbox Input Shaft Spline End After Test - Rotor Build 5.

The input pinion gear shaft microetched to show the in-line flow lines indicating that no twisting of the shaft was experienced and that the connected parts had been operating in line at one speed just prior to failure.

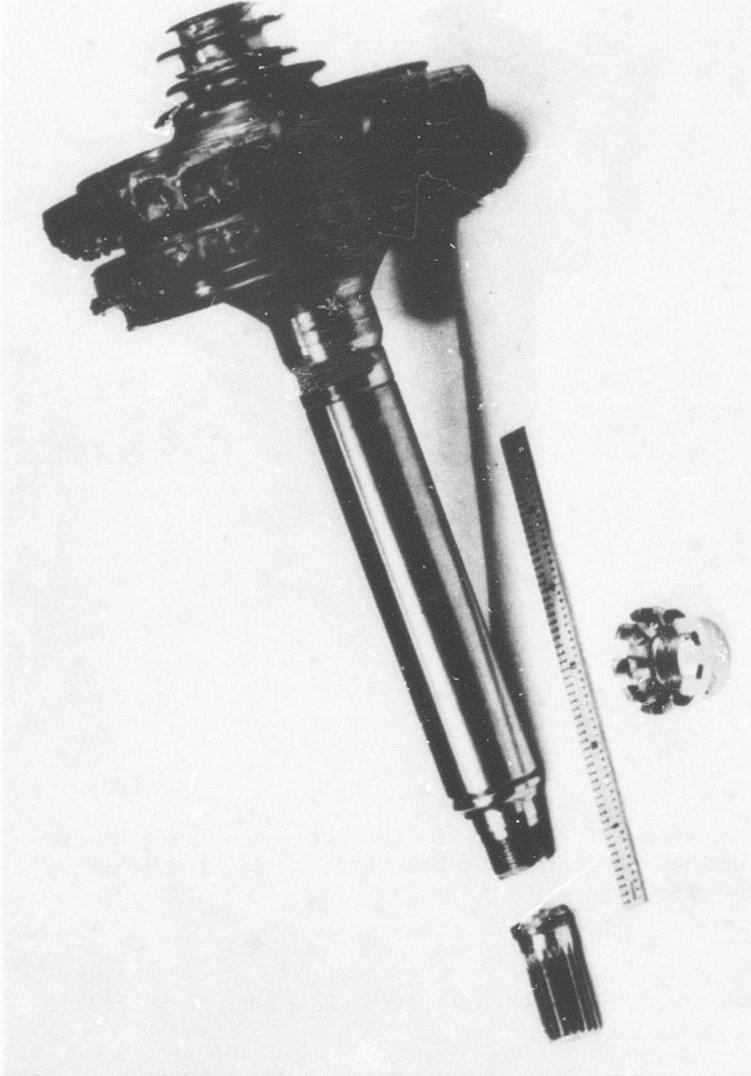
Figure 120. Turbine Rotor After Test - Rotor Build 5.

A view of the turbine rotor assembly showing the fracture location at the spline end, the fractures through the rotor blade-rear hub mating surfaces and the gas shelves, and the severe rub in the roller bearing inner race.

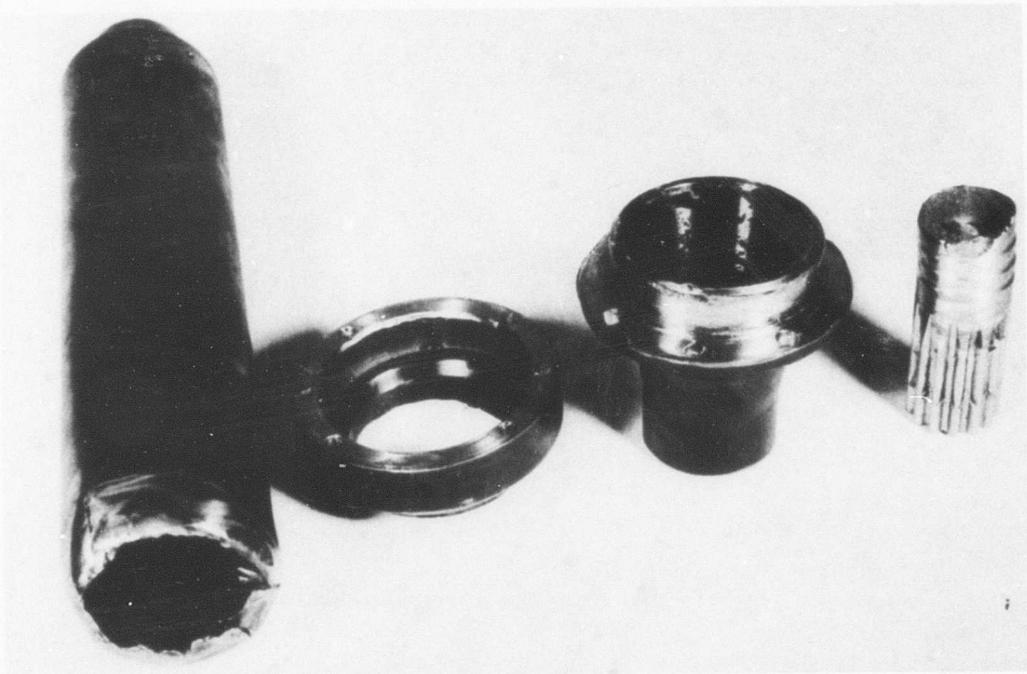
A photo showing the locations of fracture in the interconnecting shaft (three LH pieces), and the industrial gearbox shaft spline end fracture aft of the splines (RH piece).

Reexamination of Rebuild 2B parts was made in the light of the Rebuild 5 failure analysis. The condition of the parts after Rebuild 2B test was found similar to the parts as described in the Rebuild 5 discussion. Figure 121 shows the two-piece interconnecting shaft and the broken spline end from the gearbox.
