OPERATION PLUMB BOB

Project 3.2

EVALUATION OF BURIED CONDUITS
AS PERSONNEL SHELTERS

Issue Date: July 14, 1960

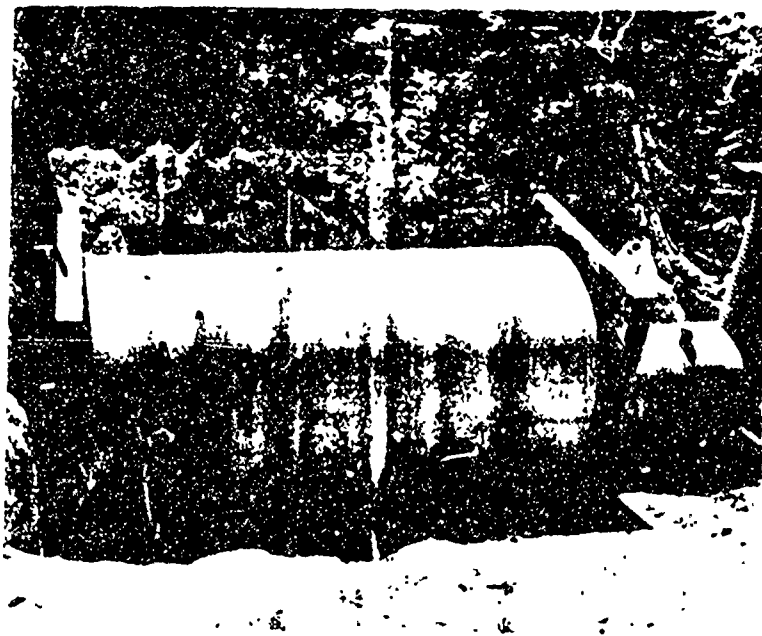
Figure 2.16 Exterior view of typical circular concrete conduit prior to backfilling.

time of assembly. The conduit sections were assembled as indicated in Figures 2.15, 2.16, 2.17, and 2.18.
