**LIGHTNING AND STATIC ELECTRICITY
CONFERENCE, 3-5 DECEMBER 1968**

PART II. CONFERENCE PAPERS

TECHNICAL REPORT AFAL-TR-68-290, PART II

AIR FORCE AVIONICS LABORATORY
AIR FORCE SYSTEMS COMMAND
WRIGHT-PATTERSON AIR FORCE BASE, OHIO

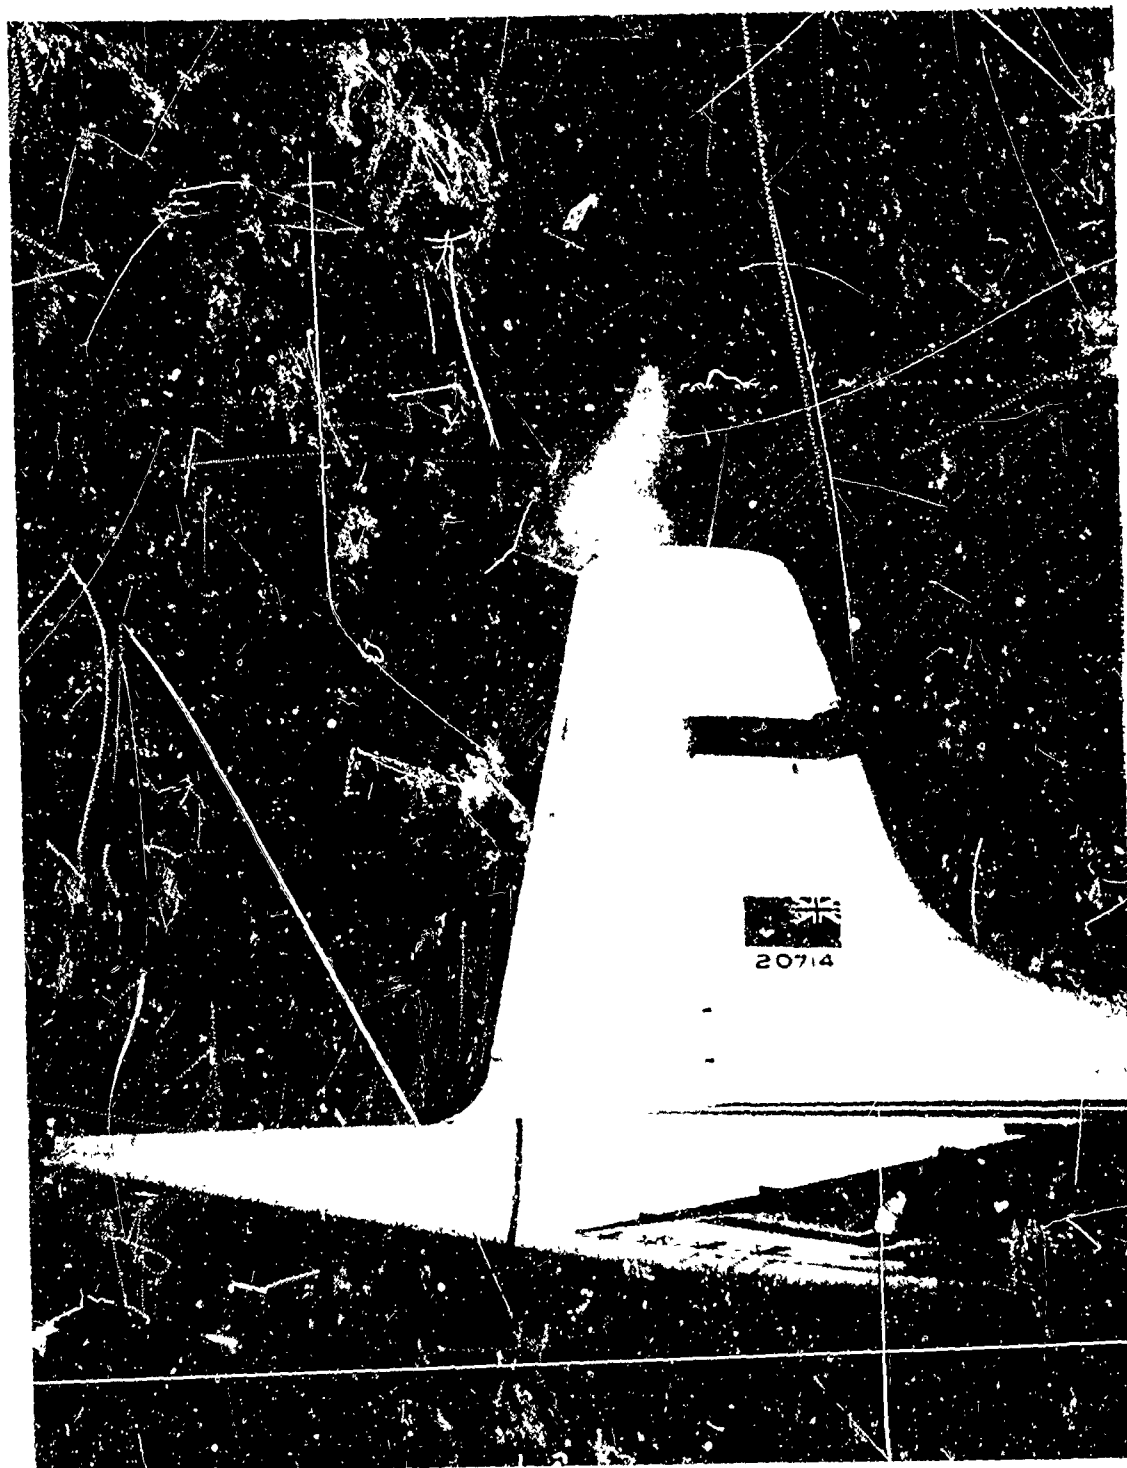
Figure 2. Artificial Lightning Discharge Tests of Graded Resistance Lightning Diverter Rods on Argus Fin Tip

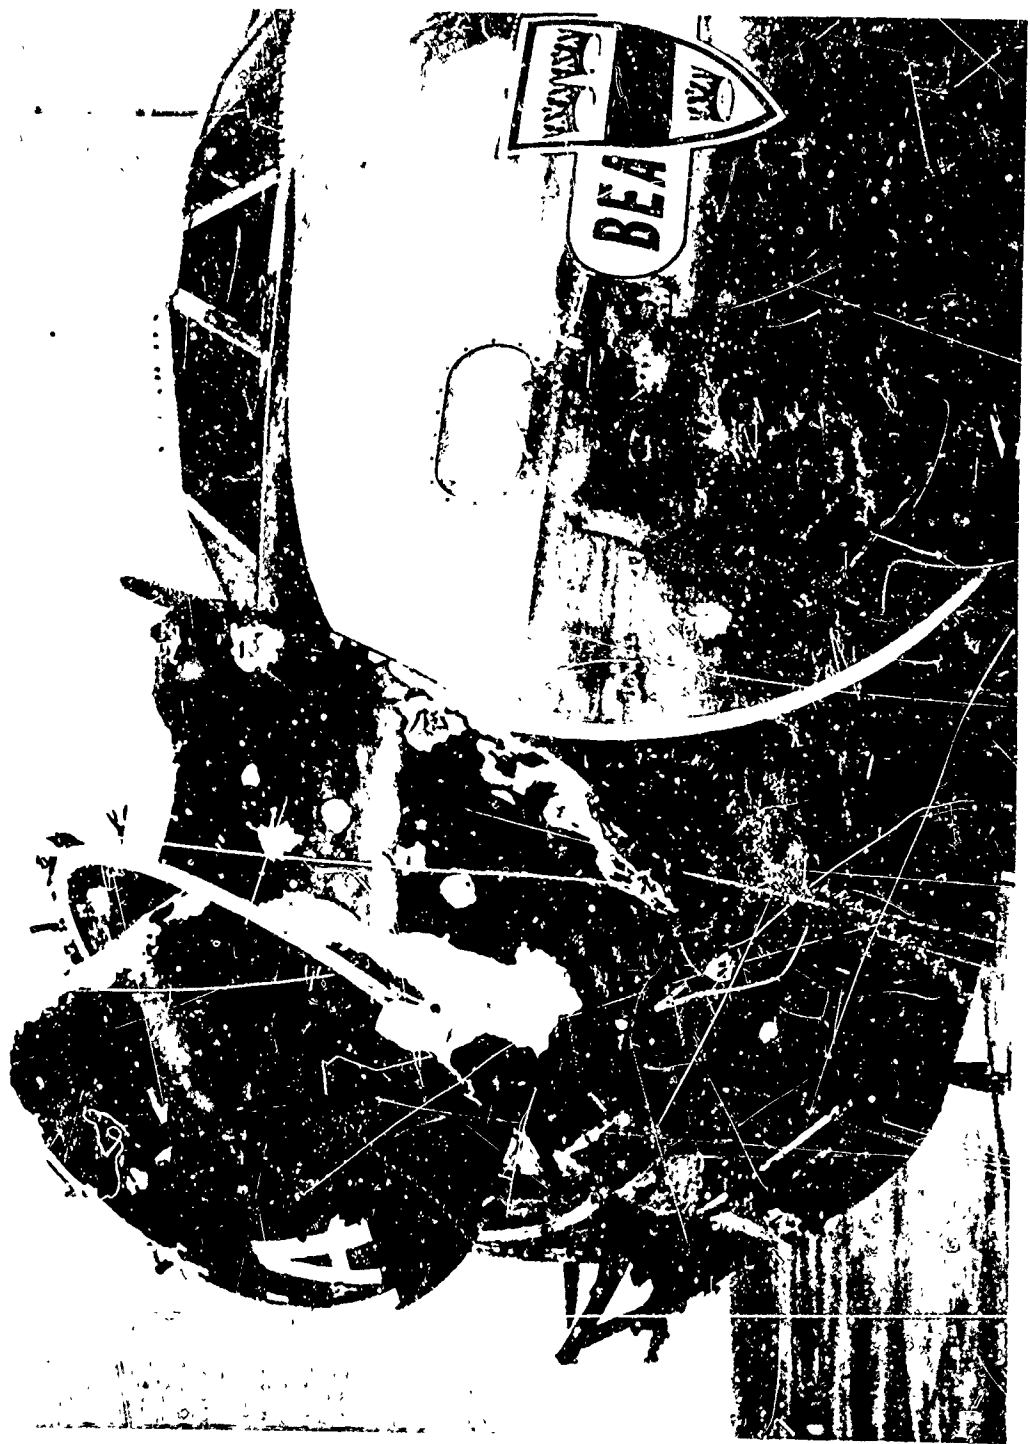
Figure 9. Damage to an Ambassador Aircraft by a Lightning Strike on the Nose Cone

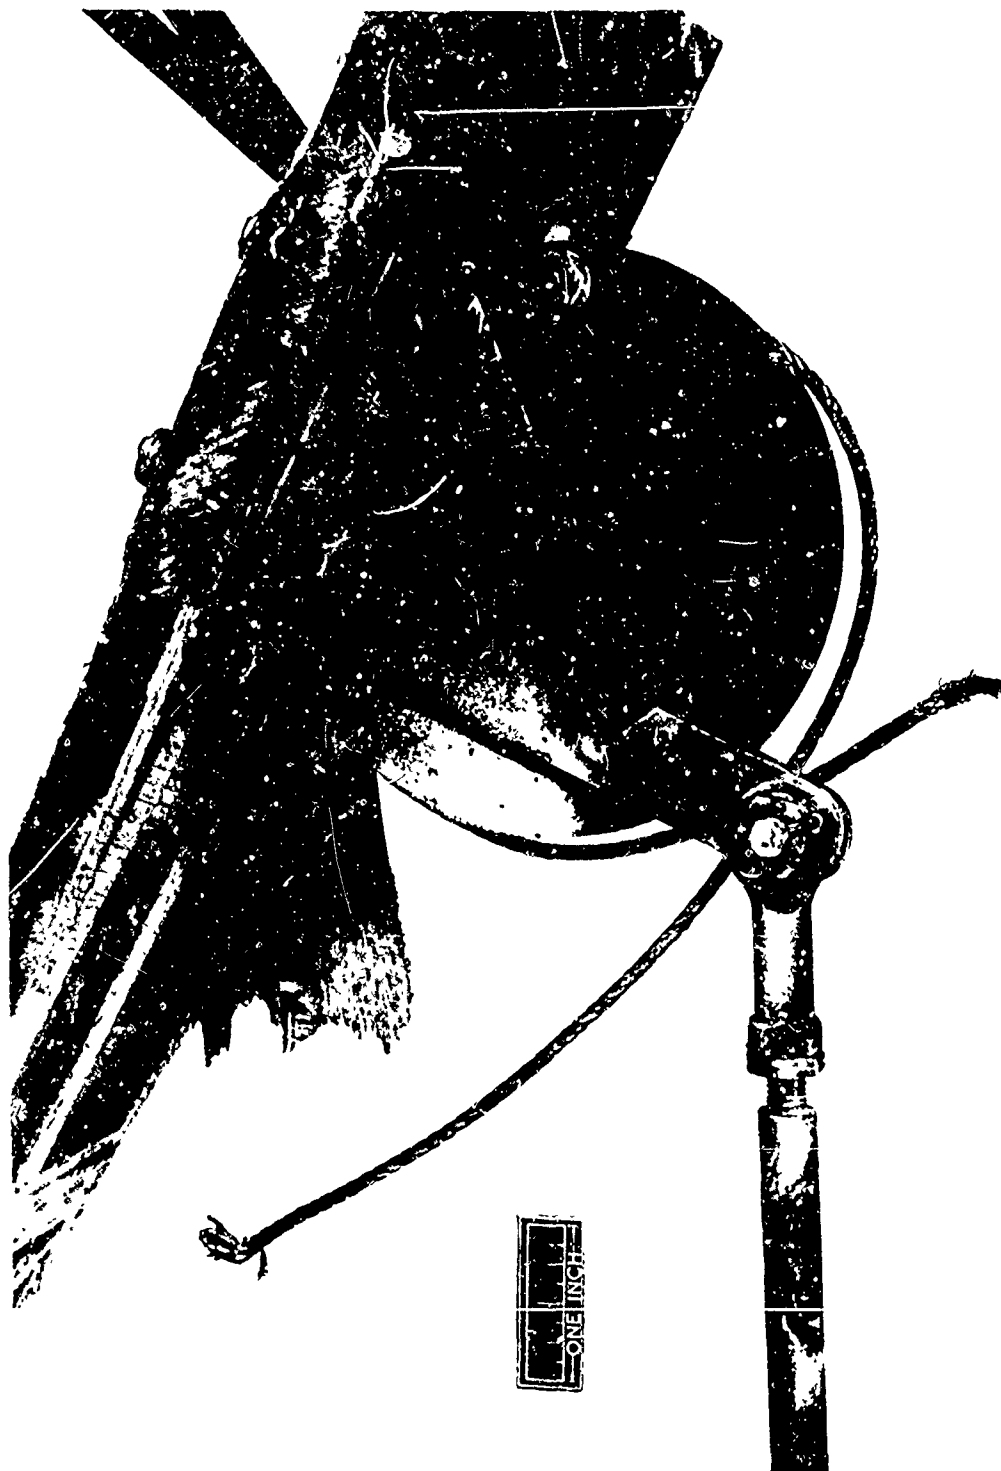
Figure 10. Effect of Lightning Strike Currents Flowing Through the Aileron Cables of a Glider of Wooden Construction

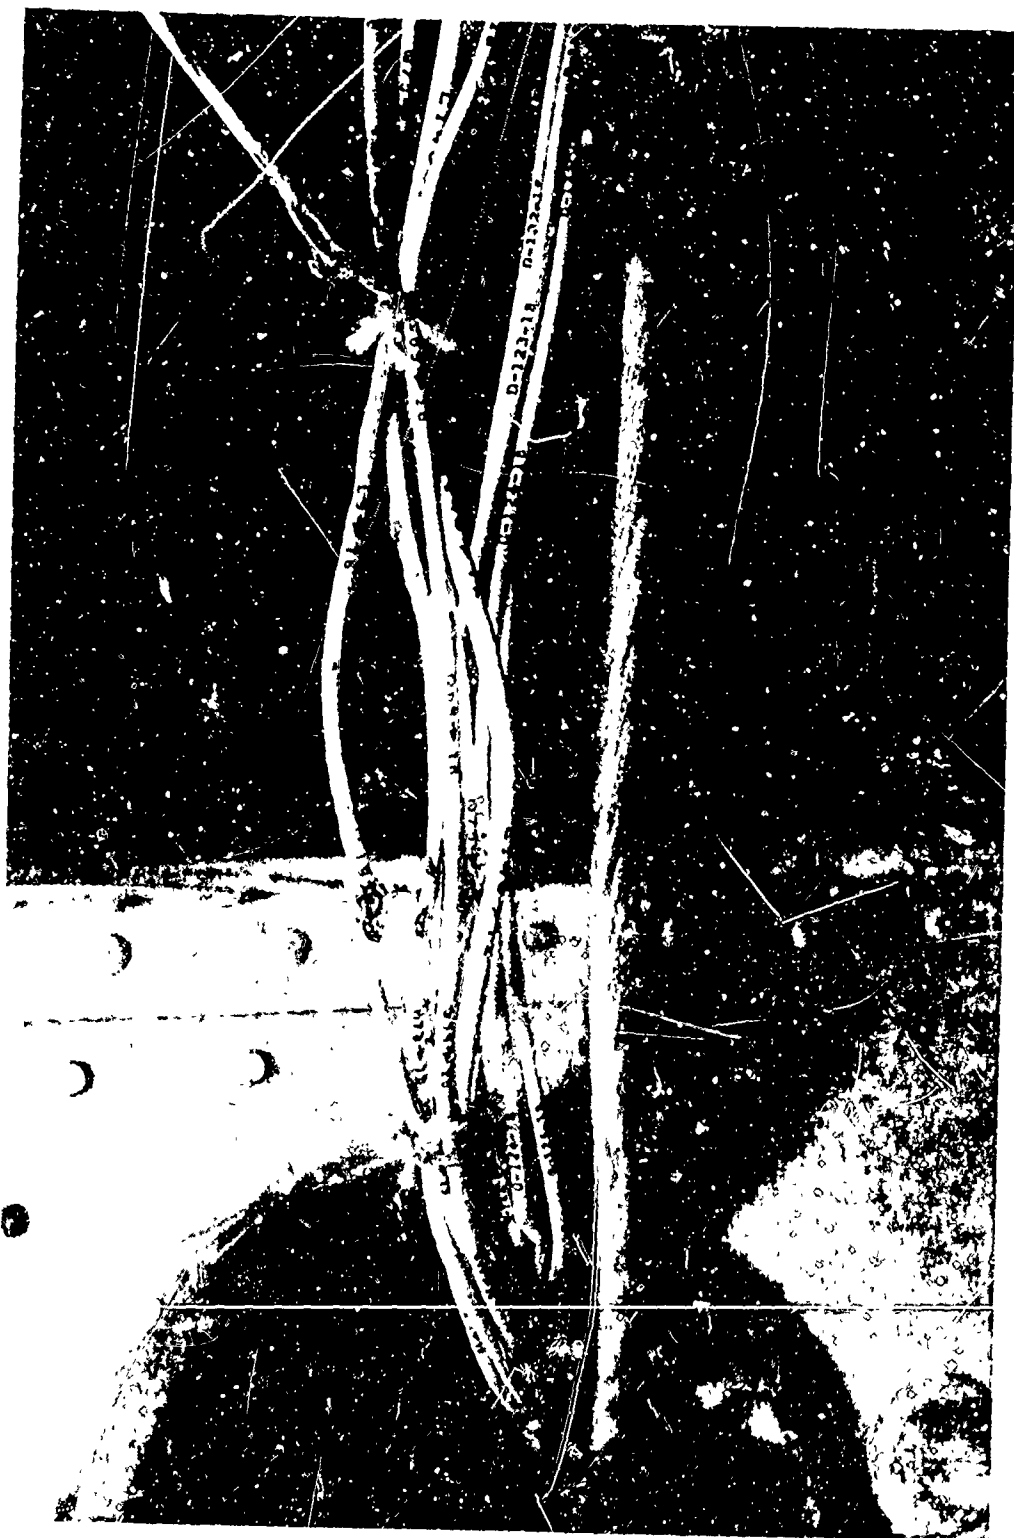
Figure 11. Damage to Electrical Cables on an Aircraft Struck by Lightning

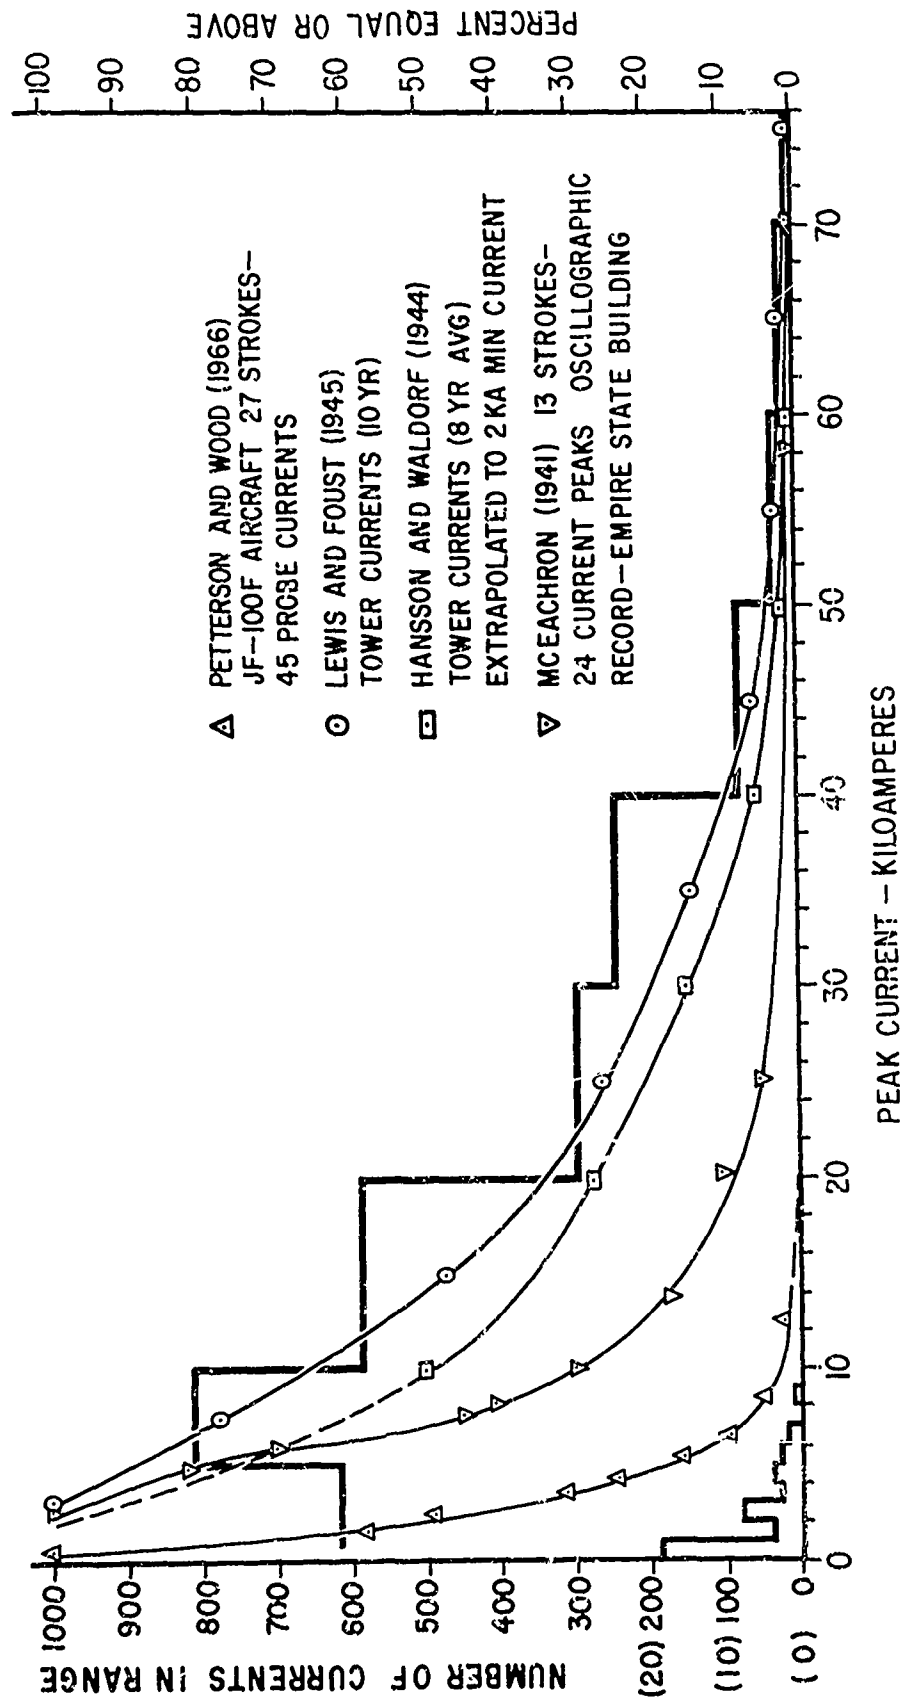
Figure 1. Lightning Current Distributions

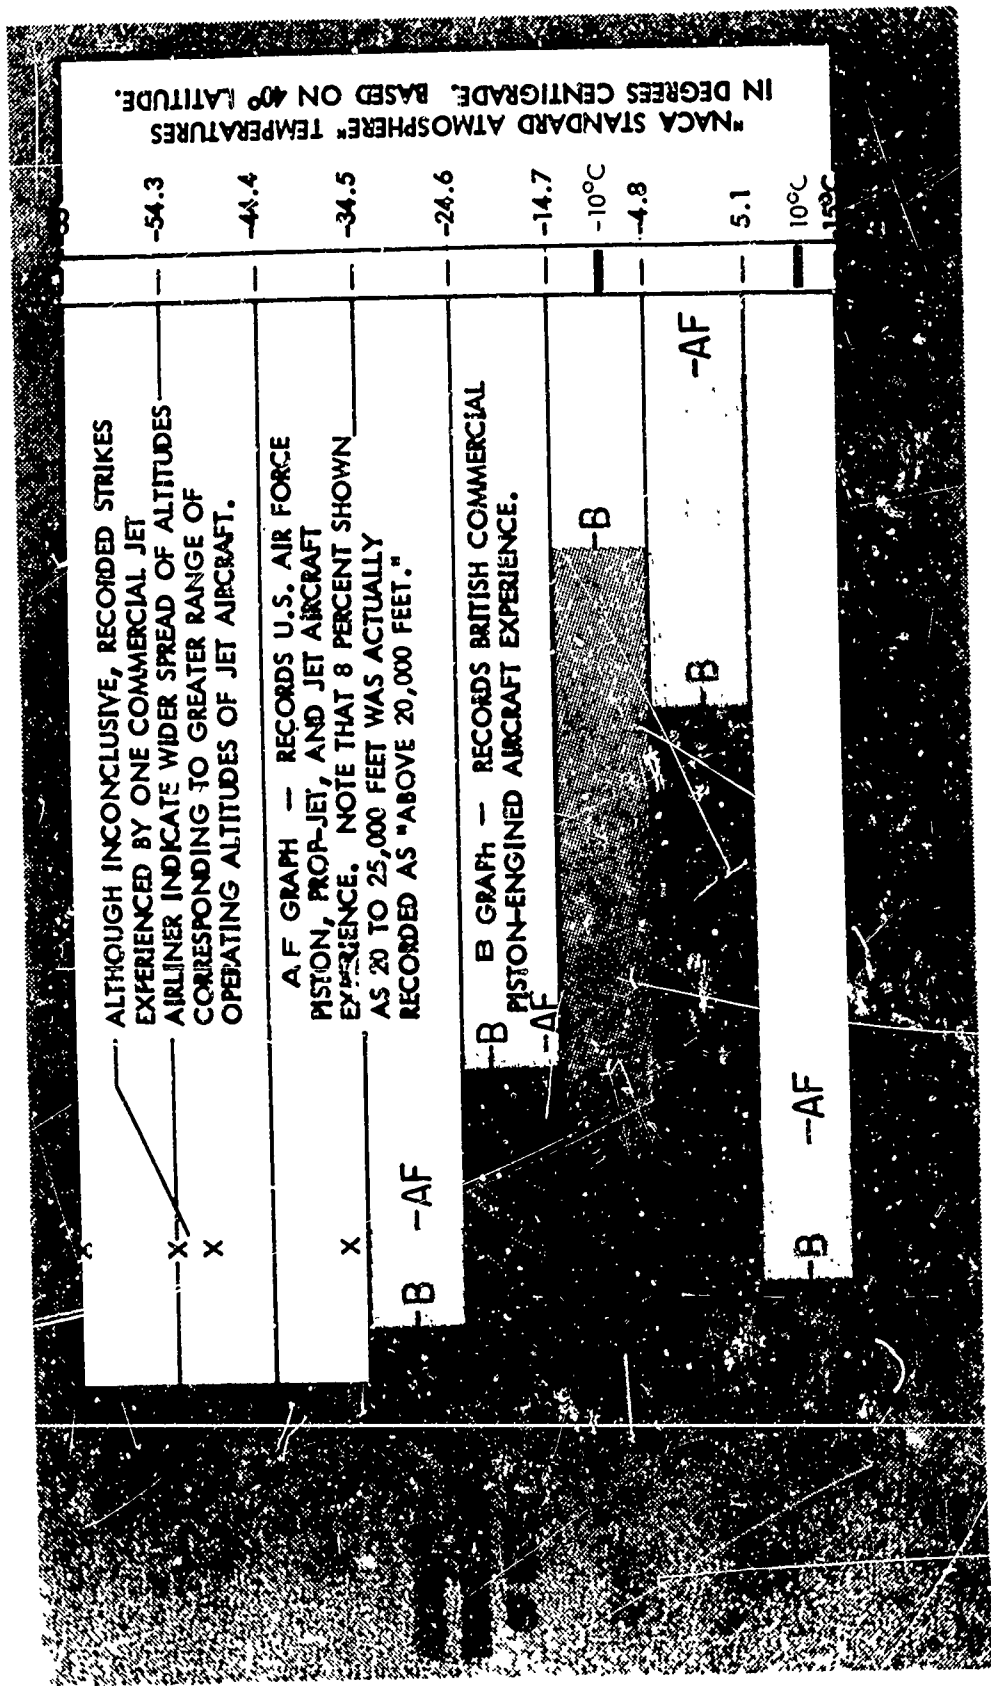
Figure 3. Normal Aircraft Lightning Statistics

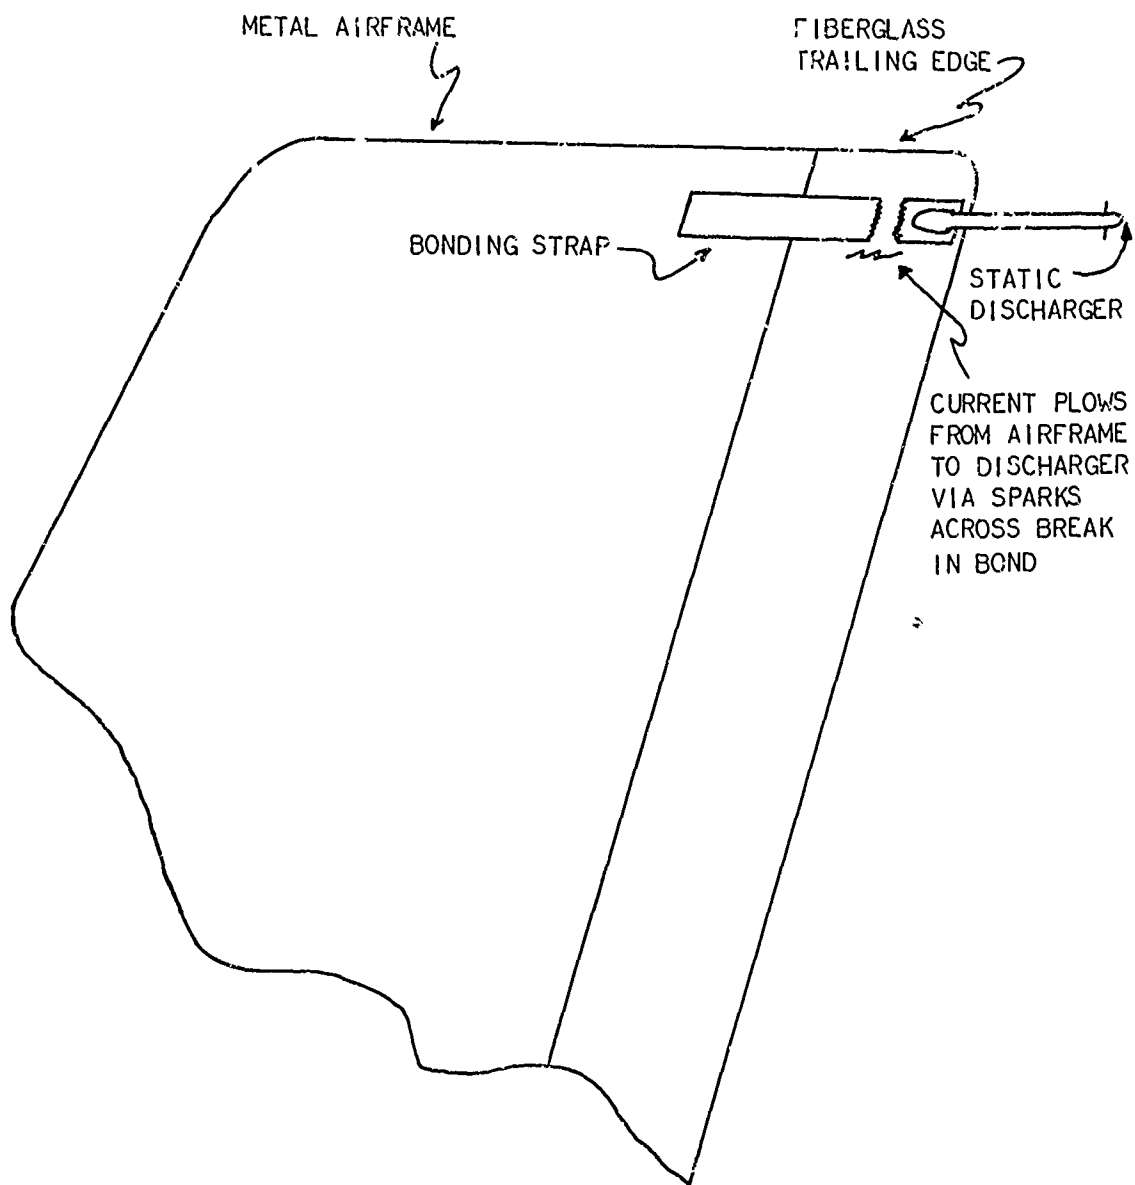
Figure 3. Broken Electrical Bond to Discharger on Vertical Fin

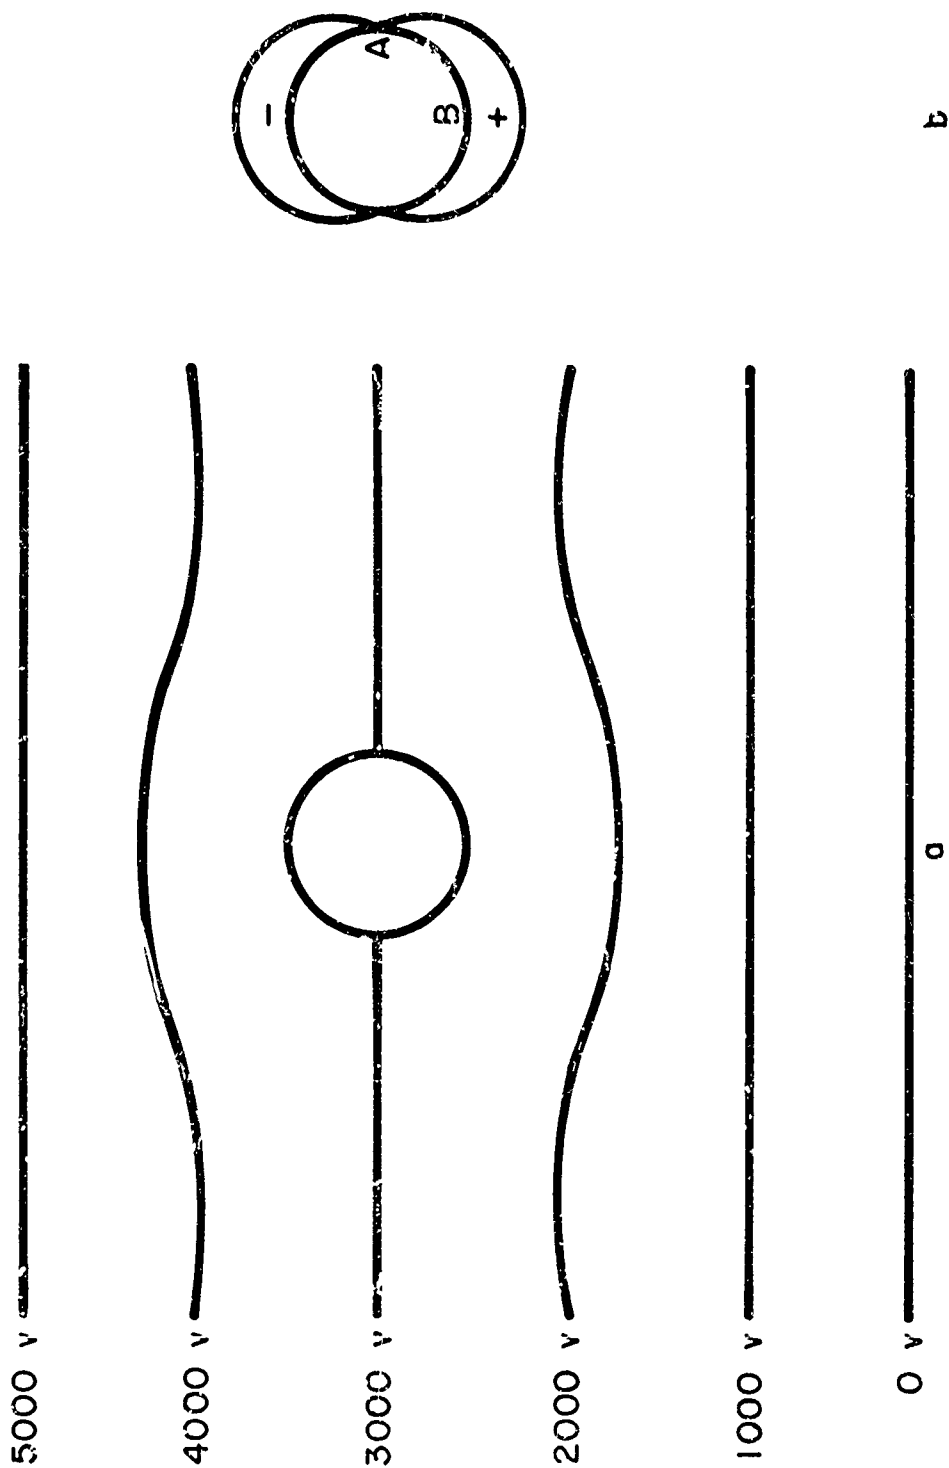
Figure 2. a. Equipotential Lines of Uncharged Sphere in a Homogeneous Electric Field
b. Charge Distribution of Uncharged Sphere in a Homogeneous Electric Field

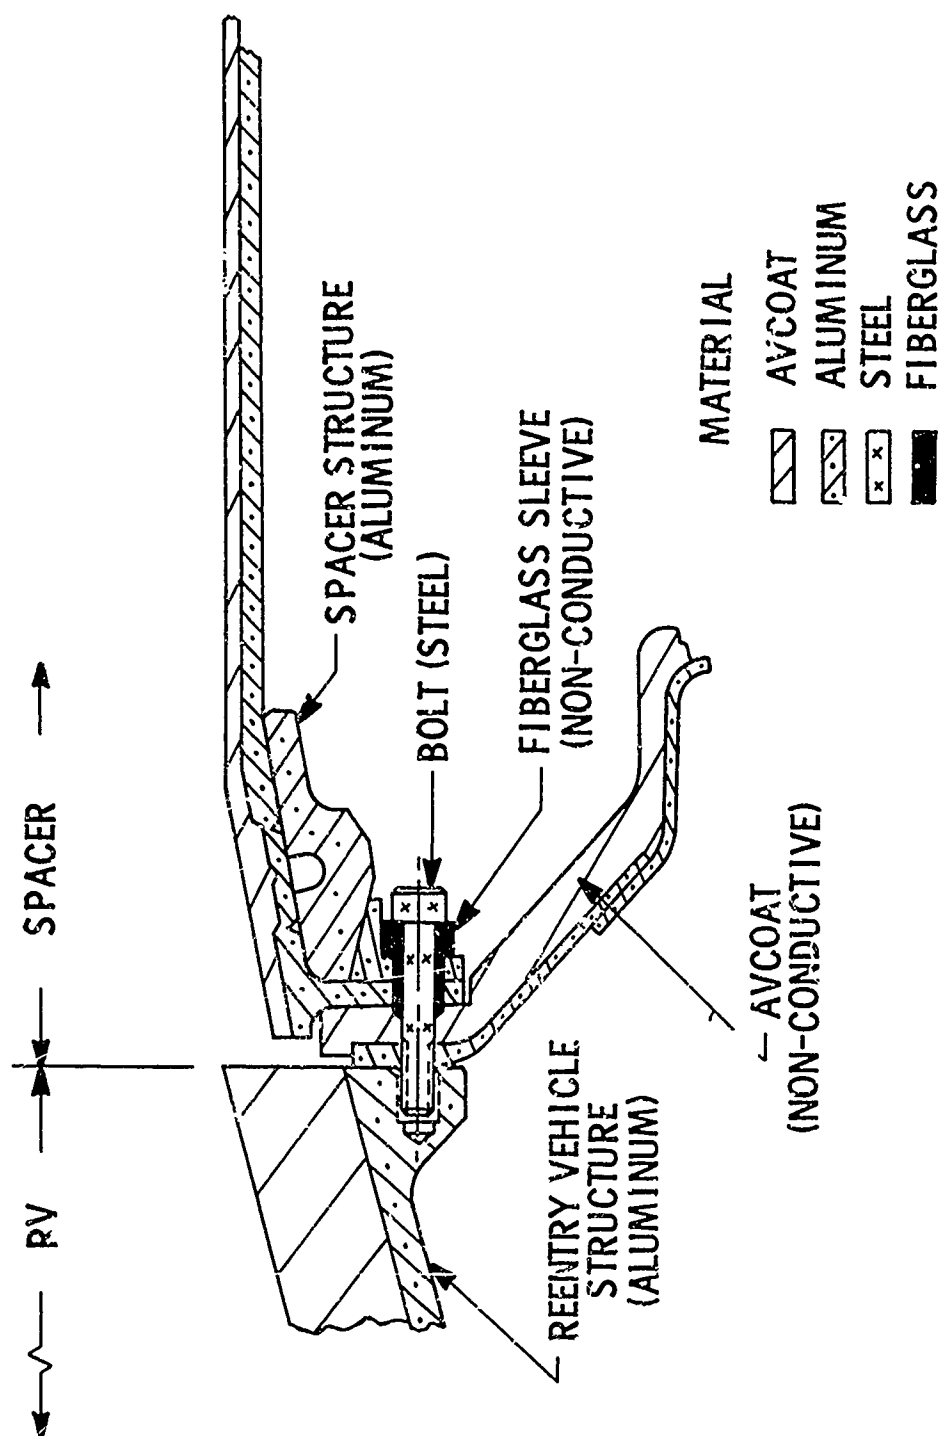
Figure 1. Detail of the Joint Between the Reentry Vehicle and Spacer Sections

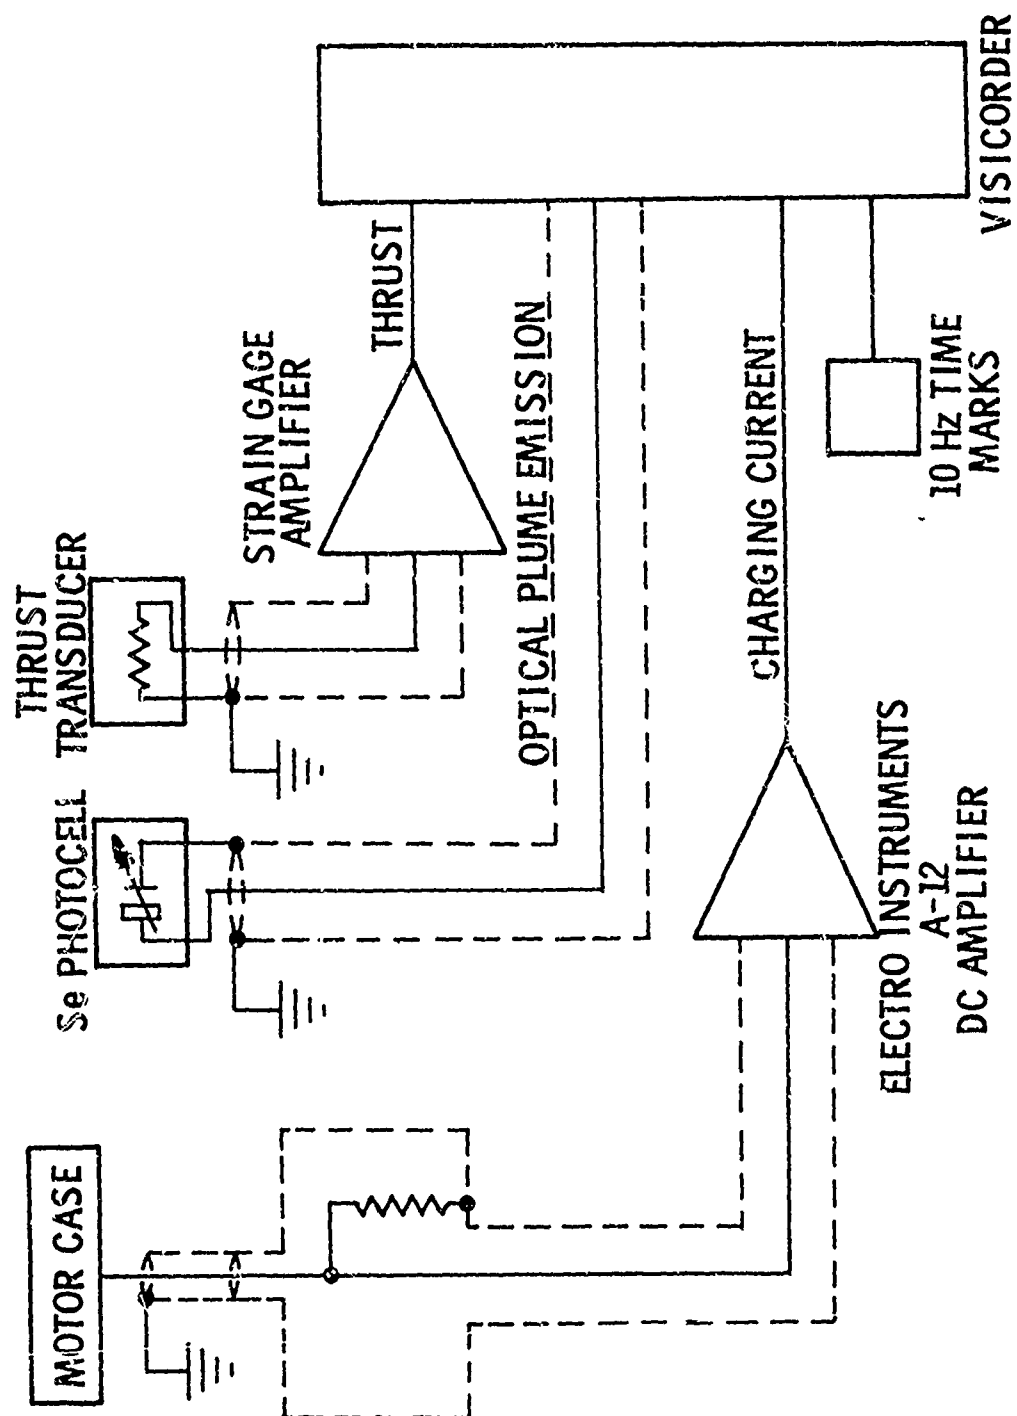
Figure 5. Instrumentation Diagram for the Later Series of Rocket Motor Tests

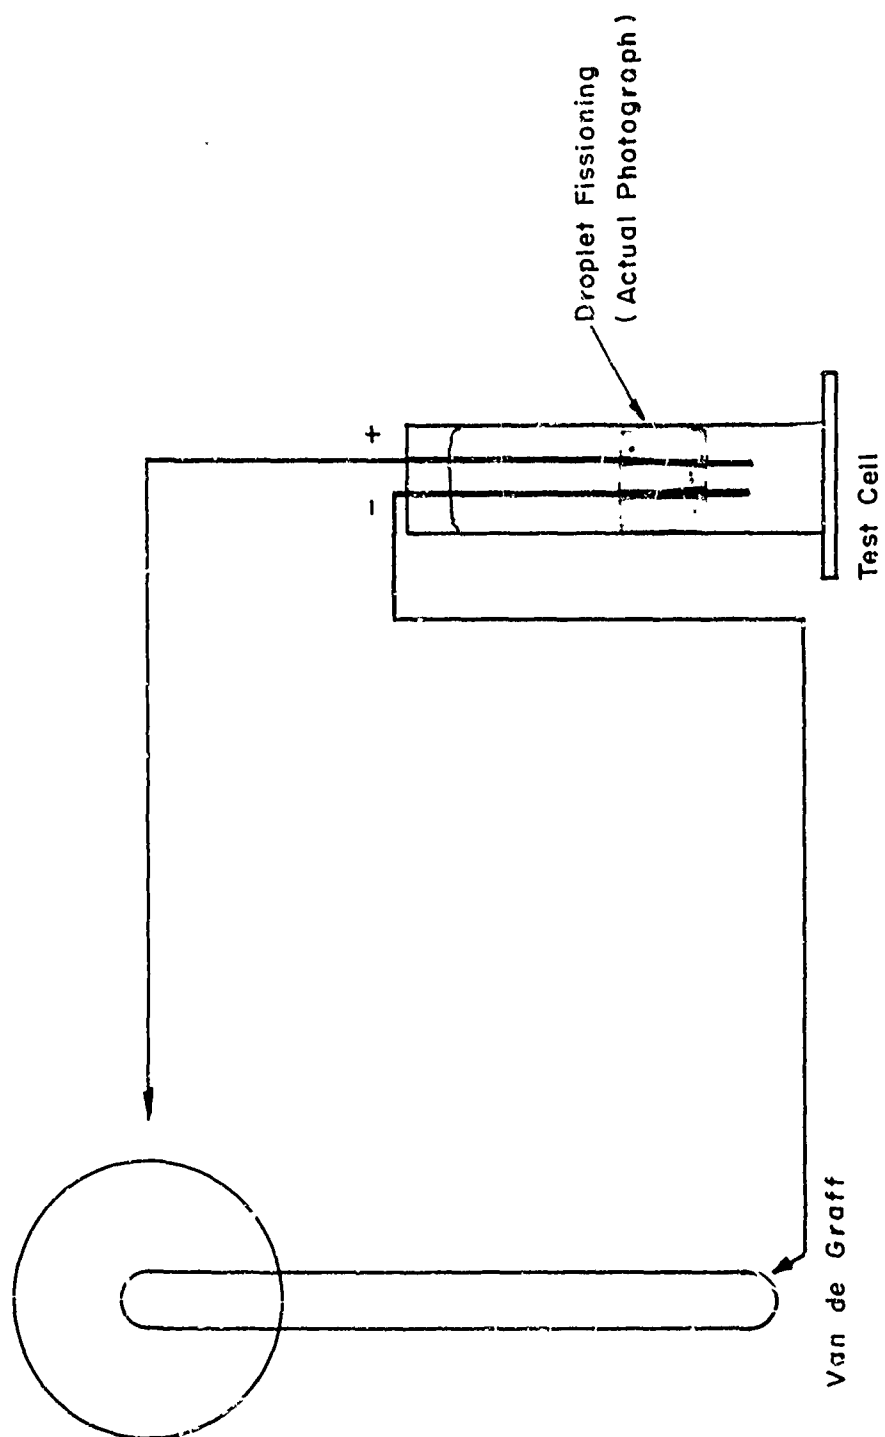
Figure 2. Schematic of Equipment Used in Experiments

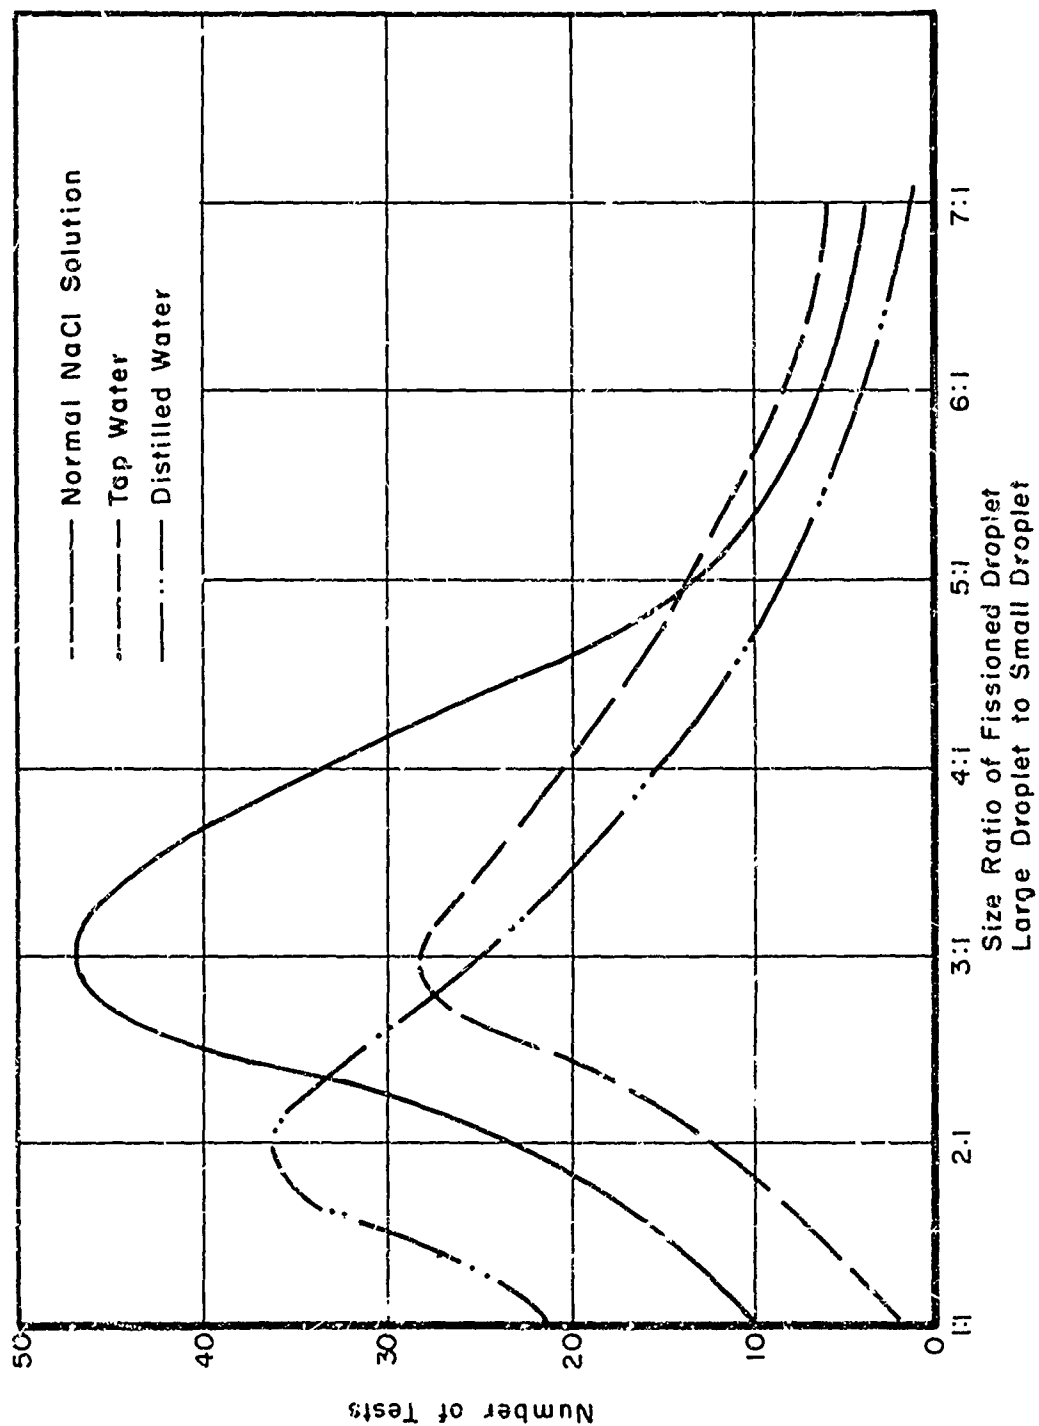
Figure 4. Graphed Results of Experiments of Size Ratio vs. Frequency

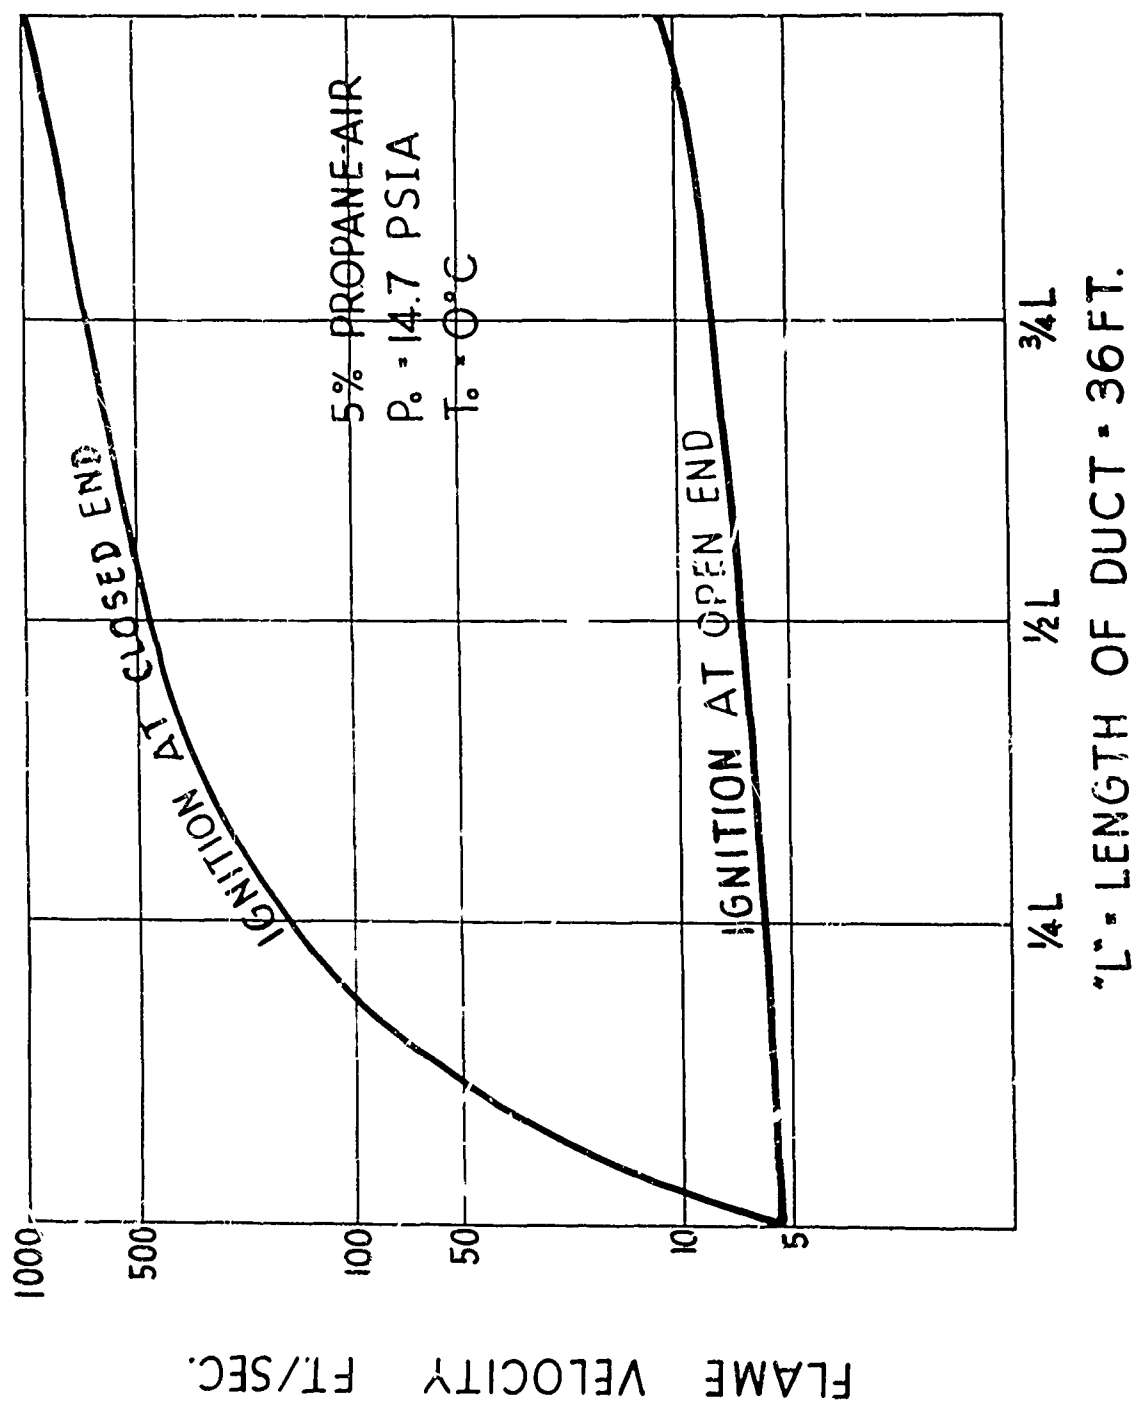
Figure 1. Flame Propagation Rates

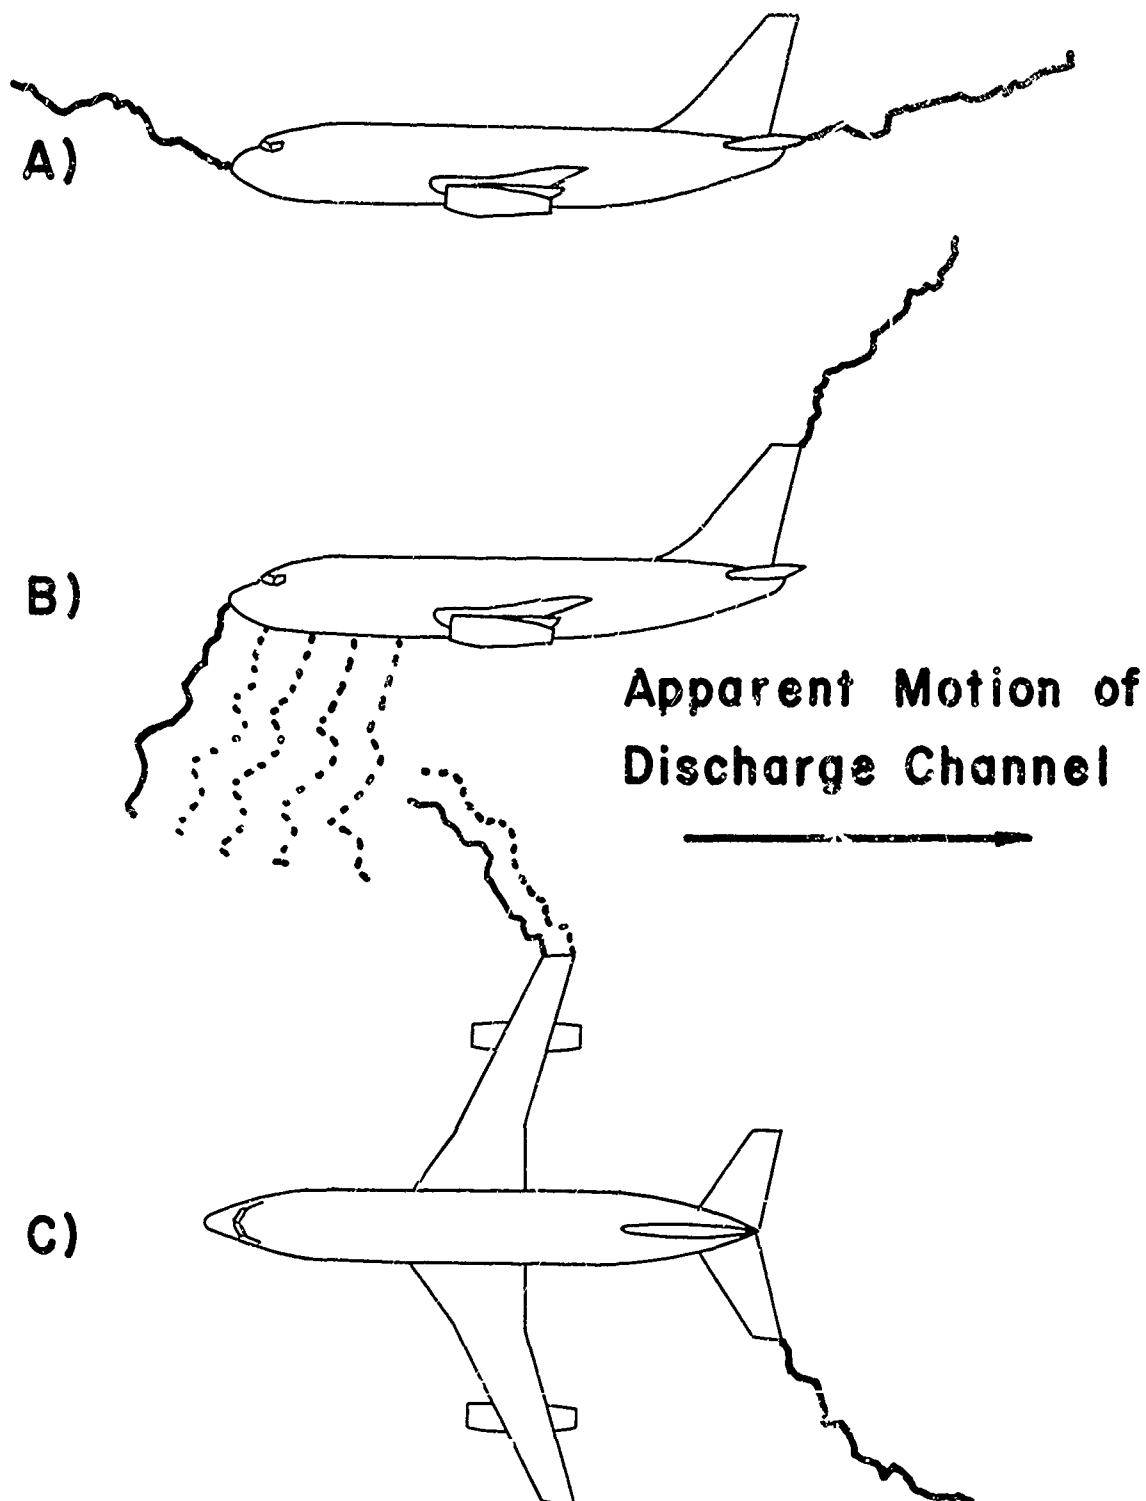
Figure 2. Lightning Discharge Attachment to Airplane

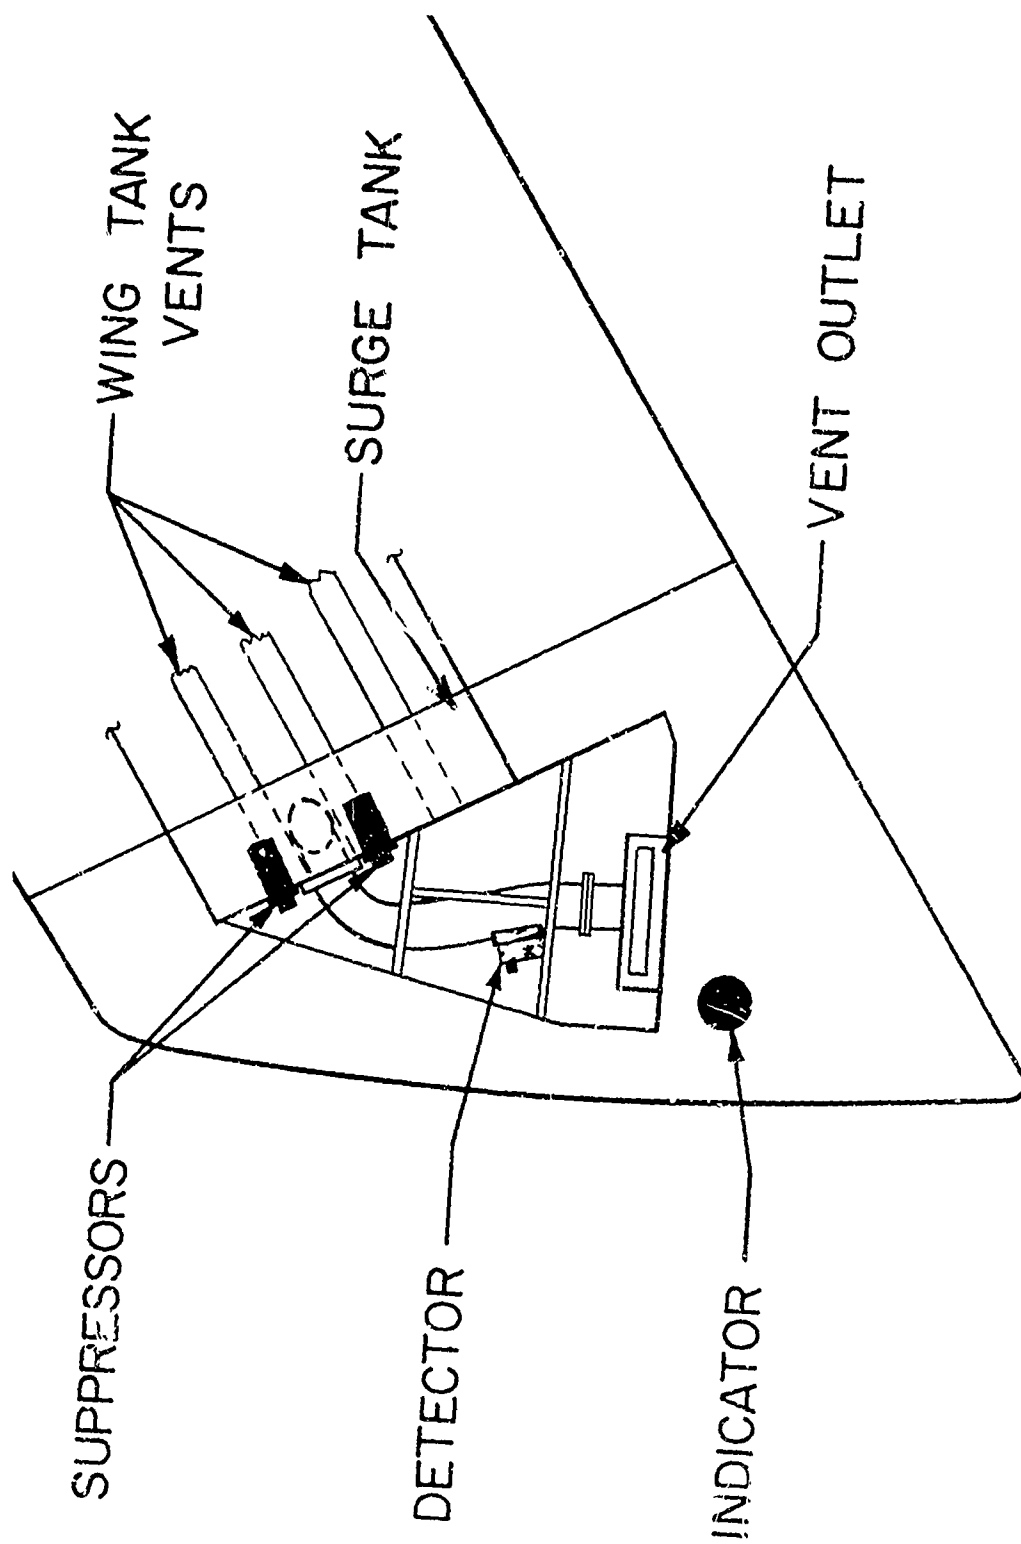
Figure 1. STP System. for 707 Aircraft
