**LIGHTNING AND STATIC ELECTRICITY
CONFERENCE, 3-5 DECEMBER 1968**

PART II. CONFERENCE PAPERS

TECHNICAL REPORT AFAL-TR-68-290, PART II

AIR FORCE AVIONICS LABORATORY
AIR FORCE SYSTEMS COMMAND
WRIGHT-PATTERSON AIR FORCE BASE, OHIO

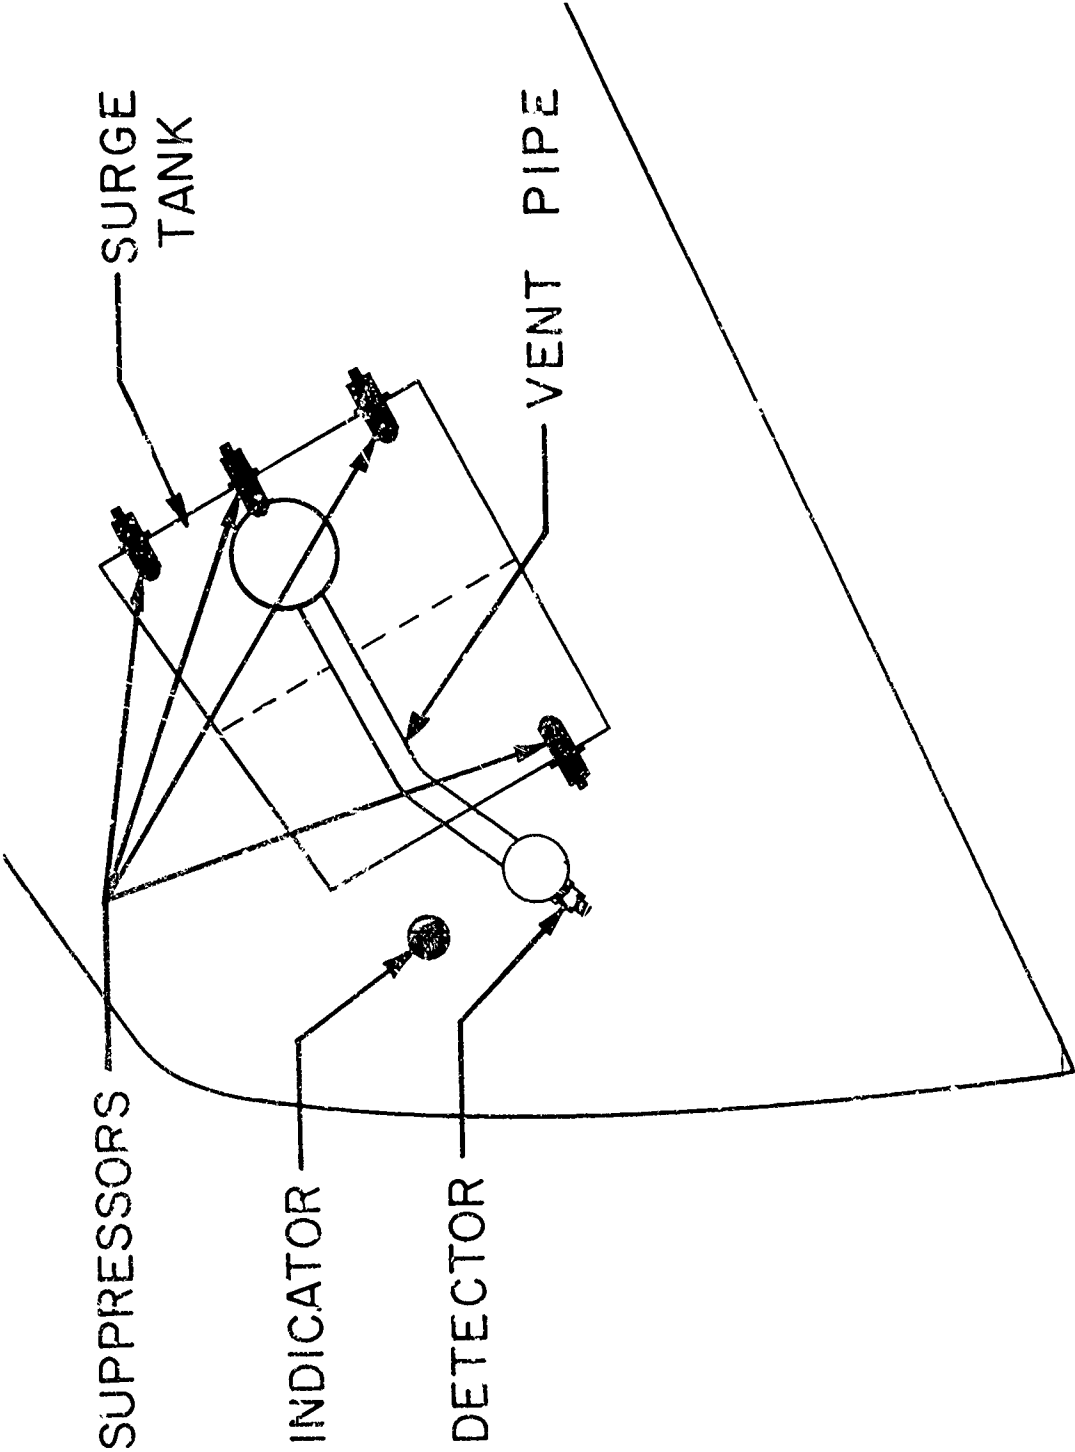
Figure 3. STP System for 747 Aircraft

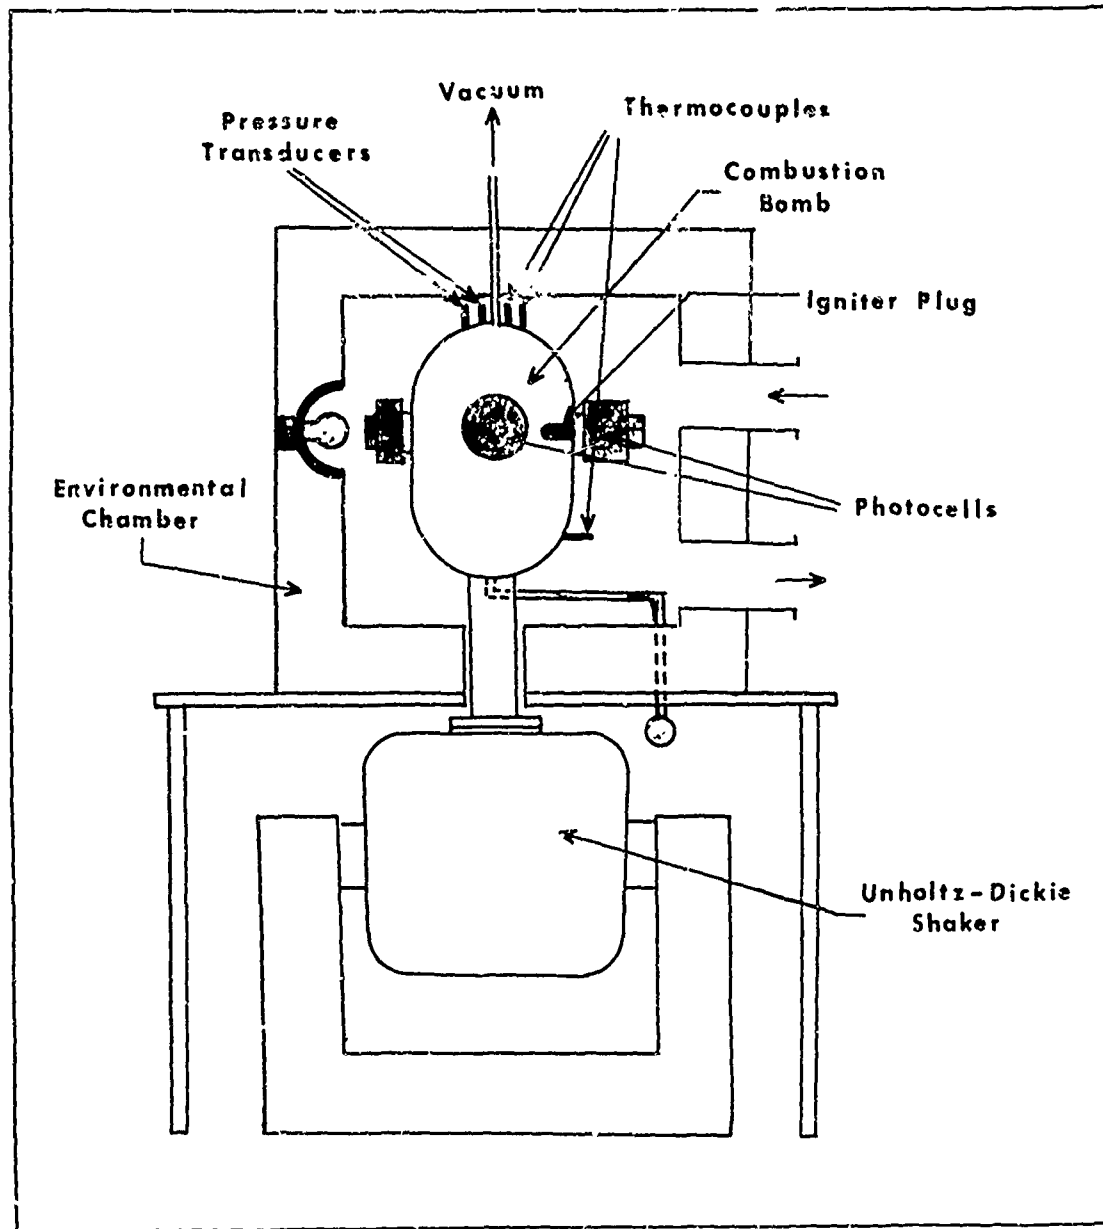
Figure 1. Dynamic Combustion Apparatus

The combustion apparatus used in these investigations is shown schematically in Figure 1. The combustion bomb was constructed from a surplus 2-1/2 gal hydraulic accumulator, having the approximate dimensions of 9 in. in diameter and 15 in. in height. It was supported within a temperature controlled chamber by an extended mounting to an electromagnetic shaker. Instrumentation

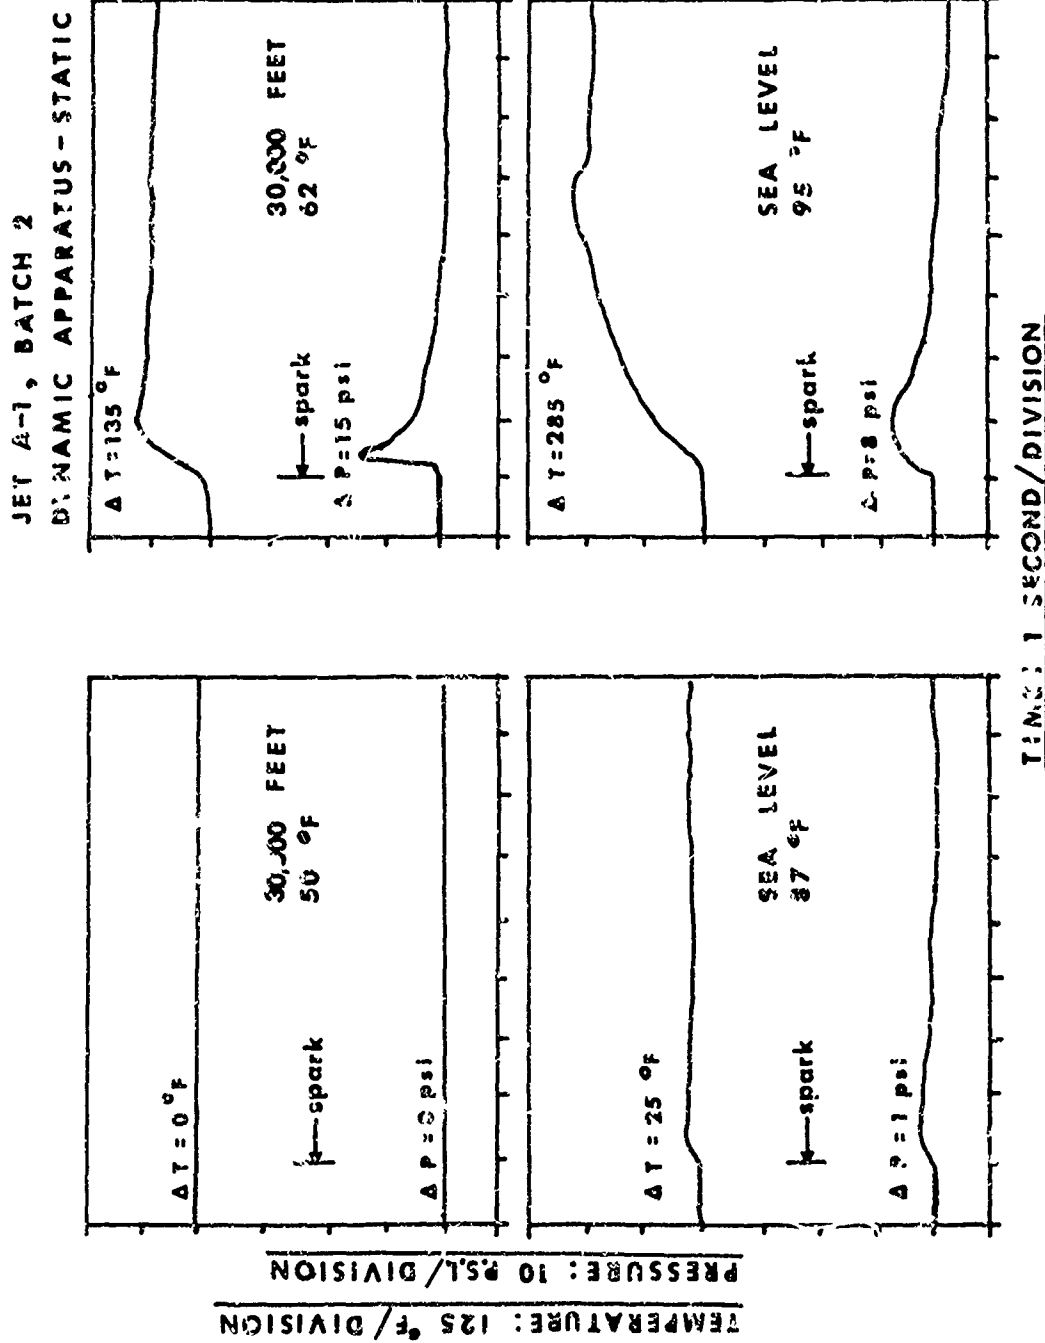
Figure 2. Representative Oscillograms Showing the Ignition Phenomenon of Jet A-1 Under Static Conditions

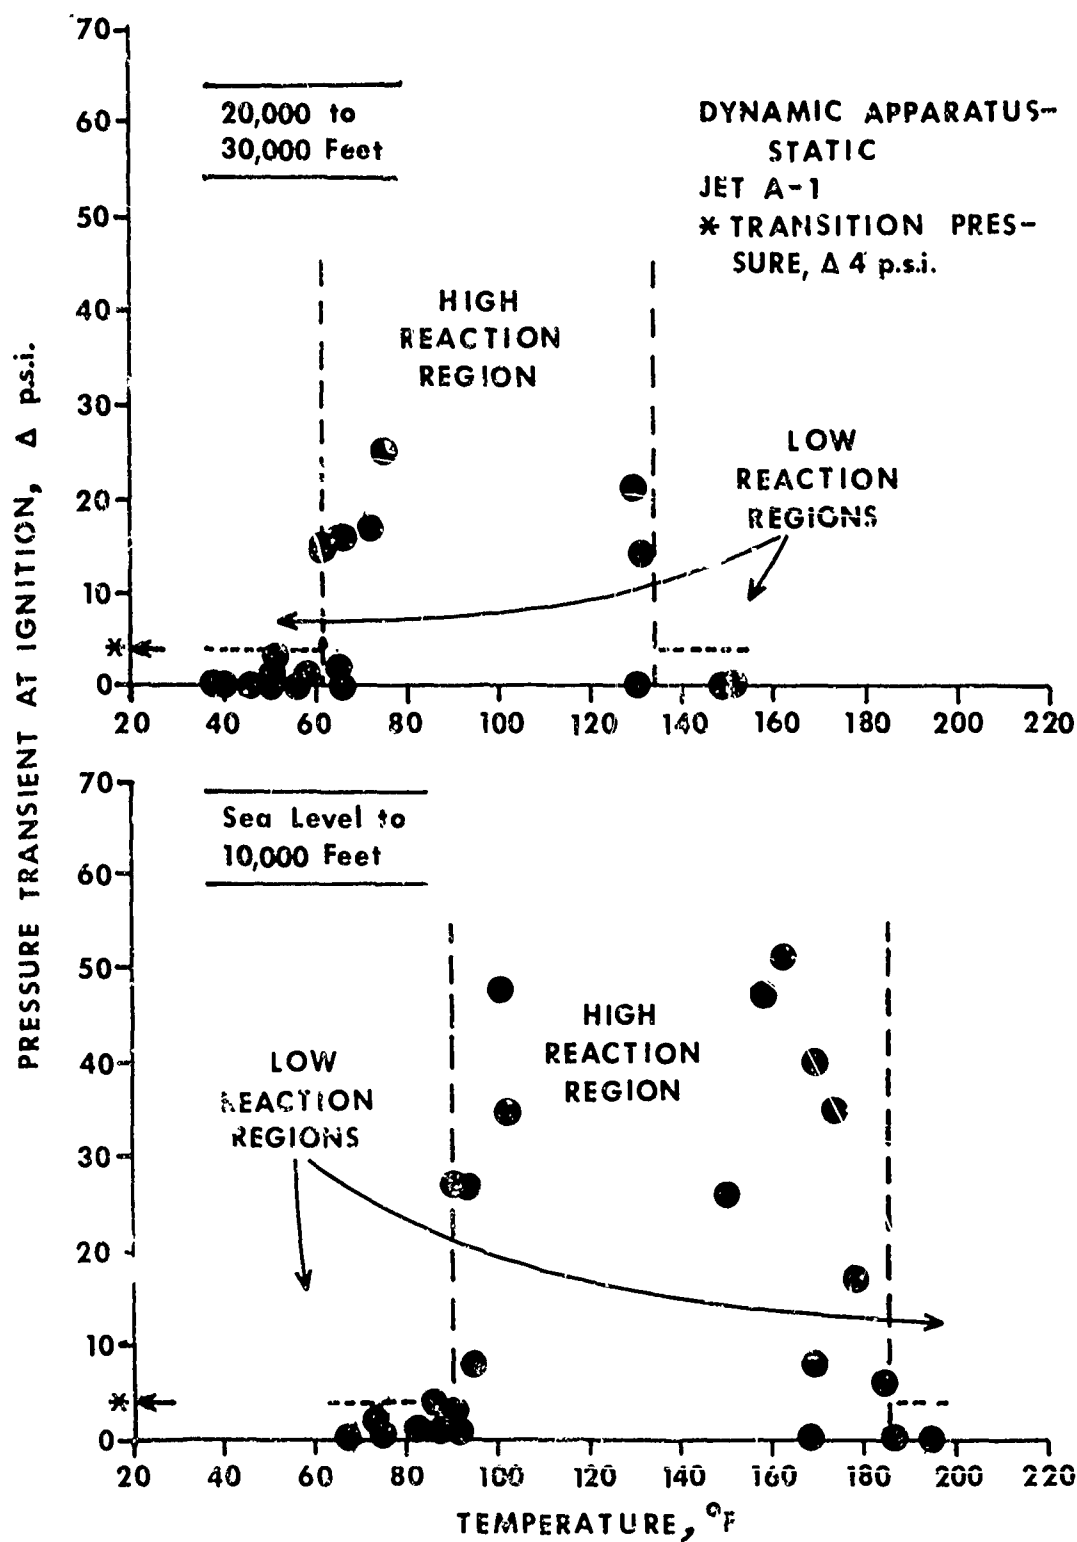
Figure 3. Transitions of Pressure Transients Between High and Low Reaction Regions

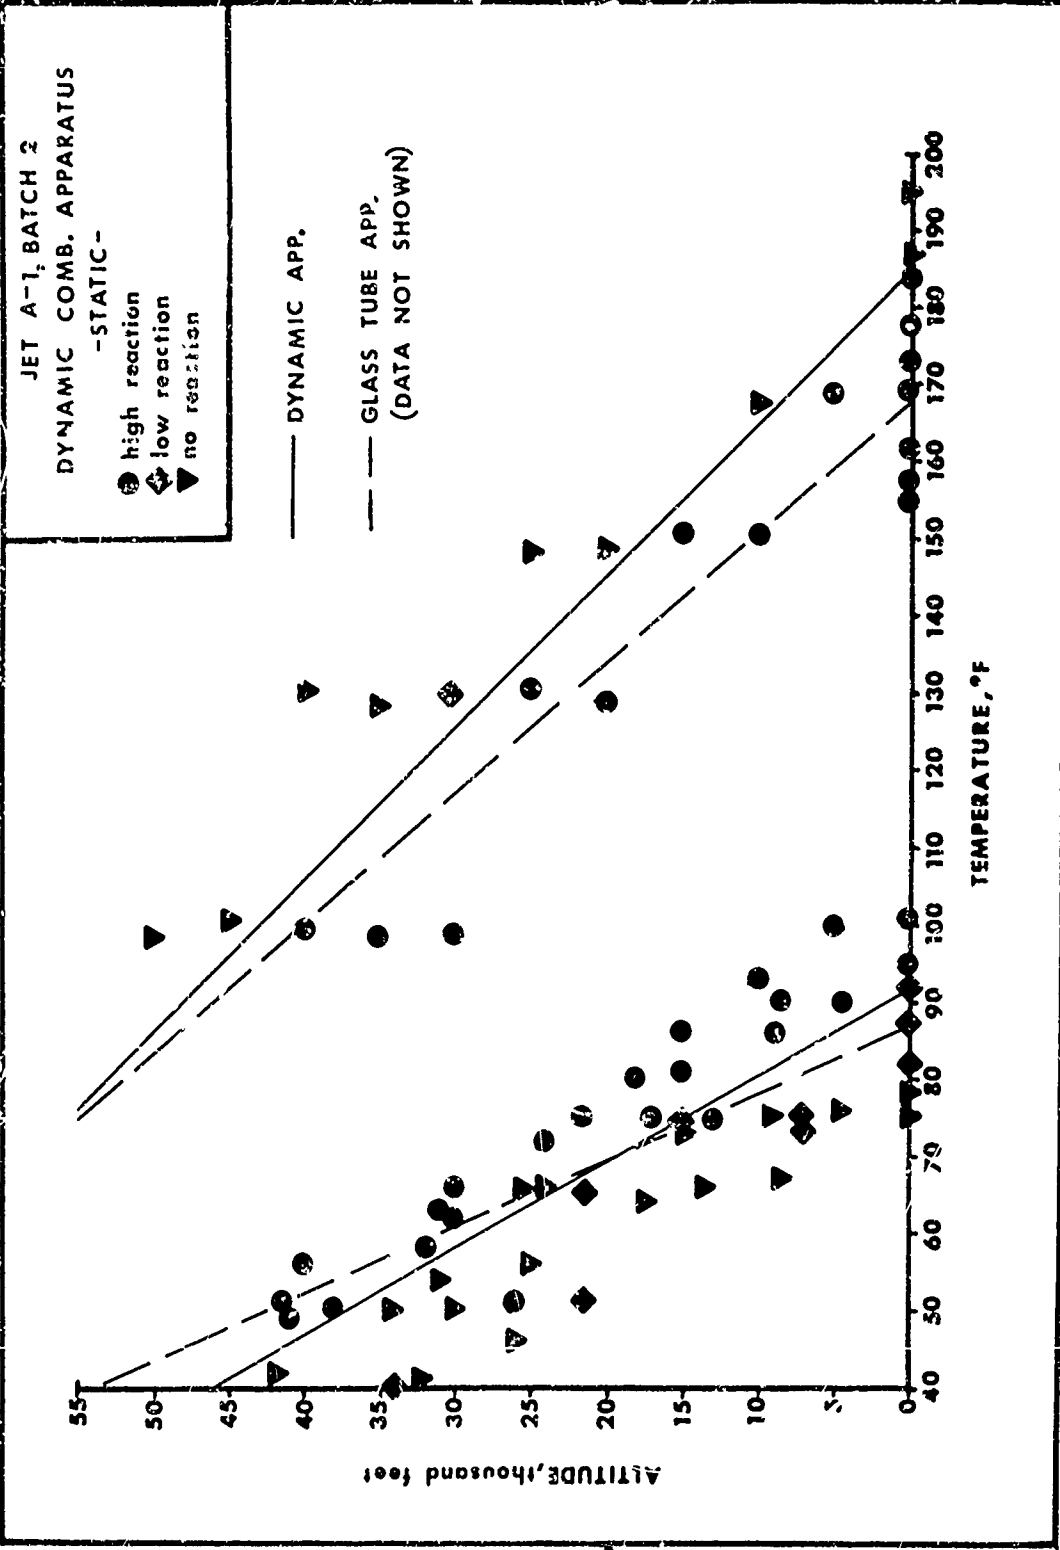
Figure 5. Equilibrium Flammability Envelope of Jet A-1

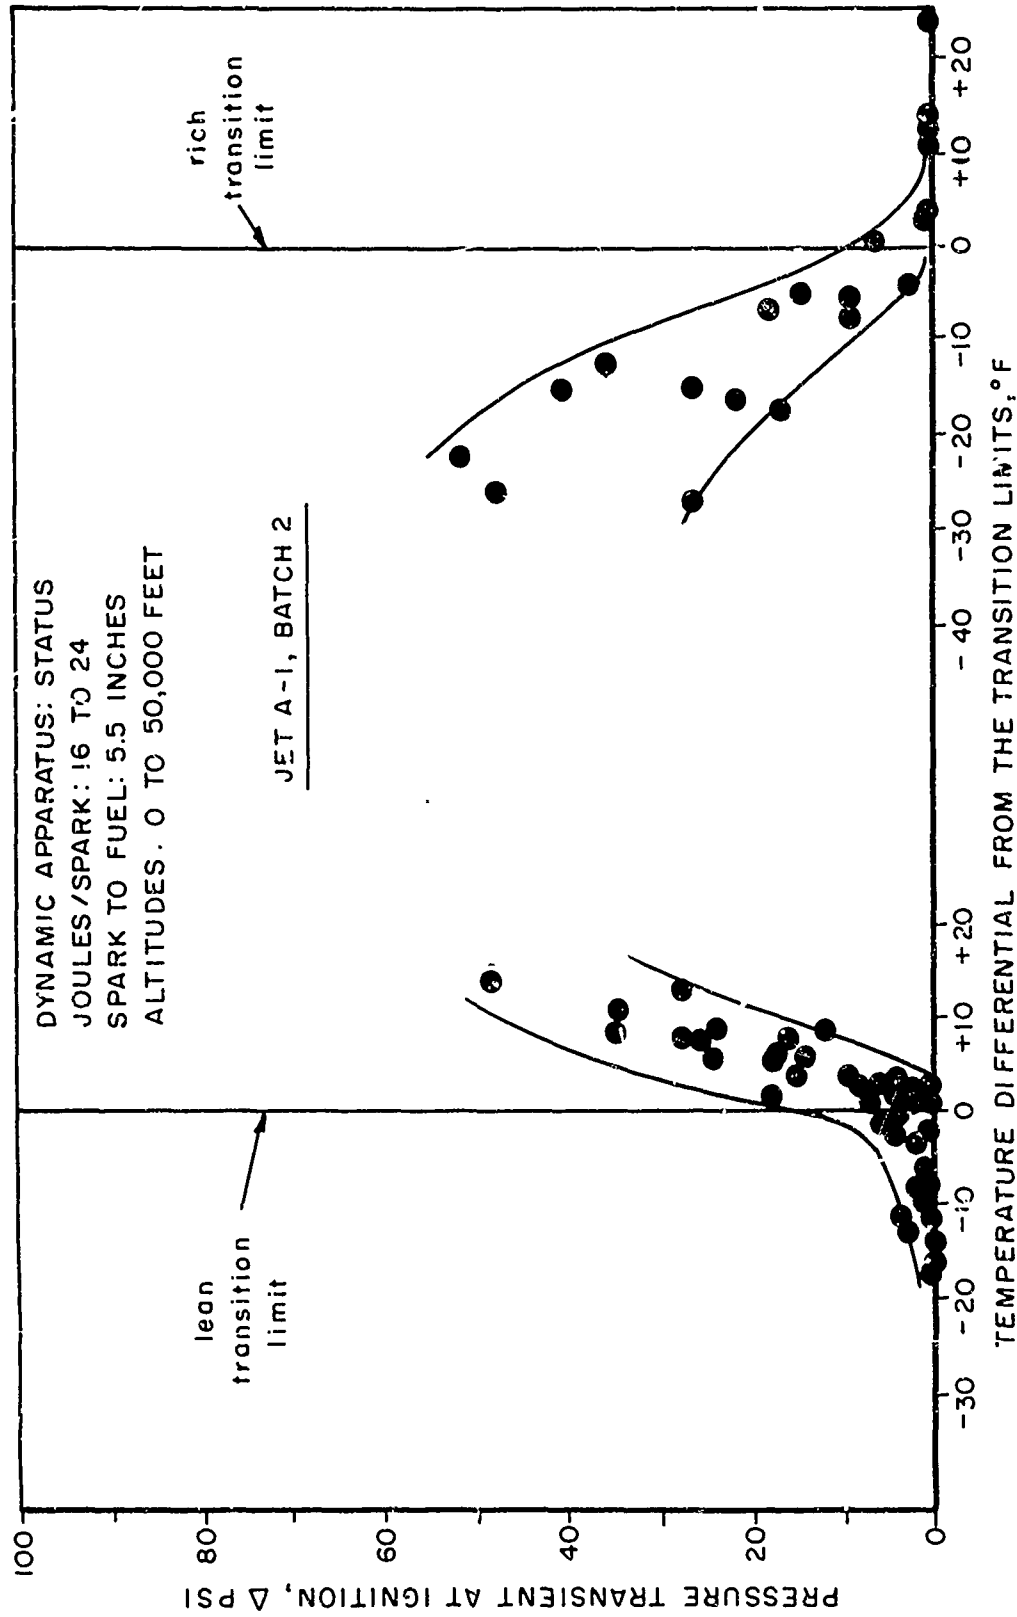
Figure 6. Pressure Profile for Jet A-1 at Equilibrium (Static) Conditions

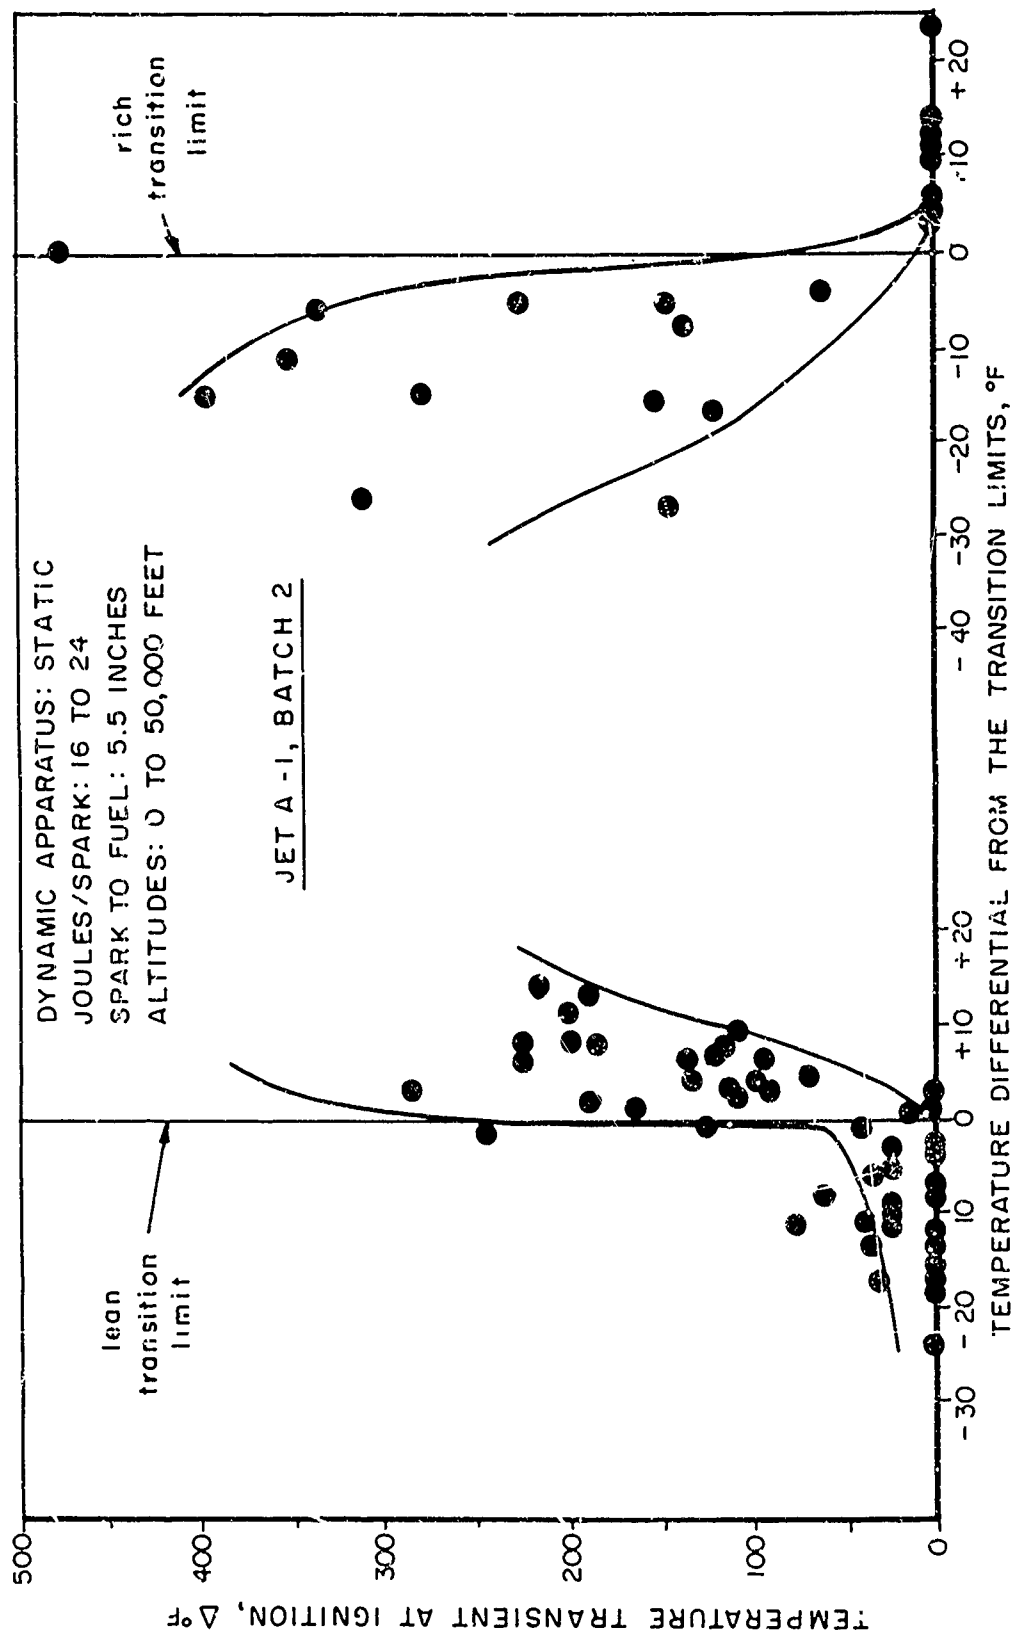
Figure 7. Temperature Profile for Jet A-1 at Equilibrium (Static) Conditions

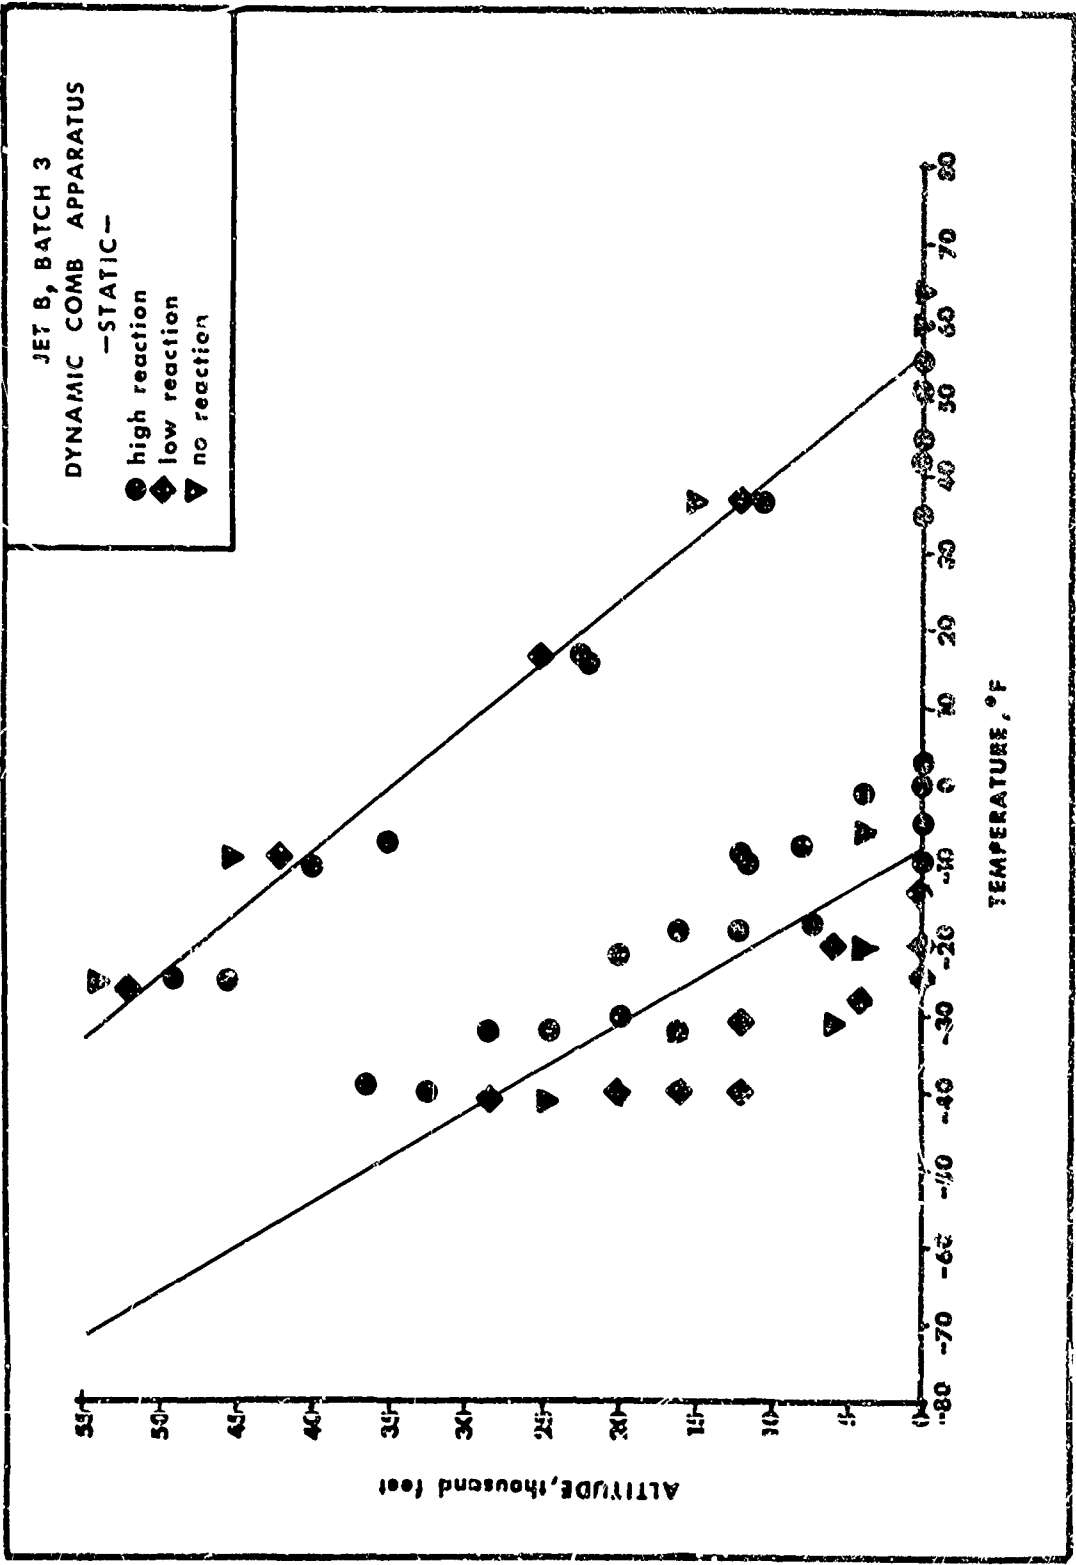
Figure 8. Equilibrium Flammability Envelope for Jet F Fuel

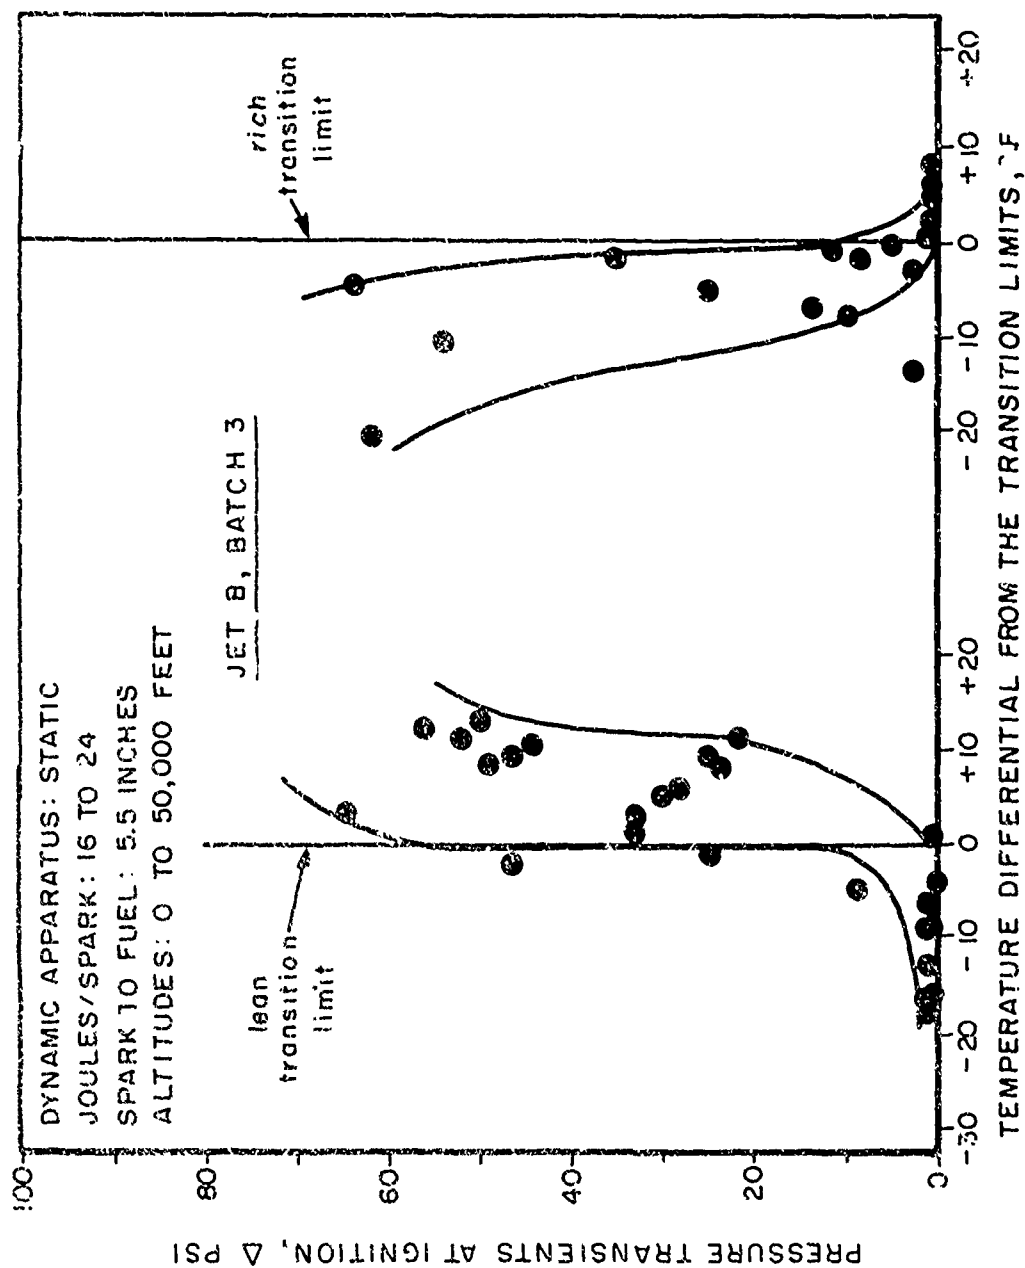
Figure 9. Pressure Profile for Jet B Fuel at Equilibrium (Static) Conditions

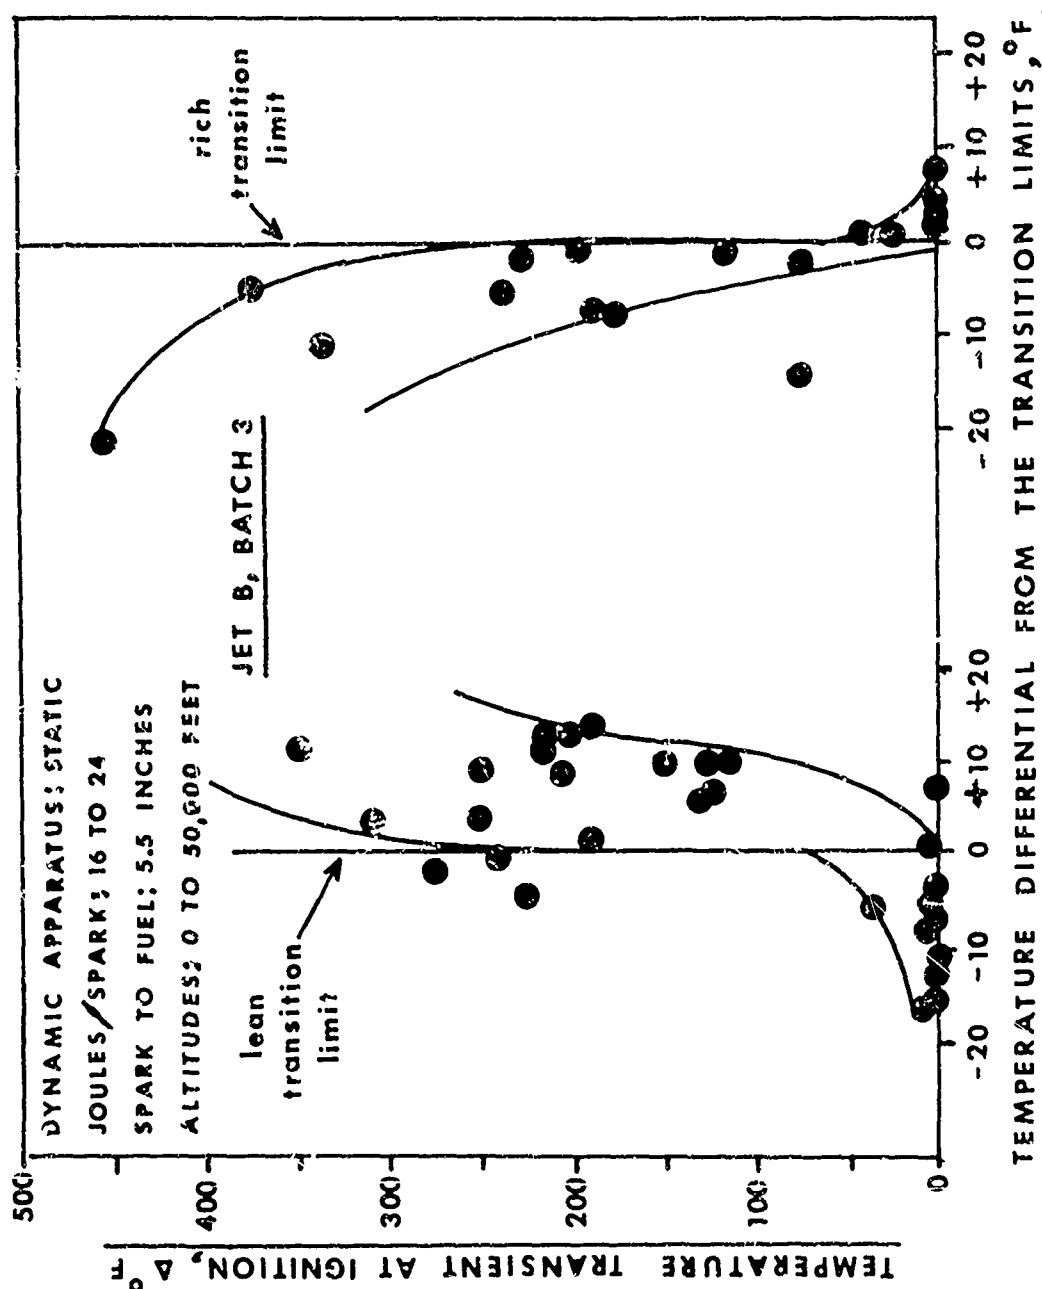
Figure 10. Temperature Profile for Jet B Fuel at Equilibrium (Static) Conditions

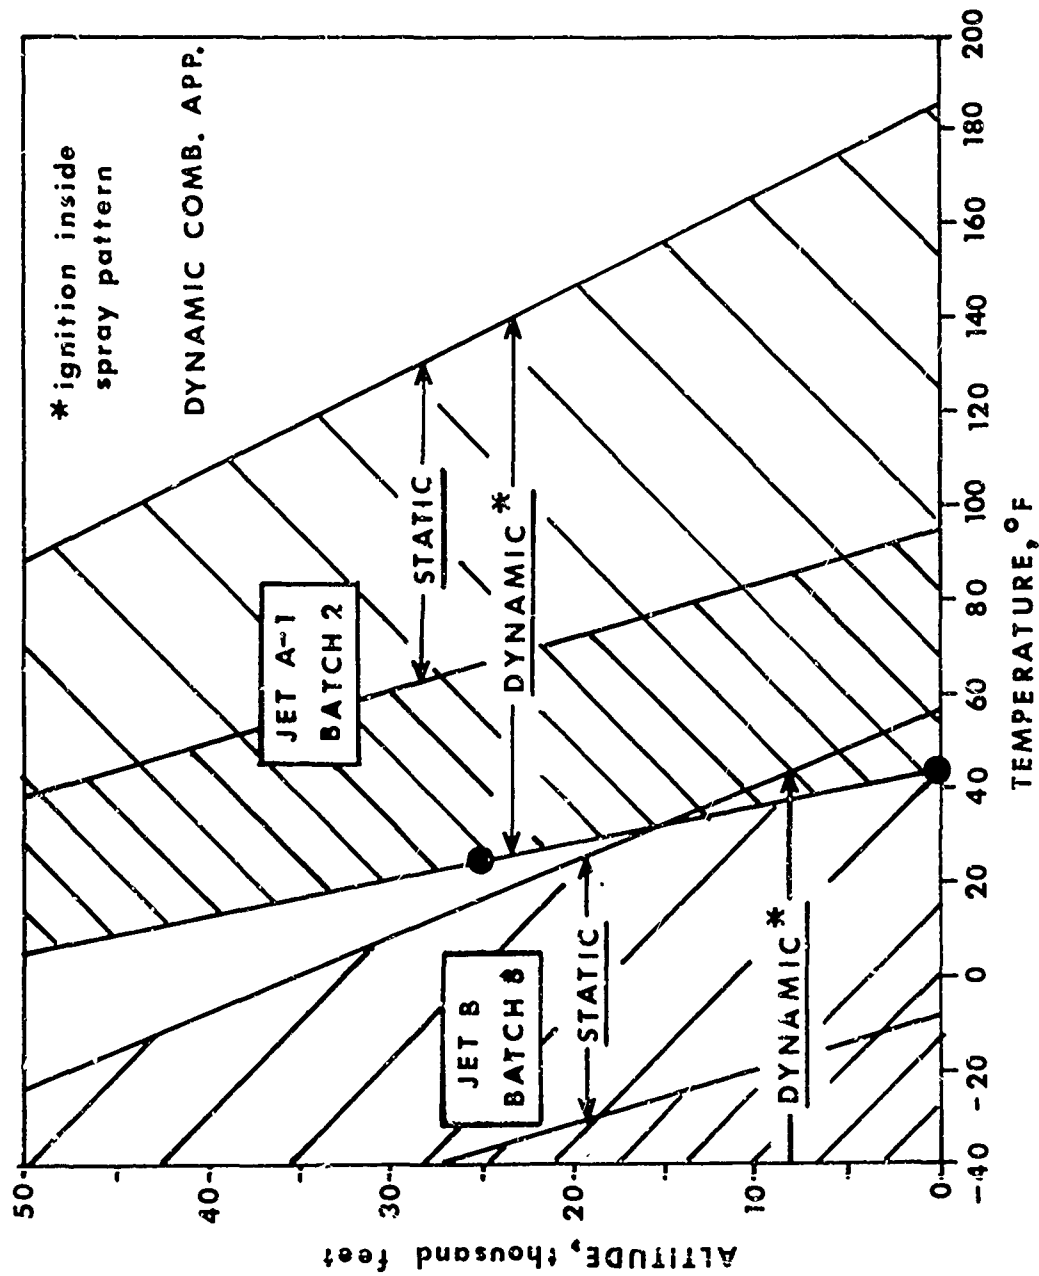
Figure 15. Flammability Envelopes of Turbine Fuels Under Static and Dynamic Conditions

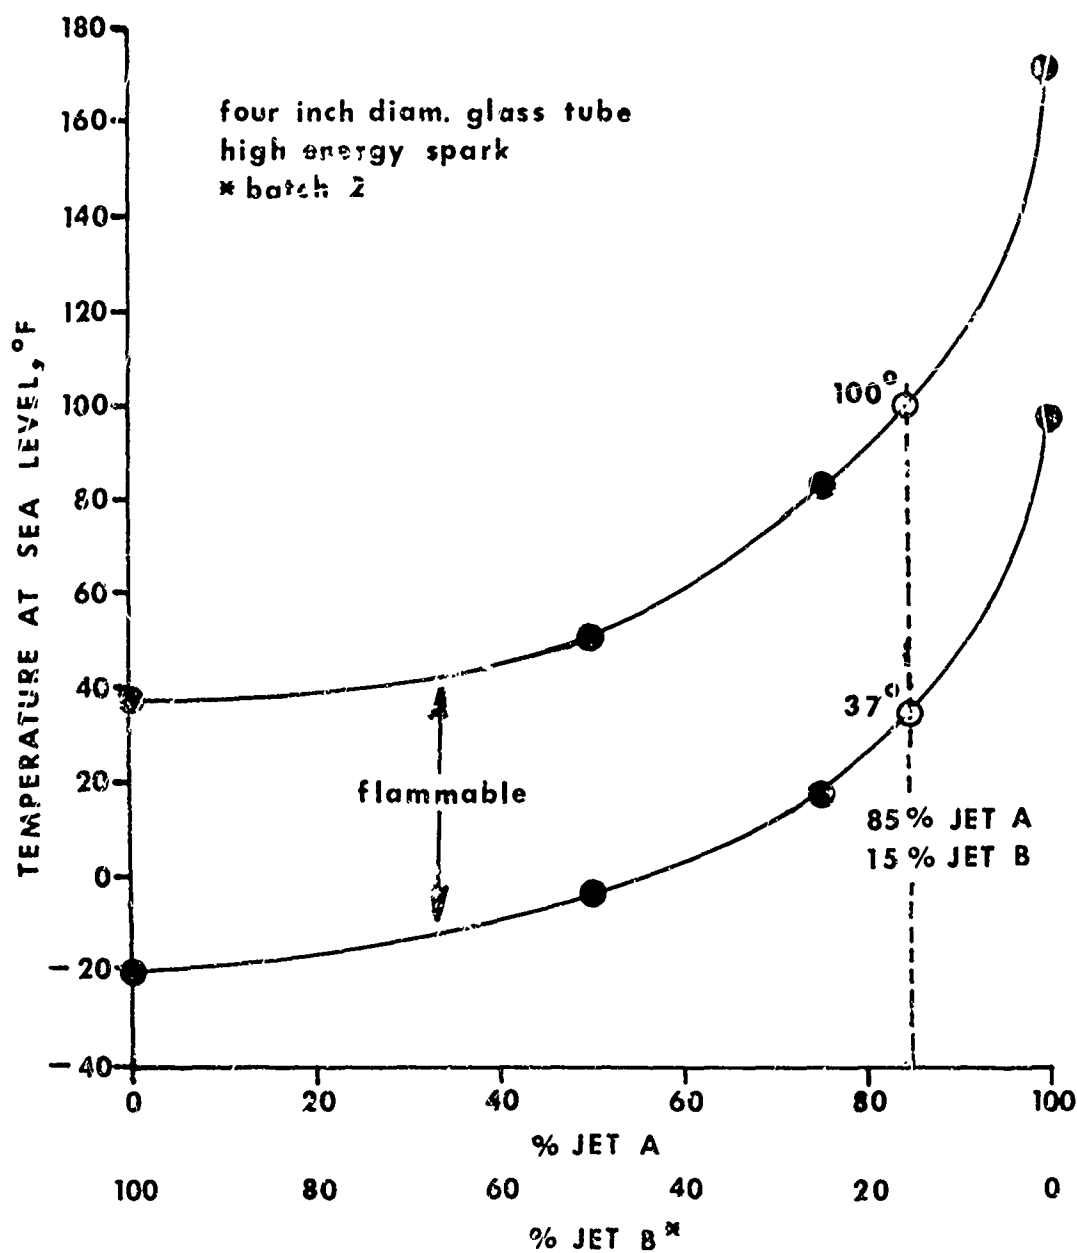
Figure 17. Variation of the Flammability Limits at Sea Level for Blends of Jet A and Jet B

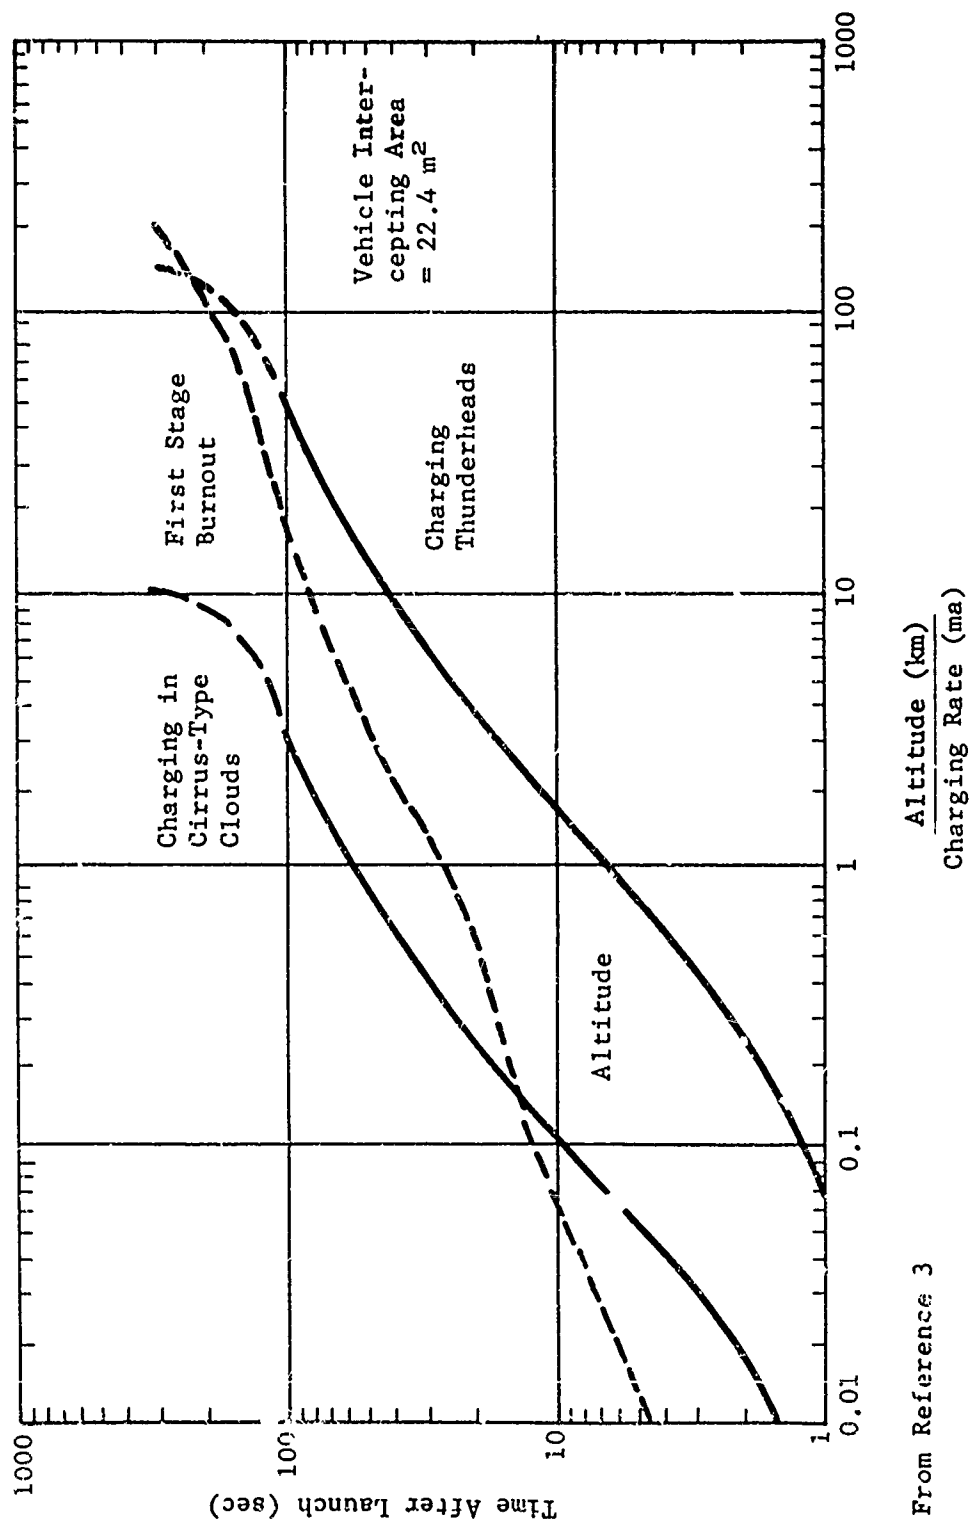
Figure 2. Maximum Charging Rate for the Saturn-Appollo Vehicle in Cirrus Clouds and in Thunderheads

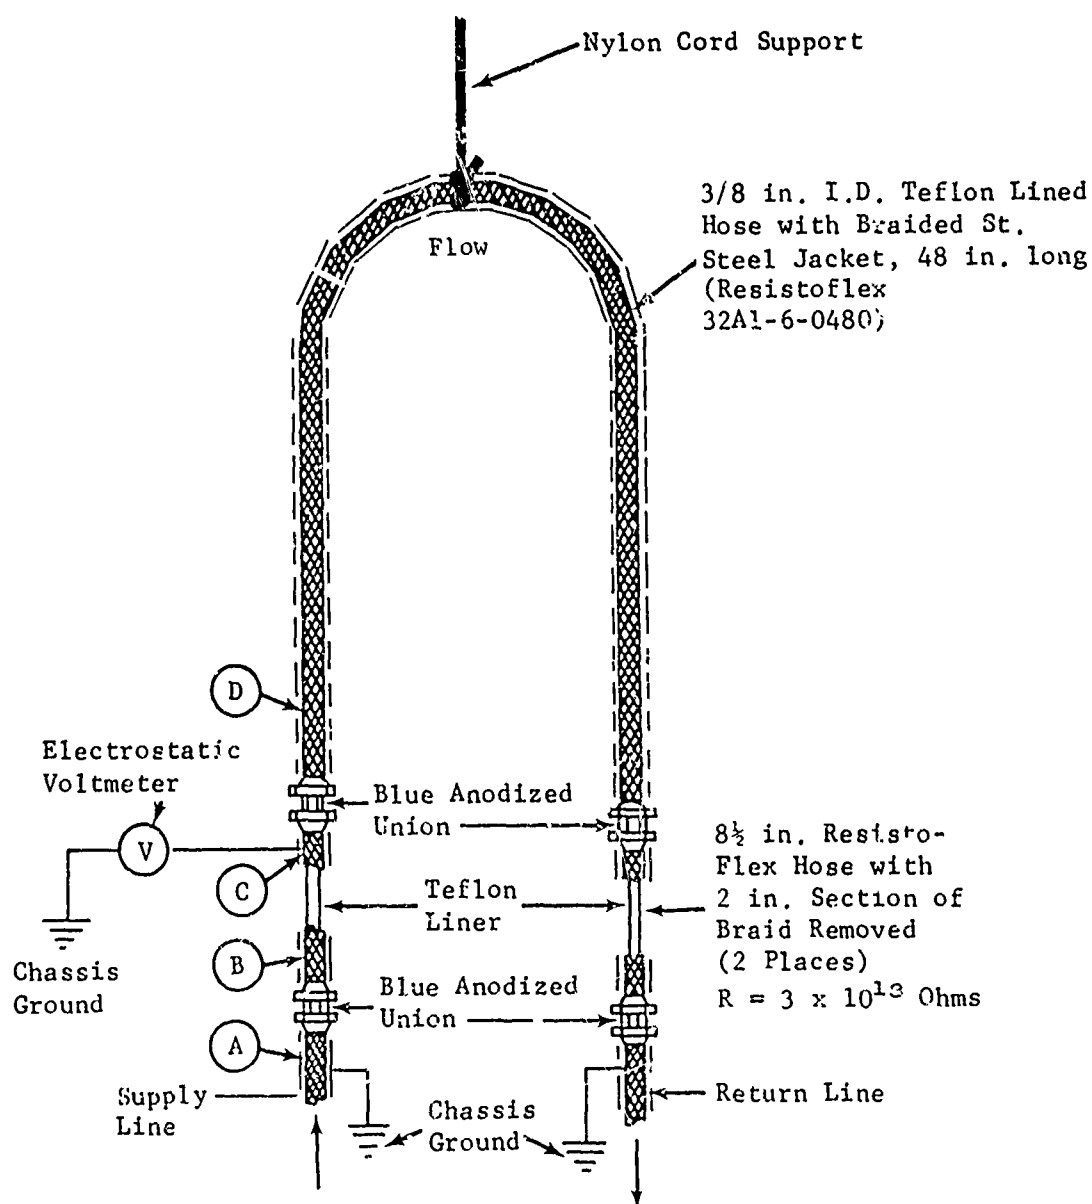
Figure 8. Arrangement for Measuring Charge Potential Under Continuous Flow Conditions

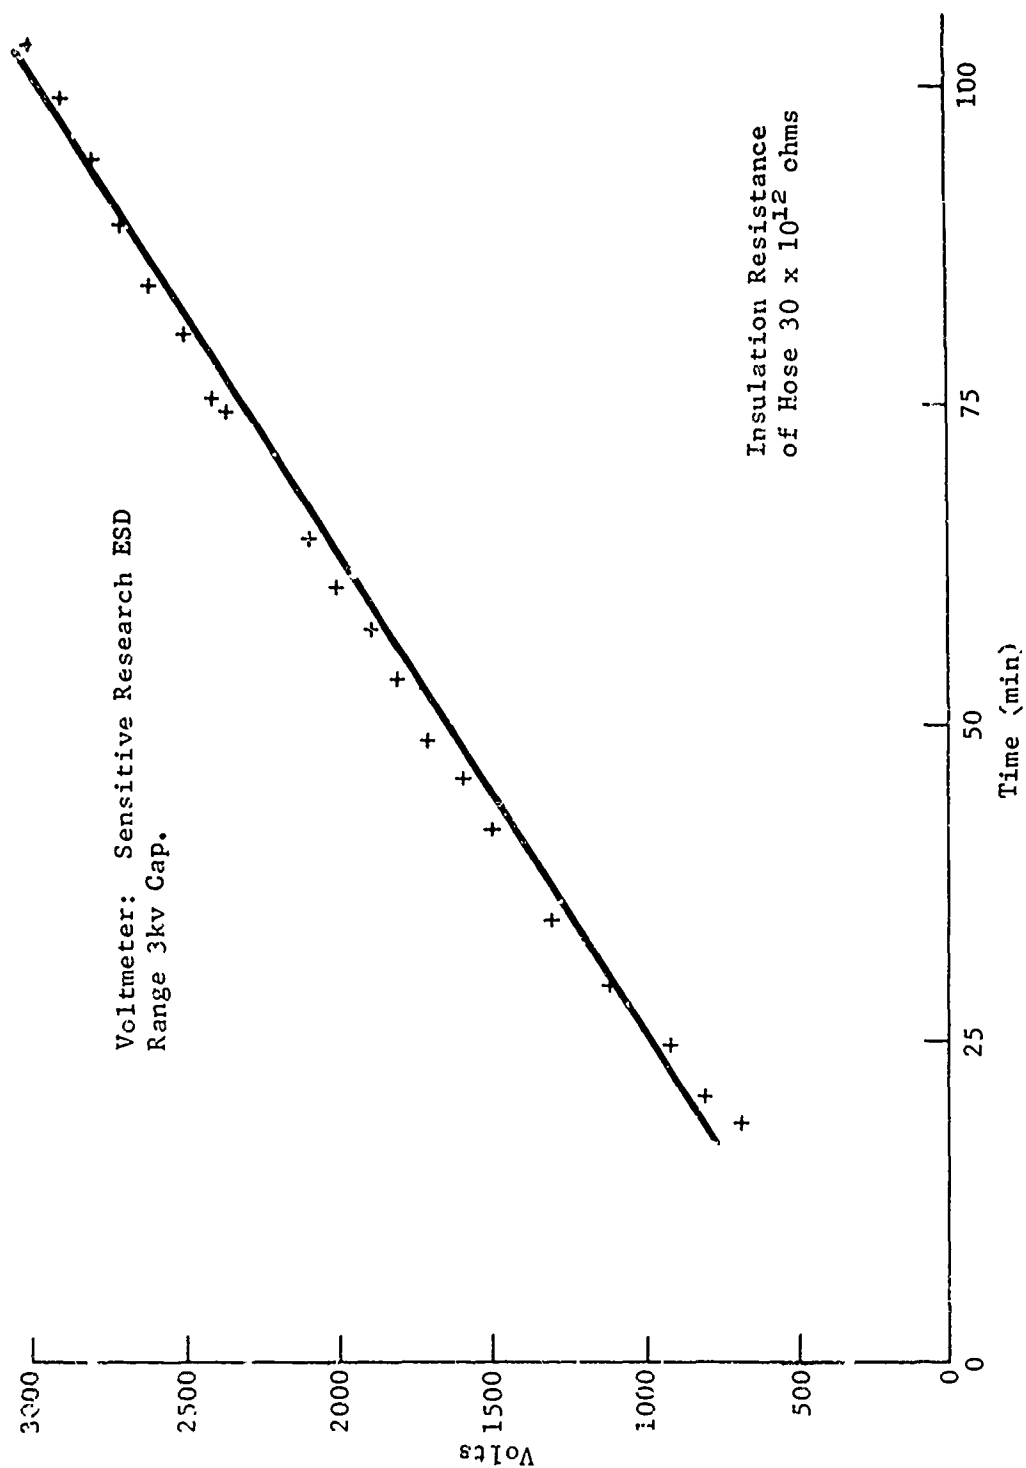
Figure 9. Voltage Generated by FC-75 Coolant Flowing in Insulated Hose
