**LIGHTNING AND STATIC ELECTRICITY
CONFERENCE, 3-5 DECEMBER 1968**

PART II. CONFERENCE PAPERS

TECHNICAL REPORT AFAL-TR-68-290, PART II

AIR FORCE AVIONICS LABORATORY
AIR FORCE SYSTEMS COMMAND
WRIGHT-PATTERSON AIR FORCE BASE, OHIO

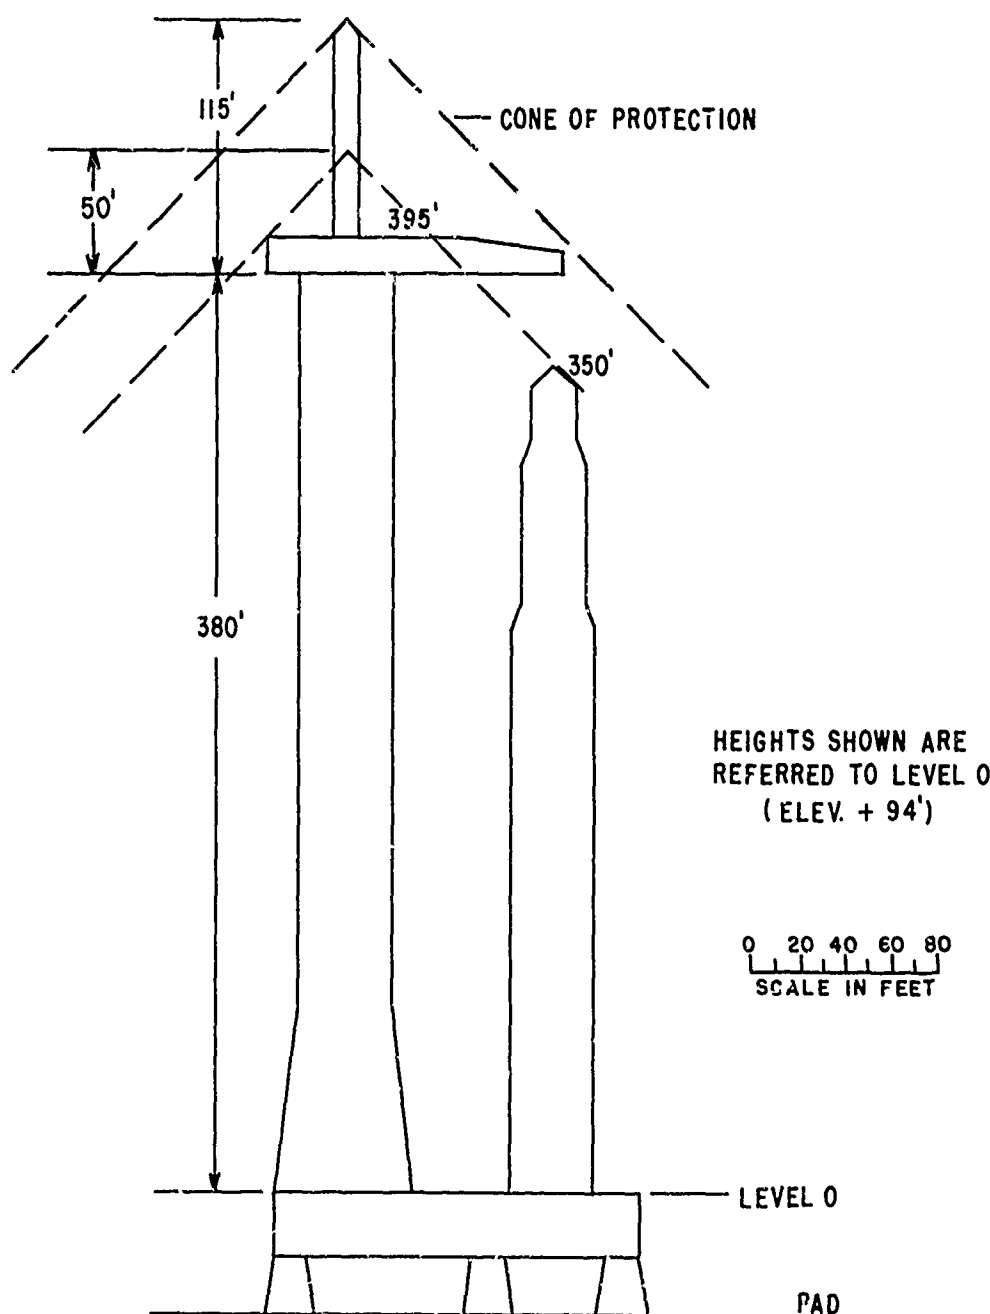
Figure 3. Single Retractable Mast — Elevation View

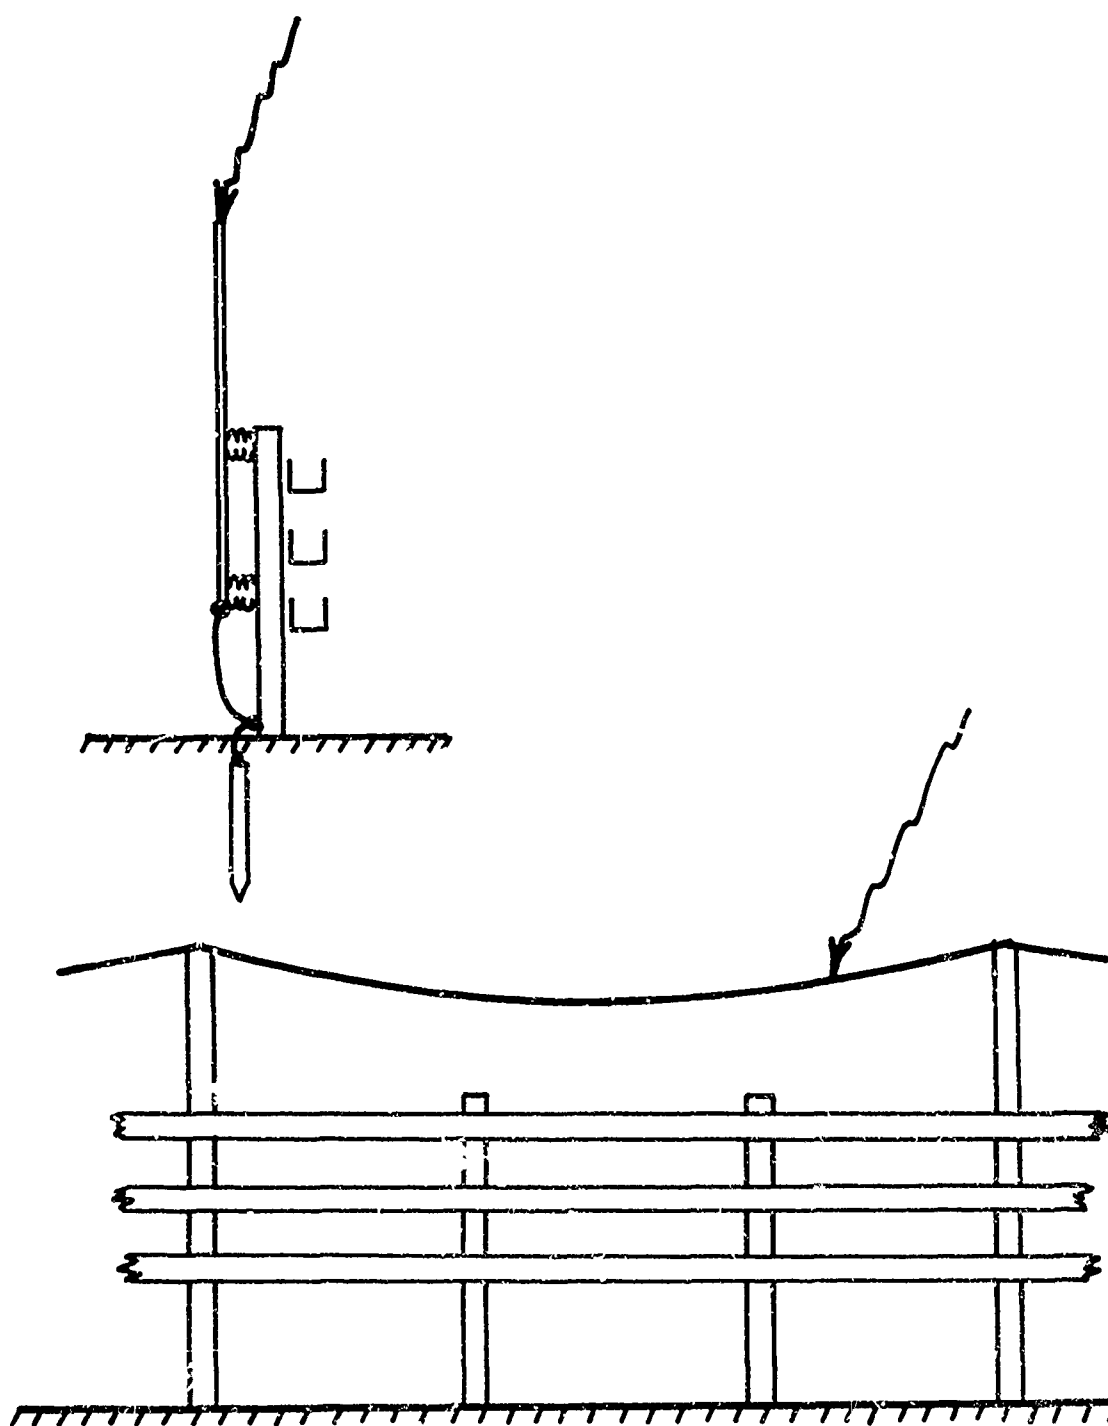
Figure 5. Direct Stroke Protection for Above-Ground Cable Trays

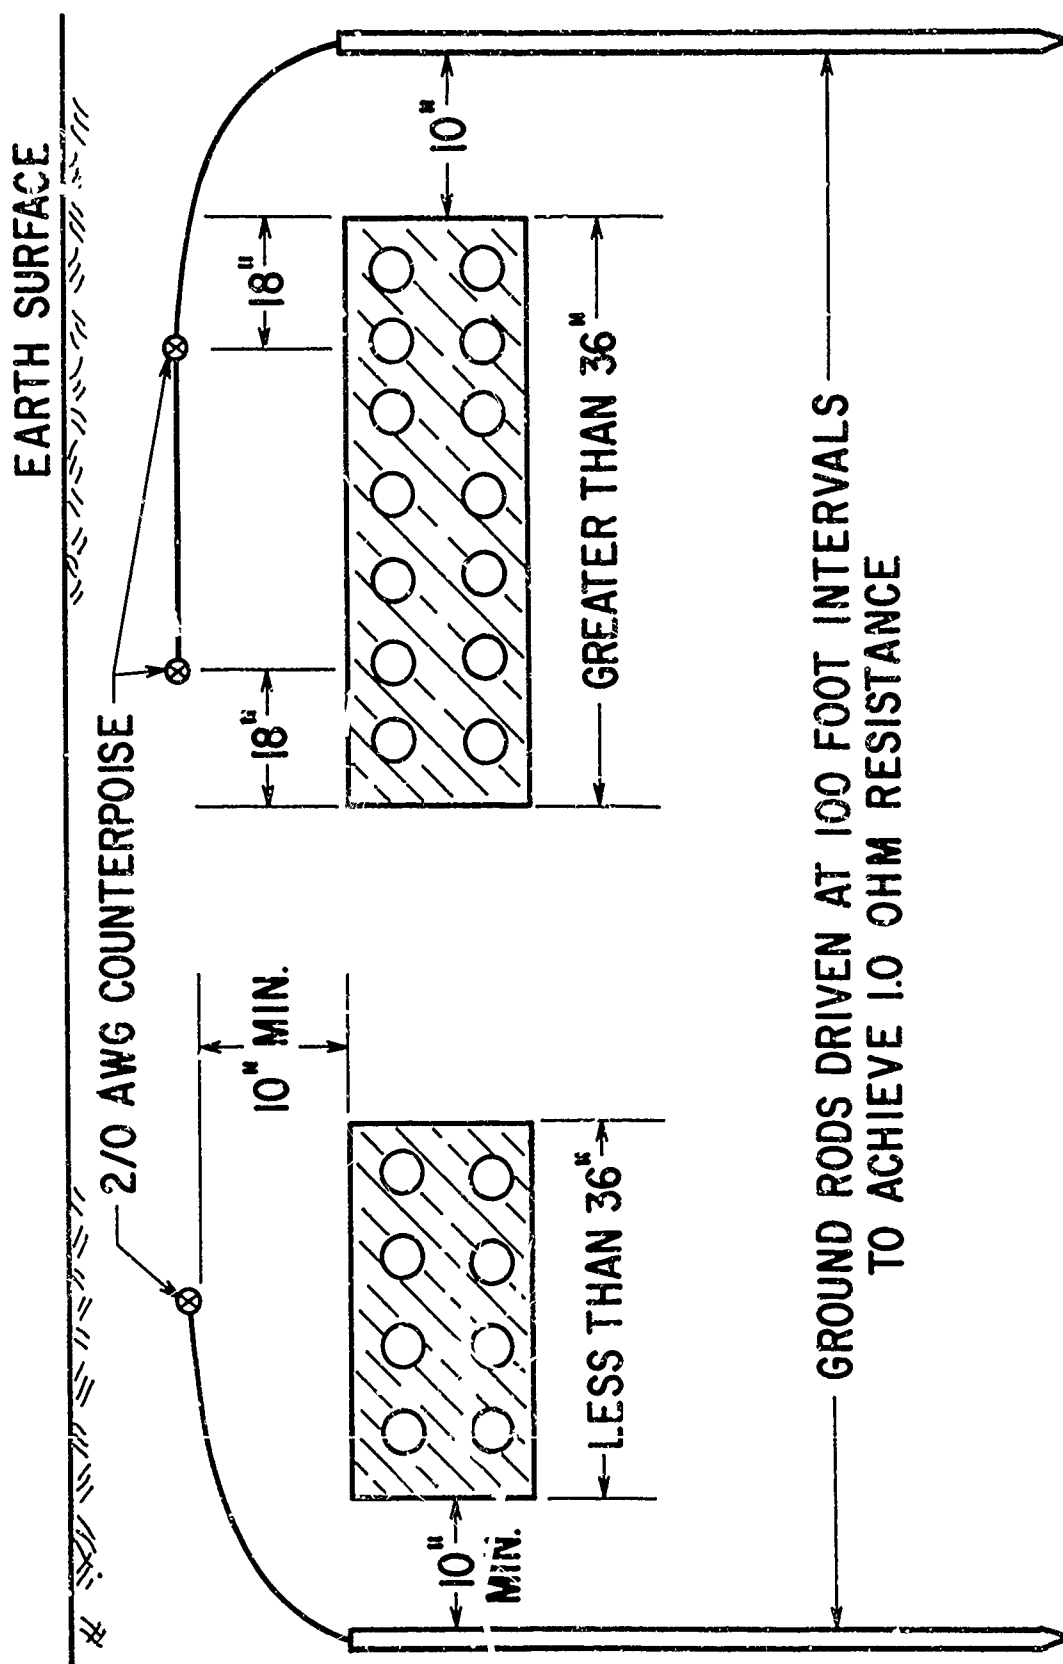
Figure 6. Underground Duct Grounding

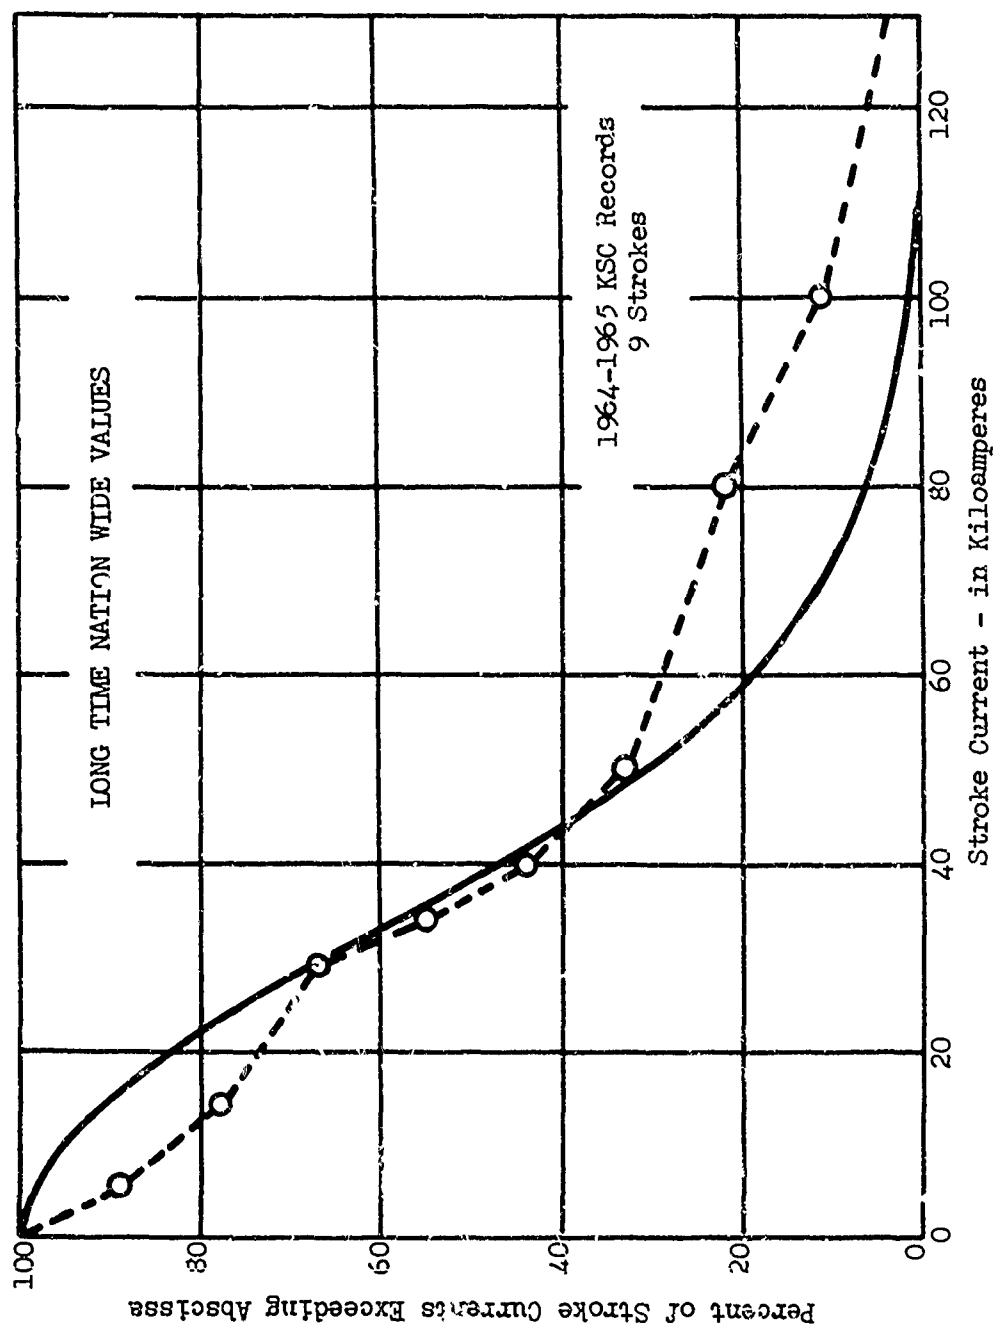
Figure 11. Measured Lightning Stroke Amplitudes

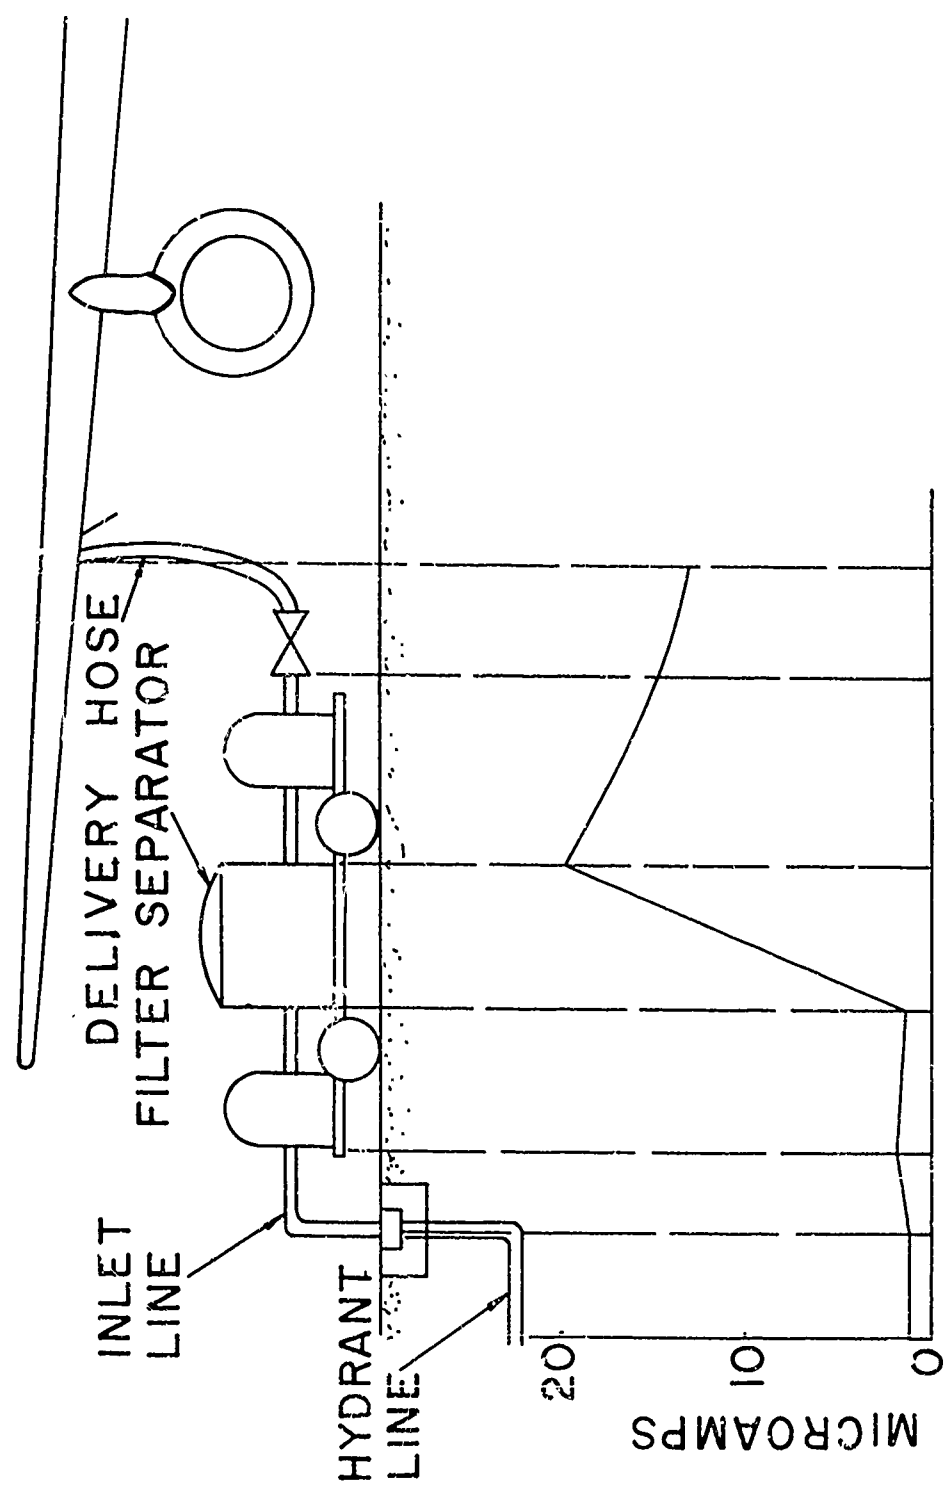
Figure 2. Electrical Charging During Refueling

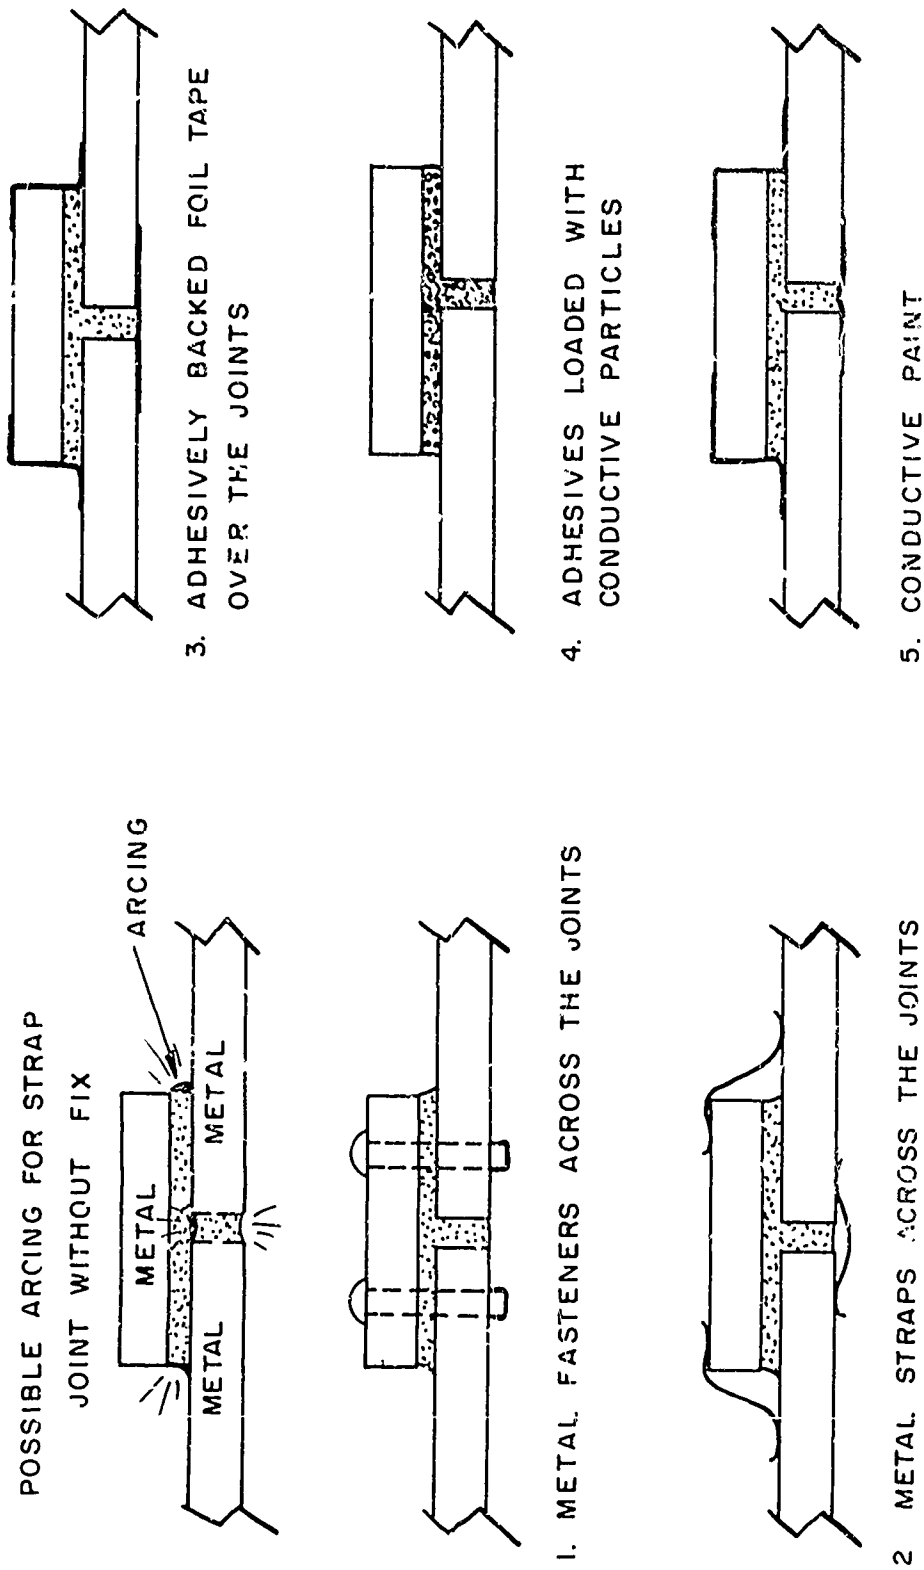
Figure 8. Bonding of Adhesive Strap Joint

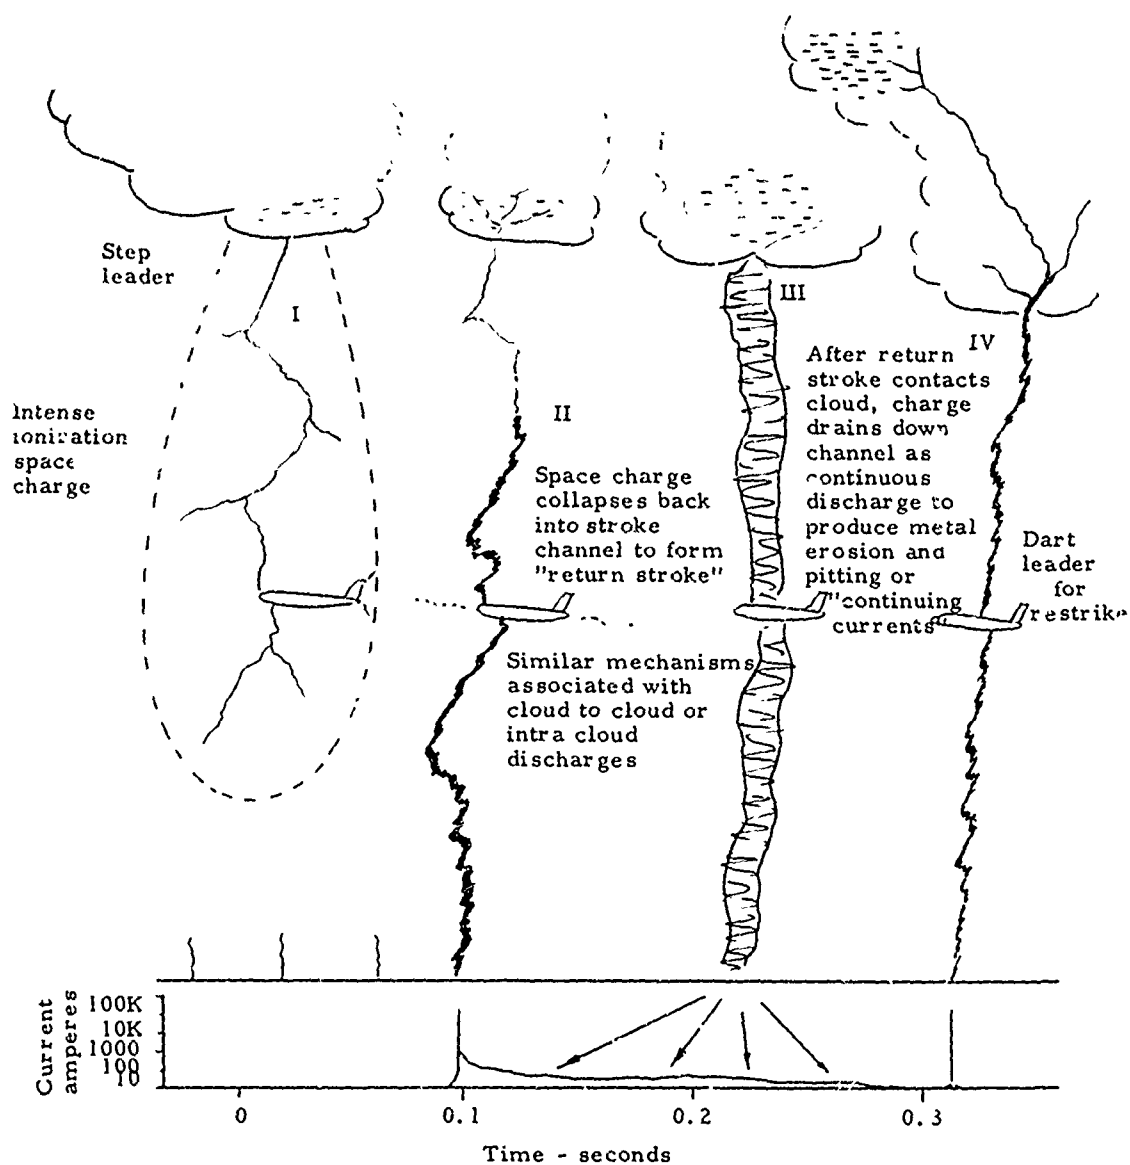
Figure 2. Probable Contact Mechanism and Aircraft Movement Through Lightning Channel; Corresponding Current Flow Indicated Below

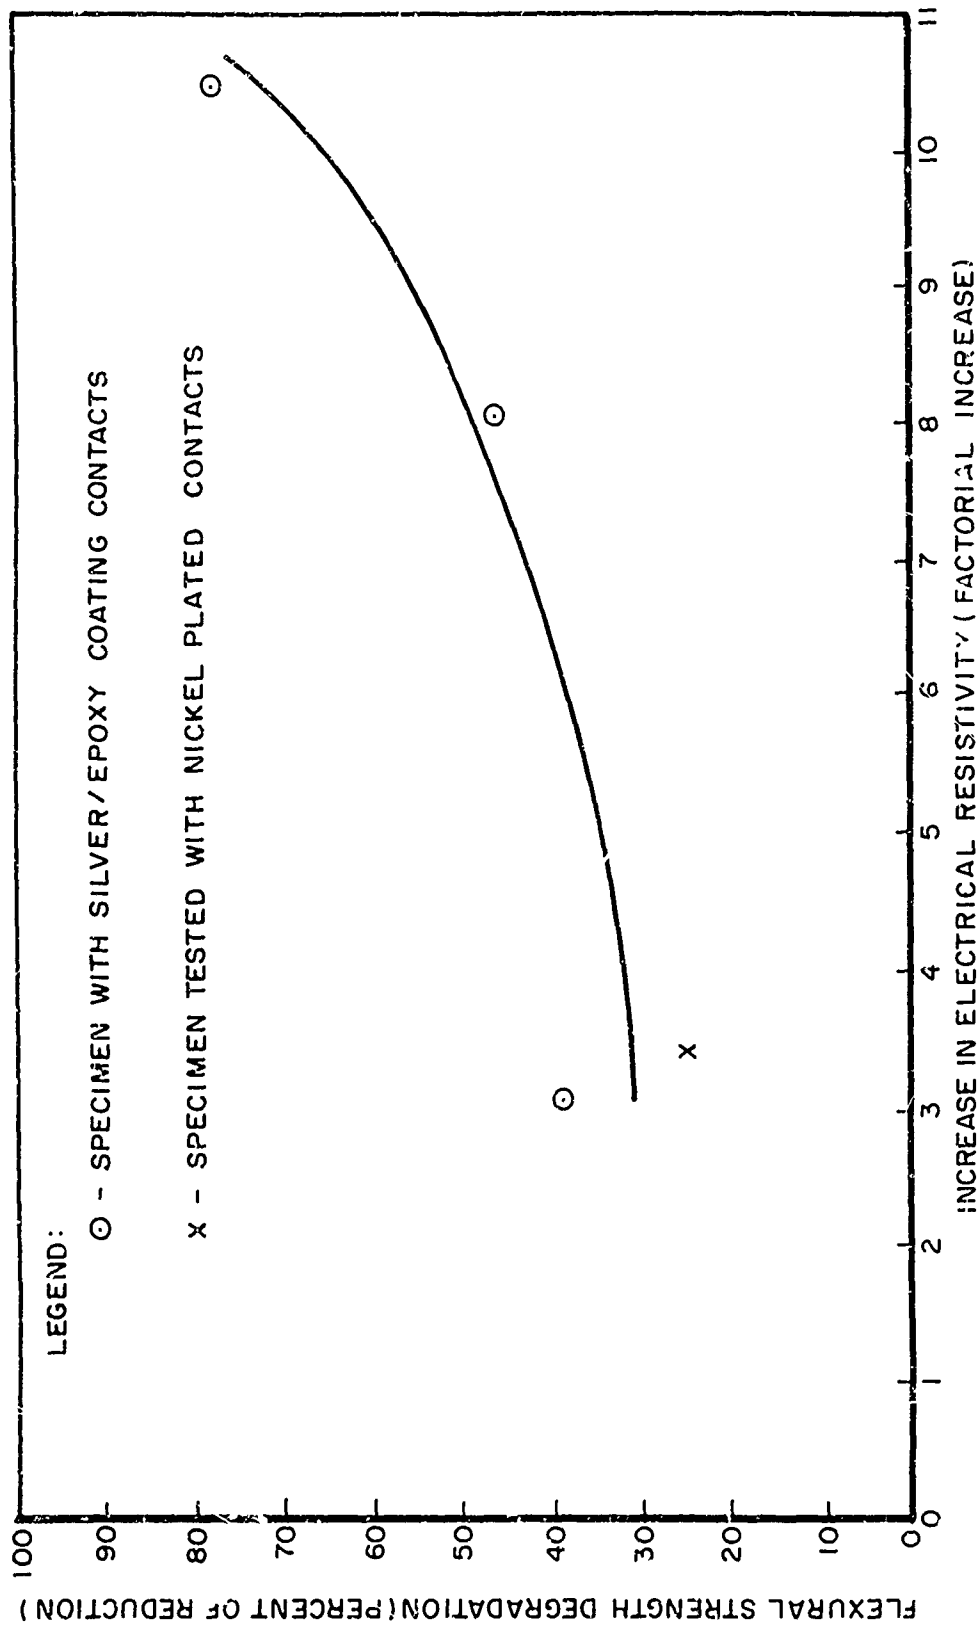
Figure 14. Flexural Strength Degradation Versus Increase in Electrical Resistivity

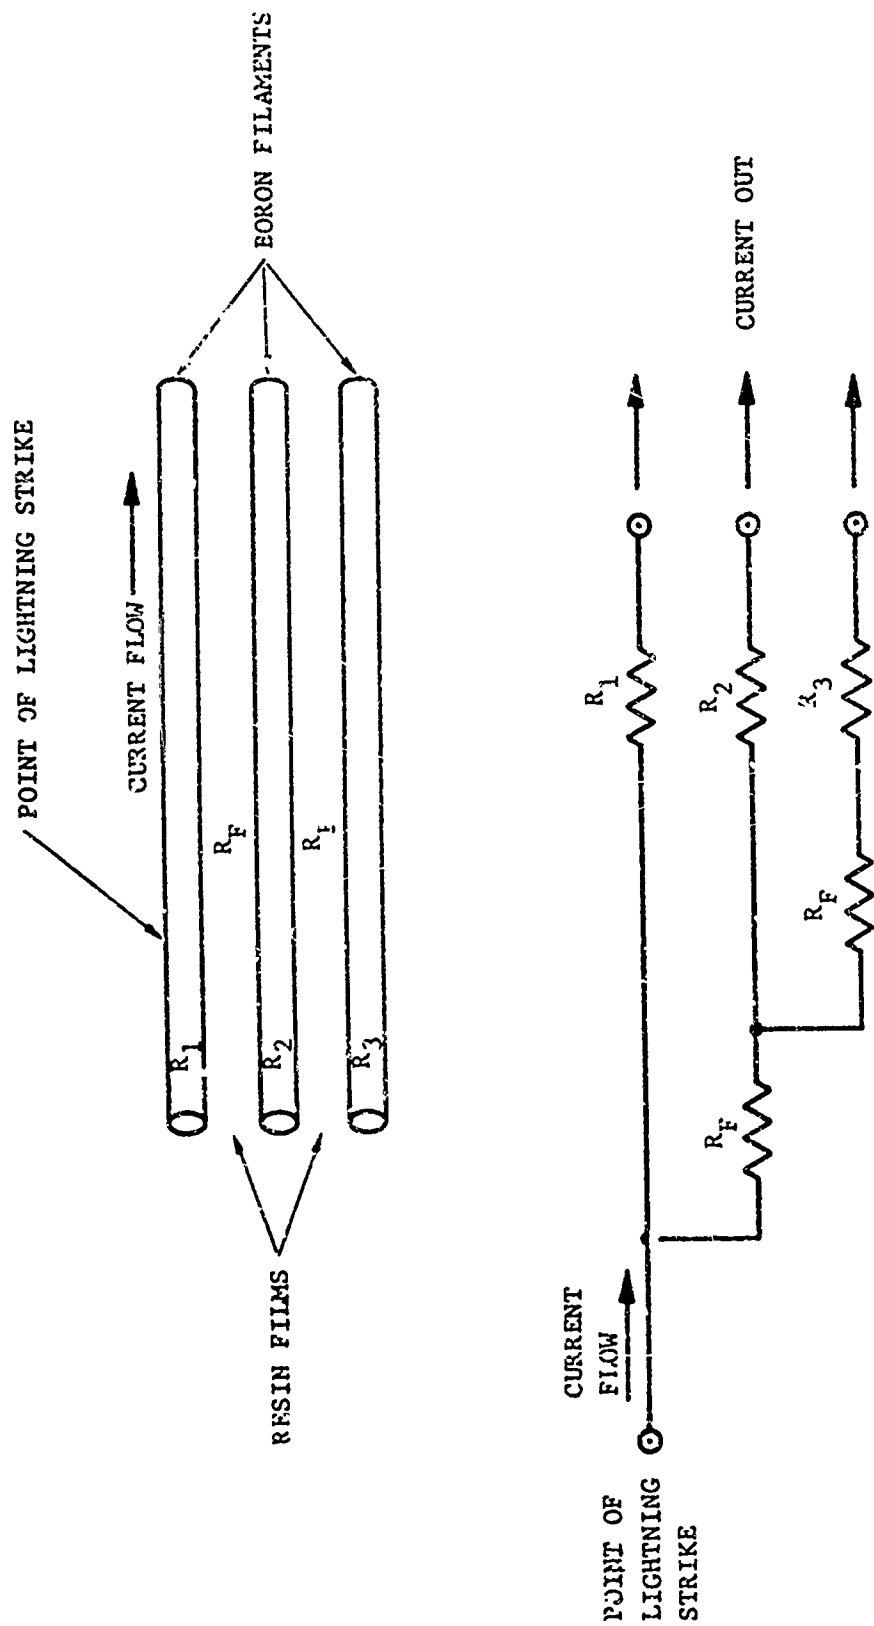
Figure 16. Lightning Strike on Composite Surface - Current Flow Model
