ARPA Coupling Program on Stress-Corrosion Cracking (Thirteenth Quarterly Report)

March 1970

NAVAL RESEARCH LABORATORY
Washington, D.C.

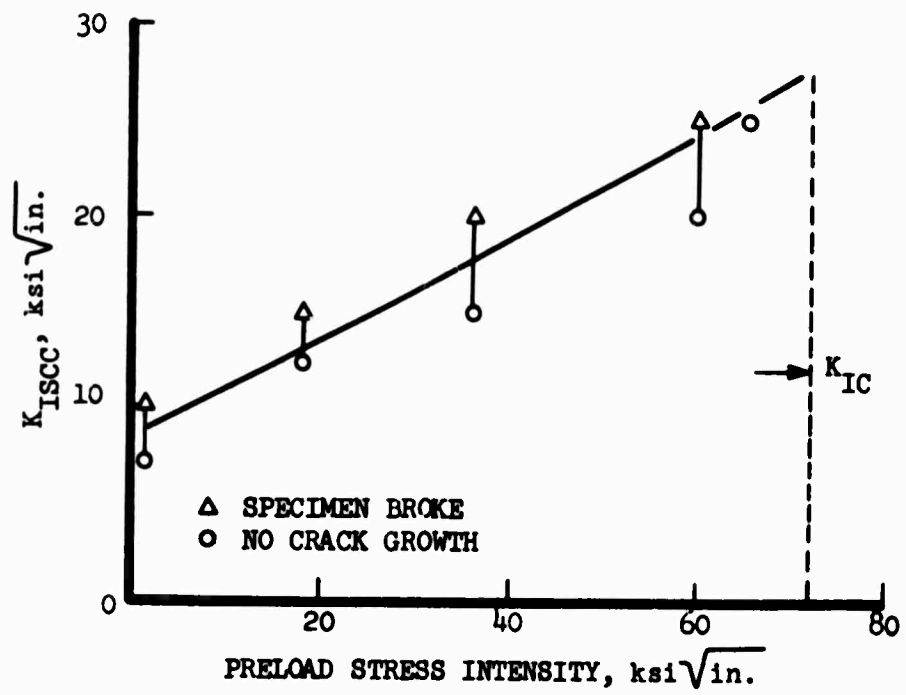
Fig. B-1 - Effect of preloading on the effective stress-corrosion-cracking threshold K_{ISCC}^* of AISI 4340 steel.

In another study at Boeing, the influence of preloading on the stress-corrosion-cracking resistance of two ultrahigh-strength steels is being investigated. Fatigue pre-cracked, single-edge-notched specimens of an AISI 4340 steel (heat treated to a yield strength of 194 ksi) and a 300-grade 18Ni maraging steel are used. Work on the AISI 4340 steel has been completed, and tests on the maraging steel are in progress. The AISI 4340 steel specimens were preloaded in three-point bending in air to various stress-intensity levels, up to 90% of the K_{Ic} of 72 ksi $\sqrt{\text{in.}}$. After unloading, the effective stress-corrosion-cracking threshold K_{Isc}^* was determined for each preload condition by testing the specimens in 3.5% aqueous sodium chloride solution under sustained-load cantilever bending. It was found that K_{Isc}^* increased from 8 ksi $\sqrt{\text{in.}}$ (with no preloading) to greater than 25 ksi $\sqrt{\text{in.}}$, in proportion to the preload stress-intensity level, (Fig. B-1). The time-to-failure at applied stress intensity (K_{II}) levels above K_{Isc}^* was not affected by the amount of preloading. The increase in the effective stress-corrosion-cracking threshold has been tentatively attributed to compressive stresses at the crack tip resulting from preloading. Preliminary results on the maraging steel indicate that preloading has little effect on the stress-corrosion-cracking threshold for this steel.

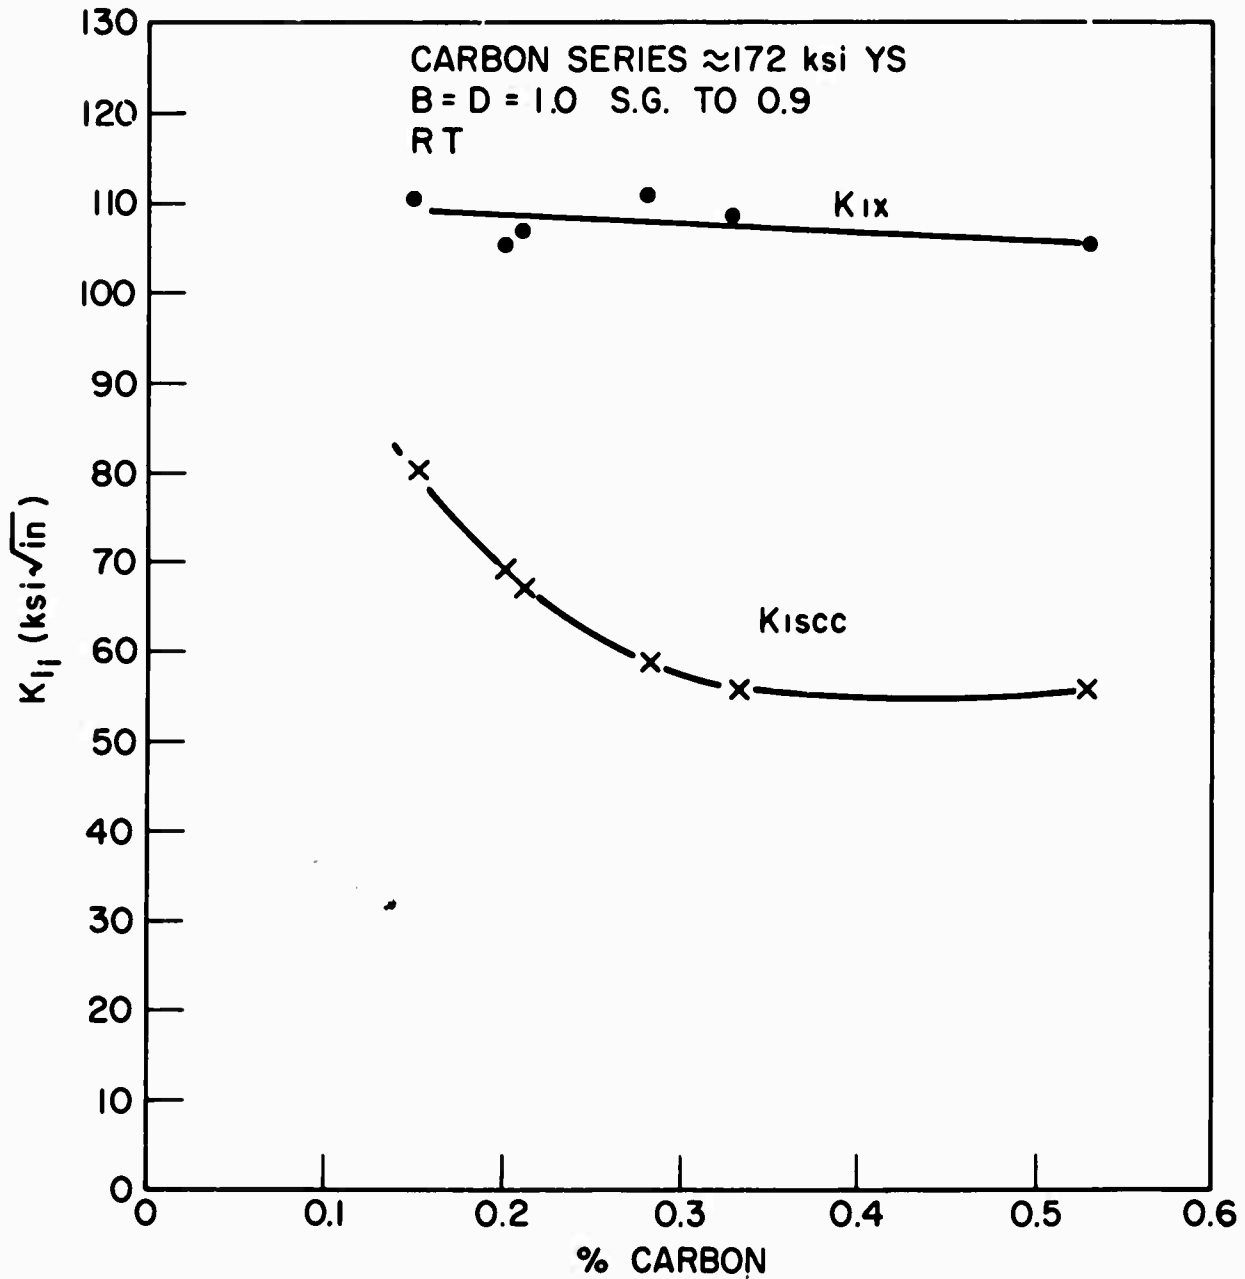
Fig. B-4 - Effects of C on the stress-corrosion-cracking resistance of steel similar to AISI 4340 in base composition and quenched and tempered to 172 ksi yield strength.

The results for carbon are given for Figs. B-4 and B-5 for the 172 ksi and 195 ksi yield strength ranges, respectively. Increasing carbon from 0.15 to about 0.4 percent reduces K_{ISCC} . This agrees with the previously reported results. Both K_{IX} and K_{ISCC} values are generally higher in the lower yield strength (172 ksi) series as compared to the higher yield strength series, as expected. A rise in K_{ISCC} as the carbon content exceeds about 0.4 percent was reported previously (1), and the new series shows a similar effect. Another series of steels has now been

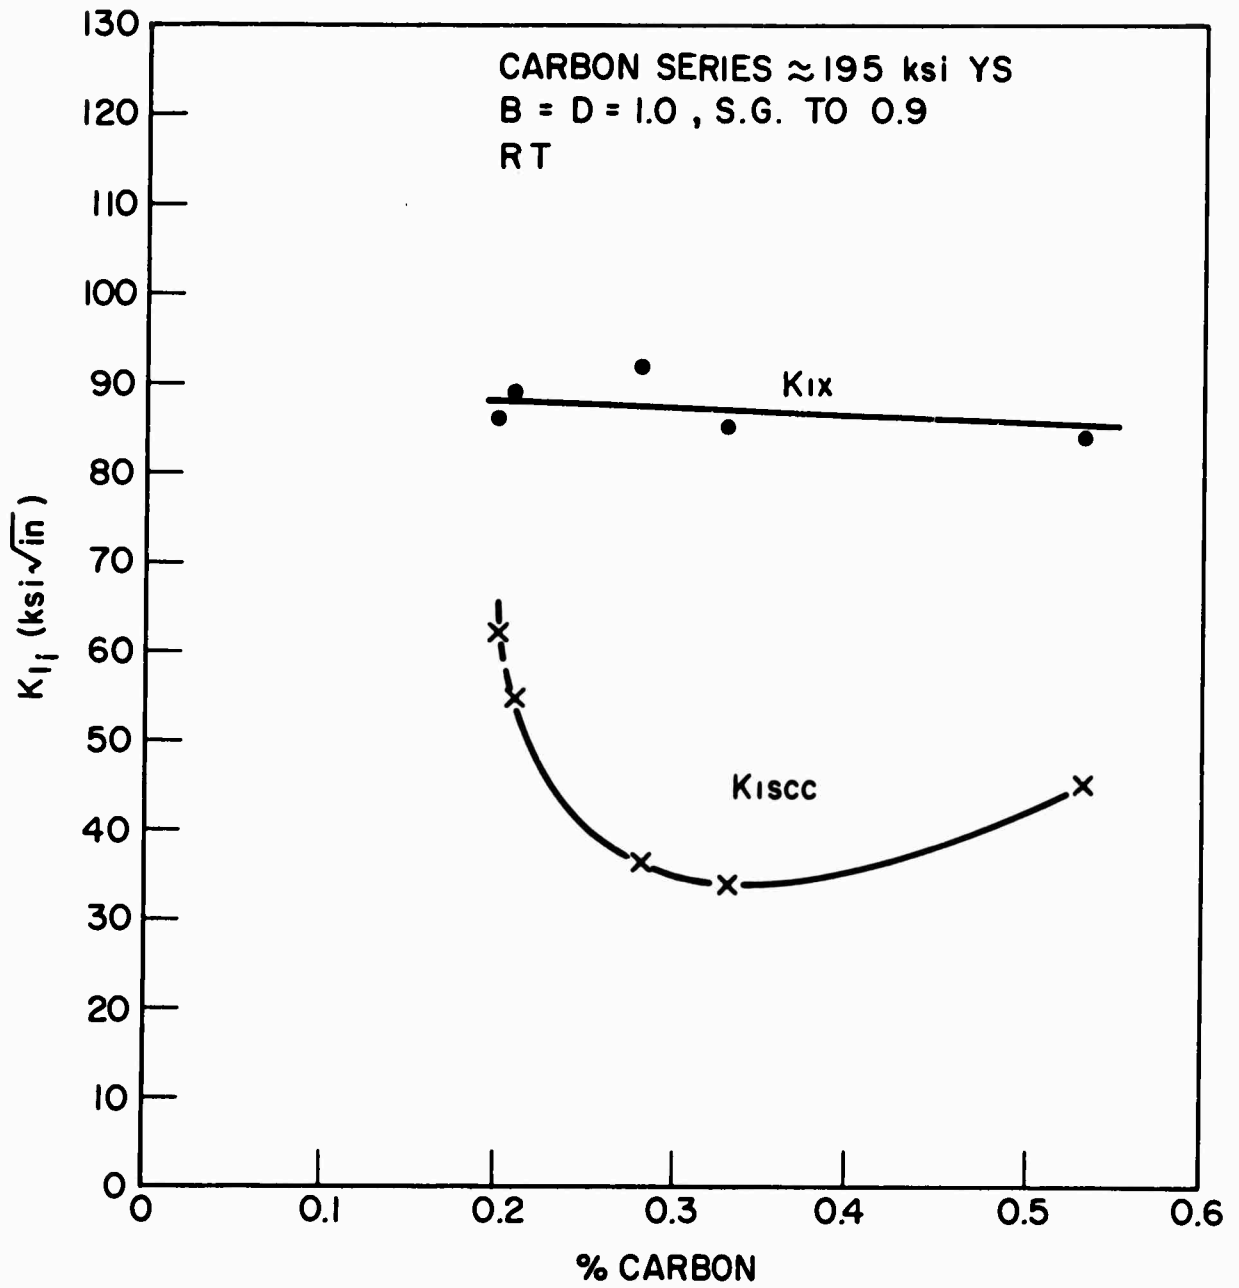
Fig. B-5 - Effects of C on the stress-corrosion-cracking resistance of steel similar to AISI 4340 in base composition and quenched and tempered to 195 ksi yield strength.

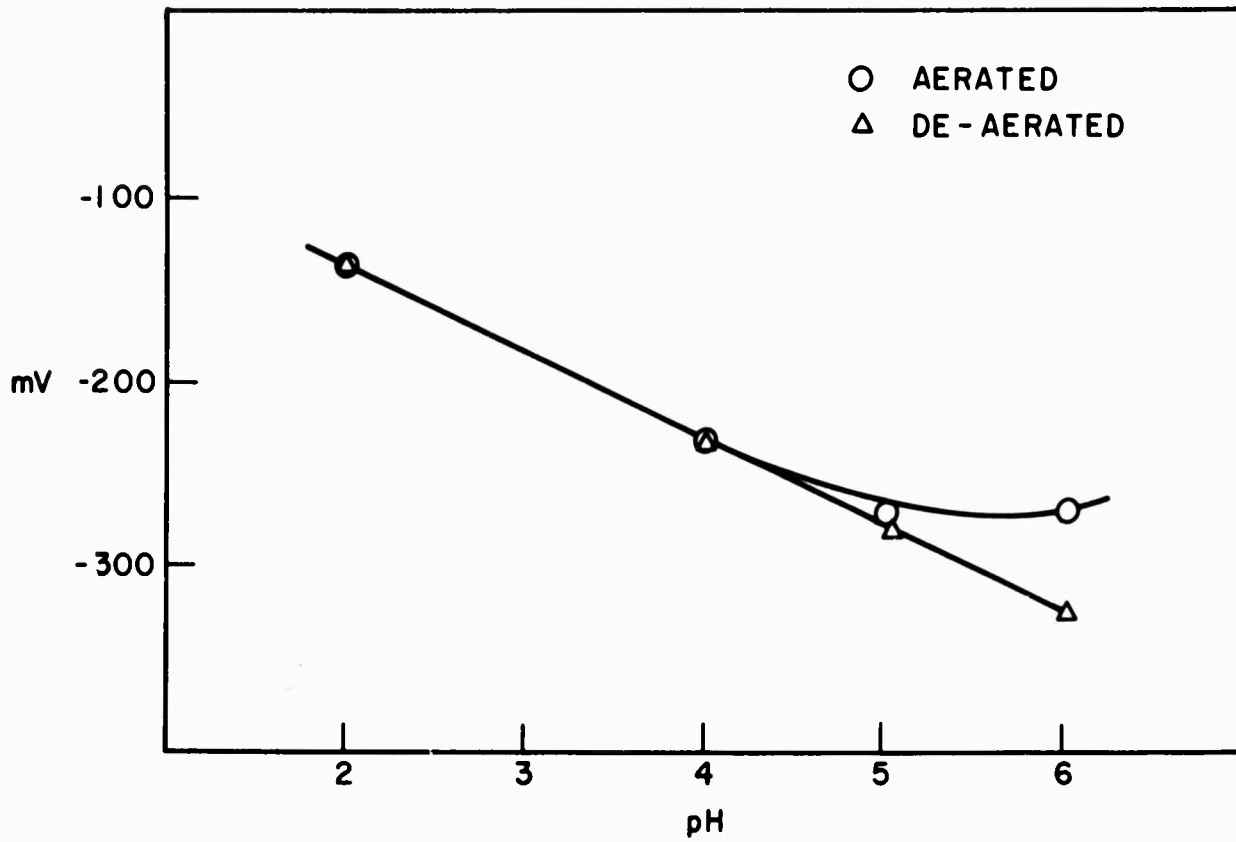
Fig. B-6 - Calibration curves for the $\text{Sb/Sb}_2\text{O}_3$ vs Ag/AgCl pH probe (normalized at pH 2) in 0.6M NaCl + 0.01M $\text{Fe}(\text{Cl})_2\text{O}$ solution.

Fig. B-6 shows normalized calibration curves for the pH probe in solutions containing ferrous iron. Under reducing conditions, the probe is well behaved over the pH range 2 to 6, but under oxidizing conditions, the oxidation of ferrous to ferric iron interferes and limits the useful range to pH 2 to 5.

This is not a serious limitation as dissolved oxygen is reduced to hydroxyl iron during the corrosion reactions, and the access of additional oxygen to the crack front is restricted. In any event, the pH in the crack front is normally within the range in which there is no interference.

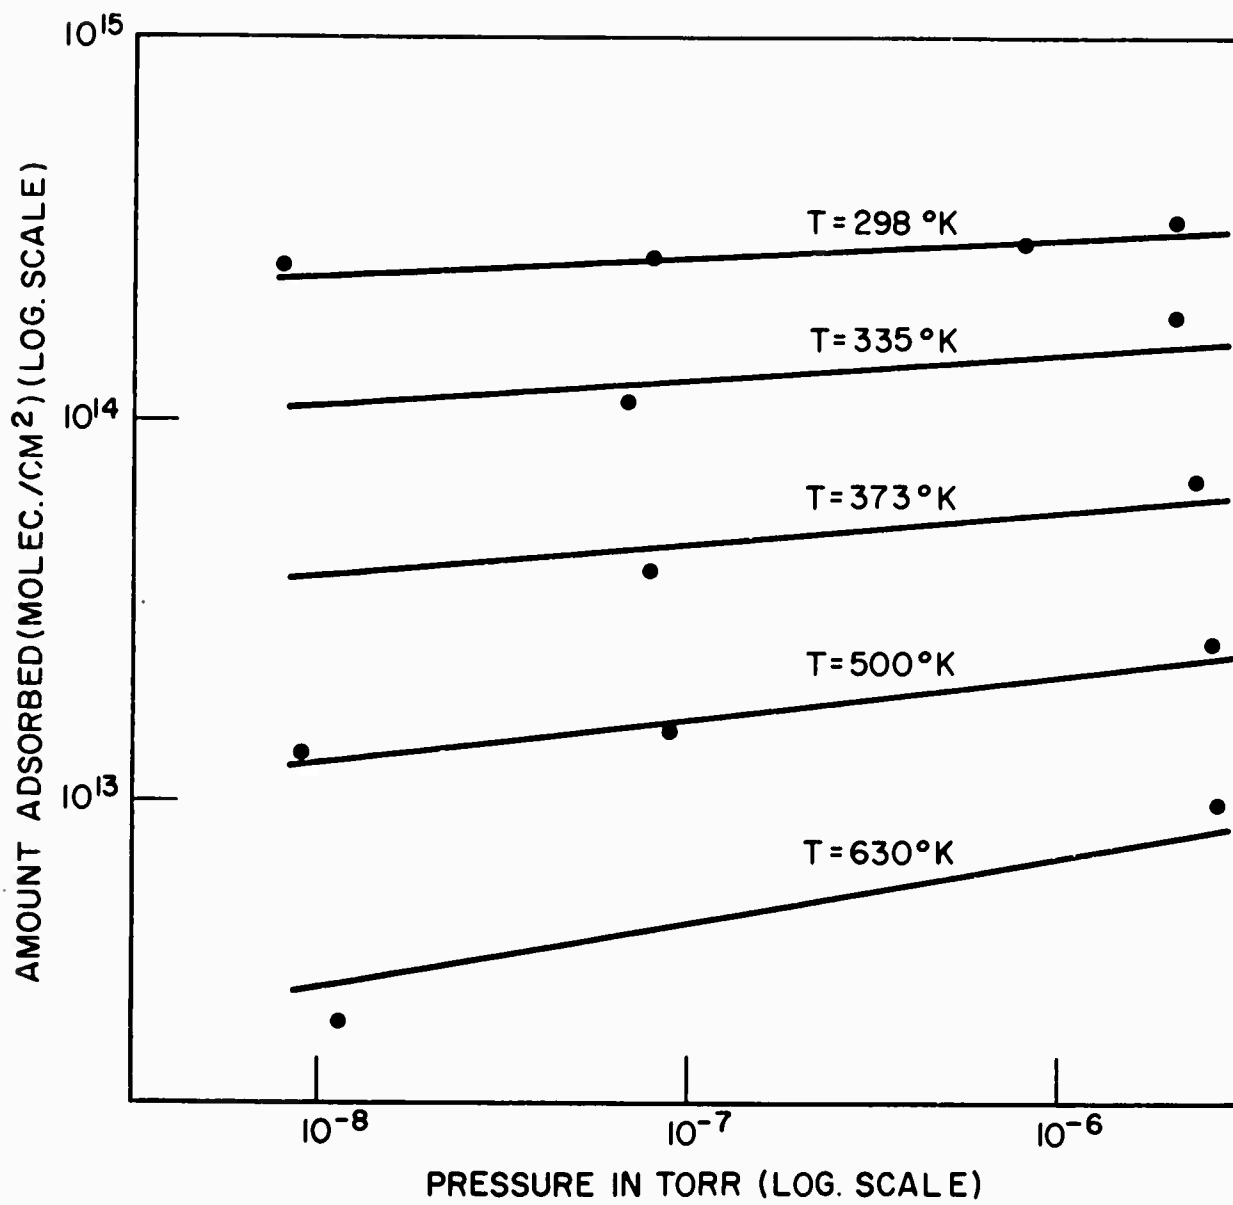
Fig. B-7 - Hydrogen adsorption on high-purity iron as functions of gas pressure and filament temperature.

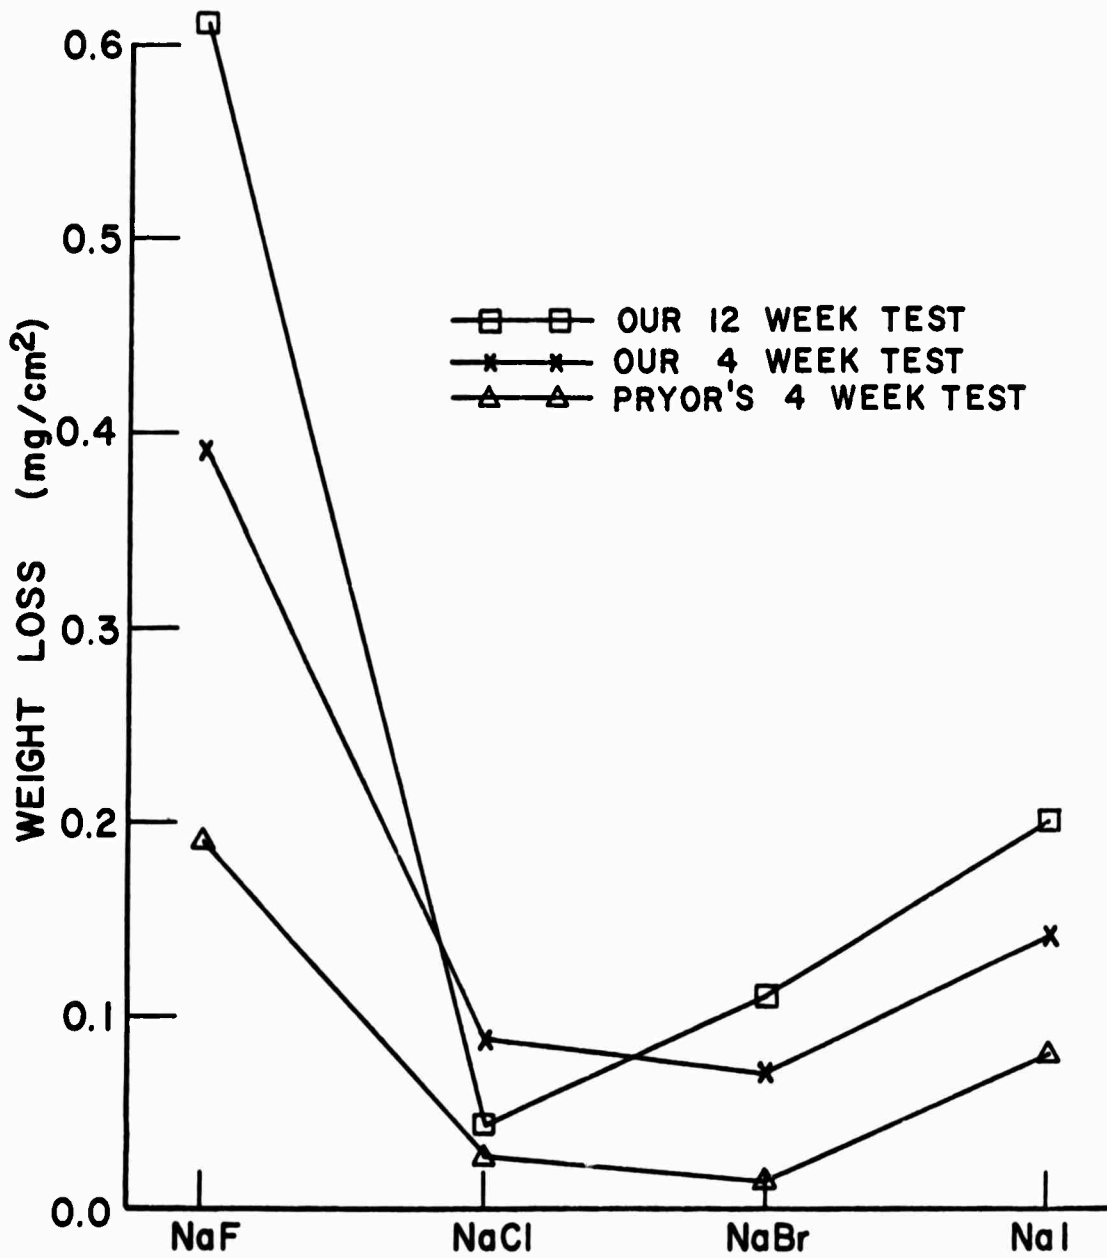
Fig. C-1 - Weight losses of aluminum alloy 1199 in 1.0 N solutions of sodium salts.

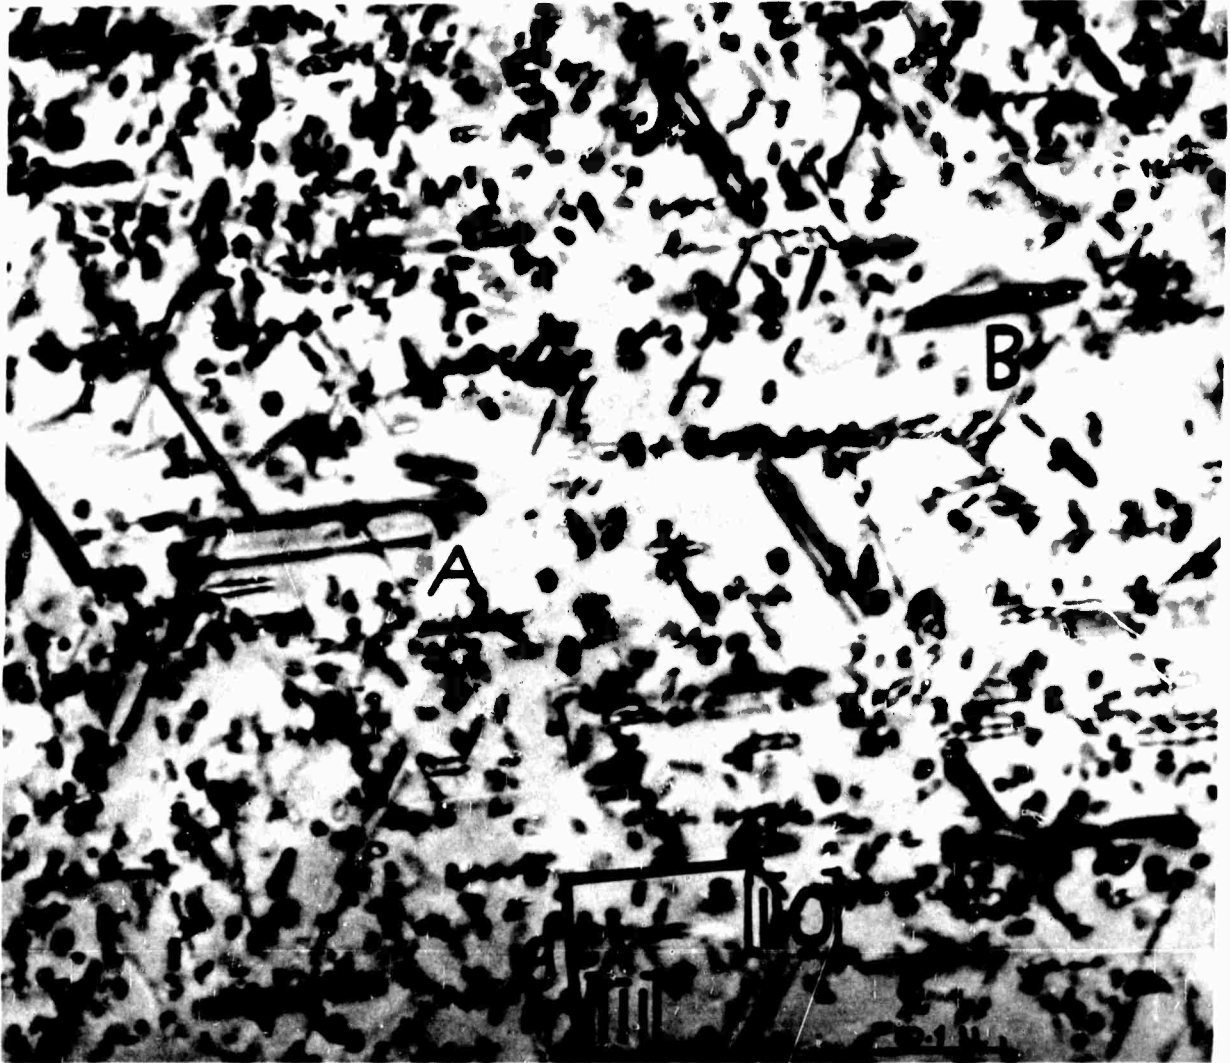
A. Dislocation ring contrast

B. Strain field contrast

Fig. C-12 - The precipitate morphology observed after aging for 80 hours at 135°C.

Figs. C-12 and 13 show the $\{111\}$ plane of a specimen aged for 80 hours at 135° C. The precipitate morphology is very complex. Approximately fifty percent of the precipitates seem to be lath shaped while the remainder are not characterized by any well-defined geometry. In Fig. C-12 several large precipitates which lie in the plane of the foil, e.g., at A (this is a type 1 precipitate), show dislocation ring contrast, while precipitates at B in Figs. C-12 and 13 exhibit well-defined strain fields with the line of no contrast perpendicular to \bar{g} . This indicates that these precipitates possess a coherent or partially coherent interface.

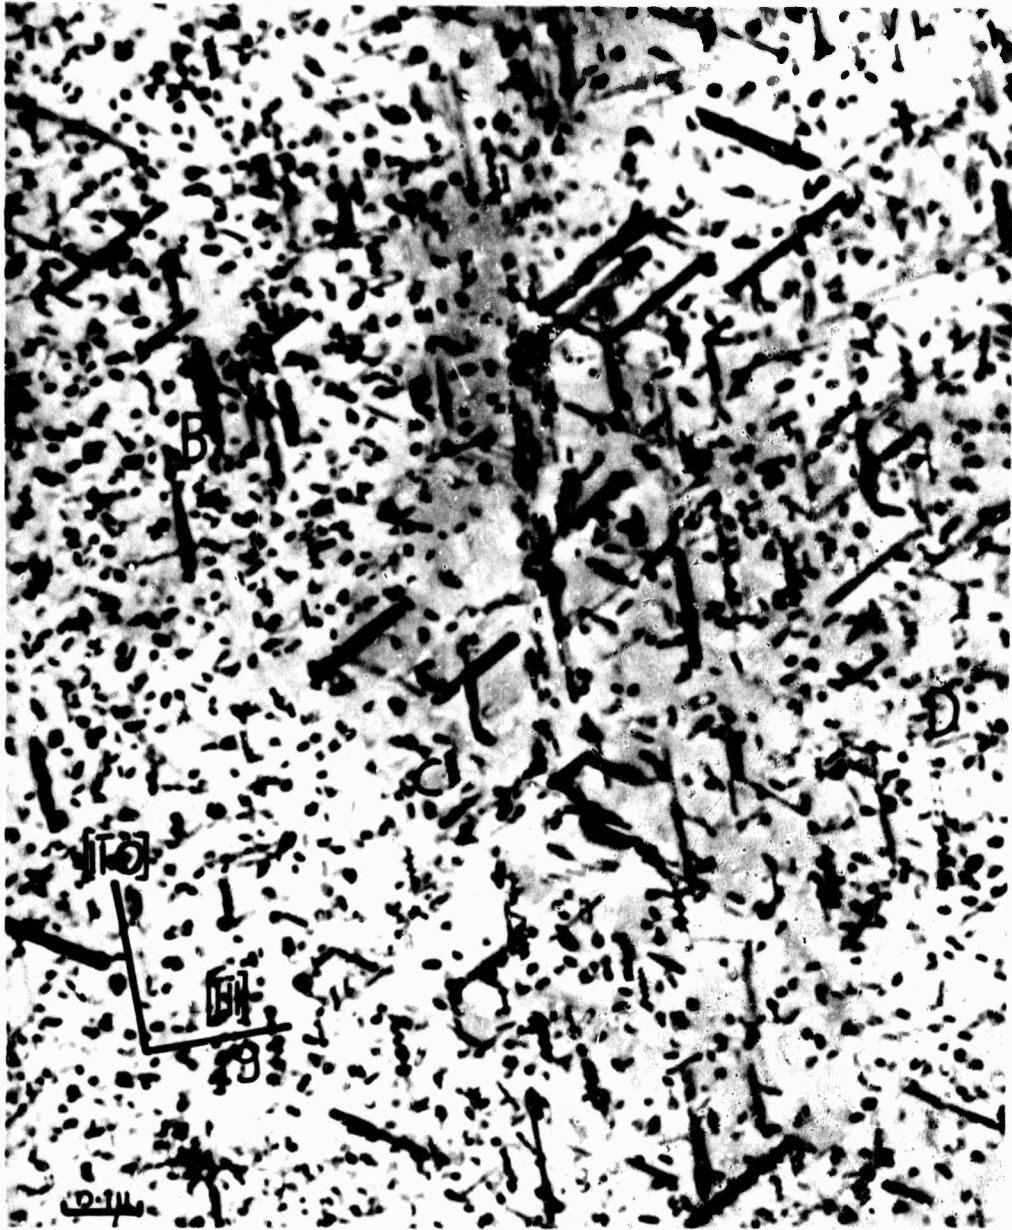
C. Displacement fringe contrast of type 1 precipitates

Fig. C-13 - The precipitate morphology observed after aging for 80 hours at 135° C.
