Permafrost
erosion
along the
Beaufort Sea
coast

FRESHWATER EROSION ALONG THE BEAUFORT SEA COAST
(U)

Robert L. Lewellen

Technical Report: Lewellen, (ONR-382:1)

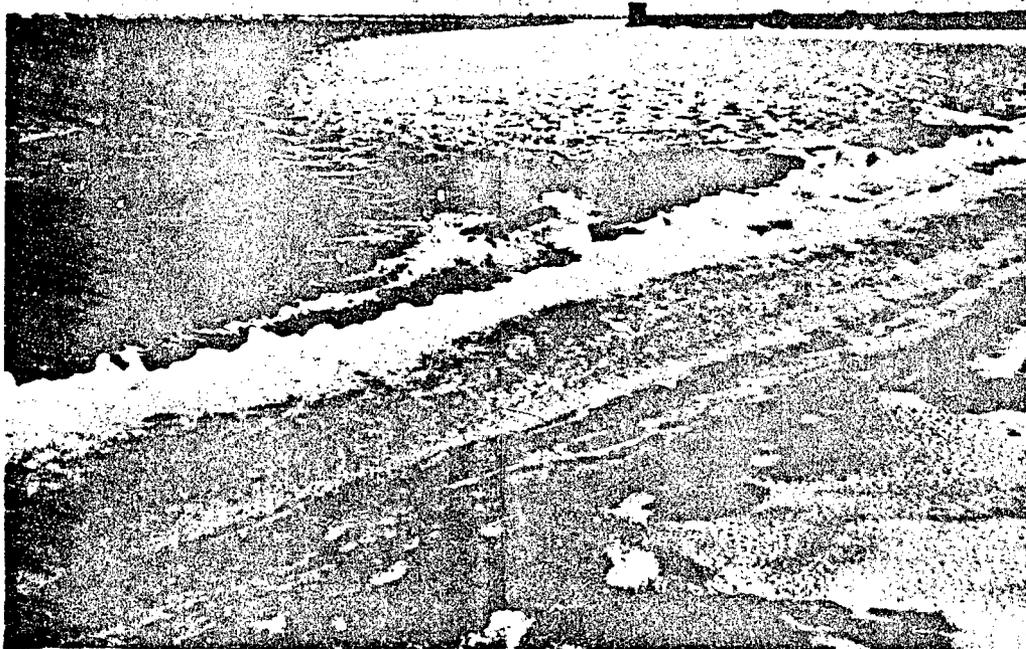
Fig. 34. Frazil ice and freezing spray accumulating along the western shore of Imikpuk Lake, Barrow, Alaska (27 September 1966). This lake is the fresh water supply for the Barrow Naval Camp. The water collection point is marked by the small building in the background of the photograph. Generally, the waves propagate about 10 to 15 meters (33 to 50 feet) into the strands of frazil ice before the waves are completely damped.

In the shallow areas around the island, the ice begins to decay during the first part of June. By late September, skim and frazil ice can form which helps to protect the shore from further wave action (Figs. 18 and 34). The 1968 Flaxman Island aerial photography mission was flown on 21 October. The Beaufort Sea was covered with frazil ice. The lagoon between Flaxman Island and the mainland was frozen over by 21 October; approximately three centimeters (one inch) of snow was overlying a few centimeters of ice. The lagoon began to freeze on 23 September. Between 23 September and 21 October westerly winds of 21 kilometers per hour (13 miles per hour) predominated. However, the fastest velocity was about 61 kilometers per hour (38 miles per hour) from the east. Air temperatures were always below freezing for the 29 day period preceding the photography mission. The lowest air temperature was about -16°C (4°F). Freezing degree-days are used to compare the magnitude and duration of freezing air temperatures. The freezing degree-days for one day are computed by subtracting 0°C (32°F) from the average daily air temperature. The accumulation or summation of freezing degree-days for a period of time gives the freezing index for that period. Normally, by 21 October, only 156°C-days (281°F-days) have accumulated for the Flaxman Island area. However, by 21 October 1968, 182°C-days (327°F-days) had accumulated. The greater freezing index for 1968 indicates a more abrupt halt to thermal erosion and a more rapid freeze-up environment for the year.
