(STATUS REPORT NO. 2)

← PILE EXTRACTION TESTS

FAIRBANKS RESEARCH AREA

SNOW ICE AND PERMAFROST  
RESEARCH ESTABLISHMENT  
Corps of Engineers  
U. S. Army  
1215 Washington Ave.  
Wilmette, Illinois

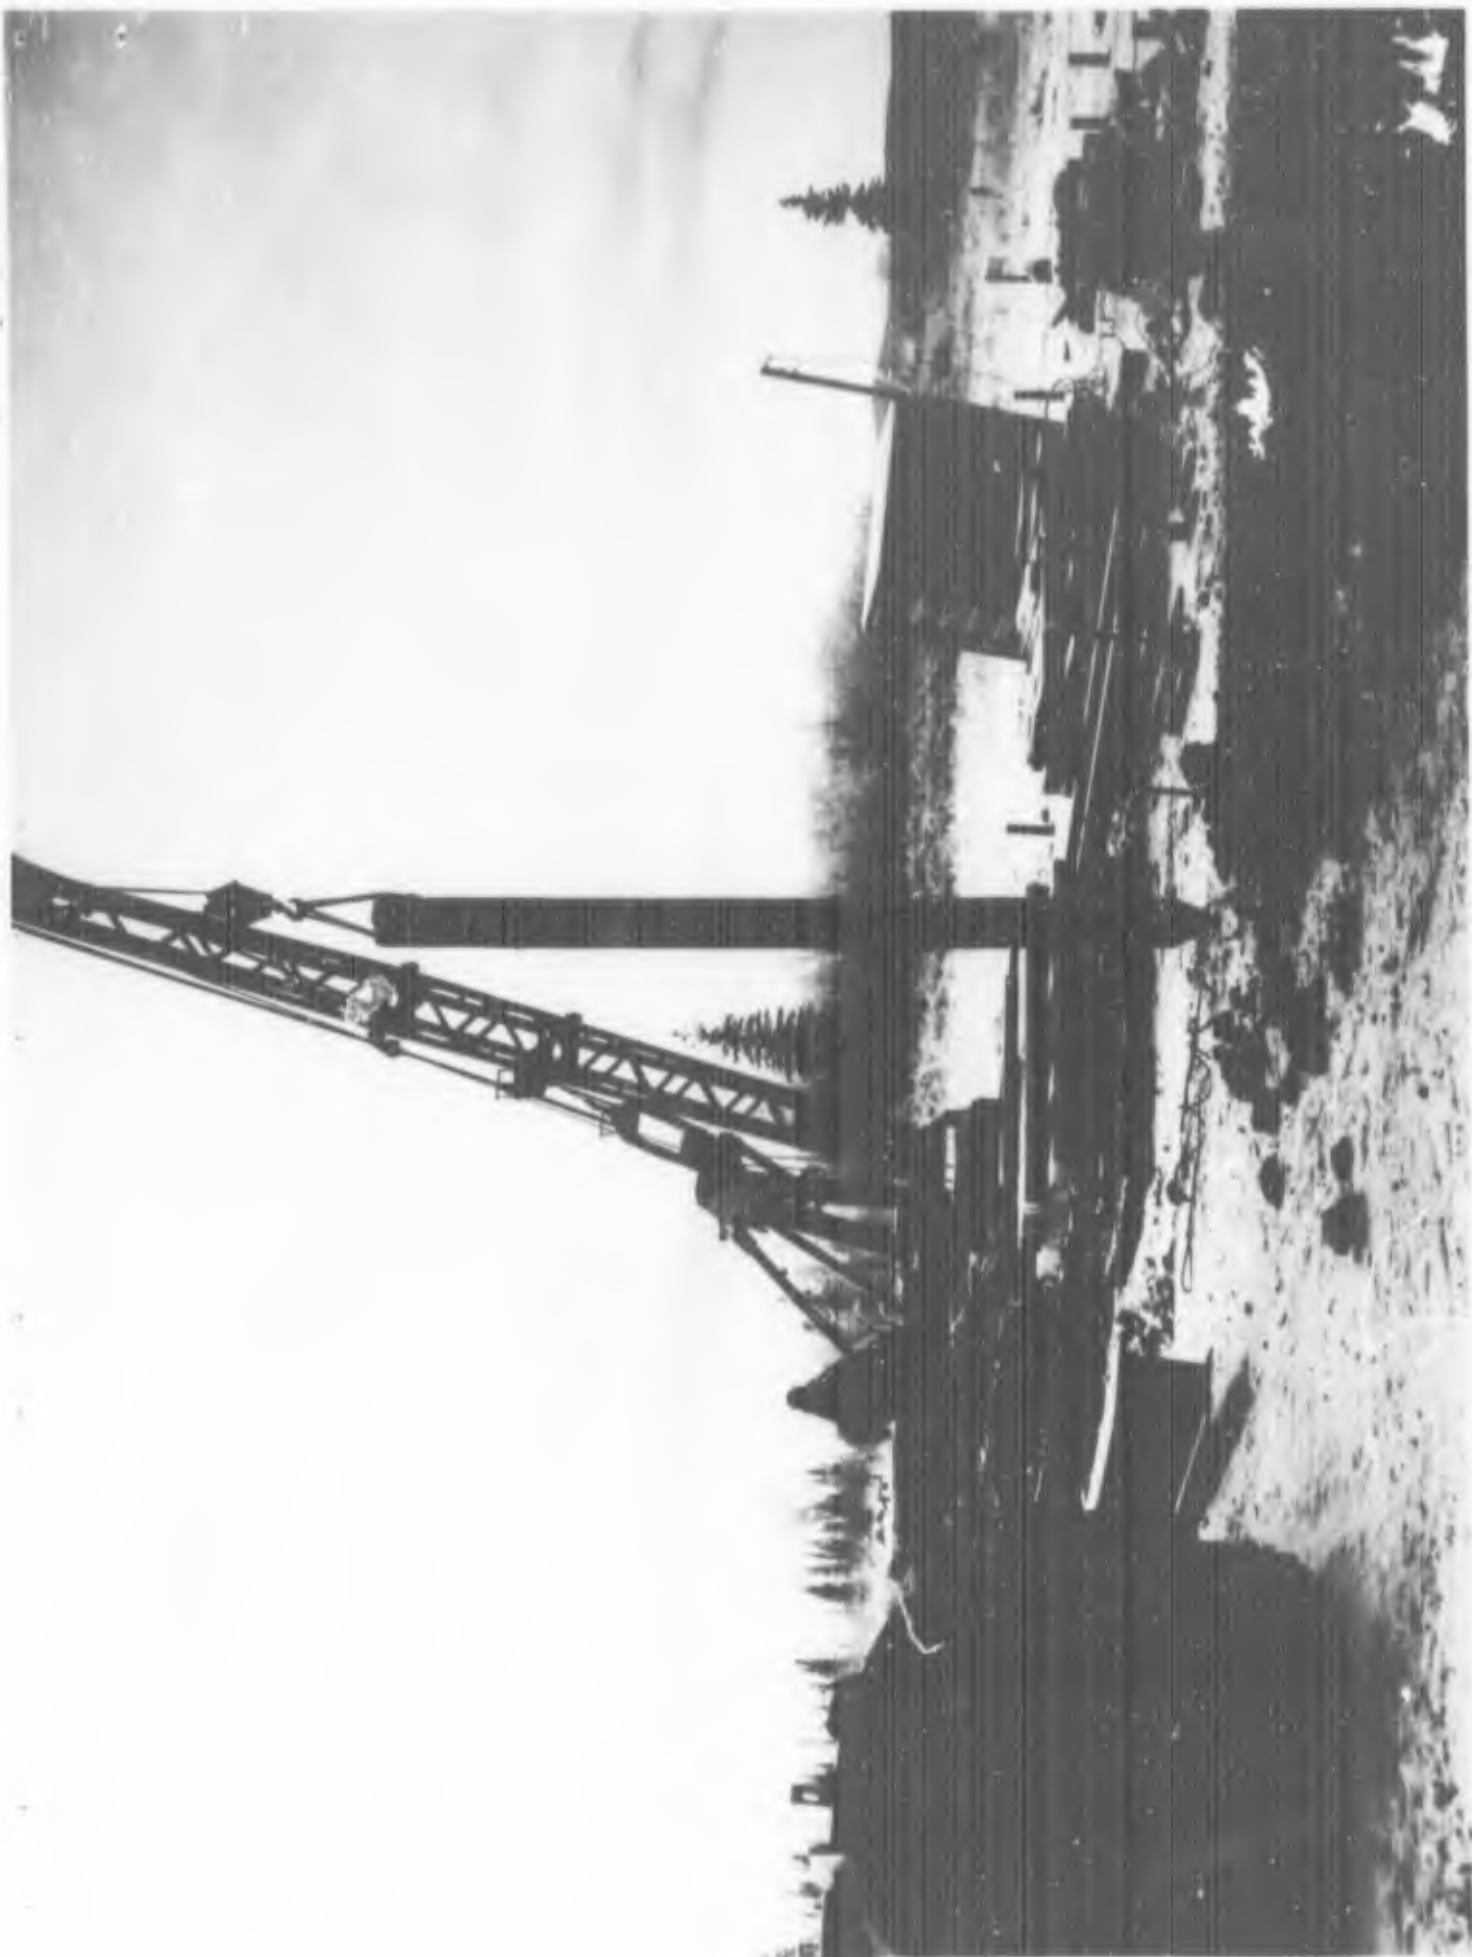
Photo 1

- Photo No. 1 PSB-92D-102. View showing complete removal of concrete pile B-16 following extraction test in Site B, Subarea No. 4
- Photo No. 2 PSB-92D-57. Concrete pile No. A-13 in foreground with other piles in background
- Photo No. 3 PSB-92D-60. Pile No. A-13, subsequent to failure showing pulling arrangement. Note total vertical movements shown between chalk marks on pile
- Photo No. 4 PSB-92D-174. View showing heated inclosure for Ames Dials to prevent frosting of dial plungers (I-beam pile No. 25)
- Photo No. 5 PSB-92D-65. Close-up of pipe pile No. A-20 showing structural failure of pile
- Photo No. 6 PSB-92D-51. View, looking north, of pile No. A-12 showing reinforcing steel after extraction test
- Photo No. 7 PSB-92D-100. Bottom concrete pile B-16 after complete removal. Note light spot near rule does not show any discoloration from contact with soil.
