Special Report 163

SNOW SURFACE EROSION FROM A PERIPHERAL JET CUSHION ACV

Gunars Abele and William H. Parrott

October 1971

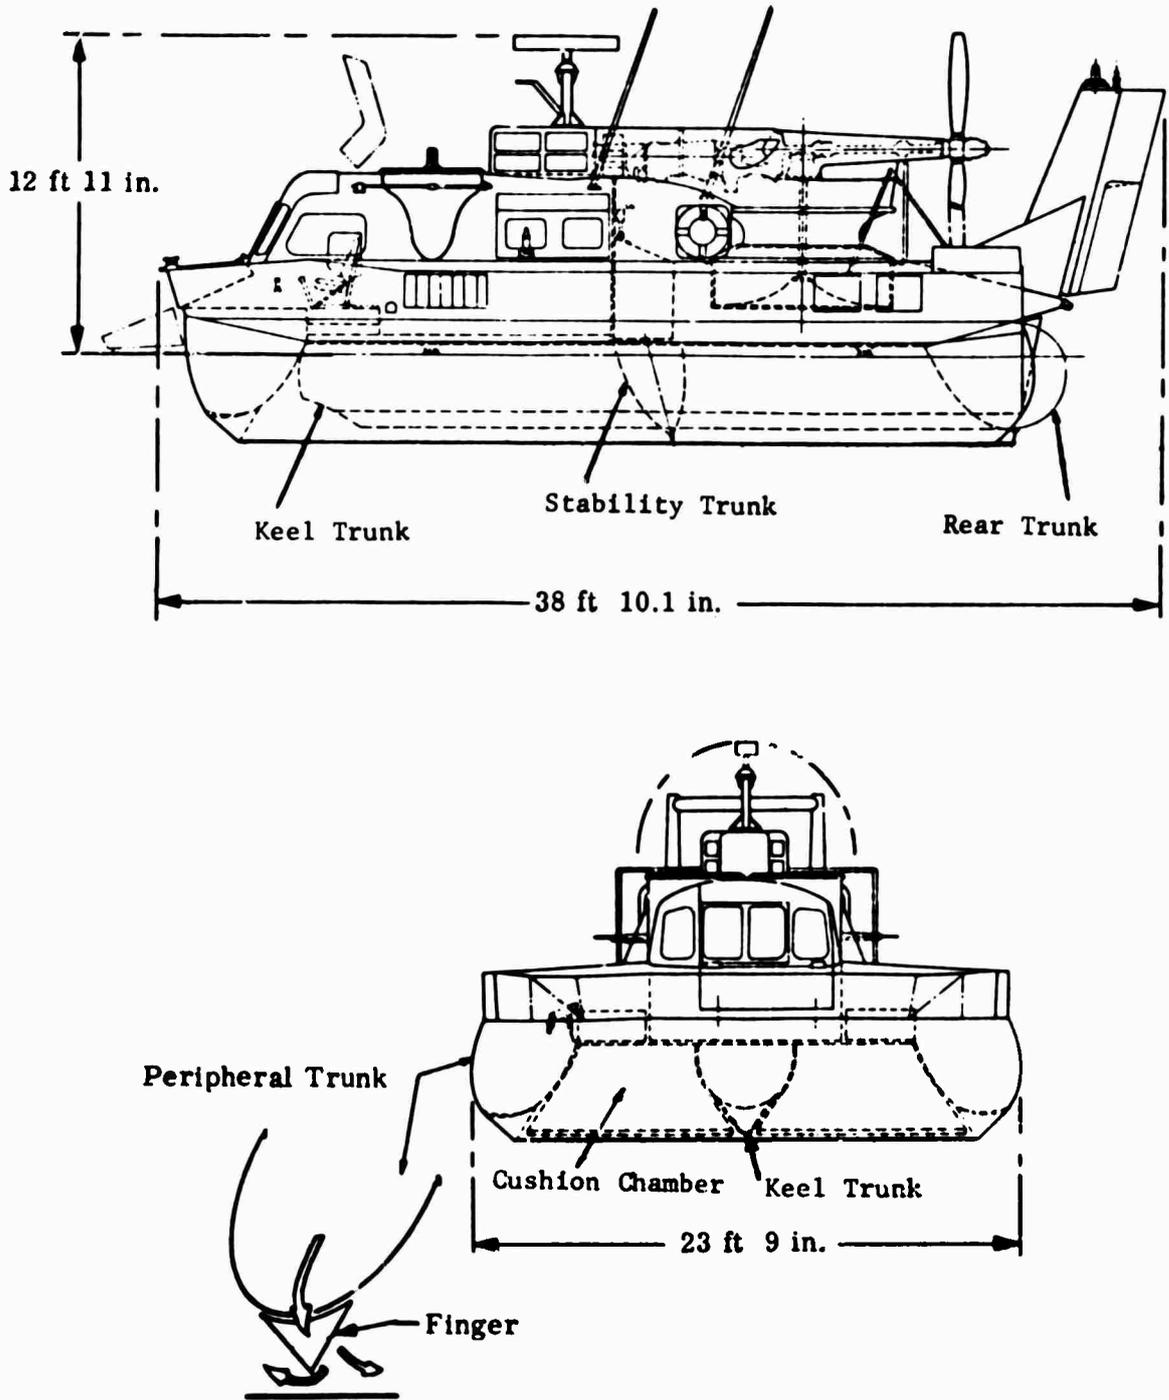
Figure 1. Test vehicle, SK-5 ACV.

The test vehicle was a Bell SK-5 ACV, previously used by the U.S. Army in South Vietnam (Fig. 1, 2). The vehicle utilizes a trunked peripheral jet cushion system. The flexible peripheral skirt or trunk is inflated by the air flow from the lift fan; the air is then directed through holes in the bottom of the skirt downward along the fingers (Fig. 1), filling the cushion chamber and maintaining an air curtain around the bottom of the cushion. The rear trunks are equipped with abrasion strakes instead of fingers.

The gross weight of the vehicle during the tests was approximately 14,000 lb, resulting in a mean cushion pressure of approximately 28 lb/ft² (0.2 psi).

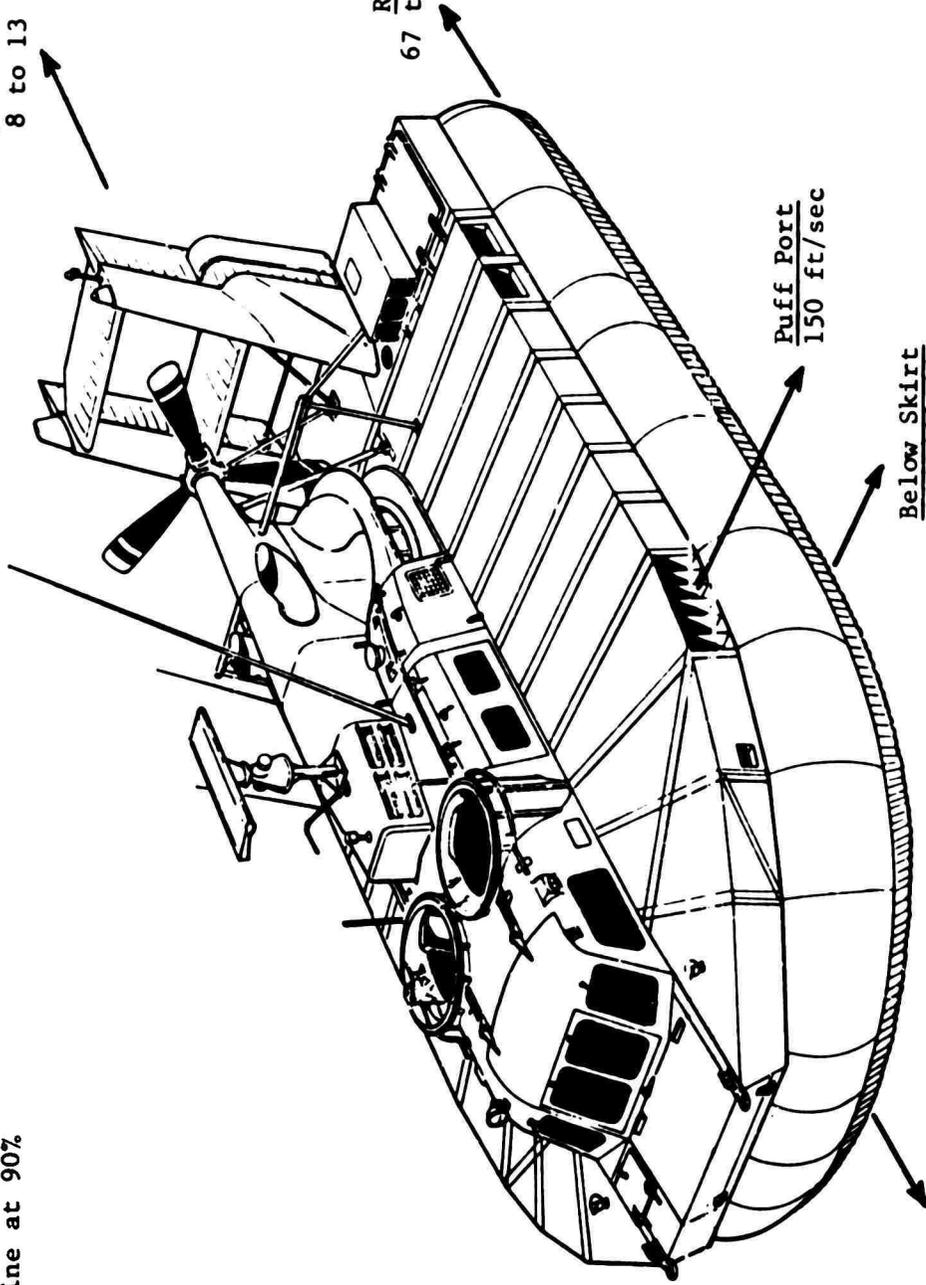
Gross Weight: 7 tons
Mean Cushion Pressure: 28 lb/ft² (0.2 psi)
Power Turbine at 90%

Prop Wash
(3 ft behind vehicle)
8 to 13 ft/sec

Rear Trunk
67 to 83 ft/sec

Puff Port
150 ft/sec

Below Skirt
75 to 117 ft/sec

Below Skirt
67 ft/sec

Figure 2. Air escape velocities from test vehicle.

The air escape velocities at various locations around the vehicle are shown in Figure 2. The air velocity through the puff ports, or through a hole in the skirt, was 150 ft/sec. The maximum observed escape velocity below the skirt was 117 ft/sec and the lowest was 67 ft/sec. The mean value for the peripheral skirt was approximately 100 ft/sec. A considerable volume of air escapes through the opening between the peripheral skirt and the rear trunk at a velocity of 70 to 80 ft/sec. These measurements were obtained during a full cushion condition, power turbine at 90%, on a hard, snow-covered pavement.

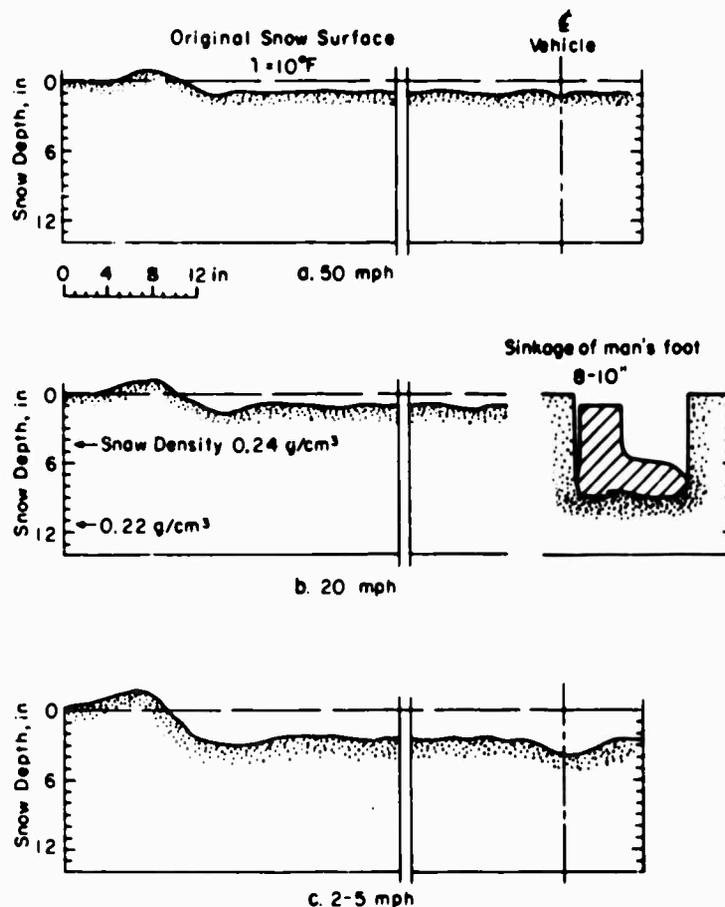
Figure 5. Deformation of soft snow surface, various vehicle speeds.

A comparison of the extent of deformation of a soft snow surface for various vehicle speeds is shown in Figure 5. The snow for the top 6 to 8 in. was quite loose, having a density of 0.24 g/cm^3 . Snow thickness was 14 in.

At 50 mph the erosion below the peripheral skirt (fingers) was not much more than 1 in.; the depression below the vehicle was about 1 in. or less (Fig. 5a). At 20 mph, the erosion was slightly deeper, almost 2 in. below the skirt and $1\frac{1}{4}$ in. below the cushion (Fig. 5b). At 2 to 5 mph, the erosion was approximately 3 in. below the skirt and $2\frac{1}{4}$ in. below the cushion (Fig. 5c). The keel trunk left a definite groove at lower speeds; occasionally it could also be detected at 50 mph.

There was a tendency for some of the "excavated" snow to fall back into the groove eroded below the skirt after the vehicle passed; therefore the actual erosion below the skirt may have been slightly deeper than shown in Figure 5.

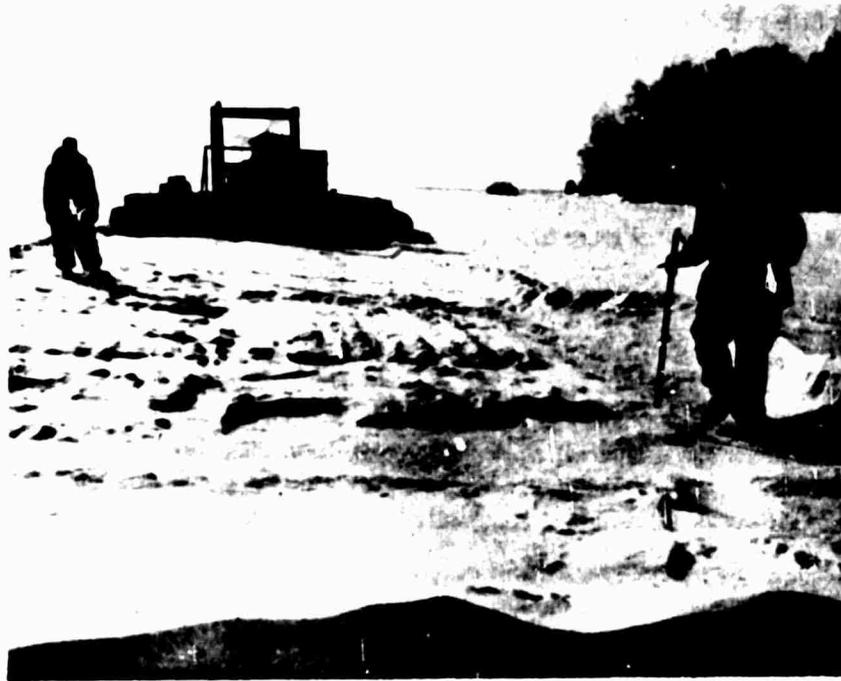
Figure 6. Erosion of soft snow surface, hovering time 15 seconds.

Figure 7. Erosion of soft snow surface, hovering time 30 seconds.

Figure 8. Erosion of soft snow surface, hovering time 1 minute.

Figure 9. Erosion of soft snow surface, hovering time 2 minutes.

Typical results of hovering the test vehicle over adjacent soft snow surfaces for periods of 15 seconds, 30 seconds, 1 minute and 2 minutes are shown in Figures 6-9. The sinkage of a man in this test area was 12 in. or more. It is apparent that the only significant erosion of the snow surface occurred below the peripheral skirt and the rear bags. The depression of the snow surface below the cushion chamber was relatively shallow, 2 to 3 in. Again, it was not clear how much of the snow below the cushion chamber was actually removed by air movement.

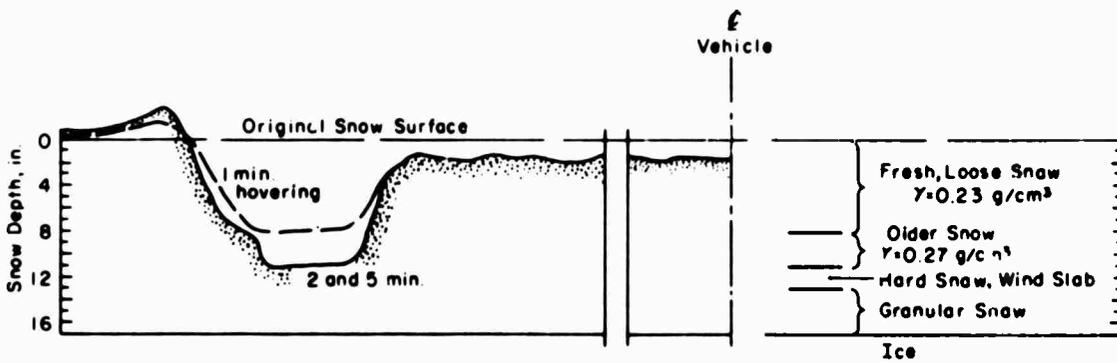
Figure 13. Cross section of snow surface erosion during hovering.

An 8-in.-thick top layer of soft, loose snow (density 0.23 g/cm^3) was eroded by the escaping air below the peripheral skirt in 1 minute or less (Fig. 13). After a total hovering time of 2 minutes, the erosion process had continued through the next layer, 3 in. thick, of more cohesive, slightly harder snow and stopped at a hard snow layer, a windslab. Continued hovering did not result in any additional measurable erosion. Measurements of the erosion where the test vehicle had hovered for 5 minutes were essentially the same as those where it had hovered for 2 minutes. The depth of the depression below the cushion was approximately 2 in. Total snow depth at this test location was approximately 17 in.

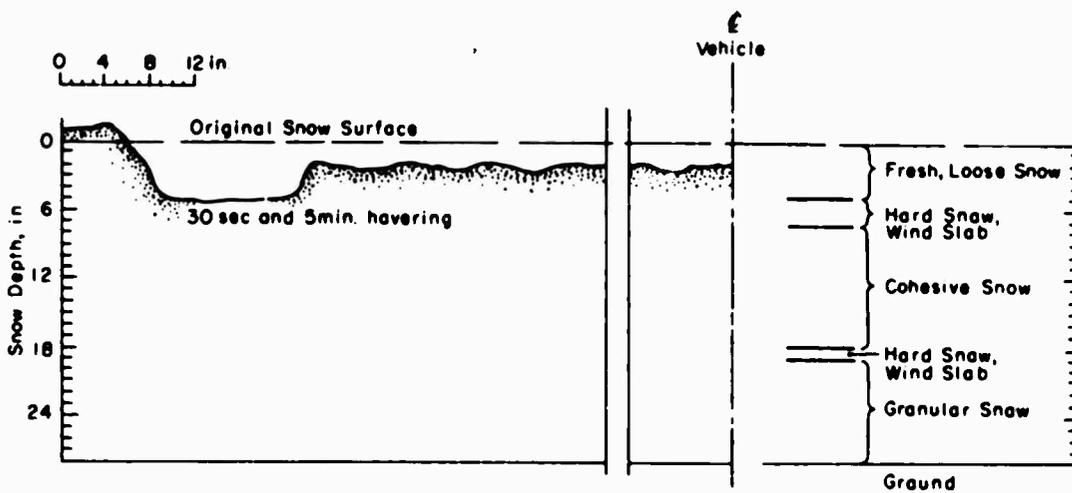
Figure 14. Cross section of snow surface erosion during hovering; deep, layered snow.

At another location (Fig. 14) with a total snow depth of 28 in. the top soft snow layer, 5 in. thick, was eroded in 30 seconds or less. The very cohesive hard snow (windslab) layer with a density of 0.3 to 0.35 g/cm³ could not be penetrated with the peripheral air jet curtain of this test vehicle; there was no increase in erosion after 5 minutes of hovering. The depth of the depression below the cushion was 2-2½ in.

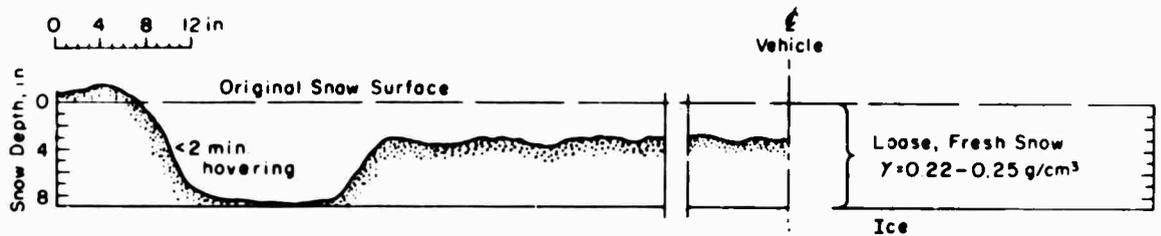
Figure 15. Cross section of snow surface erosion during hovering; shallow, soft snow.

In a shallow, soft snow area, the total 9-in.-thick snow cover was eroded below the peripheral skirt in less than 2 minutes (Fig. 15). Depression below the cushion was 3-3½ in. deep.

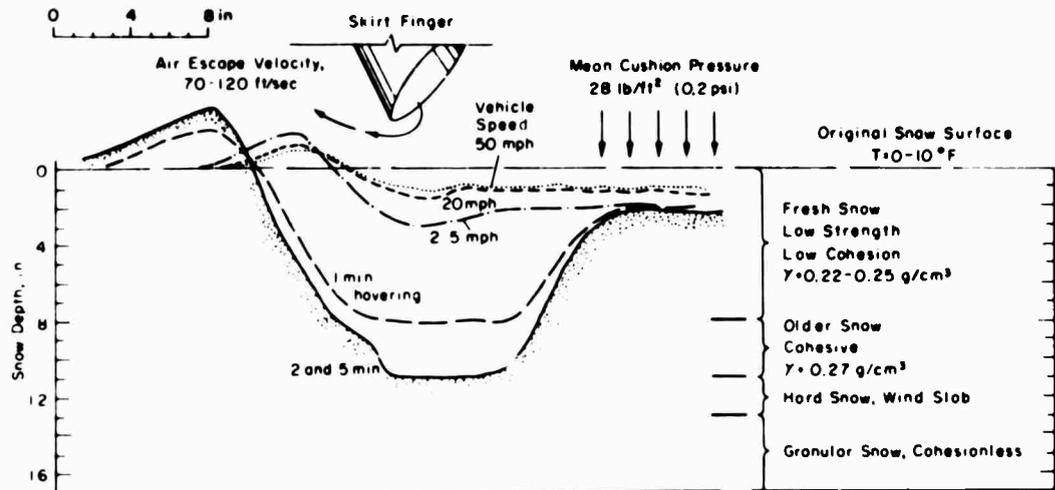
Figure 16. Cross sections of typical erosion patterns in snow below peripheral skirt.

The typical erosion profiles observed during travel (Fig. 5) and hovering (Fig. 13) on soft snow are compared in Figure 16. For comparison purposes, the 5-mph travel speed is roughly equal to a hovering time of 3 seconds for this particular test vehicle.

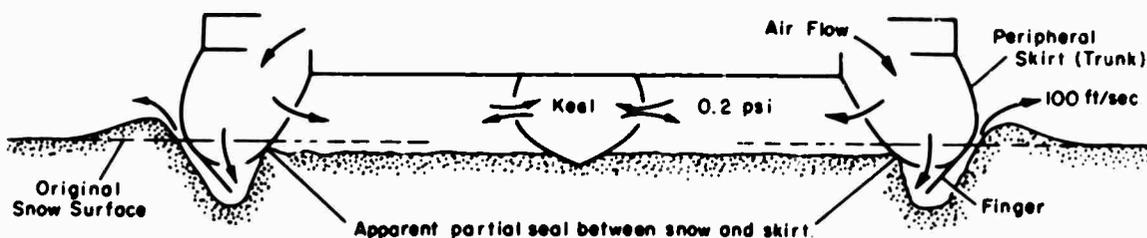
Figure 17. Cross section of trunked peripheral jet cushion type ACV hovering on soft snow.

Measurements of the erosion features in the soft snow revealed the interesting possibility that as the vehicle settles downward due to erosion below the peripheral skirt during hovering, a seal may form between the inner face of the bag-type peripheral skirt, above the fingers, and the snow (Fig. 17). This condition would most likely limit erosion of the snow below and would arrest further settling of the vehicle, since the cushion chamber, which supports the vehicle, is then fairly well or at least partially sealed by the skirt-terrain contact instead of by the air curtain. The cushion air supply is replenished through the openings in the inner face of the peripheral skirt (see Fig. 17).

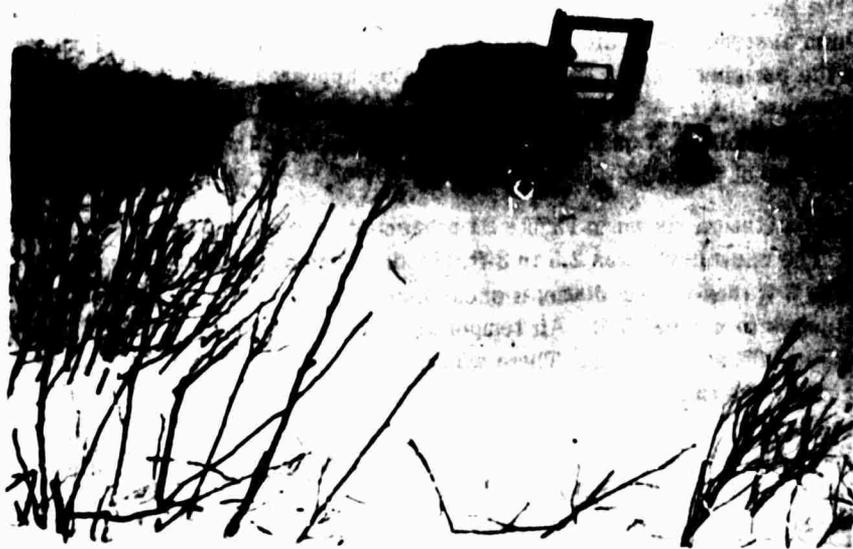
Figure 19. Test vehicle proceeding forward onto undisturbed soft snow surface.

Figure 18 shows the vehicle after several minutes of hovering in the deep snow area described above. Note the complete absence of snow spray. The limit of erosion on this terrain for this particular vehicle at that particular spot had apparently been reached. As soon as the vehicle started to proceed forward on a fresh, undisturbed snow surface, a snow cloud was produced (Fig. 19).
