SSC-223

COMPRESSIVE STRENGTH OF SHIP
HULL GIRDERS
PART II
STIFFENED PLATES

Final Report
on
Project SR-193, "Small Hull Girder Model"
to the
Ship Structure Committee

H. Becker, A. Colao, R. Goldman, and J. Pozerycki
Sanders Associates, Inc.

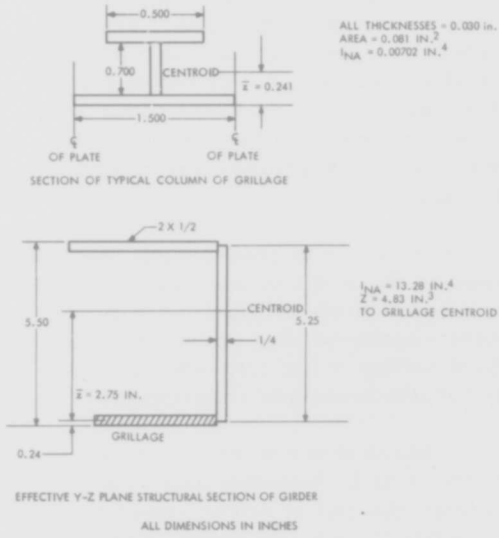
Fig. 1 - Properties of Grillage and Girders

Typical sections and corresponding section properties appear in Fig. 1. The stiffener design details were developed by rational analysis using Vasta's charts (Ref. 2) as a guide. The geometry for each of the seven grillages of this investigation is shown in Fig. 2. Three of the grillages were integrated into the three-bay girder. The other four were tested under various load conditions. An impression of an assembled grillage may be gained from the top views of the 3-grillage array which was tested in the girder investigation (Fig. 3).

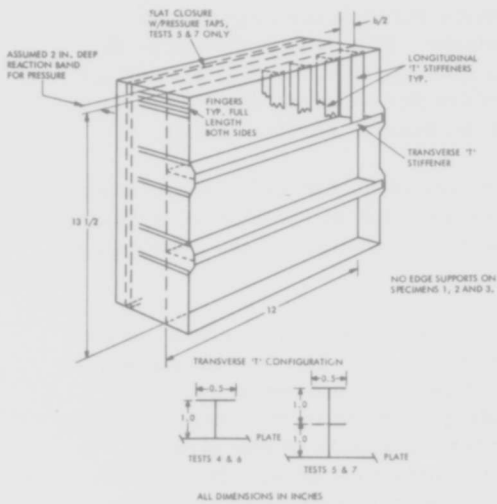
Fig. 2 - Typical Grillages, and Support Structures for Individual Grillage Tests

The internal pressure during tests 5 and 7 reacted against the grillage plate over a band estimated to be effectively 2 in. deep (Fig. 2). The vertical force from the 10 psi internal pressure would have been 240 pounds since the two grillages were 12 in. wide. Over the vertical edges the force along 13.5 in. length of the plate would have been 270 pounds. The result of each of these loads would have been a small tension force counteracting the compression from the loading heads. Therefore, the values were subtracted from the total applied loads after computing the machine-induced stresses.

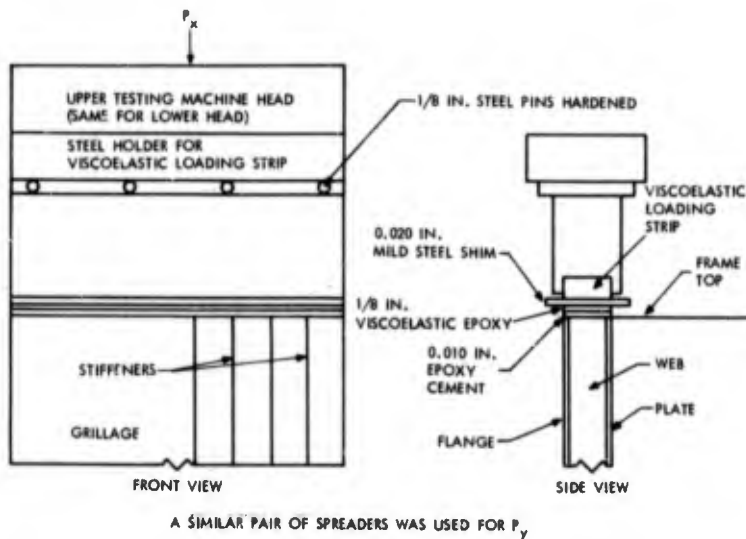
Fig. 4 - Load Spreaders for Grillage Tests

All the test specimens were loaded in the 25,000 pound testing machine, described in Part 1. Longitudinal compression was applied directly by the crossheads of the machine through load spreaders typical of those used to achieve uniformity. Fig. 4 is a sketch of the spreader system used for longitudinal load application (N_x) as well as the device used to achieve load uniformity for N_y from the 4,000 pound machine, which also was employed in the biaxial studies of Ref. 1.

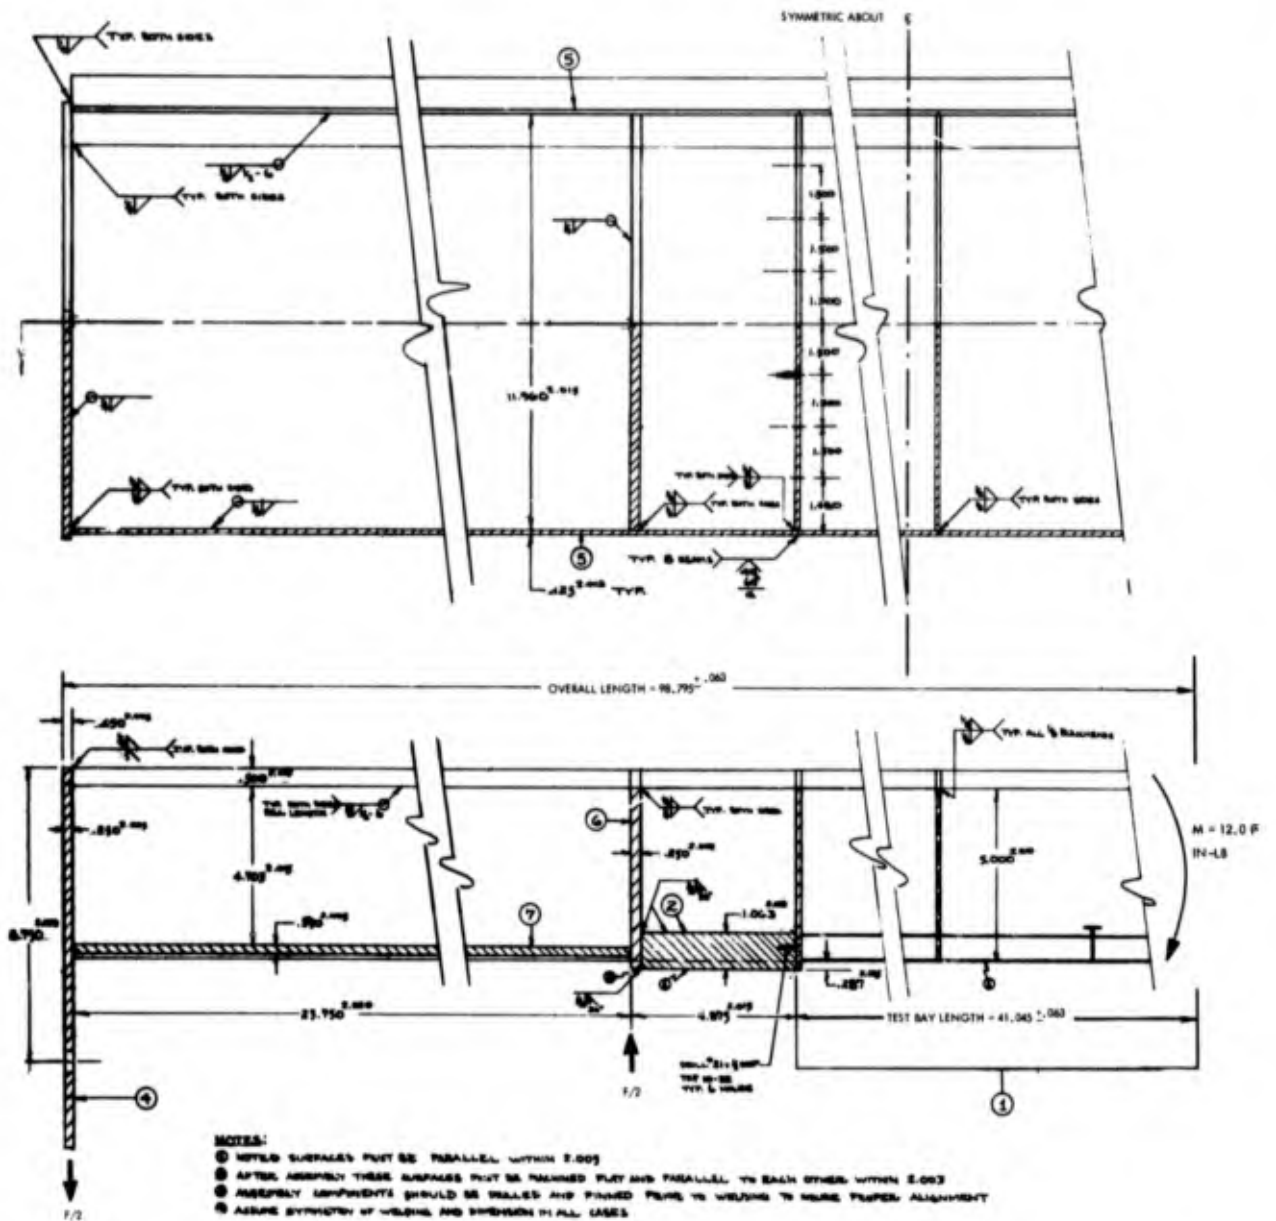
Fig. 5 - Girder Arrangement Drawing

A small-scale reproduction of the structural arrangement drawing for the girder experiment appears in Fig. 5. The machine load, F , was halved to each end of the girder. The reactions were 24.0 in. inside the loading tabs so that the bending moment in the center region was $(12.0)F$ in.-lbs. (Fig. 5). The internal details of the girder construction were designed to induce as uniform a stress distribution as possible within a practical length before introduction to the outermost edges of the 3-grillage test region. Photographs of the test arrangement are in Fig. 6.

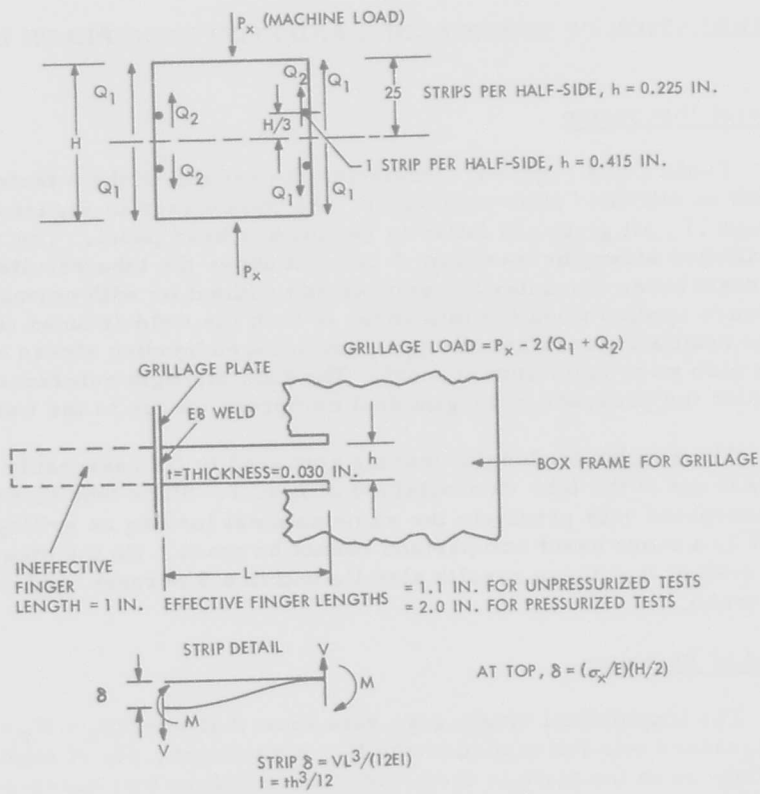
Fig. 7 - Behavior of Grillage Edge Supports

The plate edges parallel to the stiffeners were supported normal to the plane of the plates by fingers welded to the plate and continuous with the back structure of each of the support frames. The amount of longitudinal load which could have been supported by all the fingers was less than 5 percent if both edges of each finger were built-in (Fig. 7) for those on the grillages of tests 4 and 6 on which the finger lengths were 1.1 in., while it was less than 0.8 percent for 5 and 7 on which the fingers were 2.0 in. long. This was determined by a straightforward analysis of the finger system as a series of beams which deflected vertically by an amount dependent upon the nominal axial stress in the grillage and proportional to the distance on either side of the midplane transverse to the stiffener direction. The basis for the analysis appears in Fig. 7.

The above values for the maximum amount of finger load probably were too high since completely built in edges were unlikely at the plate-finger attachments. The exact amount would have required an extensive series of measurements on the grillage framing structure and some theoretical interpretation of the results. The framing structure-finger-grillage system is complex. Furthermore, load redistribution occurred within the grillage structure at about 60 percent of failure in all cases. Consequently, the precise value of finger load would have been indeterminate to some extent in spite

of such analyses. It is estimated that the fingers carried 3 percent of the applied longitudinal load on tests 4 and 6, and no longitudinal load on tests 5 and 7.

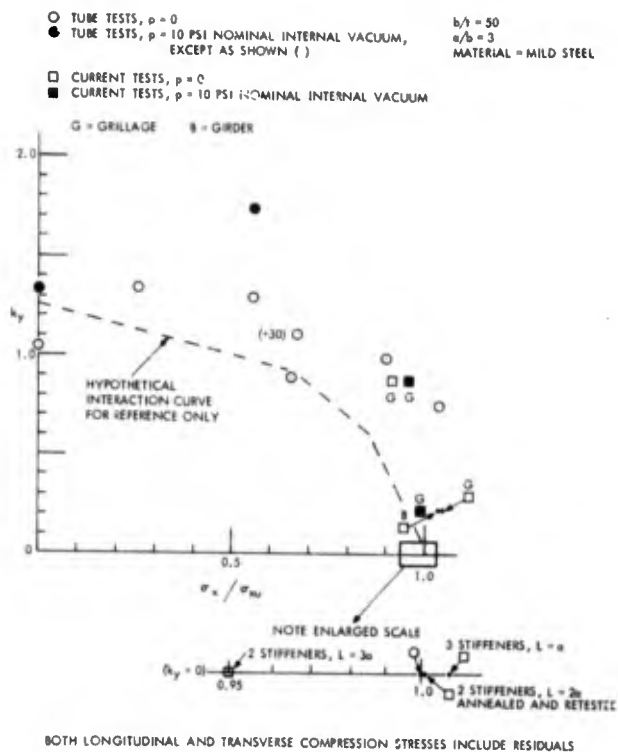
Fig. 8 - Comparison of Unstiffened and Stiffened Plate Data

Table 2 and Figure 8 summarize the results of the 8 tests conducted on stiffened plate structures. As can be seen in Figures 9 through 11, all grillages failed in the loading head panel. The range of stiffened strengths was from 7 percent above the tube results to 1 percent below for uniaxial compression without or with normal pressure applied when the influences of both the weld-induced transverse residual stress and the pressure-induced bending stress on the plate side were taken into account. The tube strength reference test included the presence of longitudinal compression due to the welding.

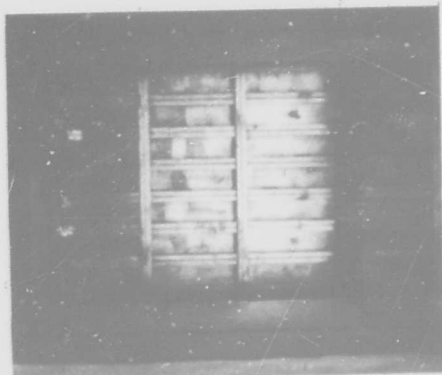
Fig. 11 - Girder Failure, Which Occurred in First Panel of Left End Grillage (Reinforcing Plates Were Removed to Obtain This View).

One of the grillages with permanently-buckled and reflattened plates was that in which failure occurred during the girder test. (In fact, several reworked plates were in the end panel where the girder failure was observed). In order to assess the possibility of girder strength loss if that grillage were to be used, a 2-panel-length segment of specimen 2 was flattened and annealed for retest. Permanent buckling had occurred in those two panels during the initial

The failure stress at the centroid of the grillage was 3.7 percent above the tube value which is within the range of scatter for the tube test data, and is of the same magnitude as the total experimental error. The strain gages showed a peak plate strain of 638μ at 7750 pounds of machine load (above the tare of 250 pounds at which the zero readings were taken). The corresponding linear extrapolation to failure at 12,700 pounds, with $E = 29.2$ msi, yields $\sigma = 30.53$ ksi, or 0.2 percent above the tube value. It is conceivable that the intermittent $1 \times 1/2$ framing bars at the upper flange may have contributed to this difference between the calculated strength and the strain-extrapolated strength. The flange strains were in approximately the same proportion to the plate strains as the distances from the neutral axis when the stresses were elastic. This might indicate a slightly higher effective section moment of inertia than given in Fig. 1. It also would appear to indicate the use of the distance to the plate centroid instead of to the grillage centroid in calculating the section modulus.

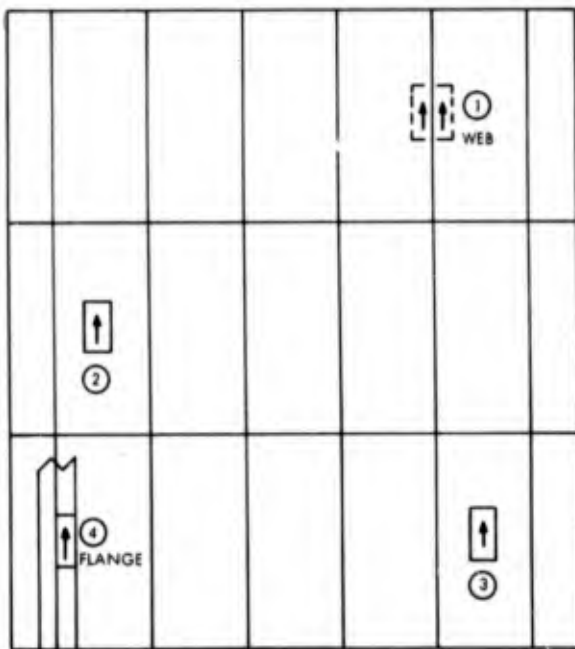
Fig. A-1 - Specimen 4, Strain
Gage Locations

The sketches in Figures A-1 through A-5 depict the strain gage locations. Strains are summarized in Tables A1 through A5.

Strain Gages: EA 0.06 - 125 BIT ·
120 Micro-Measurements
All Back-to-Back on
All Grillages
