# **LONG-TERM STORABILITY OF PROPELLANT TANKAGE**

**TECHNICAL REPORT AFRPL-TR-71-113**

**NOVEMBER 1971**

**AIR FORCE ROCKET PROPULSION LABORATORY**

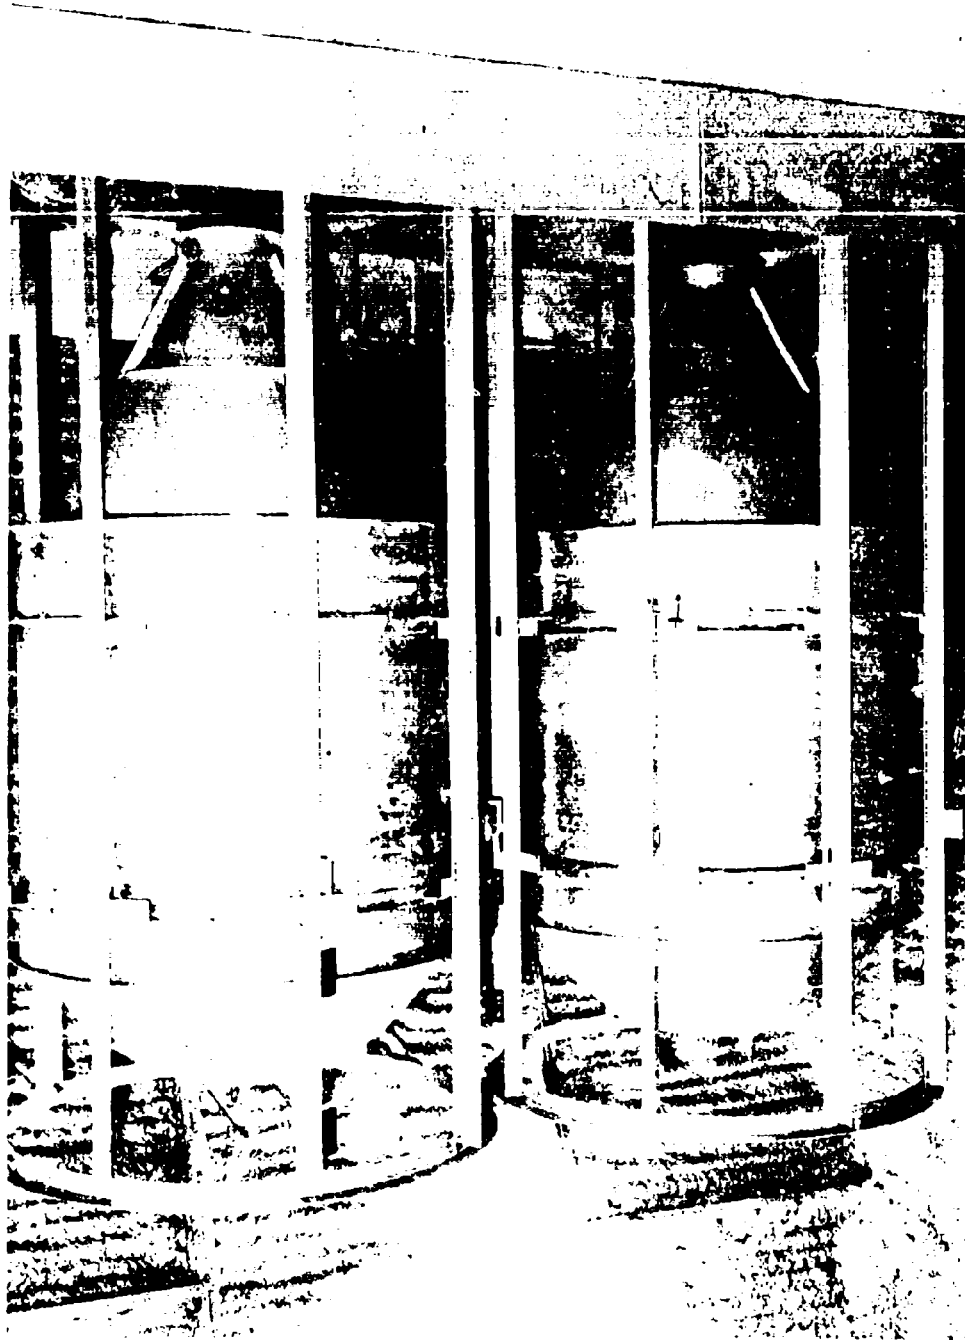
Figure 9. ULPR Tanks

c. ULPR Tanks. These tanks were surplus from the AFRPL Ultra Low Pressure Rocket (ULPR) Program (Figure 9). They are two 2219-T81 tanks and are loaded with  $N_2O_4$  (specification MSC-PPD-2A).
