MISCELLANEOUS PAPER S-71-27

DESIGN OF UNSURFACED SOIL FACILITIES FOR OPERATIONS OF C-5A AIRCRAFT

December 1971

Conducted by **U. S. Army Engineer Waterways Experiment Station, Vicksburg, Mississippi**

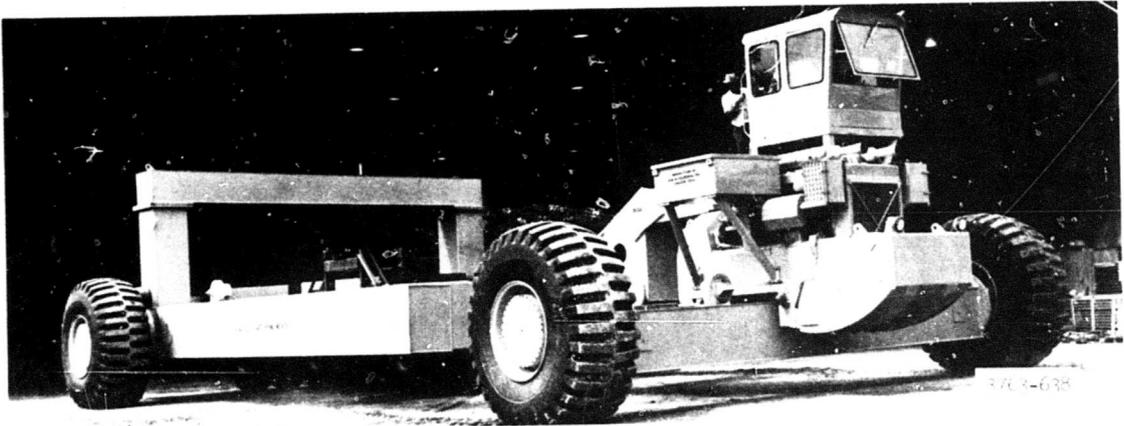
6. The load cart used to apply traffic to test section 1 and to lane 2 of test section 2 is shown in fig. 1. This load cart is driven by electric motors in each wheel and consists of a power unit and frame

Fig. 1. Load cart used for C-5A tests

and two interior load compartments with the tracking wheels. Weights were placed in the load compartments to provide the desired test load of 252,000 lb, which is the load on 12 main gear tires of the C-5A at a gross load of 571,000 lb. The configuration and tire size of the tracking wheels were the same as one main landing gear of the C-5A aircraft. The load boxes are interconnected, and the forward box is connected to the frame by two draw pins. The boxes are free to move in a vertical direction independent of the frame. This load cart was operated in such a manner that the wheels of the frame did not traffic the test lanes.

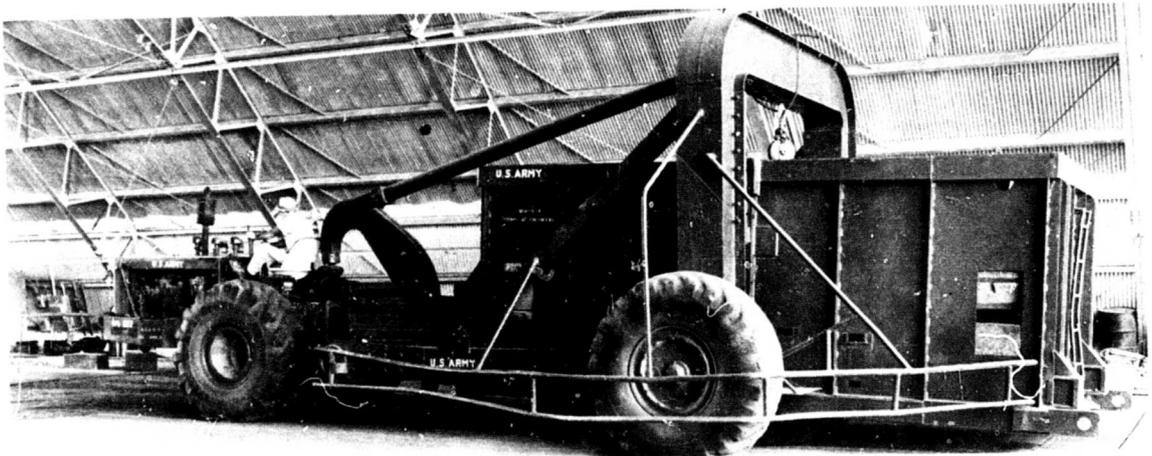
7. The load cart used to apply traffic to lane 1 of test section 2 is shown in fig. 2. The cart is drawn by a commercial-type tractor

Fig. 2. Load cart used for single-wheel tests

and consists of an interior load compartment with loaded tracking wheels and an outer support frame. The load compartment is connected to the frame by a single draw pin in the front, providing free vertical movement independent of the frame. The wheels of the tractor trafficked the test lane, but the weight and tire pressures were small and this traffic was considered negligible.

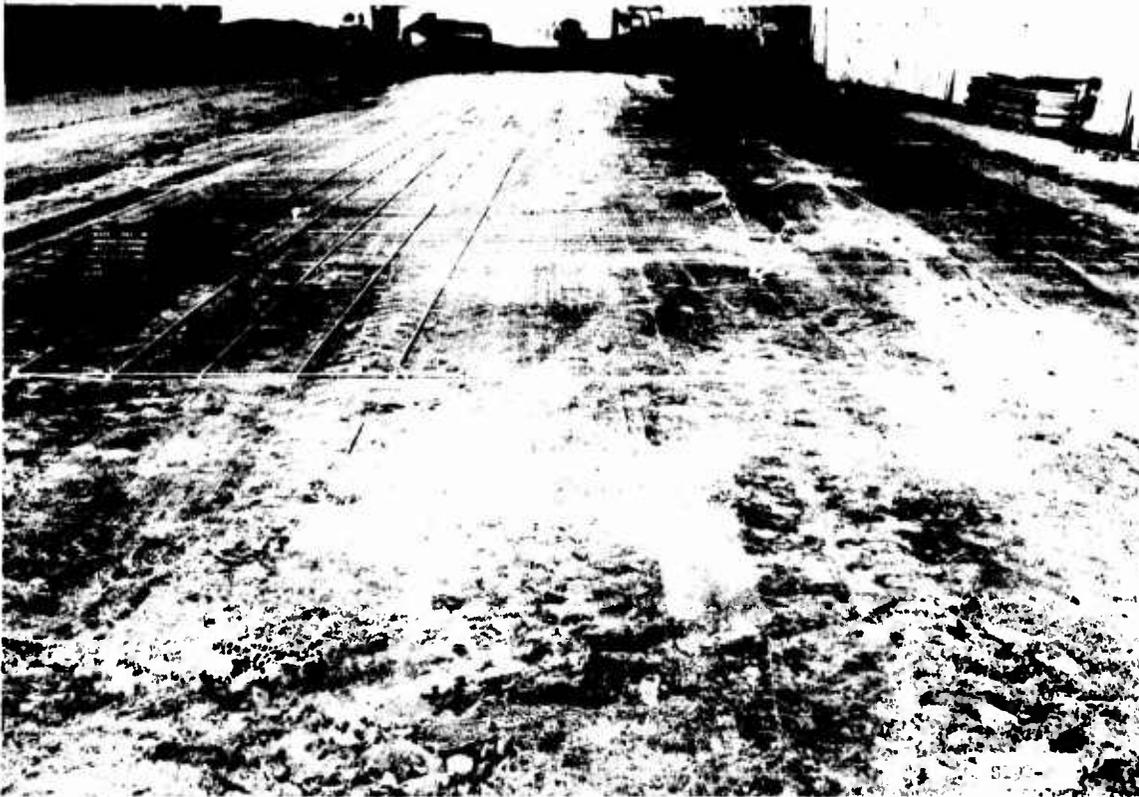
Photo 1. Test section 1, item 1, prior to traffic

19. Item 1 prior to traffic is shown in photo 1. After two passes with the test vehicle, rutting was negligible. After 96 coverages, the maximum rut depth measured was 2.6 in. (photo 2). Traffic was continued to 128 coverages, at which time severe rutting had developed and item 1 was considered failed (photo 3).

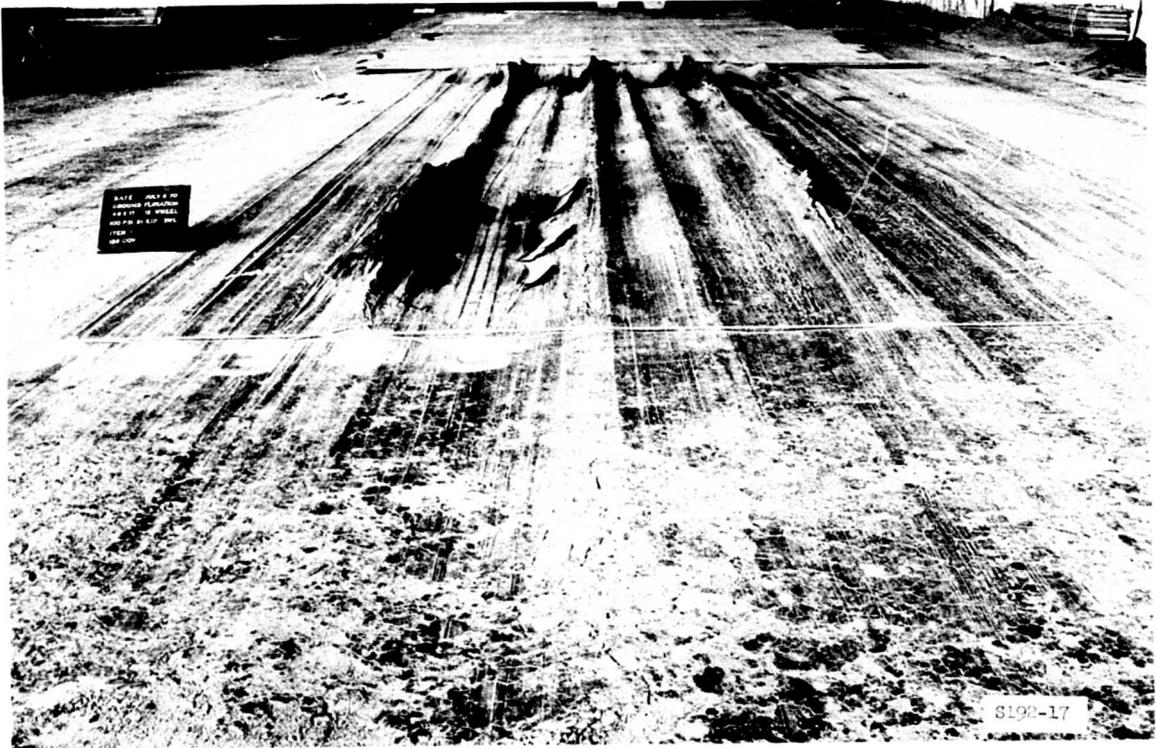
Photo 3. Test section 1, item 1, after failure at 128 coverages

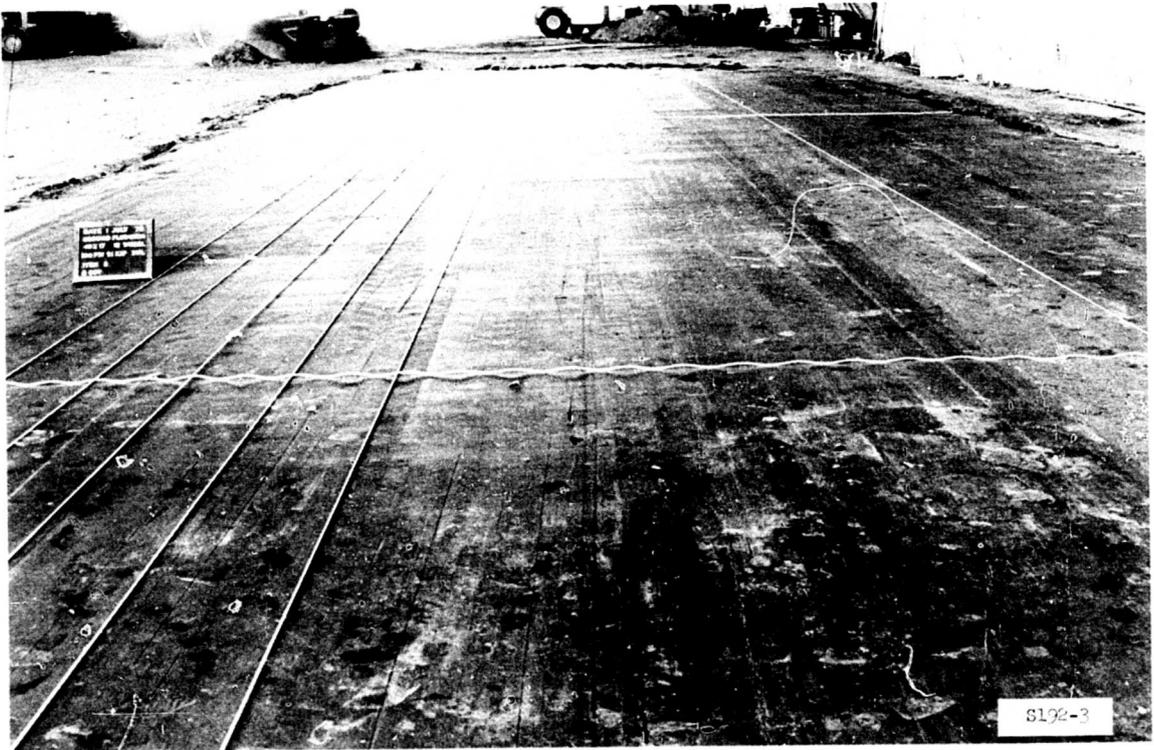
Photo 4. Test section 1, item 2, prior to traffic

20. Item 2 prior to traffic is shown in photo 4. Moderate rutting developed in item 2 at two passes of the load vehicle, and at 16 coverages, the item was considered failed (photo 5).

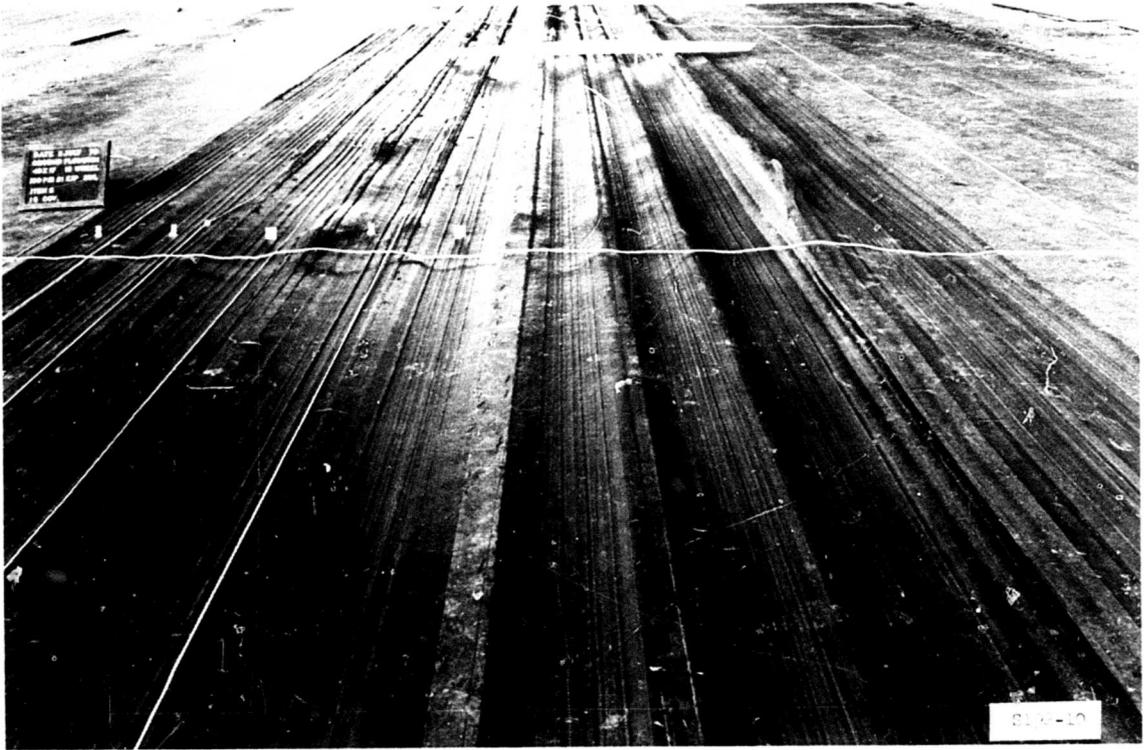
Photo 5. Test section 1, item 2, after failure at 16 coverages

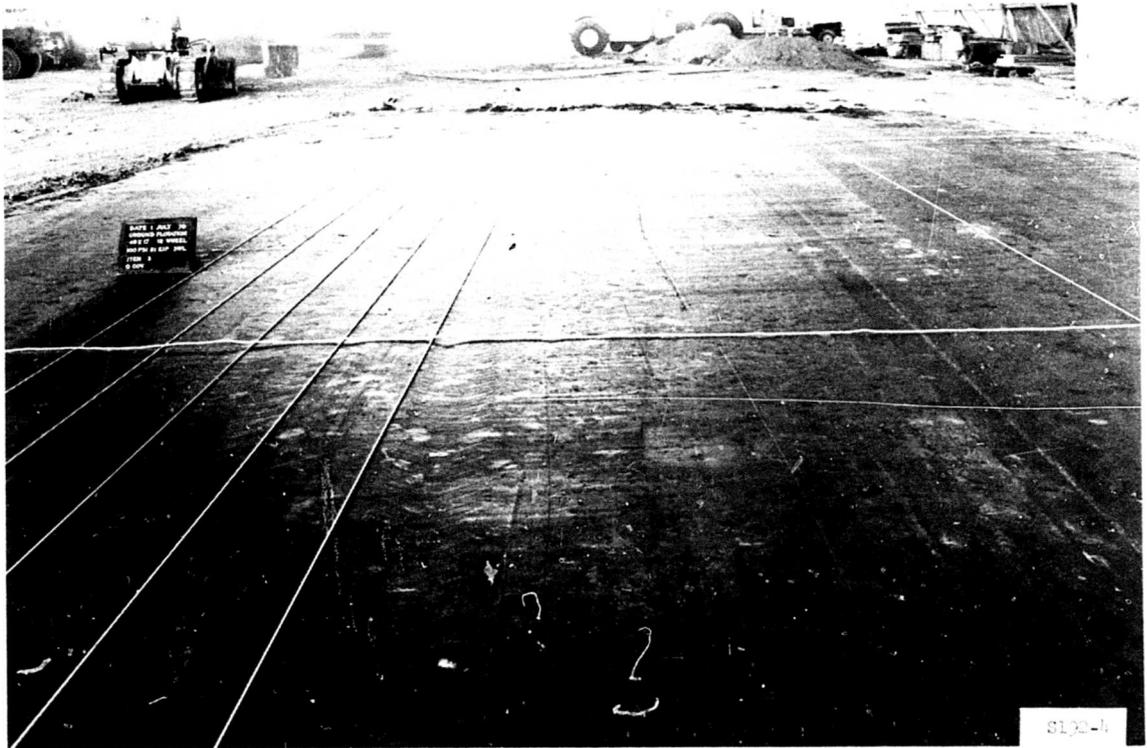
Photo 6. Test section 1, item 3, prior to traffic

21. Item 3 prior to traffic is shown in photo 6. Severe rutting developed immediately with the application of test traffic, and the item was considered failed after one forward and one backward pass of the load cart in the same path. Failure in terms of coverages may then be considered to be between 4 and 8 coverages. For this study, failure was considered to be at 8 coverages (photo 7).

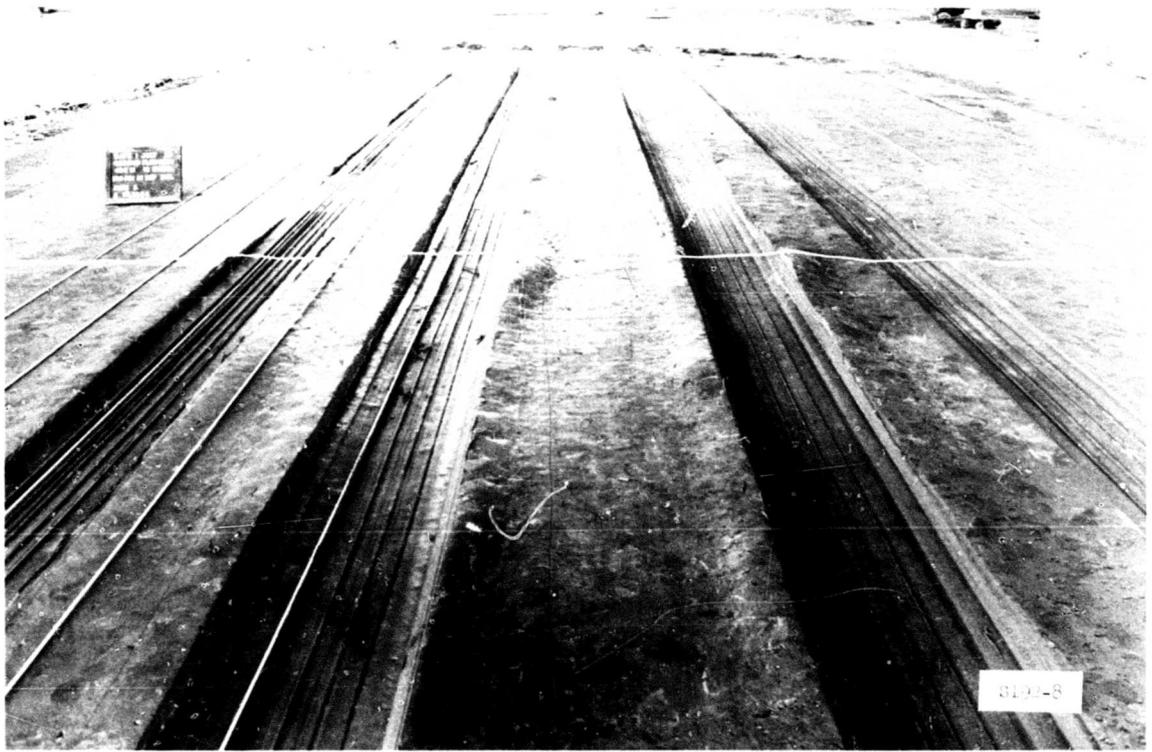
Photo 7. Test section 1, item 3, at failure

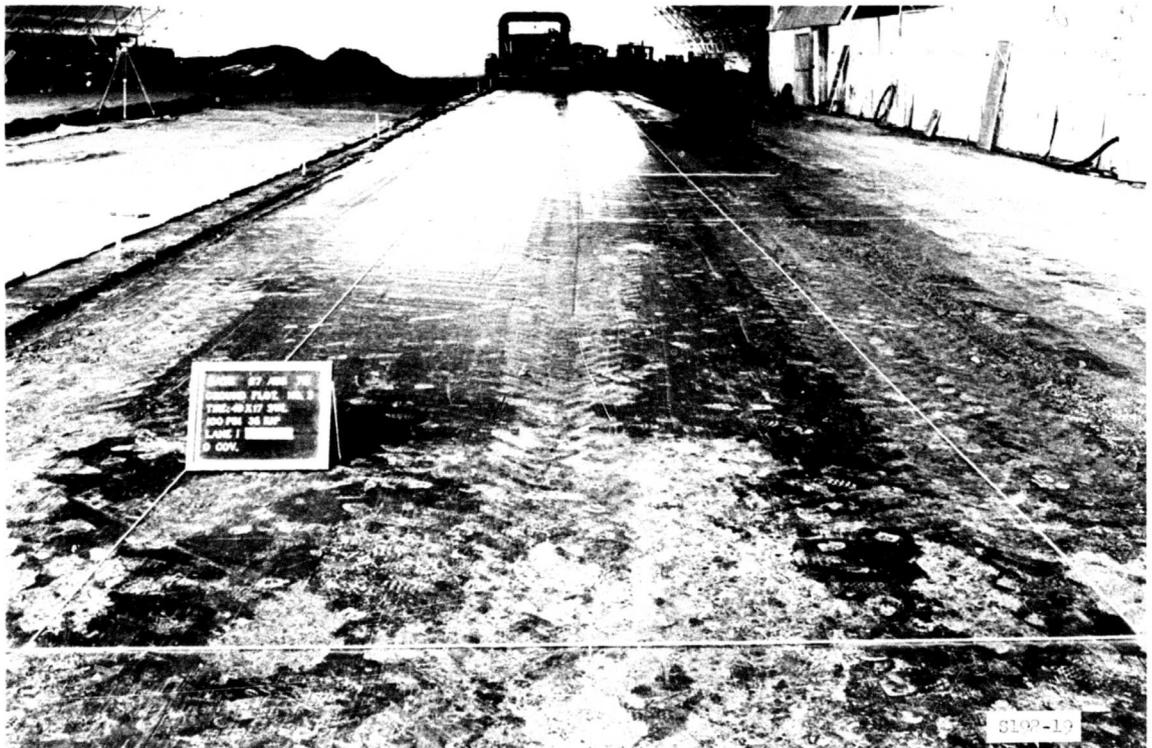
Photo 8. Test section 2, lane 1, prior to traffic

25. Lane 1 was trafficked with a 35,000-lb single-wheel load on a tire inflated to 100 psi, and lane 2 was trafficked with a 252,000-lb load on the 12-wheel C-5A gear with tires inflated to 100 psi. Lane 1 of test section 2 prior to traffic is shown in photo 8.

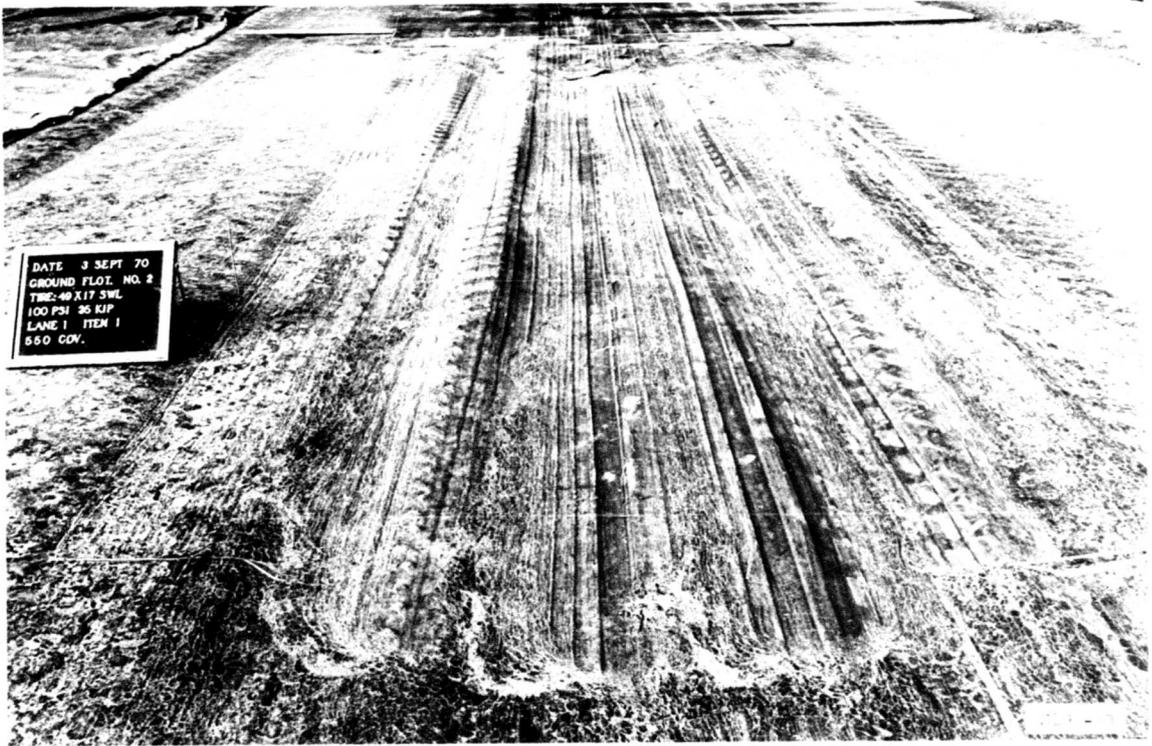
DATE 3 SEPT 70
GROUND PLOT NO. 2
TIME: 40 X 17 SWL
100 PSI 35 KIP
LANE 1 ITEM 1
550 COV.

Photo 9. Test section 2, lane 1, item 1, after failure at 550 coverages

26. Item 1. Item 1 held up well under traffic, with only minor rutting and gradual subsidence. The deformation increased slowly until at 550 coverages the item was considered failed based on a differential deformation exceeding 4 in. Photo 9 shows item 1 at 550 coverages.

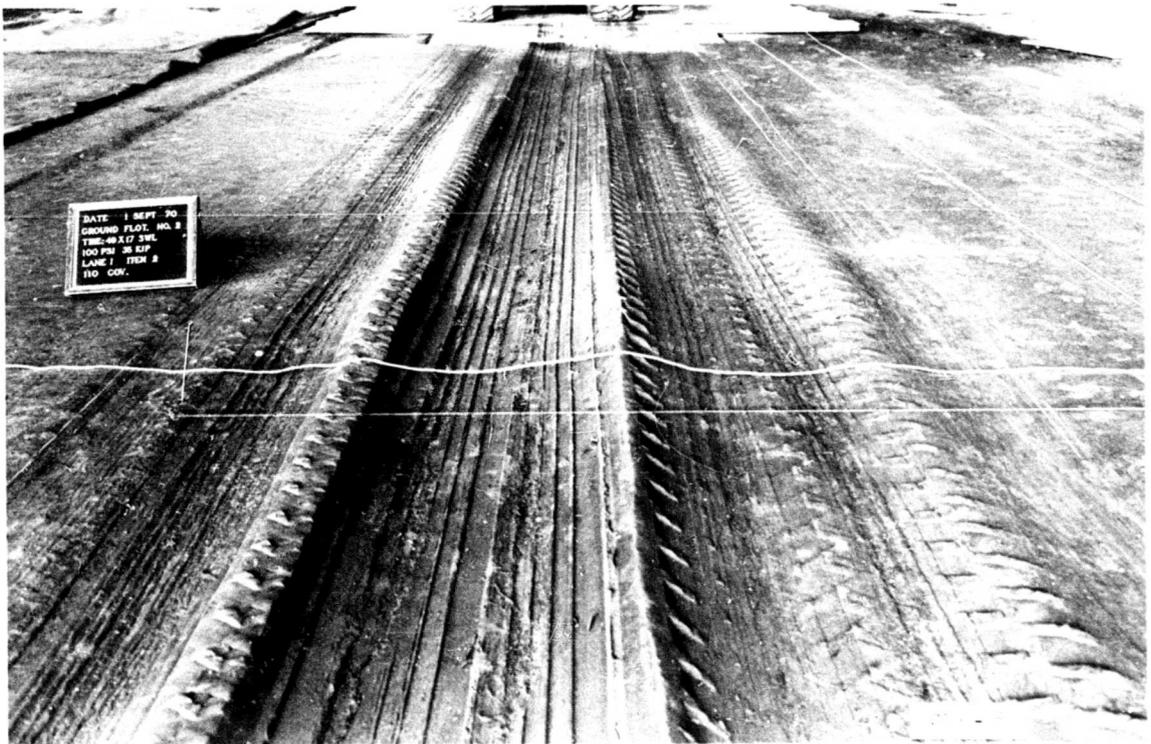
DATE 1 SEPT 70
GROUND PLOT NO. 2
TIME: 40 X 17 SWL
100 PSI 35 KIP
LANE 1 ITEM 2
110 COV.

Photo 10. Test section 2, lane 1, item 2, after failure at 110 coverages

27. Item 2. Rutting developed at a moderate rate in item 2 until the item was considered failed at 110 coverages. At this time, the average rut depth was 3 in., and the maximum rut depth was greater than 4 in. (photo 10).

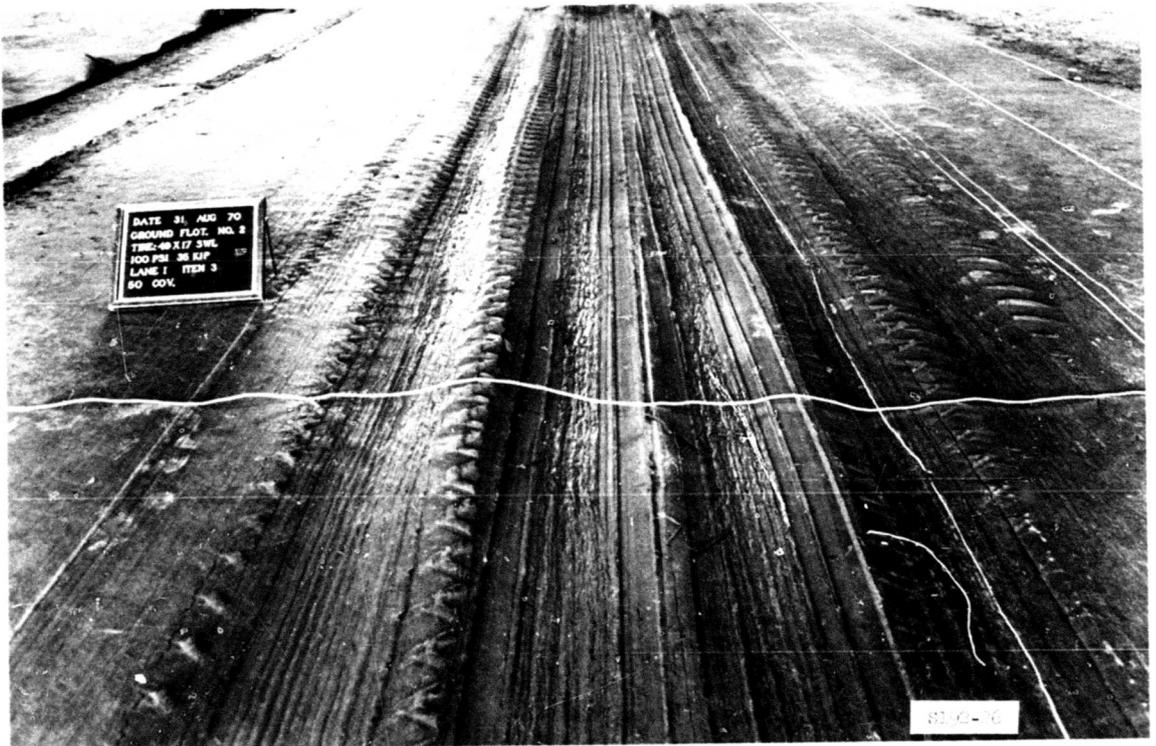
Photo 11. Test section 2, lane 1, item 3, after failure at 50 coverages

28. Item 3. Severe rutting developed in the early stages of traffic, and item 3 was considered failed at 50 coverages. Photo 11 shows item 3 at failure.

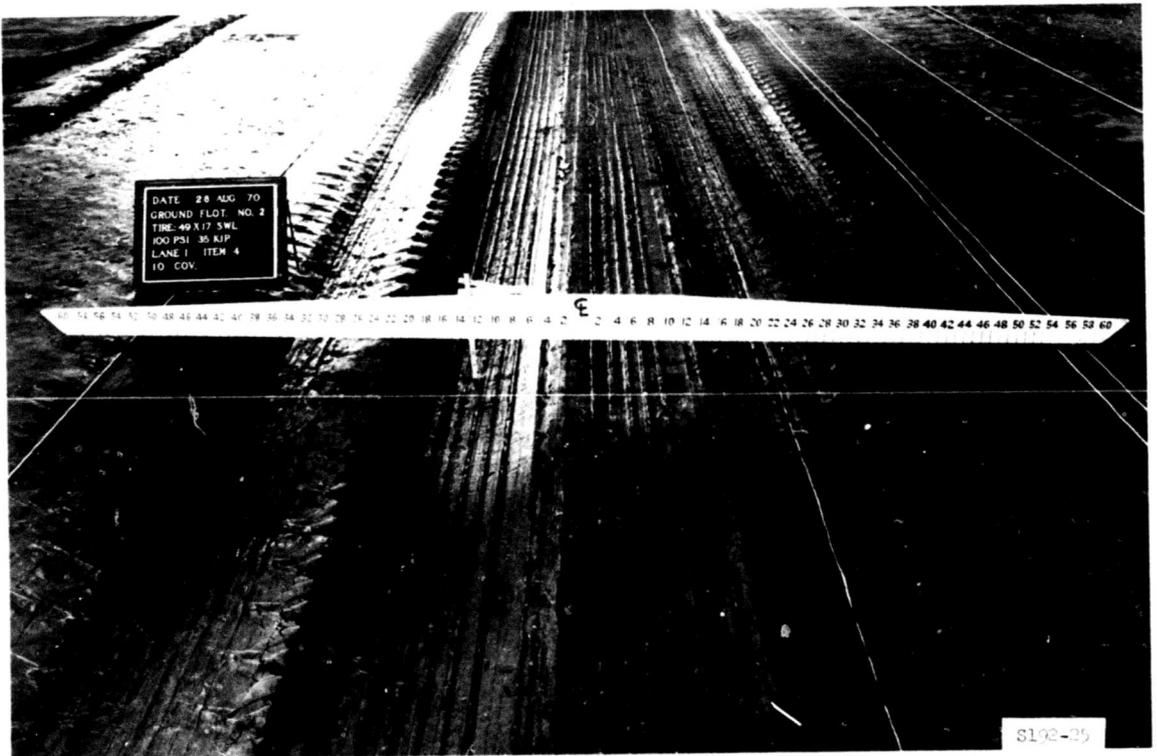
Photo 12. Test section 2, lane 1, item 4, after failure at 10 coverages

29. Item 4. The initial passes caused very severe rutting, and at 10 coverages, item 4 was considered failed. Photo 12 shows item 4 at failure.

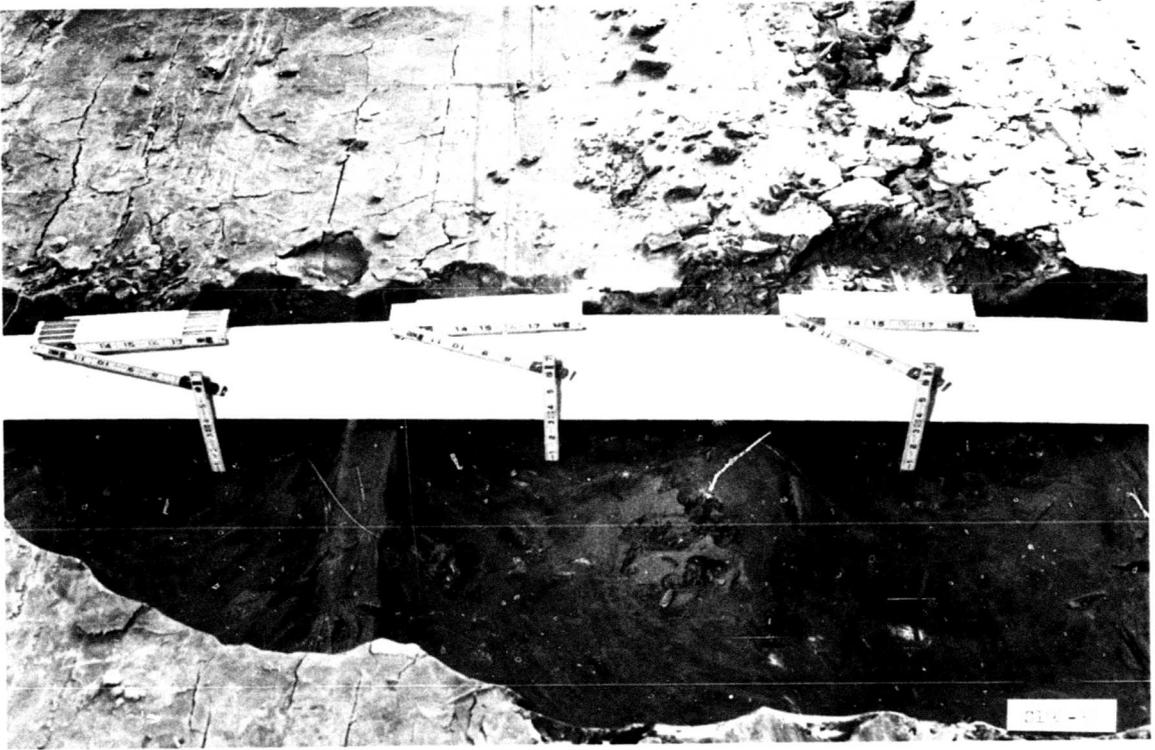
Photo 13. Typical subgrade deformation at failure in test section 2, lane 1

31. Subgrade deformation (items 1-4). Typical cross sections of the interface of the two soil layers in each item are shown in plate 8. These data indicate that the failures noted in the surface of each item were contributed to by deformation in the soil subgrade. Photo 13 shows typical subgrade deformation upon failure of an item.

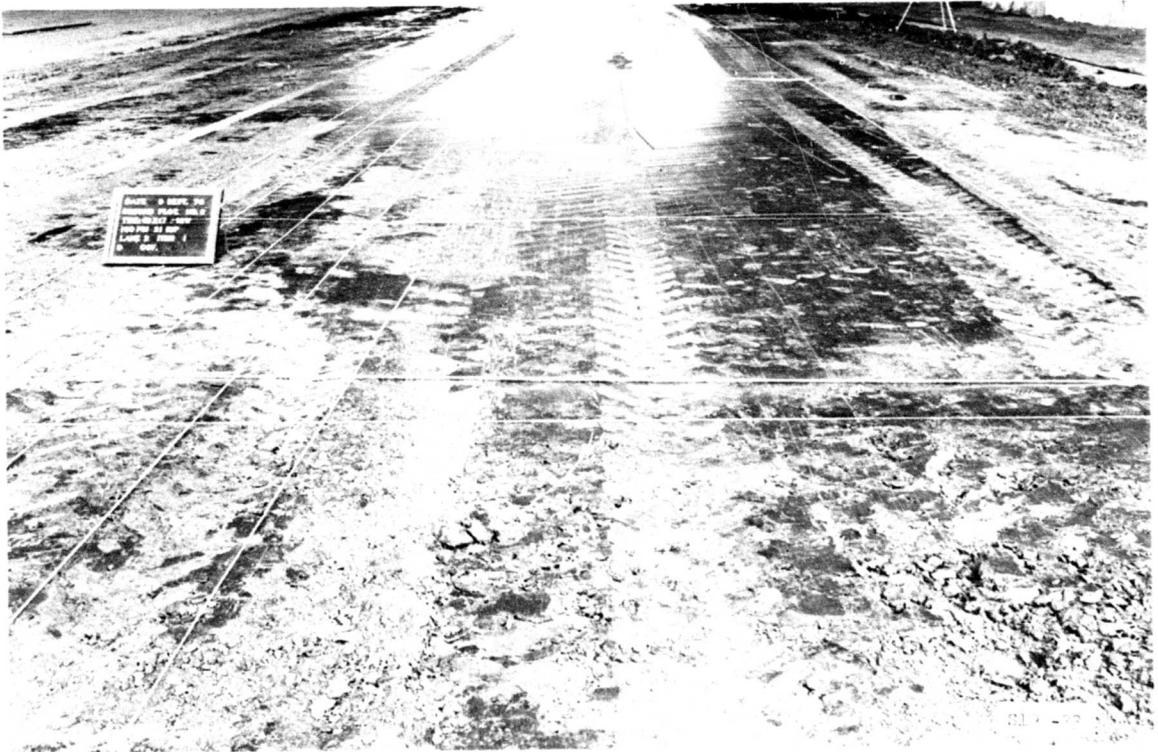
Photo 14. Test section 2, lane 2, prior to traffic

33. Test lane 2 (see plate 2 and tabulation in paragraph 24) prior to traffic is shown in photo 14.

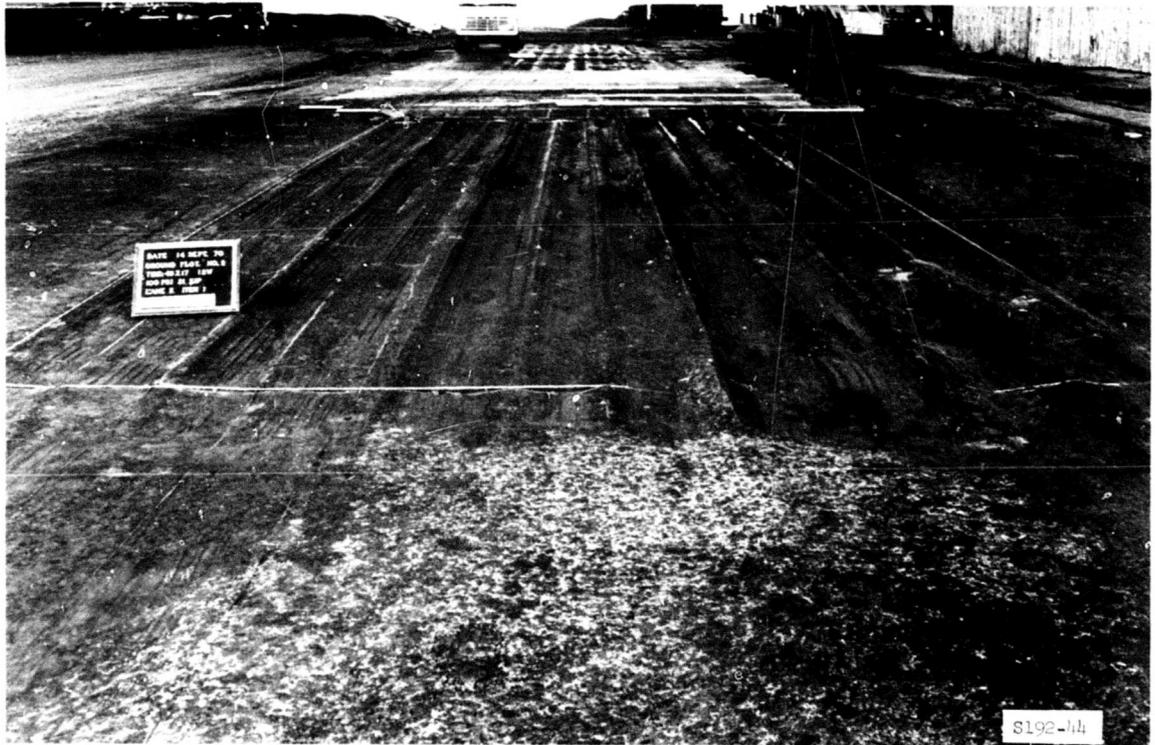
Photo 15. Test section 2, lane 2, item 1, at failure after 228 coverages

34. Item 1. Rutting remained negligible in item 1 for about 100 coverages of traffic; however, at this point, rutting began to increase significantly, and at 228 coverages the item was judged failed. Photo 15 shows item 1 at failure.

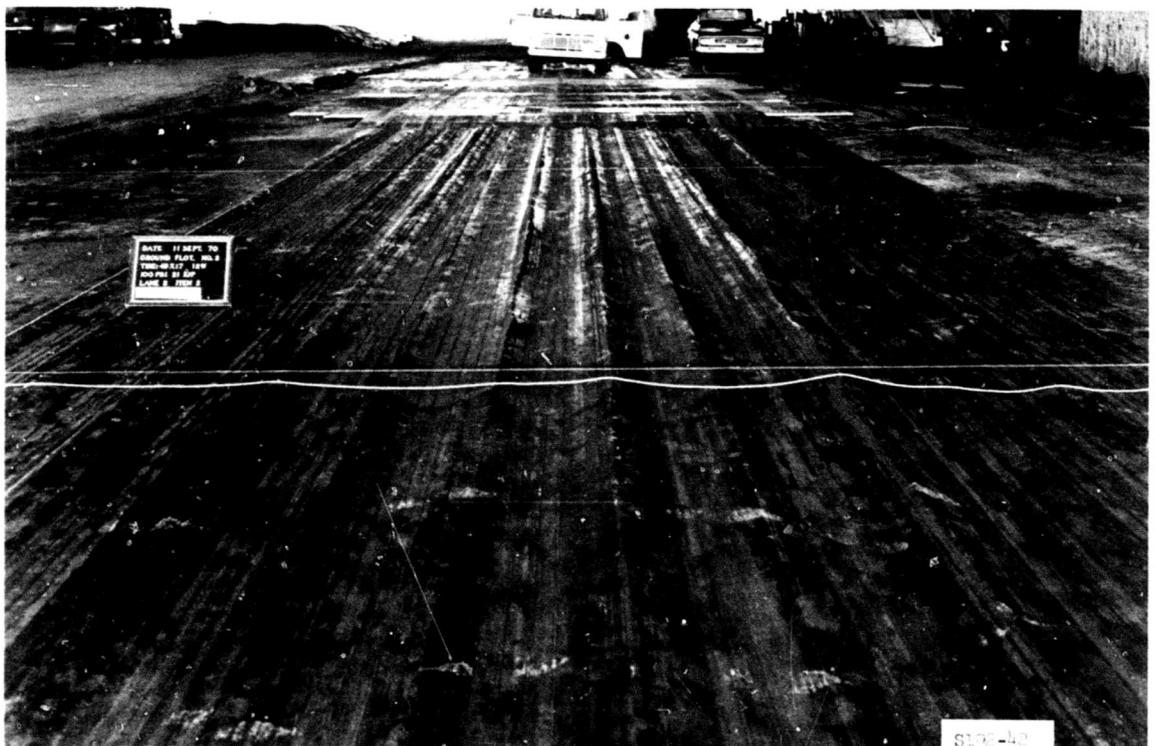
Photo 16. Test section 2, lane 2, item 2, at failure after 76 coverages

35. Item 2. Very slight rutting occurred in item 2 upon application of traffic and increased until failure occurred at 76 coverages. Photo 16 shows item 2 at failure.

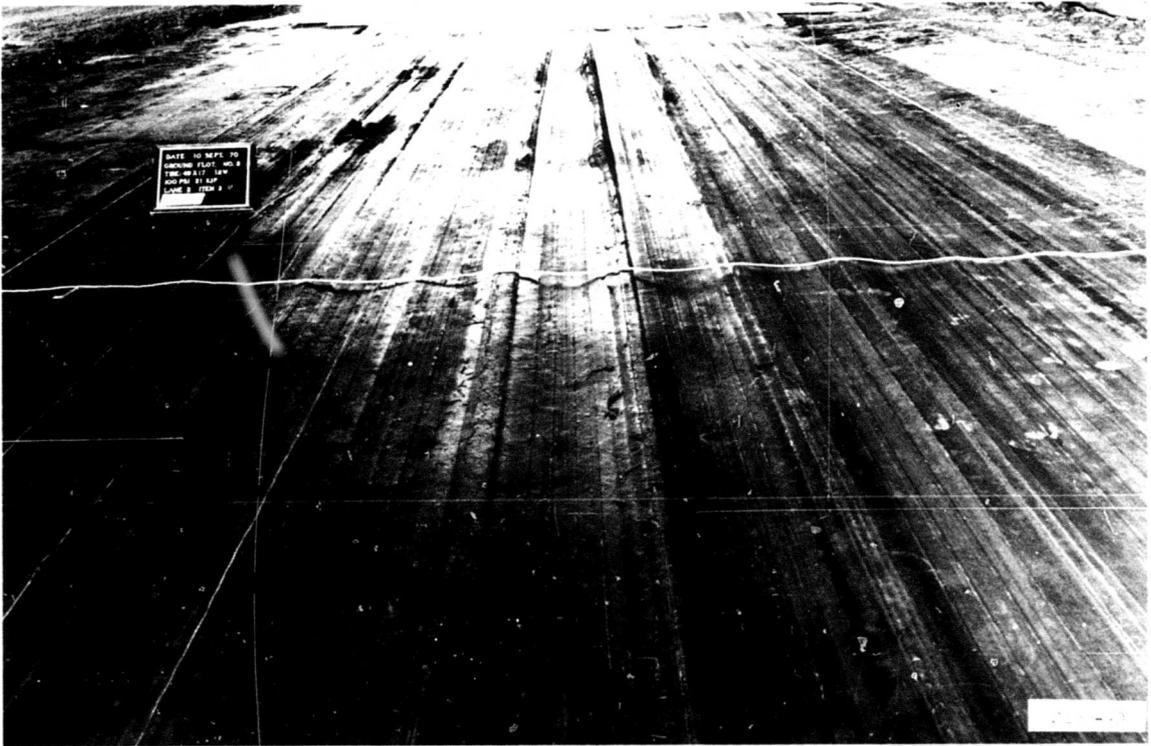
Photo 17. Test section 2, lane 2, item 3, at failure after 40 coverages

36. Item 3. Significant rutting took place in item 3 upon application of the initial pass of traffic, and at 40 coverages the item was considered failed. Photo 17 shows item 3 after failure.

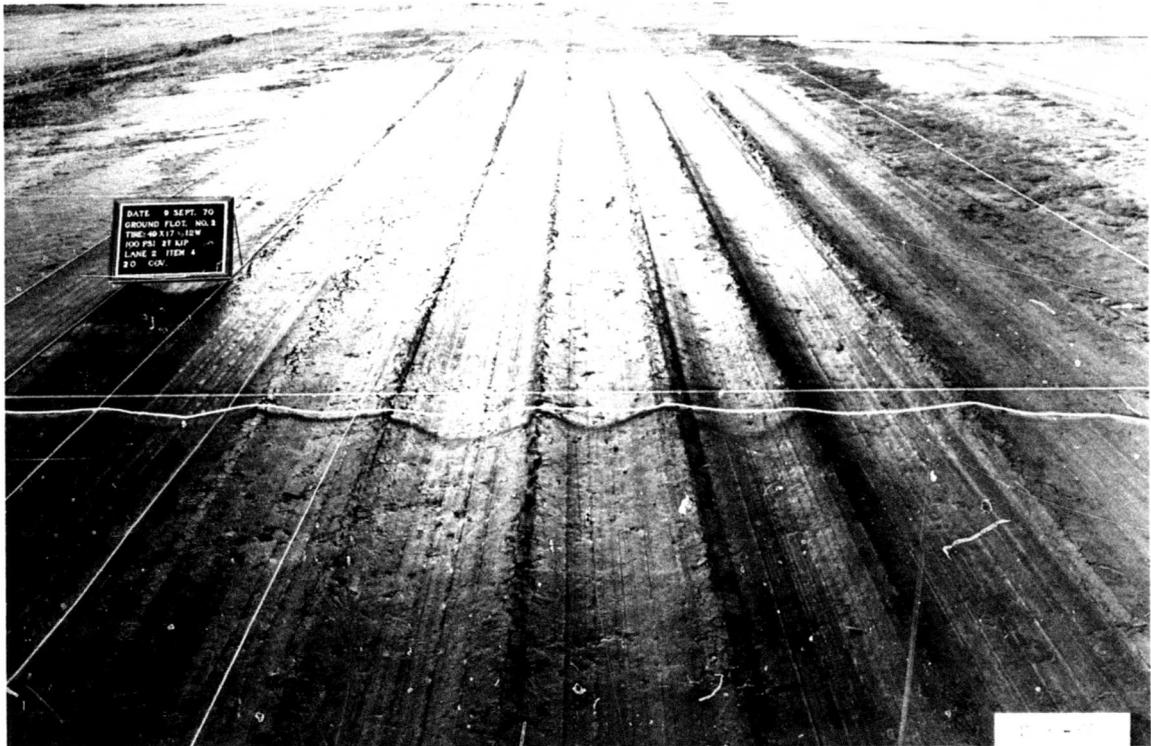
Photo 18. Test section 2, lane 2, item 4, at failure after 20 coverages

37. Item 4. Severe rutting in item 4 resulted from the first pass of the tracking vehicle, and after 20 coverages the item was judged failed. Photo 18 shows item 4 after failure.

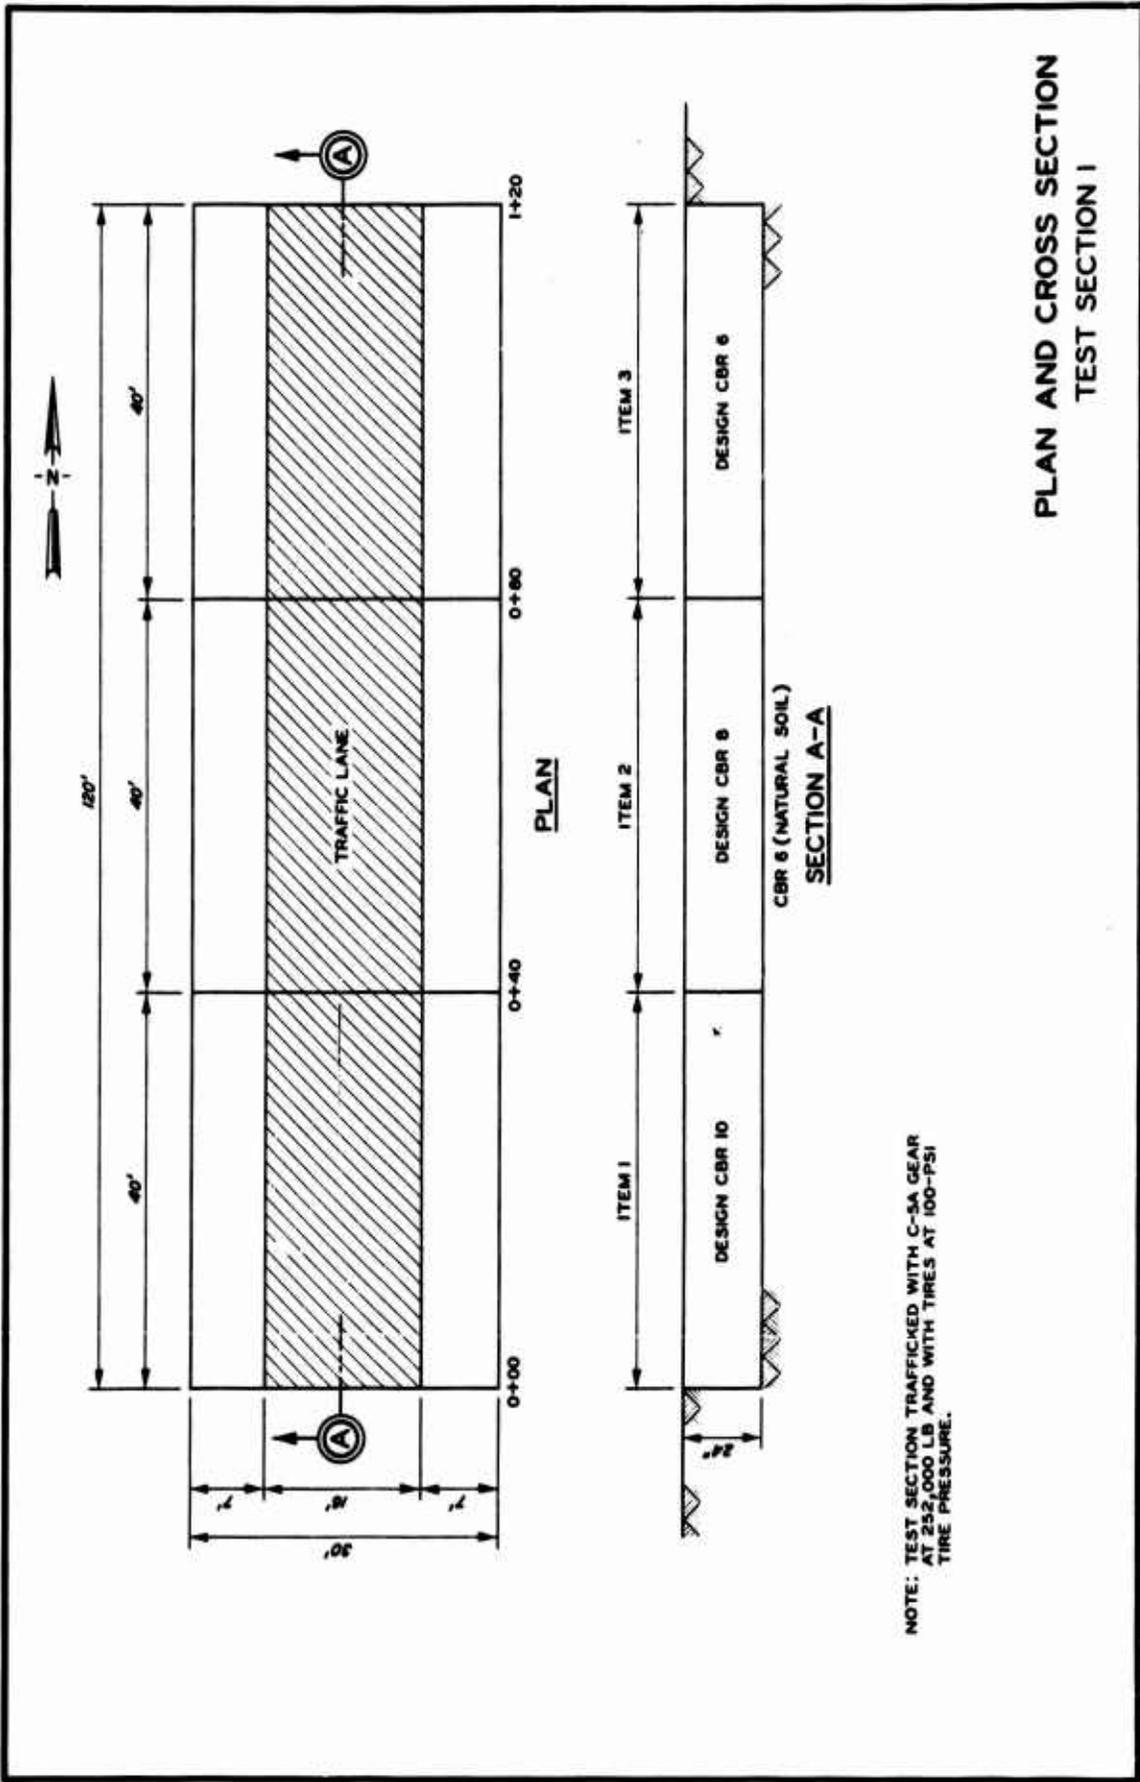
NOTE: TEST SECTION TRAFFICKED WITH C-5A GEAR AT 25,200 LB AND WITH TIRES AT 100-PSI TIRE PRESSURE.

**PLAN AND CROSS SECTION
TEST SECTION I**

4. The test sections were constructed under a roofed area in order that the subgrade strength of the test items could be controlled. Layouts of the test sections are shown in plates 1 and 2. Test section 1 was constructed with one traffic lane consisting of three test items. Test section 2 was constructed with two lanes of four items each. To construct the test sections, the natural soil was excavated to a depth of 2 ft for test section 1 and 3 ft for test section 2, and the area was backfilled with a local heavy clay. The fill material was processed and compacted to provide the design strength. For test section 1, test items 1, 2, and 3 had design strengths of 10, 8, and 6 CBR, respectively. For test section 2, item 1 had 12 in. of 14-CBR material over an 8-CBR subgrade; item 2 had 9 in. of a 14-CBR material over an 8-CBR subgrade; item 3 had 15 in. of a 12-CBR material over a 4-CBR subgrade; and item 4 had 10 in. of a 12-CBR material over a 4-CBR subgrade.

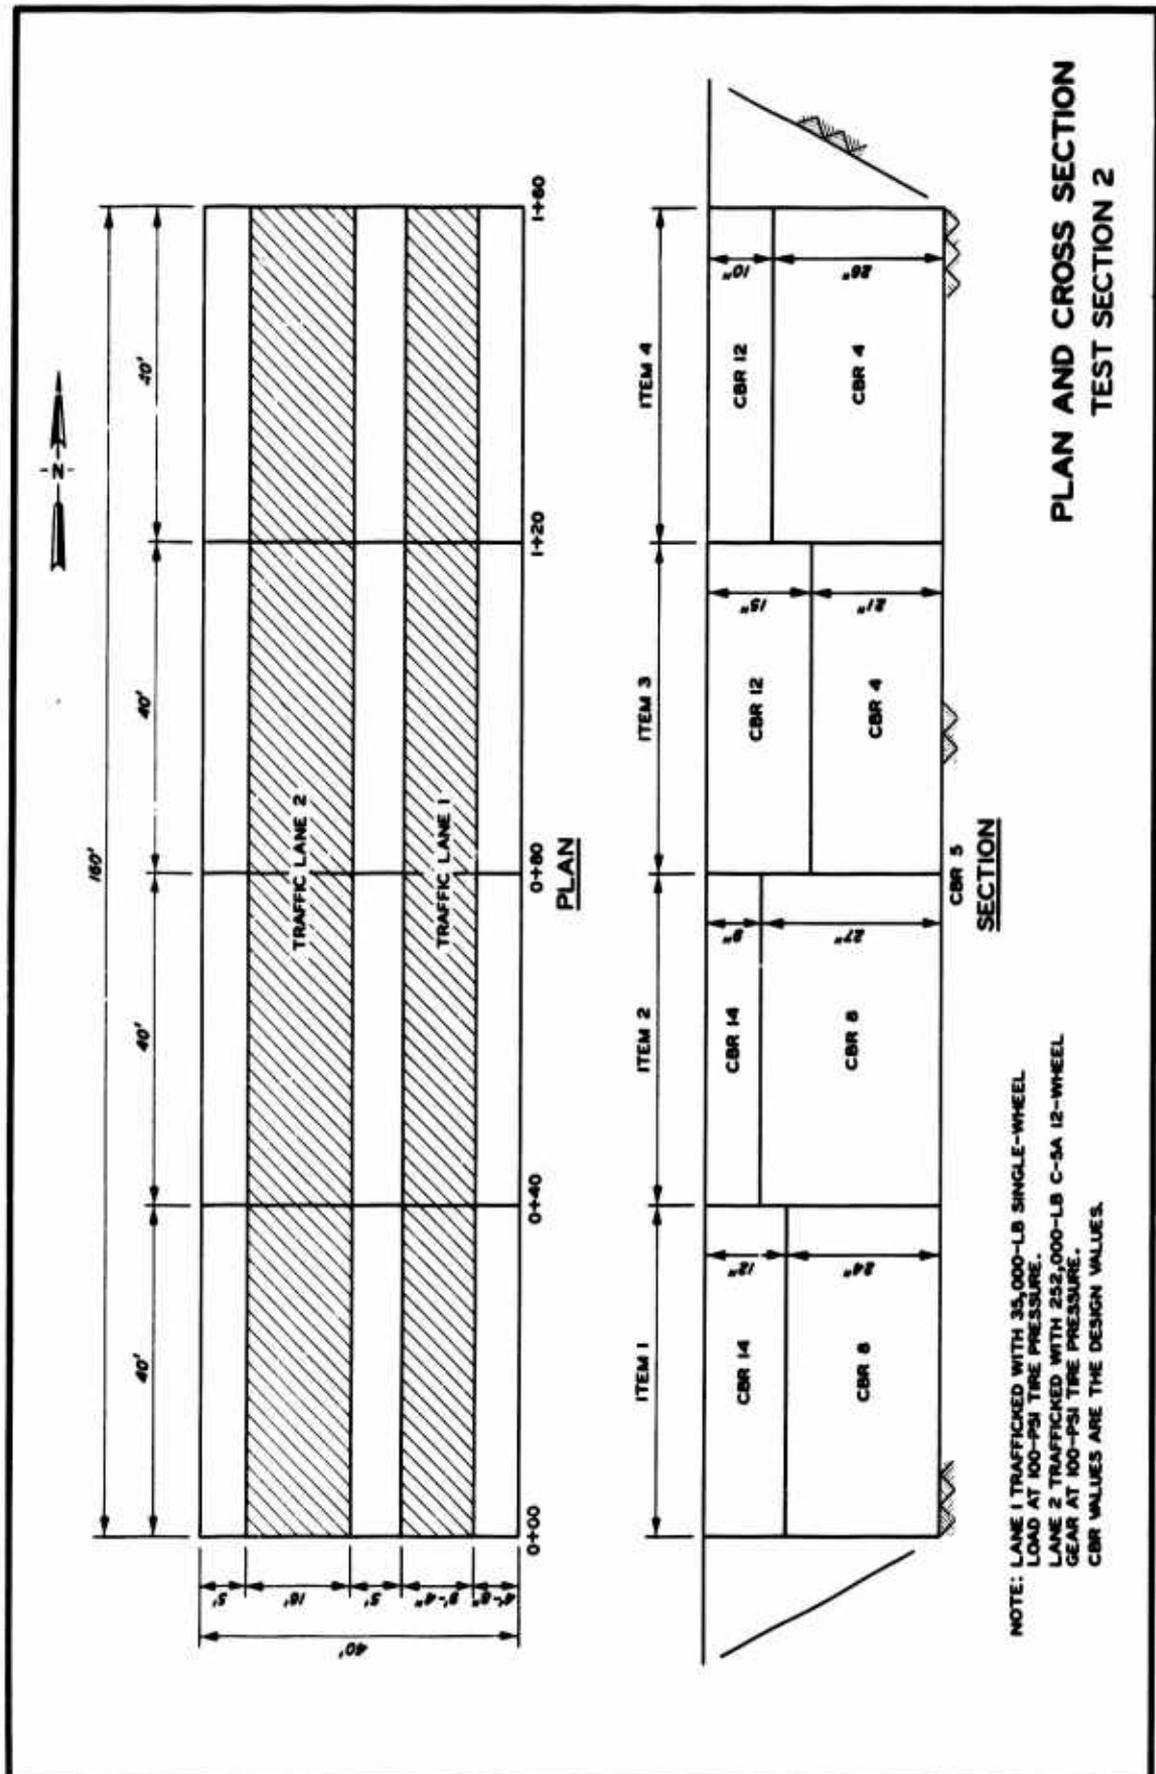
PLATE 2

**PLAN AND CROSS SECTION
TEST SECTION 2**

24. Test section 2 was constructed with two traffic lanes consisting of four items each. A brief description of the test section is presented in the tabulation below, and a plan and cross section of the test section are shown in plate 2.

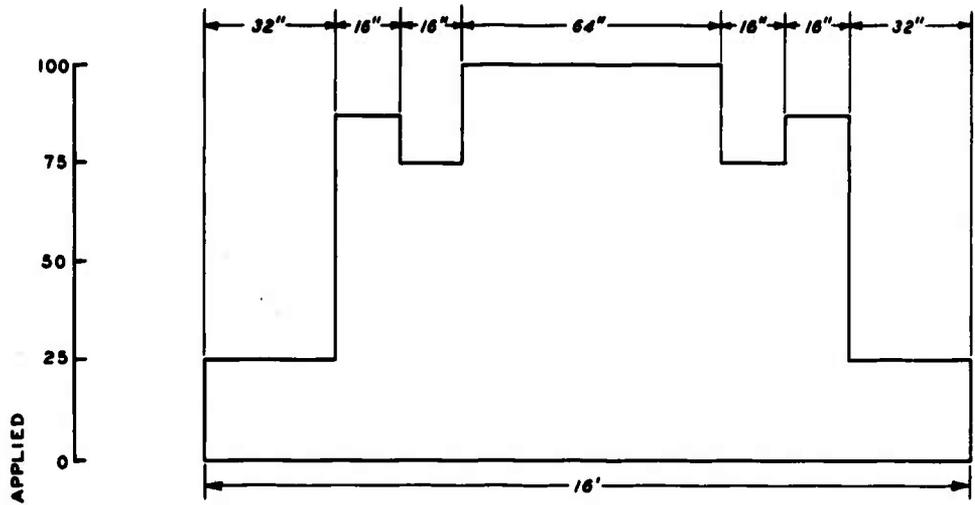
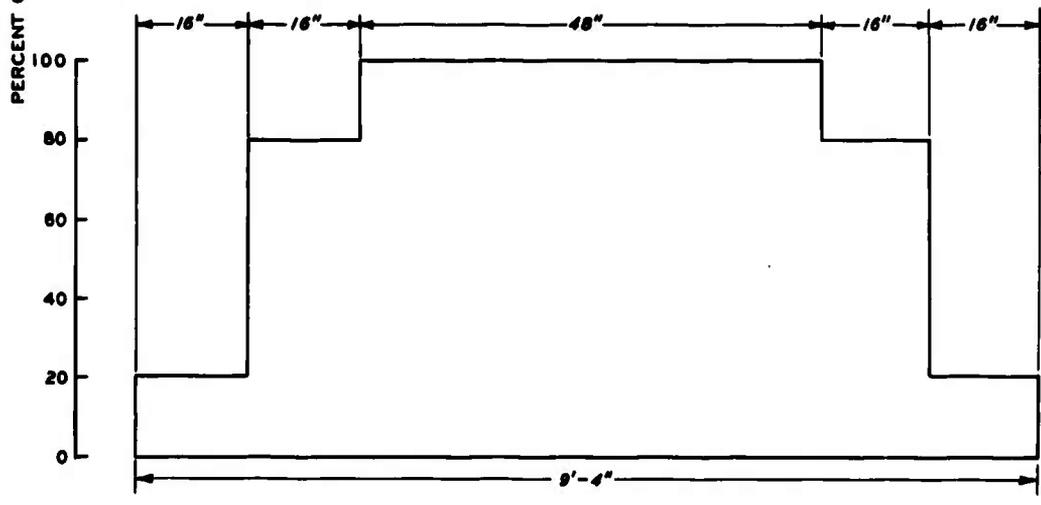
a. TEST SECTION 1 AND LANE 2 OF TEST SECTION 2

b. LANE 1 OF TEST SECTION 2

TRAFFIC DISTRIBUTION PATTERNS
