MISCELLANEOUS PAPER S-71-27

DESIGN OF UNSURFACED SOIL FACILITIES FOR OPERATIONS OF C-5A AIRCRAFT

December 1971

Conducted by **U. S. Army Engineer Waterways Experiment Station, Vicksburg, Mississippi**

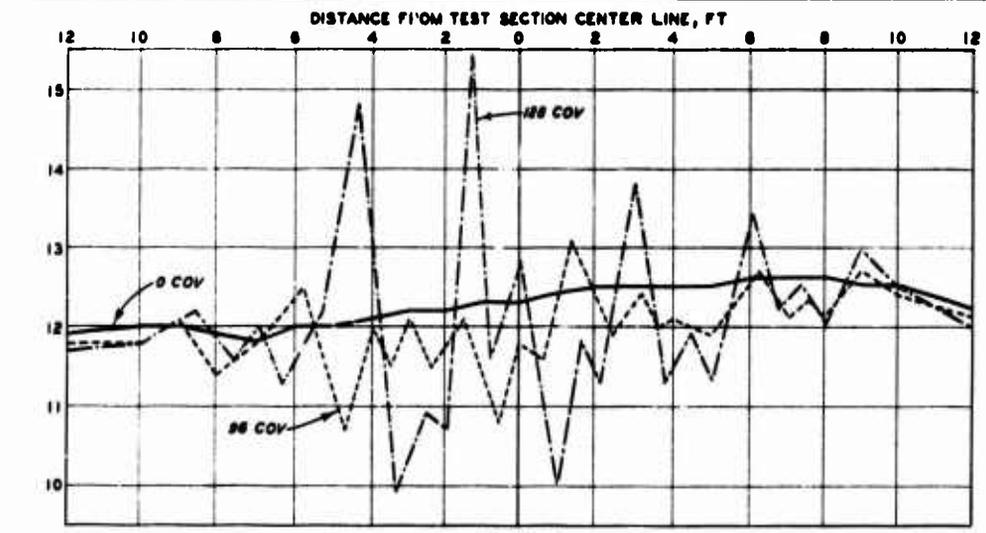
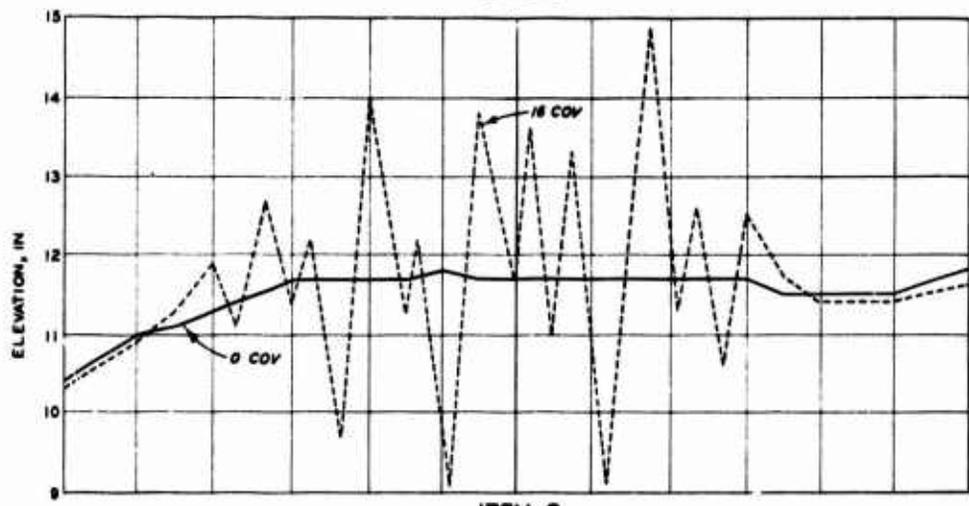
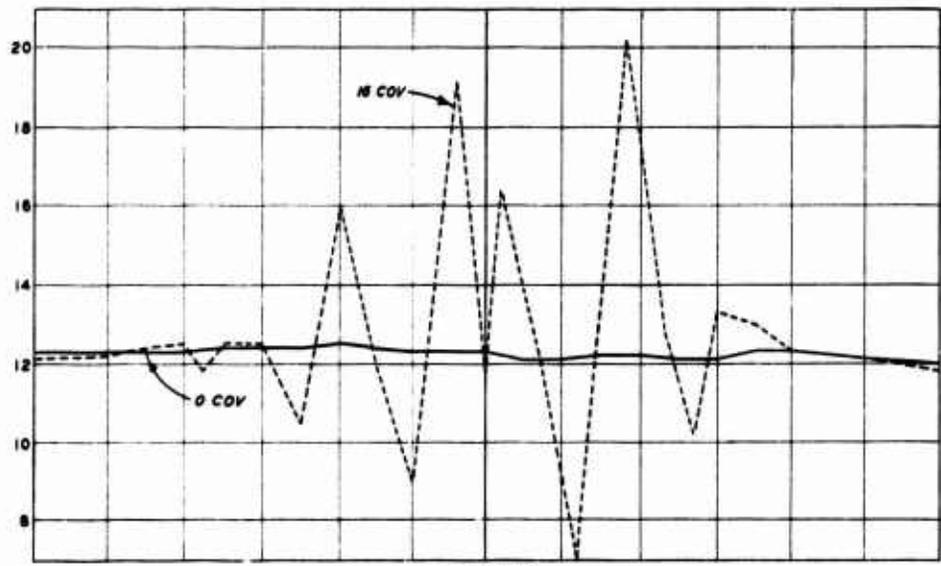
**CROSS SECTIONS
TEST SECTION 1**

22. Typical cross-sectional elevations of items 1, 2, and 3 are shown in plate 4. The cross section for item 3 was taken at 16 coverages rather than at 8 coverages when failure occurred. These plots indicate the severe deformation that occurred in each item at failure. Rut depth measurements taken at failure in each item are shown in table 3. Average rut depths in items 1, 2, and 3 were 3.1, 3.2, and 3.0 in., respectively. Maximum rut depths at failure in items 1, 2, and 3 were 5.0, 5.5, and 3.3 in., respectively. Profile elevations taken

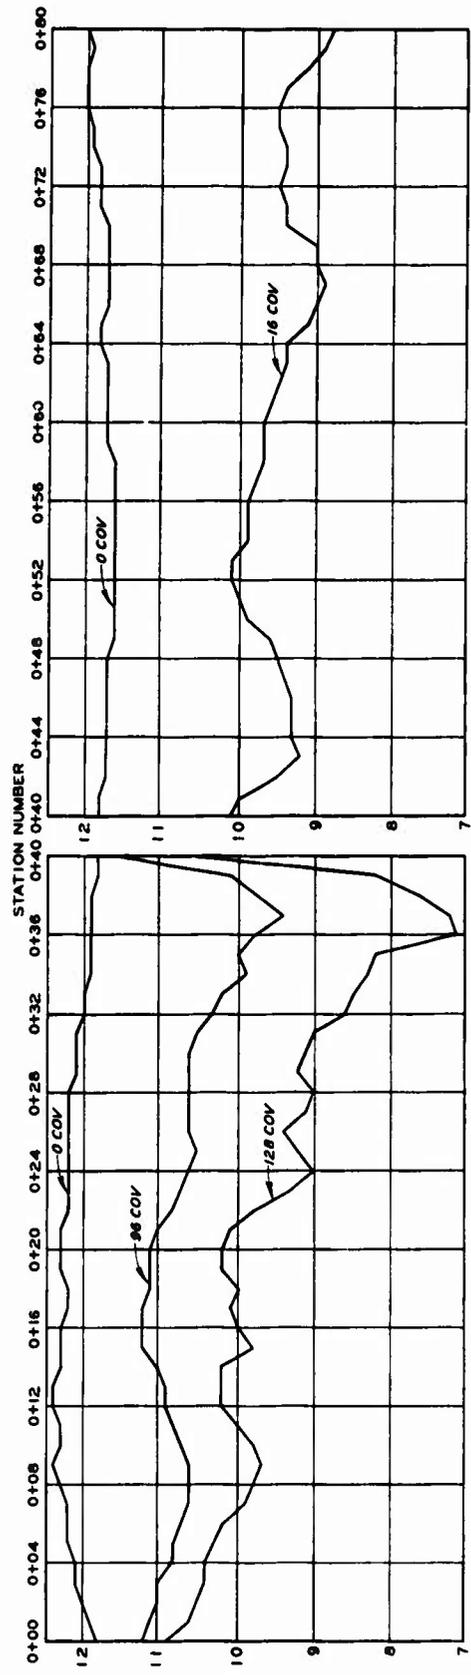
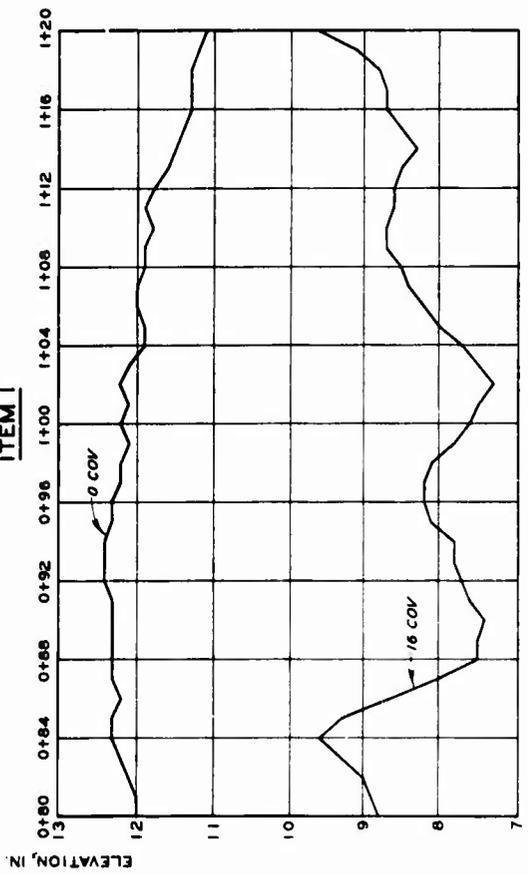
PROFILES
TEST SECTION I

along the center line of each item at various coverage levels in items 1-3 are shown in plate 5. The profile for item 3 is for 16 coverages, although failure occurred at 8 coverages.

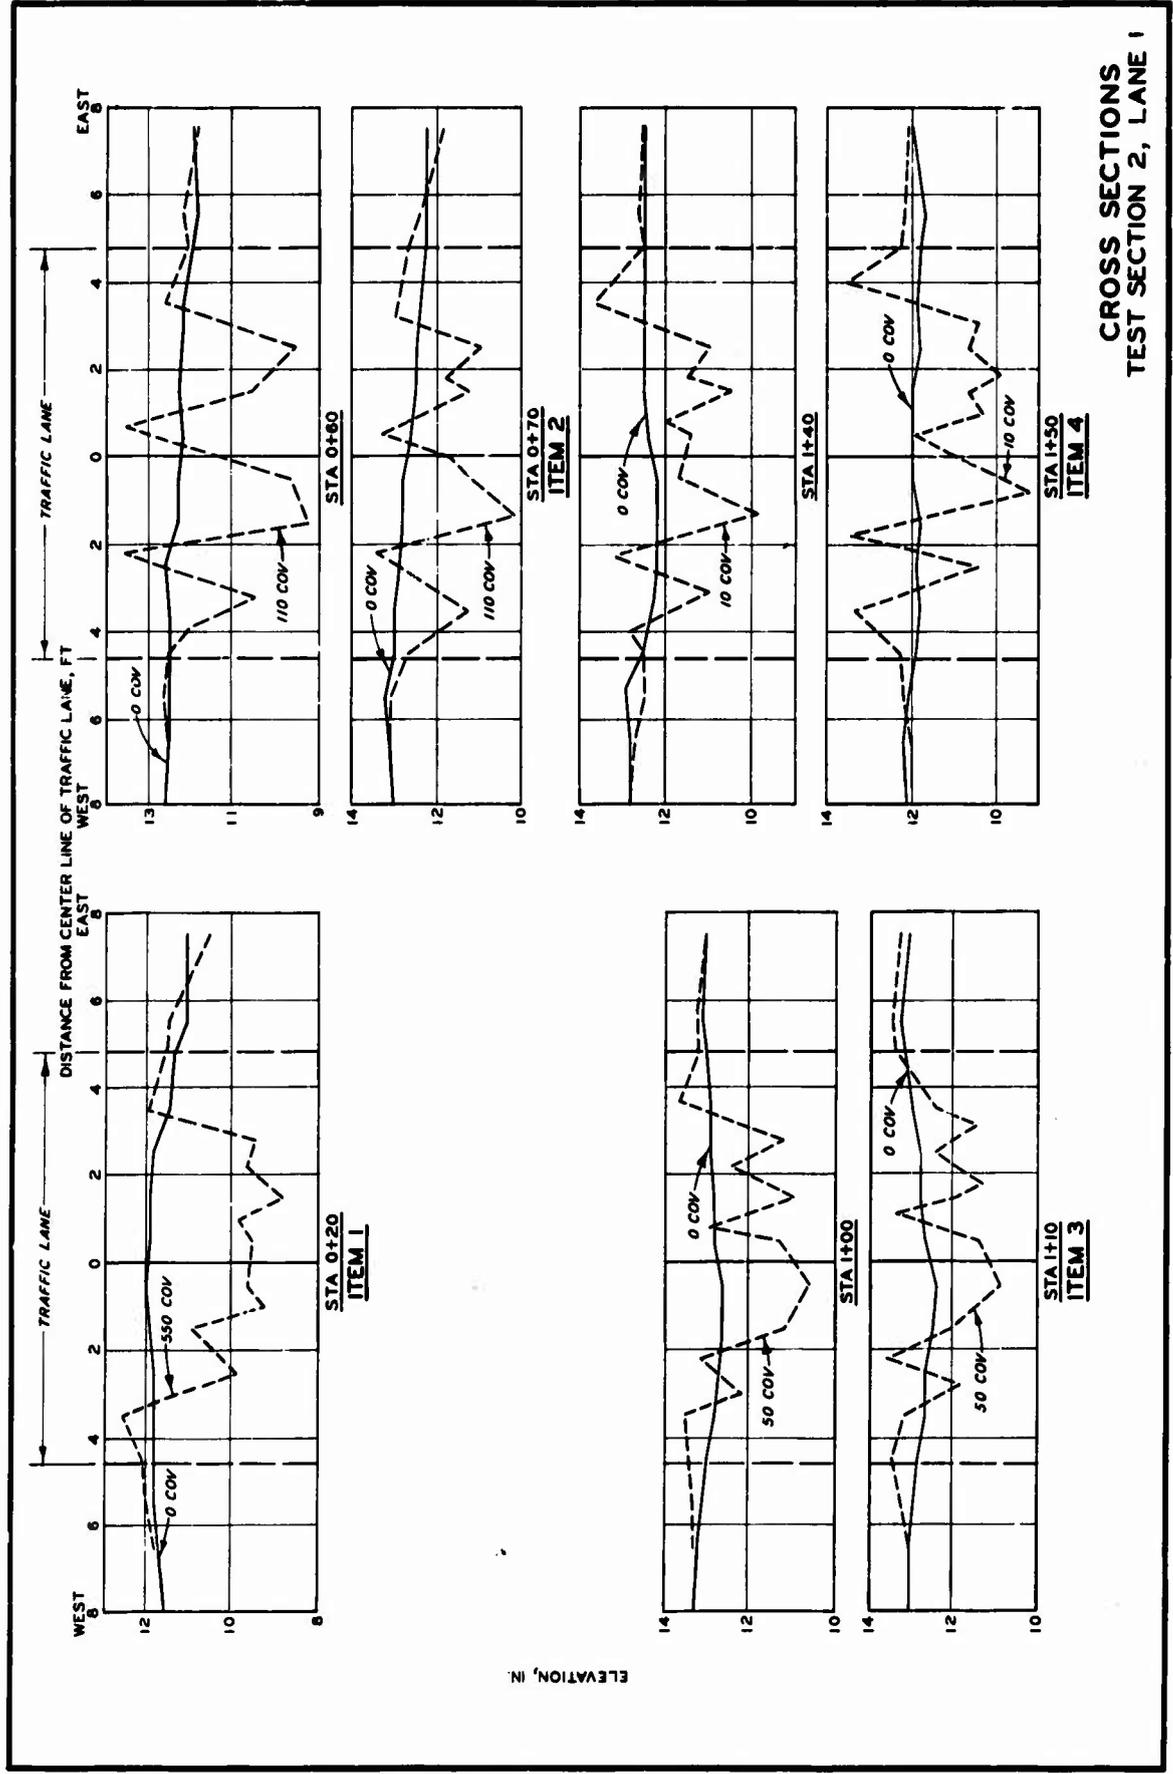
PLATE 6

**CROSS SECTIONS
TEST SECTION 2, LANE 1**

30. Surface deformation and rutting (items 1-4). Typical cross-sectional elevations of items 1-4 of lane 1 are shown in plate 6. These data indicate the severe surface deformation that had occurred in each item at failure. Rut depth measurements taken in each item at failure are shown in table 4. These values indicate that the average rut depths of the items at failure were each at least 3 in. and that the maximum rut depths were at least 4 in. Profile elevations taken along the center line of each item at 0 coverages and after failure are shown in plate 7.

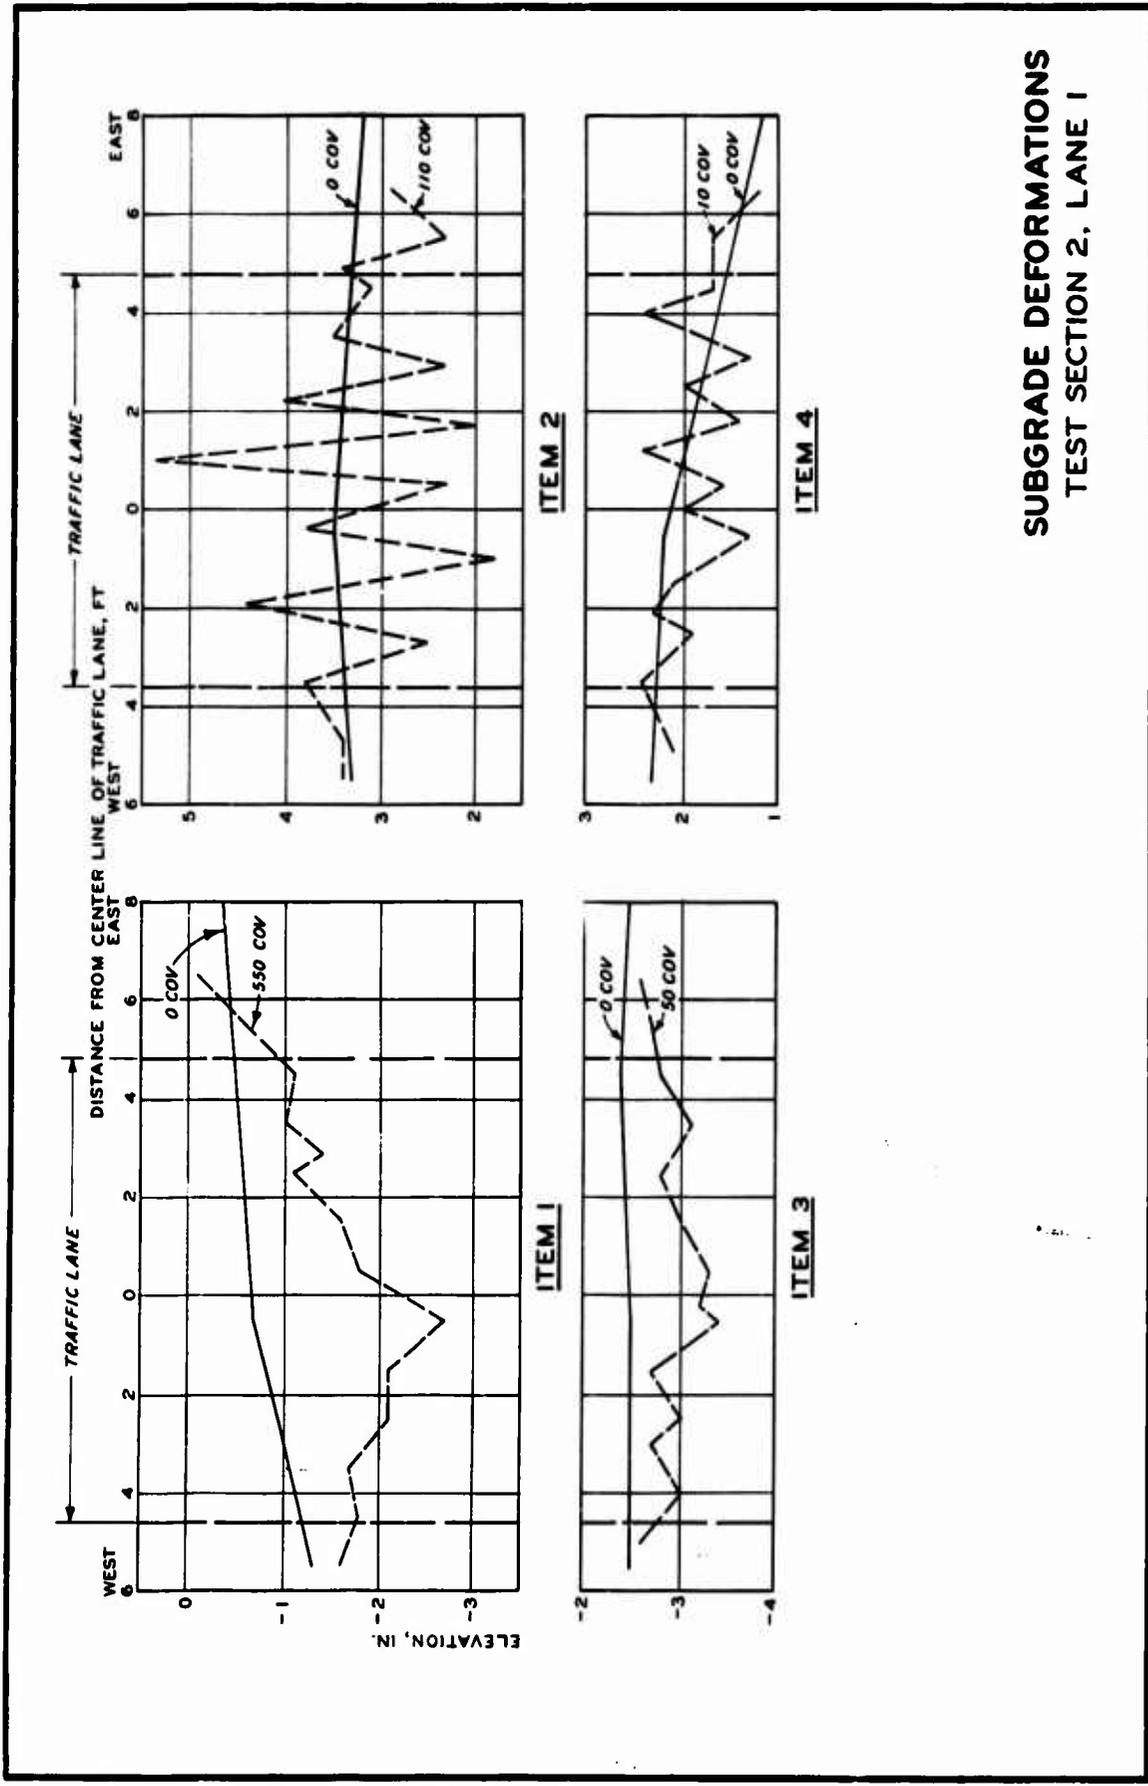
**SUBGRADE DEFORMATIONS
TEST SECTION 2, LANE 1**

31. Subgrade deformation (items 1-4). Typical cross sections of the interface of the two soil layers in each item are shown in plate 8. These data indicate that the failures noted in the surface of each item were contributed to by deformation in the soil subgrade. Photo 13 shows typical subgrade deformation upon failure of an item.

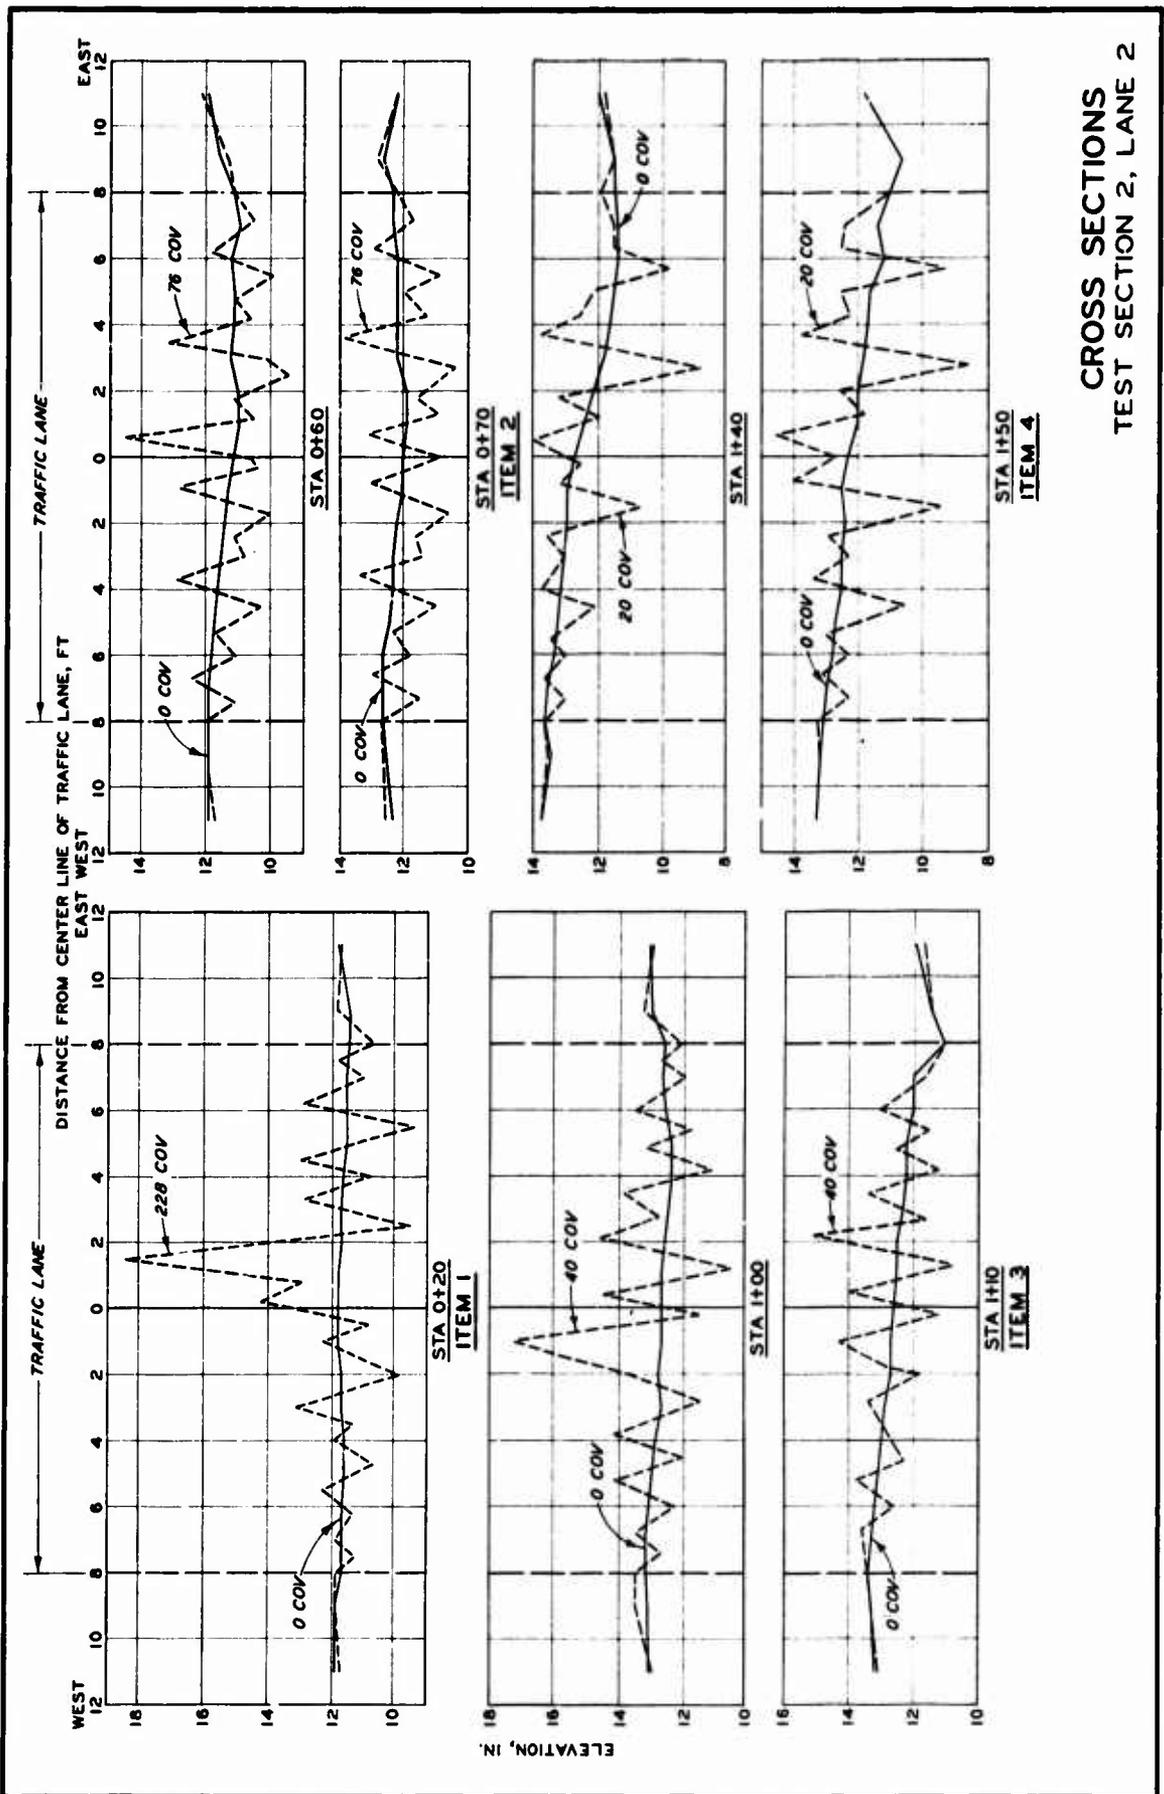
CROSS SECTIONS
TEST SECTION 2, LANE 2

38. Surface deformation and rutting (items 1-4). Typical cross sections of items 1-4 are shown in plate 9. These data show the deformation that occurred in each item at failure. Rut depth measurements taken at failure in each item are shown in table 4 and indicate that the average depths were at least 3 in. and that maximum depths all exceeded 4 in. Profile elevations taken along the center line of each item prior to traffic and upon failure are shown in plate 10.

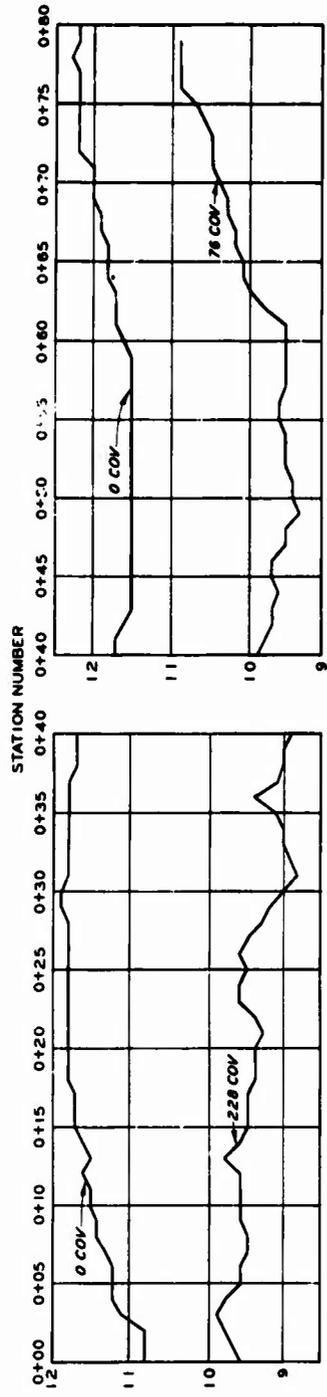
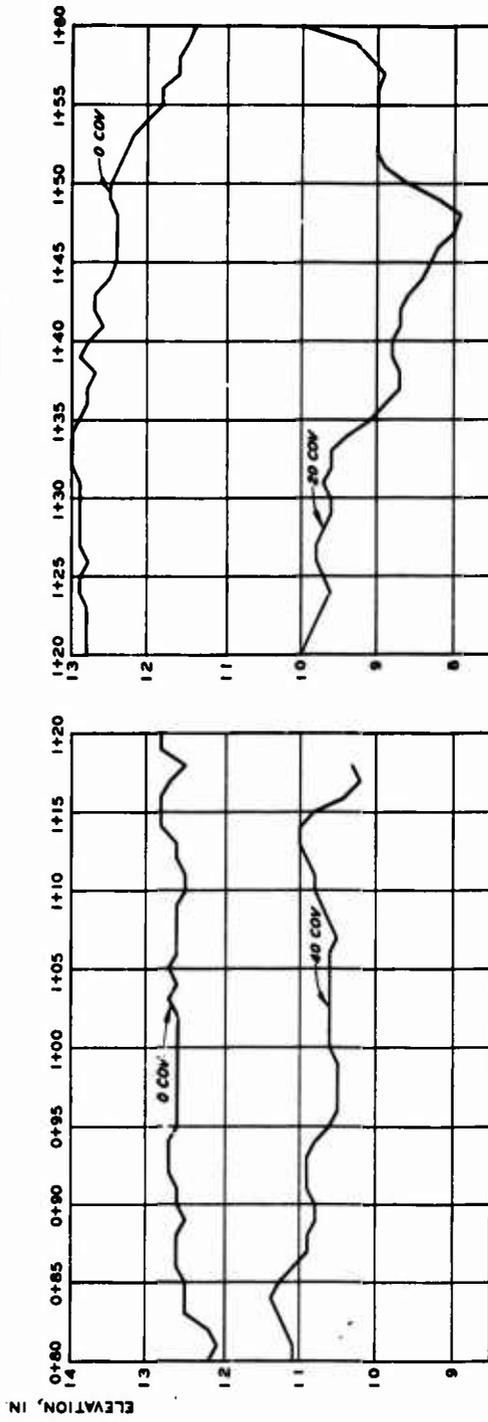
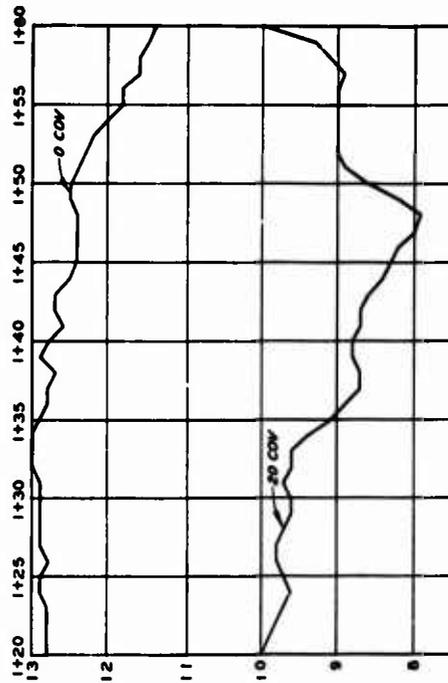
PROFILES
TEST SECTION 2, LANE 2

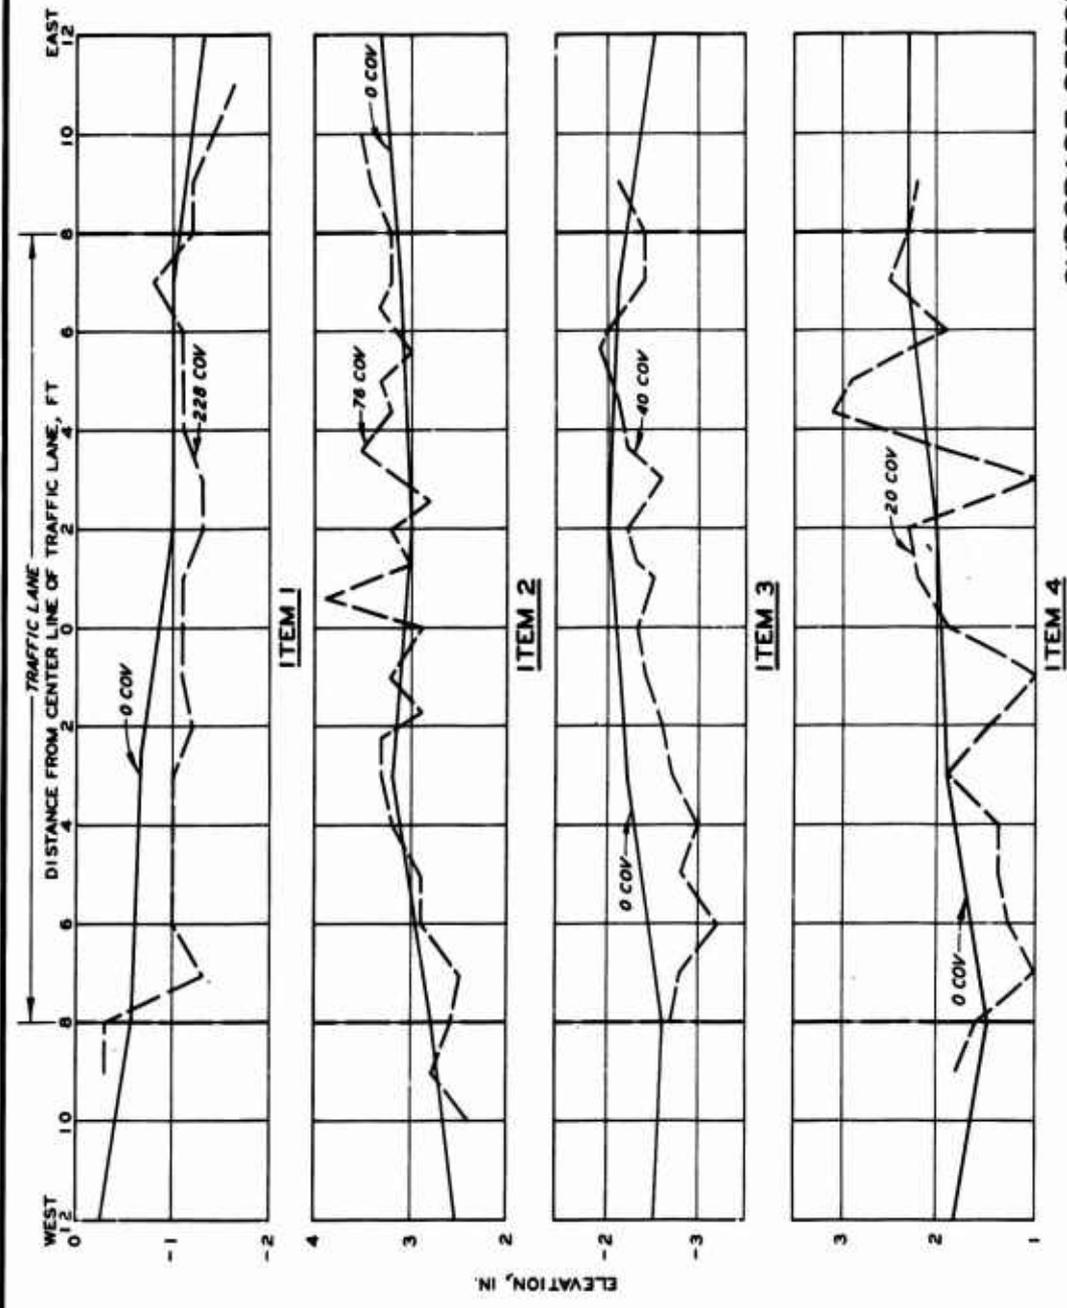
SUBGRADE DEFORMATIONS
TEST SECTION 2, LANE 2

39. Subgrade deformation (items 1-4). Typical cross sections of the interface of the two soil layers in each item are shown in plate 11. These data indicate that the failures noted in the surface of each item were contributed to by deformation in the soil below the interface of the two layers.

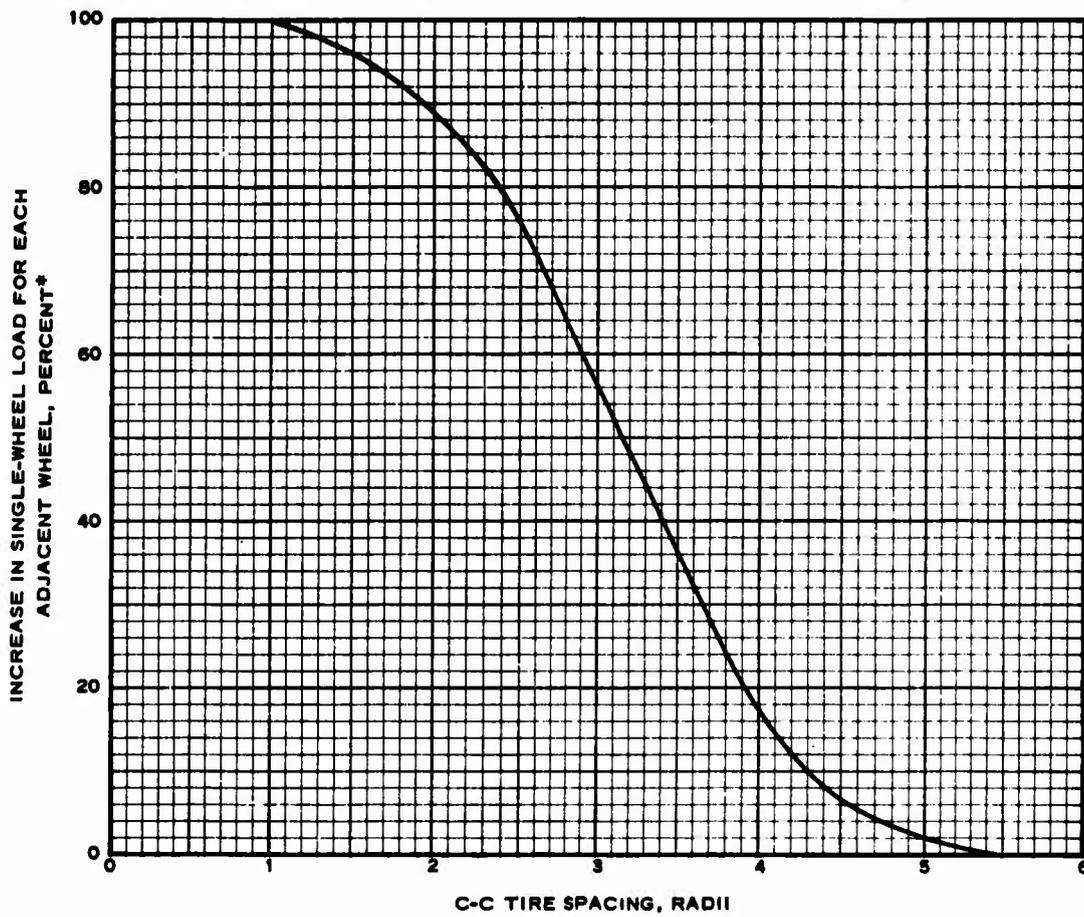
PLATE 13

* INCREASE IN LOAD ON A SINGLE WHEEL OF A MULTIPLE-WHEEL GEAR TO ACCOUNT FOR EFFECTS OF ADJACENT WHEELS OF THE MULTIPLE-WHEEL GEAR IN ARRIVING AT AN EQUIVALENT SINGLE-WHEEL LOAD.

EQUIVALENT SINGLE-WHEEL
LOAD-ADJUSTMENT CURVE
FOR UNSURFACED SOILS

43. The ESWL's were determined by use of plate 13. This plate shows wheel spacing versus the percent influence that one wheel has on another. The wheel spacing is expressed in radii and is determined by dividing the wheel spacing in inches by the radius of a circle having the same area as the contact area of one tire. The percent influence that one wheel has on another represents the amount that one wheel load

must be increased to determine the ESWL. For the C-5A, the least spacing between two wheels is 34 in. Since the contact area of one tire is 195 sq in., the radius of this area is $\sqrt{195/\pi}$, or 7.89 in. The spacing between the tires is, therefore, $34/7.89 = 4.31$ -in. radii. From plate 13, the influence of one wheel on the other is found to be 10 percent. The ESWL is, therefore, $21,000 \text{ lb} \times 1.10 = 23,100 \text{ lb}$. The other wheels of the assembly are spaced so that they have no influence on the ESWL.

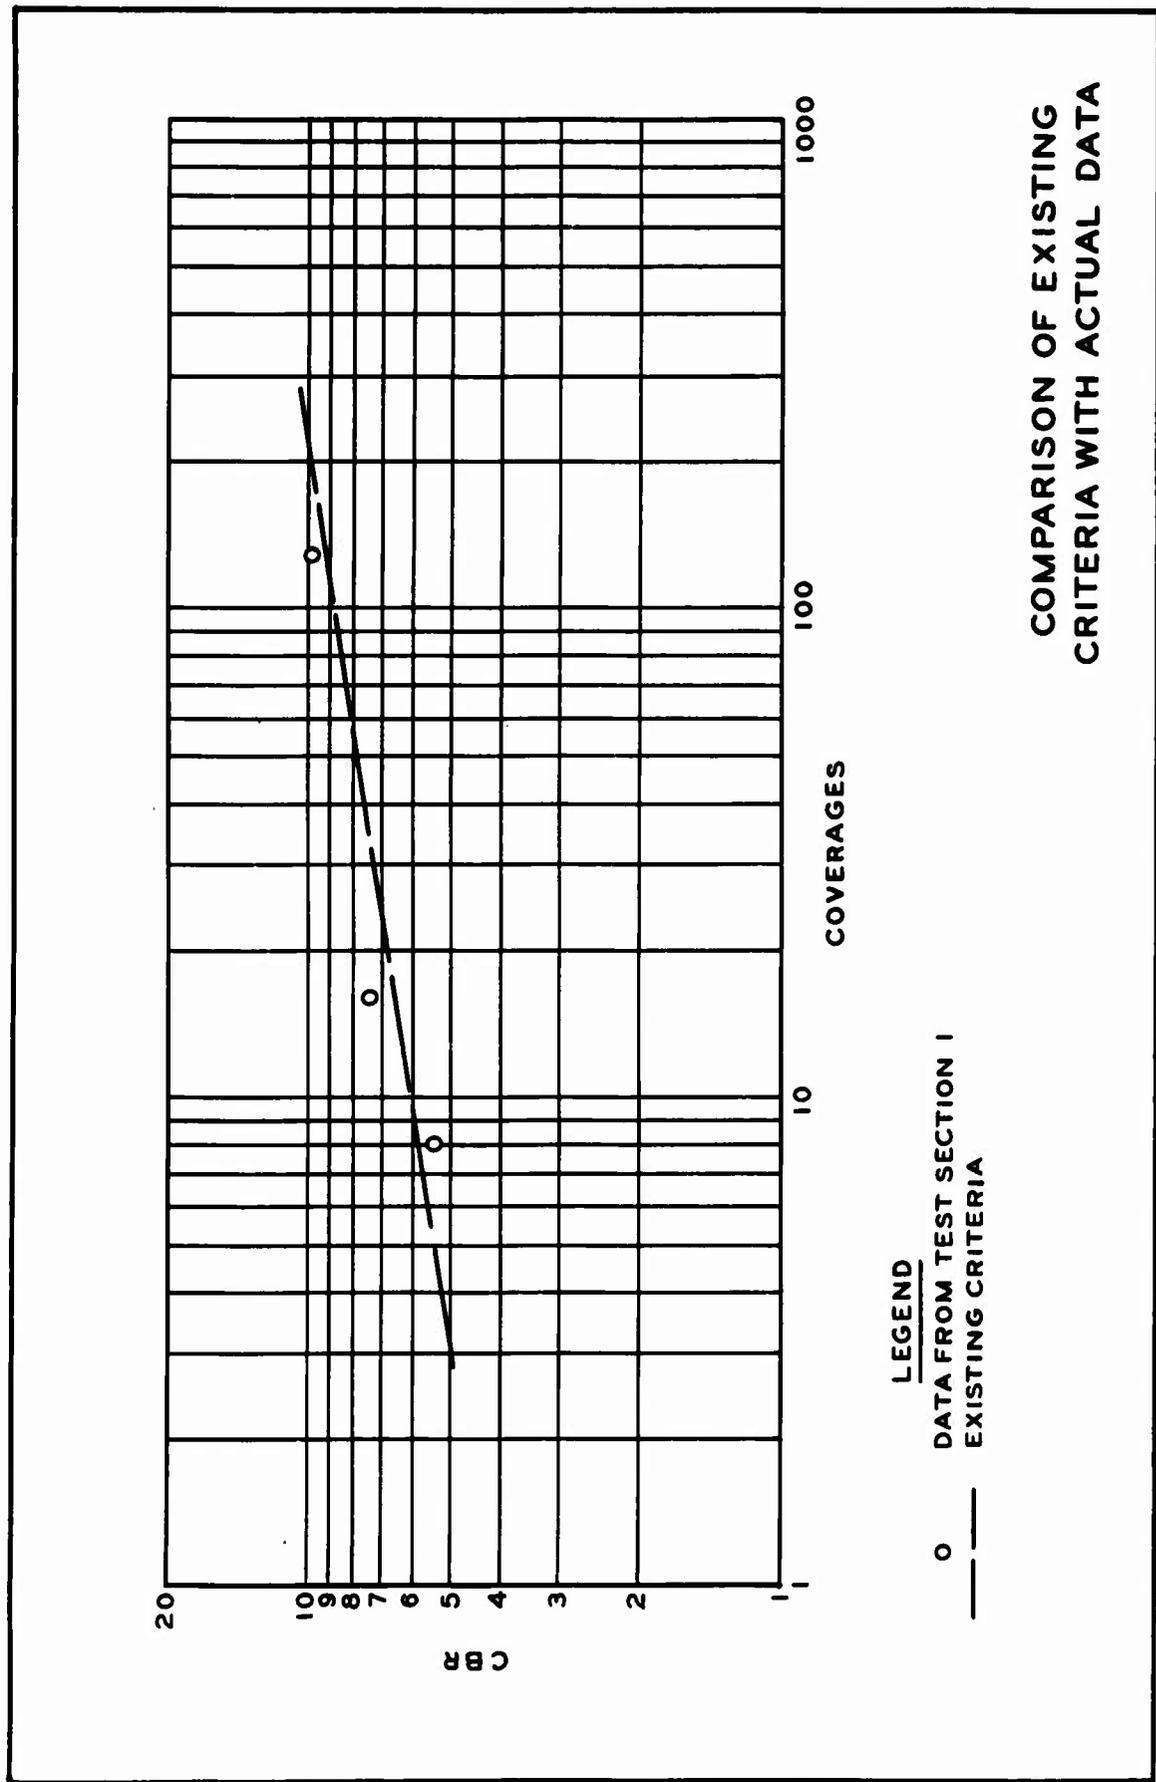
PLATE 14

COMPARISON OF EXISTING
CRITERIA WITH ACTUAL DATA

LEGEND
 ○ DATA FROM TEST SECTION I
 — EXISTING CRITERIA

44. A plot of the actual test results is shown in plate 14. This is a plot of coverages versus CBR for the load and tire pressure used in the test. In order to see how these test results compared with the existing criteria, the nomograph was used to estimate the number of coverages that the test items should have sustained. These data were then plotted as a curve in plate 14. As can be seen, the test points fall reasonably close to the curve. The differences that exist between the test points and the criteria can perhaps be attributed to the inability to accurately measure the CBR. Since a change in the rated CBR by as little as $1/2$ CBR would place the test points almost on top of the criteria curve, it is considered that the test results correlate reasonably well with the existing criteria and that the nomograph can be used in the design of unsurfaced airfields to accommodate C-5A aircraft.

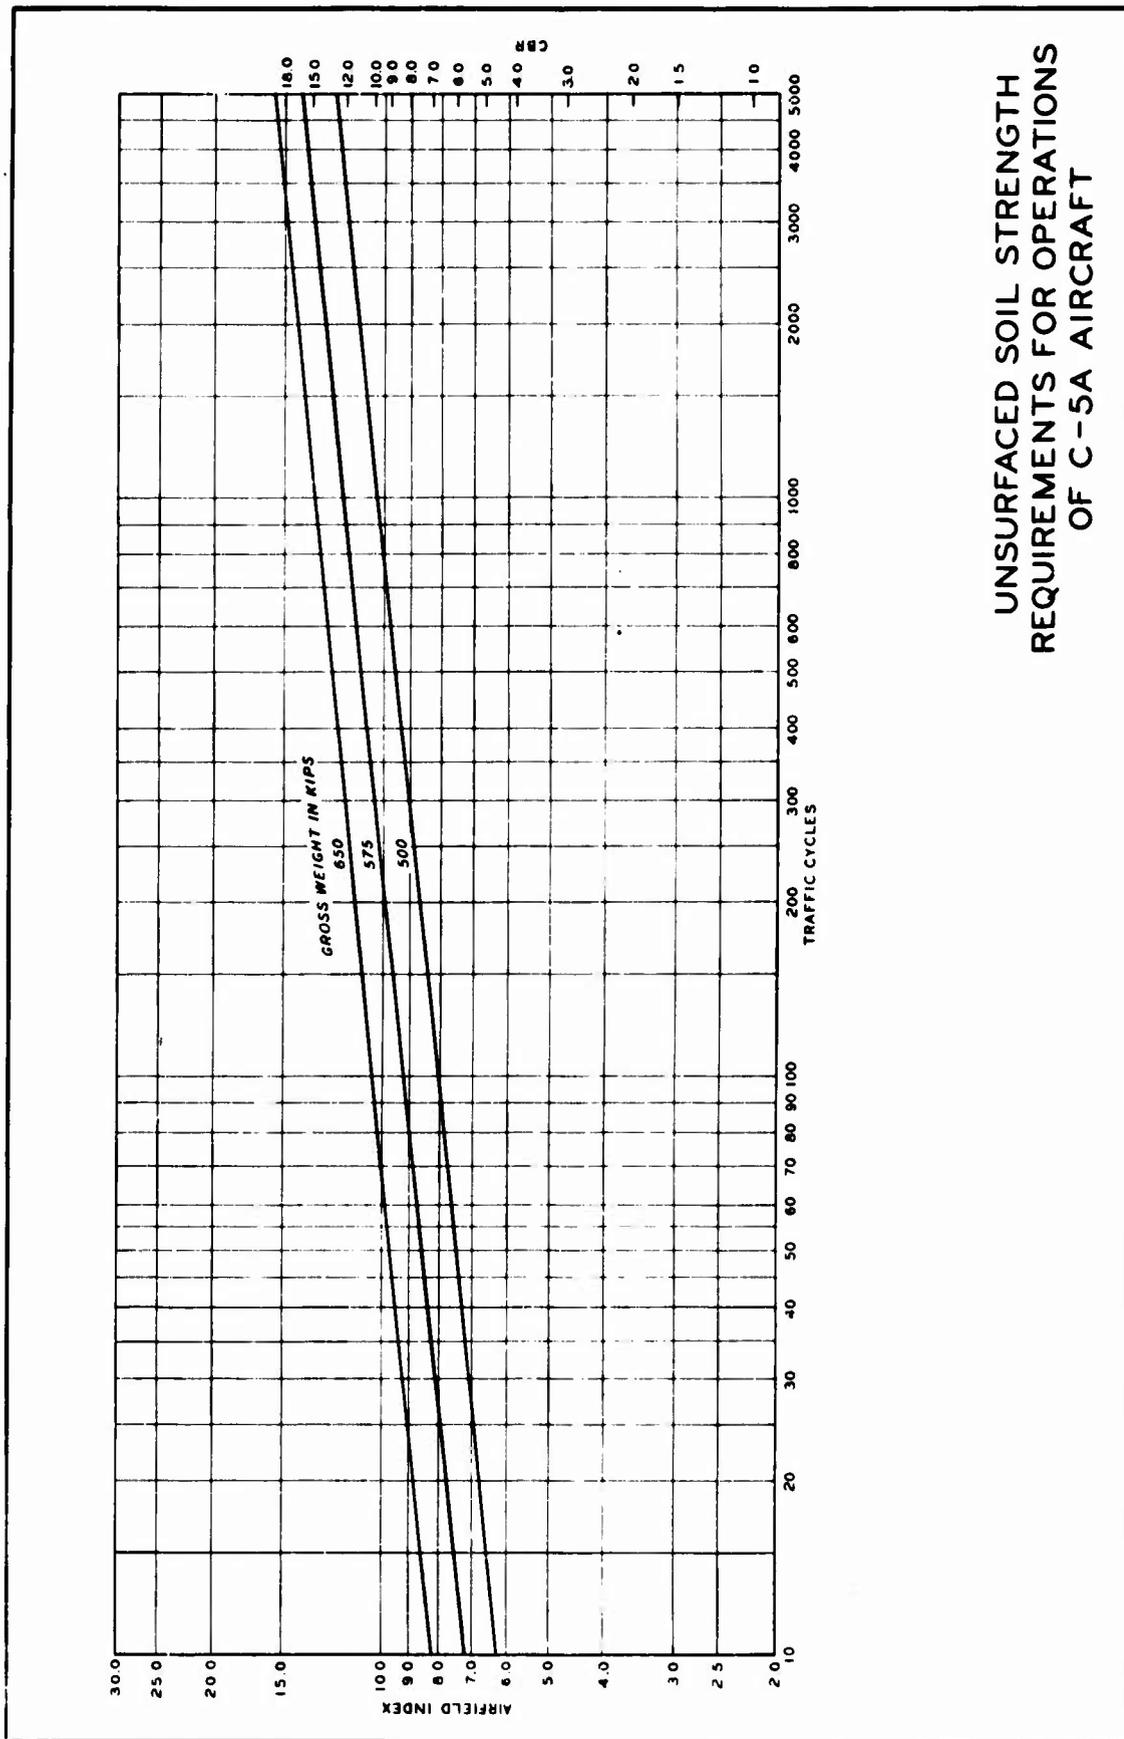
UNSURFACED SOIL STRENGTH
REQUIREMENTS FOR OPERATIONS
OF C-5A AIRCRAFT

45. Specific design curves for determining the soil surface strength required to support operations of C-5A are shown in plate 15. These curves relate traffic cycles to CBR and airfield index. The nomograph, plate 12, presents traffic in terms of coverages. However, traffic cycle, as used in plate 15, is a more common term and is related to coverages by a cycles per coverage factor of 0.69. Also, soil strength, in a military situation, is normally measured in terms of airfield index, not CBR; therefore, the airfield index is shown along with CBR in plate 15.
