MISCELLANEOUS PAPER NO. 4-789

EVALUATION OF BUTLER AM2 LANDING MAT

Naval Air Engineering Center
Philadelphia, Pennsylvania.

U. S. Army Engineer Waterways Experiment Station
CORPS OF ENGINEERS
Vicksburg, Mississippi

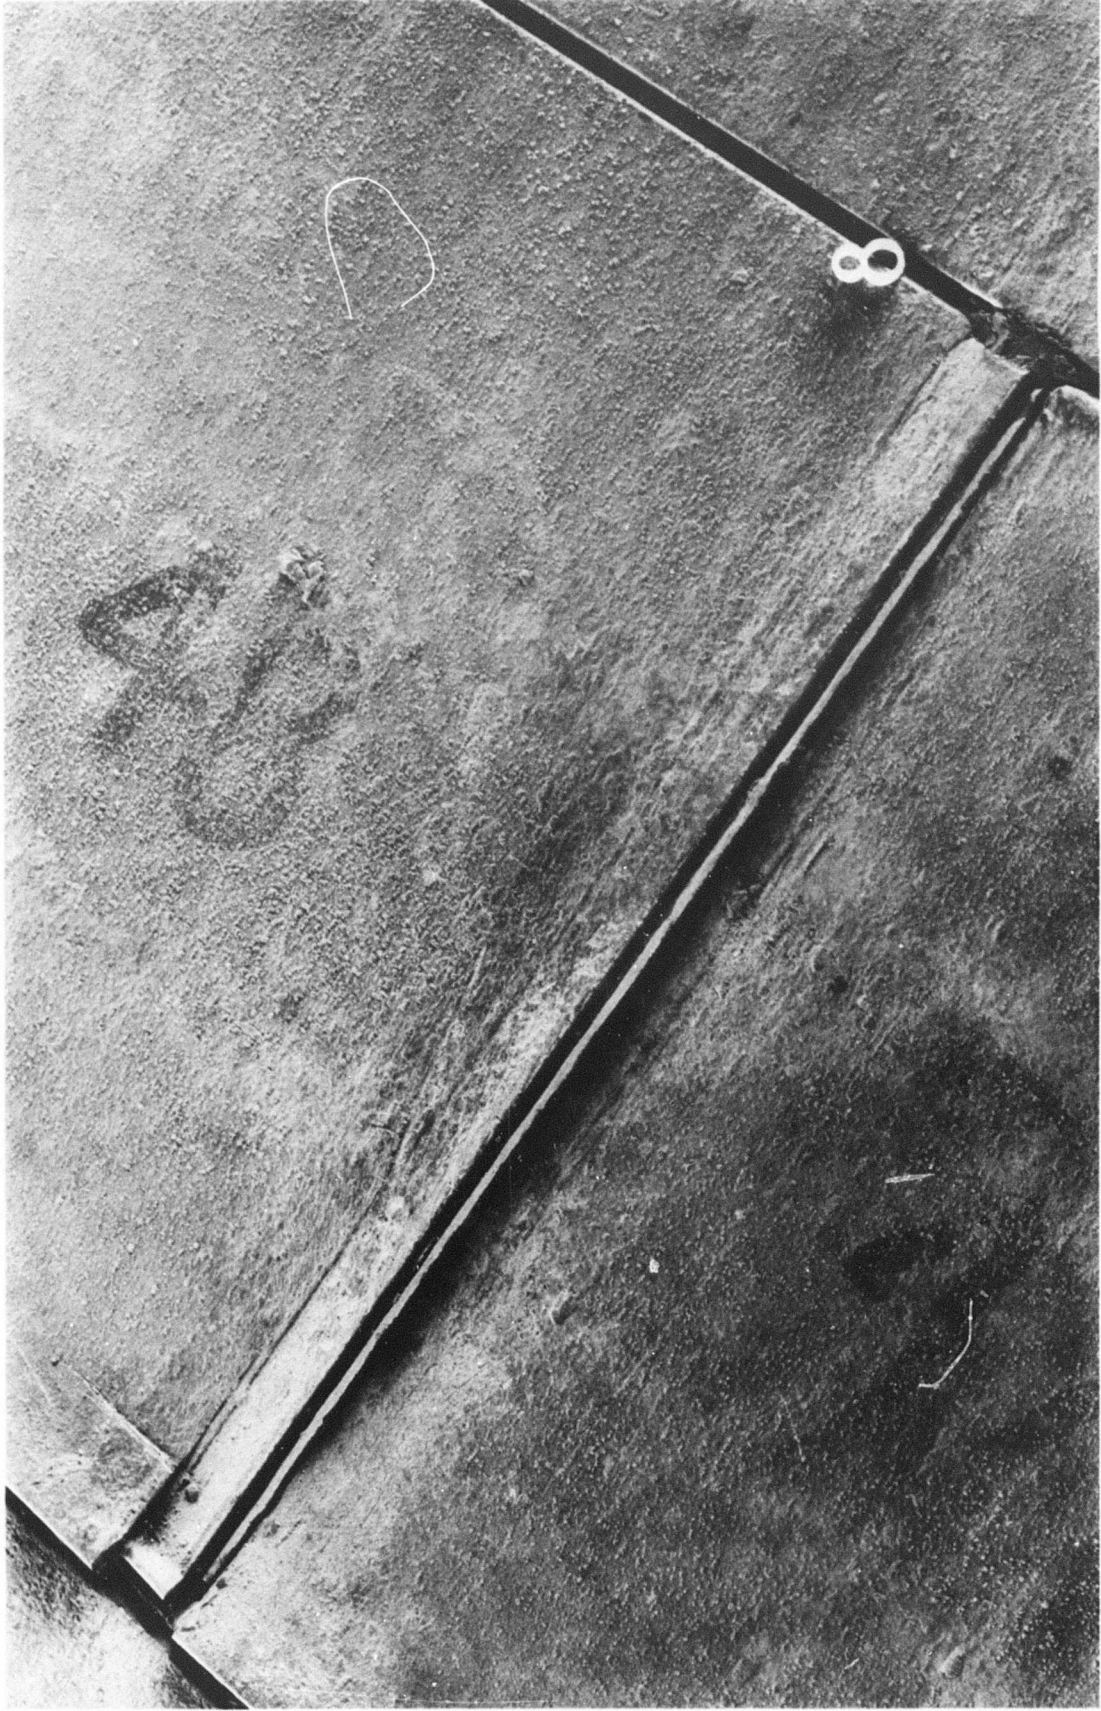
Photograph 8. Sheared end joint in item 2 after 150 coverages
of 27,000-lb single-wheel load

26. The same progressive type end-joint failures noted in item 1 occurred in item 2. The first sheared end joint occurred at 100 coverages, and seven more of these failures were noted by the end of 120 coverages of traffic. Photograph 8 shows a sheared end joint with a small tear in the top skin at 150 coverages when traffic was stopped. Several top skin tears were noted, but their occurrence followed the failure of the end joint. A general view of item 2 after 150 coverages is seen in photograph 9. As indicated by the uneven traffic lines in photograph 9, a considerable amount of lateral shifting of the mat occurred during trafficking.
