MISCELLANEOUS PAPER NO. 4-788

EVALUATION OF AM2 LANDING MAT
REPLACEMENT PANELS AND
KEYLOCK ASSEMBLIES

Naval Air Engineering Center
Philadelphia, Pennsylvania

U. S. Army Engineer Waterways Experiment Station
CORPS OF ENGINEERS
Vicksburg, Mississippi

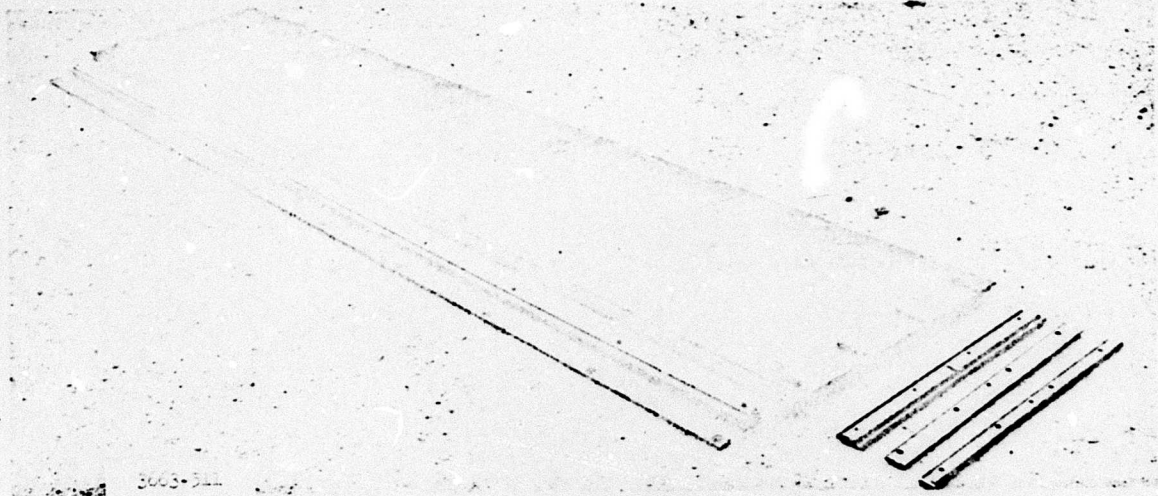
5. The replacement panels, fabricated by Harvey Aluminum Company, Torrance, Calif., are 10 ft long, 2 ft wide, about 1-1/2 in. thick, and average about 145 lb in weight. Figs. 1 and 2 show a replacement panel

Fig. 1. Unassembled AM2 landing mat replacement panel

with the side and end connectors disassembled and assembled, respectively. The side connector consists of two pieces which are held in place on the panel by ten 3/8-in. Allen screws and the end connector consists of three pieces which are held together and in place on the panel by four Allen screws. The four screws for the end connector are recessed in vertical-walled counterbores and the 10 screws for the side connector are countersunk.

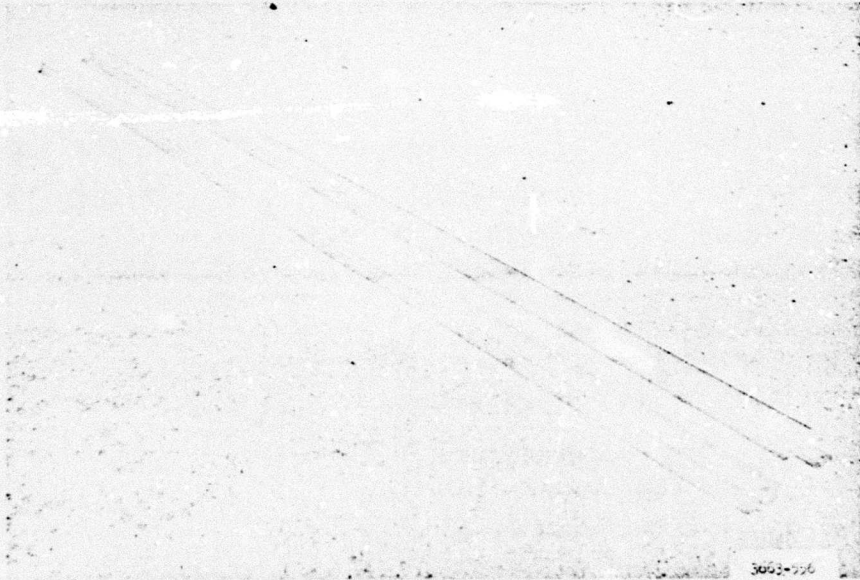
6. The keylock assemblies were also fabricated by Harvey. They are 12 ft long, 4 in. wide, and weigh about 22 lb. The standard keylock assemblies (fig. 3a) have the same side connectors as the AM2 mat. Also tested were modified keylock assemblies (fig. 3b) which had male connectors on both sides, enabling the mat to be placed on both sides. The modified keylocks were about the same size as the standard keylocks and weighed 28 lb each. All of the keylocks were 12 ft long originally, but some were sawed into other lengths to accommodate the unusual mat size combinations. An Allen screw located at the end of the keylocks was used to lock them together.

a. Standard

Fig. 3. Keylock assembly

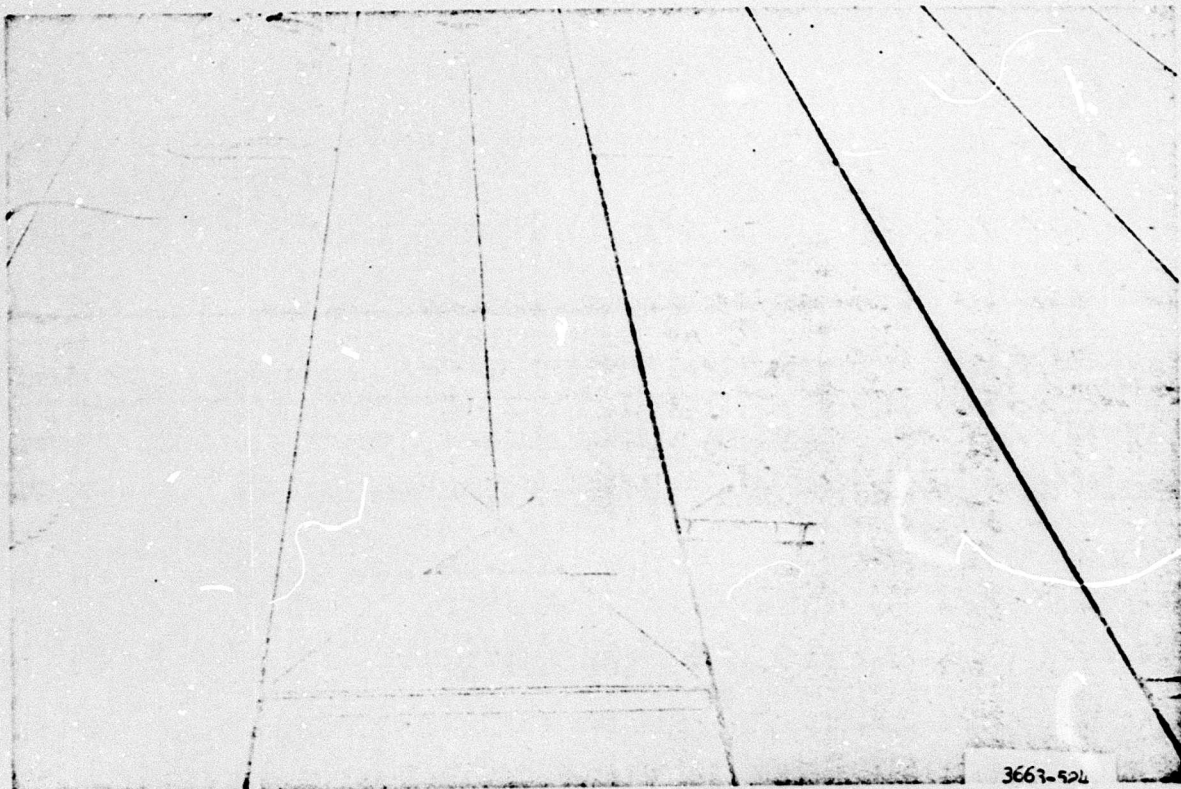
Fig. 6. Small triangles removed from damaged panel.

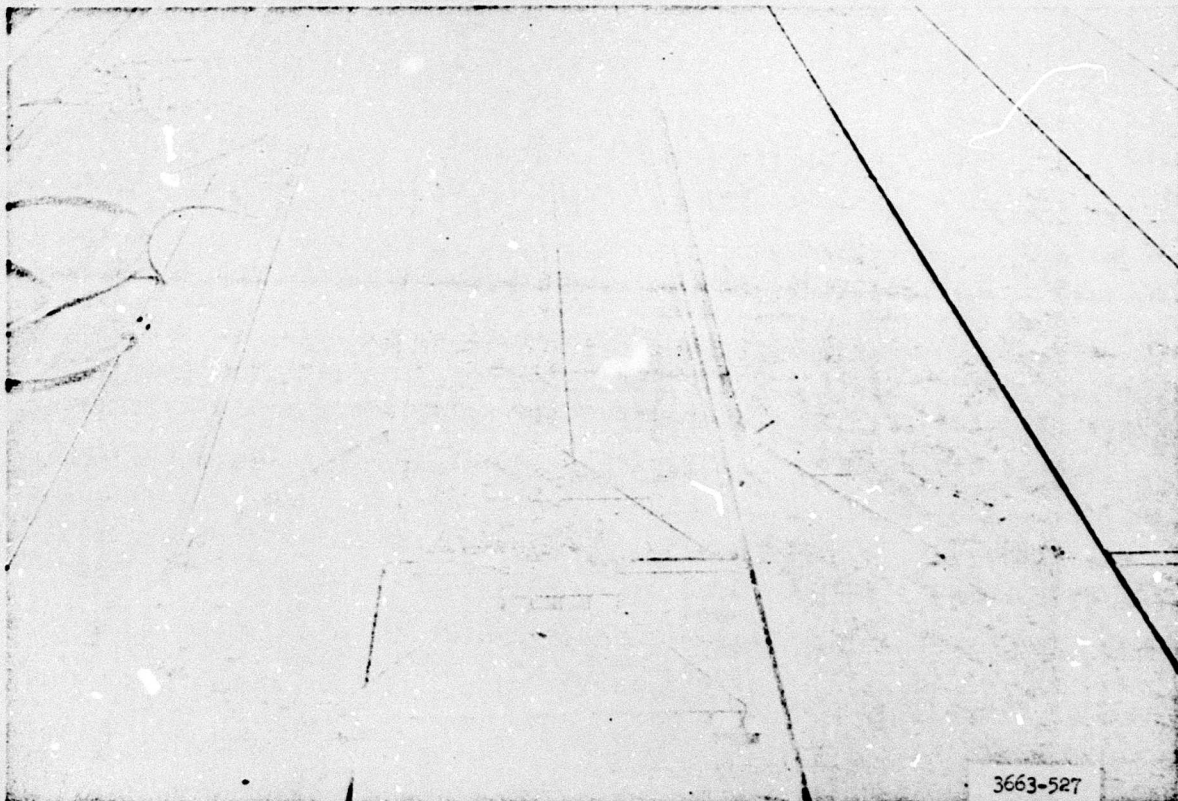
Fig. 8. Entire damaged panel removed
