USAAMRD TECHNICAL REPORT 72-1

WIRE-BRAIDED HOSE CHAFING TESTS

Donald R. Artis, Jr.

January 1972

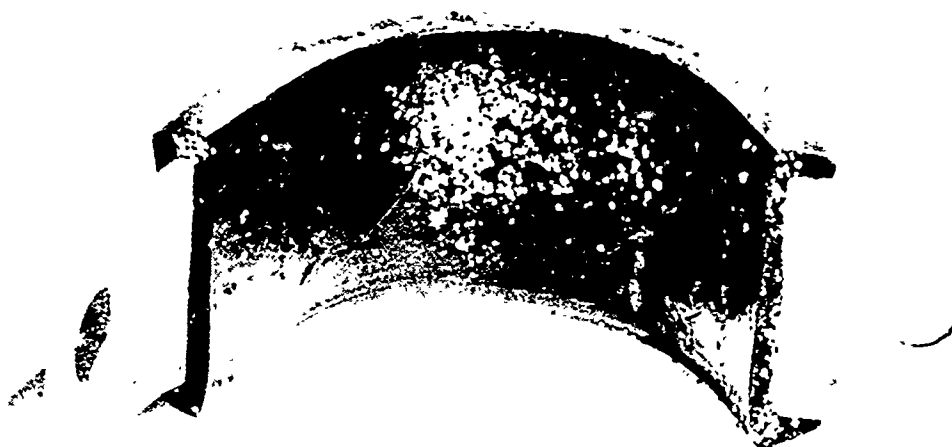
Figure 58. Test Specimen 42AC Clamp No. 8
(100,000 Seconds Test Time).

One additional test was conducted to determine if a failure could be induced by vibrating a hose within a loose-fitting hose clamp when the clamp and hose are covered with hydraulic fluid and sand. No wear of either the hose or the clamp was detected; therefore, this potential mode of failure was not considered to be significant.
