Operation

NOUGAT

SHOT HARD HAT

PROJECT OFFICERS REPORT—PROJECT 3.6

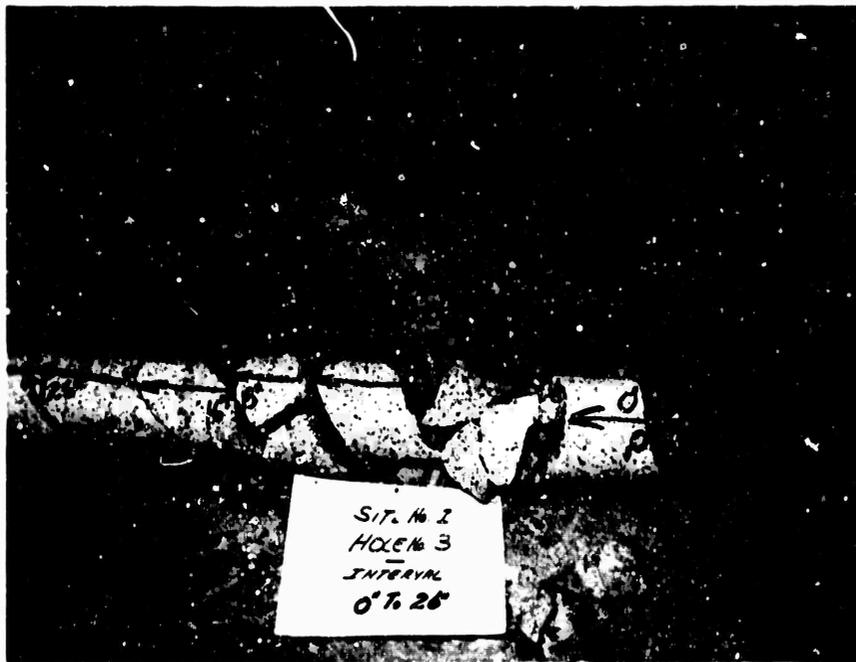
Figure 6a Site 1, Hole 3, interval 0 feet to 26 inches, core sampling. (DASA 435-03-NTS-62)

- 1) No deformation measurement could be obtained between the collar of the hole and a depth of 32 inches because of blasting fracture, Figure 6a.

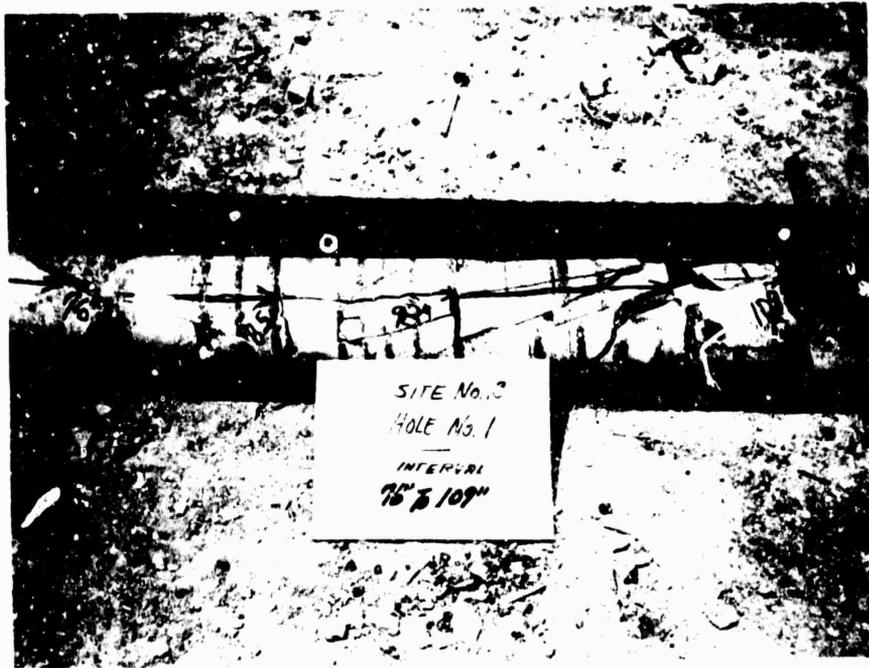
Figure 7c Site 2, Hole 1, interval 76 to 109 inches, core sampling. (DASA 451-07-NTS-62)

- 1) The first 30 inches of the hole were fractured, Figure 7a, presumably from blasting. Also, a fractured zone occurred between 85 and 109 inches, Figure 7c. The extent of the fracture in this hole limited the number of deformation measurements.
- 2) The maximum stress ($S = 2,150$ psi) occurred at a depth of 30 inches, and S decreased to a minimum of 750 psi at 114 inches.
- 3) The stress at the end of Hole 1 did not level off, but further measurement was discontinued because of drilling difficulty.
- 4) The direction of the secondary principal stresses was relatively constant and inclined at an angle of 60° from the vertical.

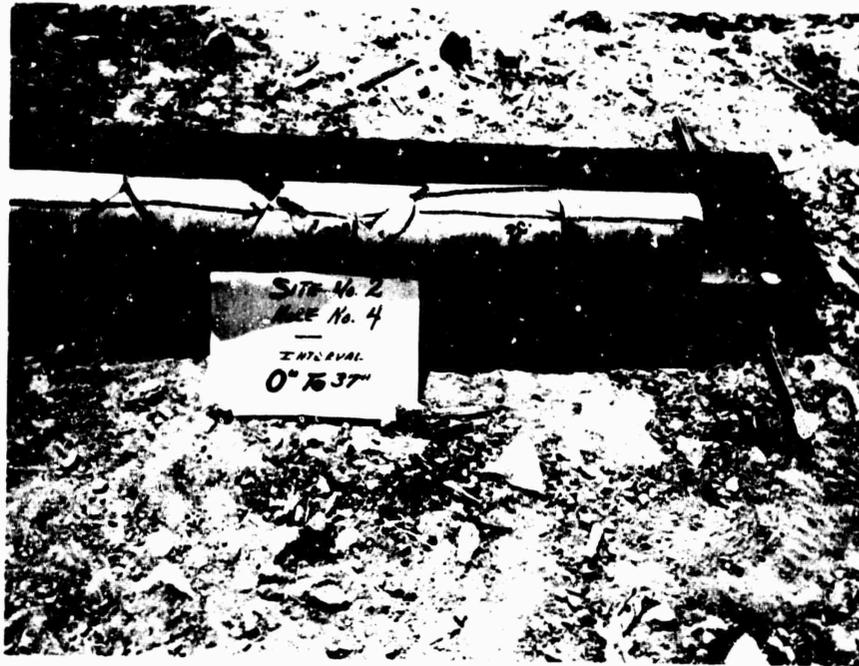
Figure 10a Site 2, Hole 4, interval 0 to 37 inches, core sampling. (DASA 451-08-NTS-62)

- 1) The rock was heavily fractured to a depth of 24 inches, probably from blasting (Figure 10a). Also, there was a fracture zone near the end of the hole.
- 2) From a depth of 24 to 42 inches, the rock stress was almost hydrostatic, that is, $S = T$, and the magnitude of S and T indicated a near-surface stress relaxation. From 42 to 96 inches, S and T went through a weak maximum (peak at 72 inches) with S = 1,350 psi (maximum). From 96 to 120, S leveled off at 1,125 psi.
- 3) From 70 to 120 inches the direction S was inclined 20° to 25° from the horizontal.
