FATIGUE BEHAVIOR  
OF GRAPHITE COMPOSITES

Final Report  
(9 Feb. 1971 to 8 Feb. 1972)  
February, 1972

IIT RESEARCH INSTITUTE

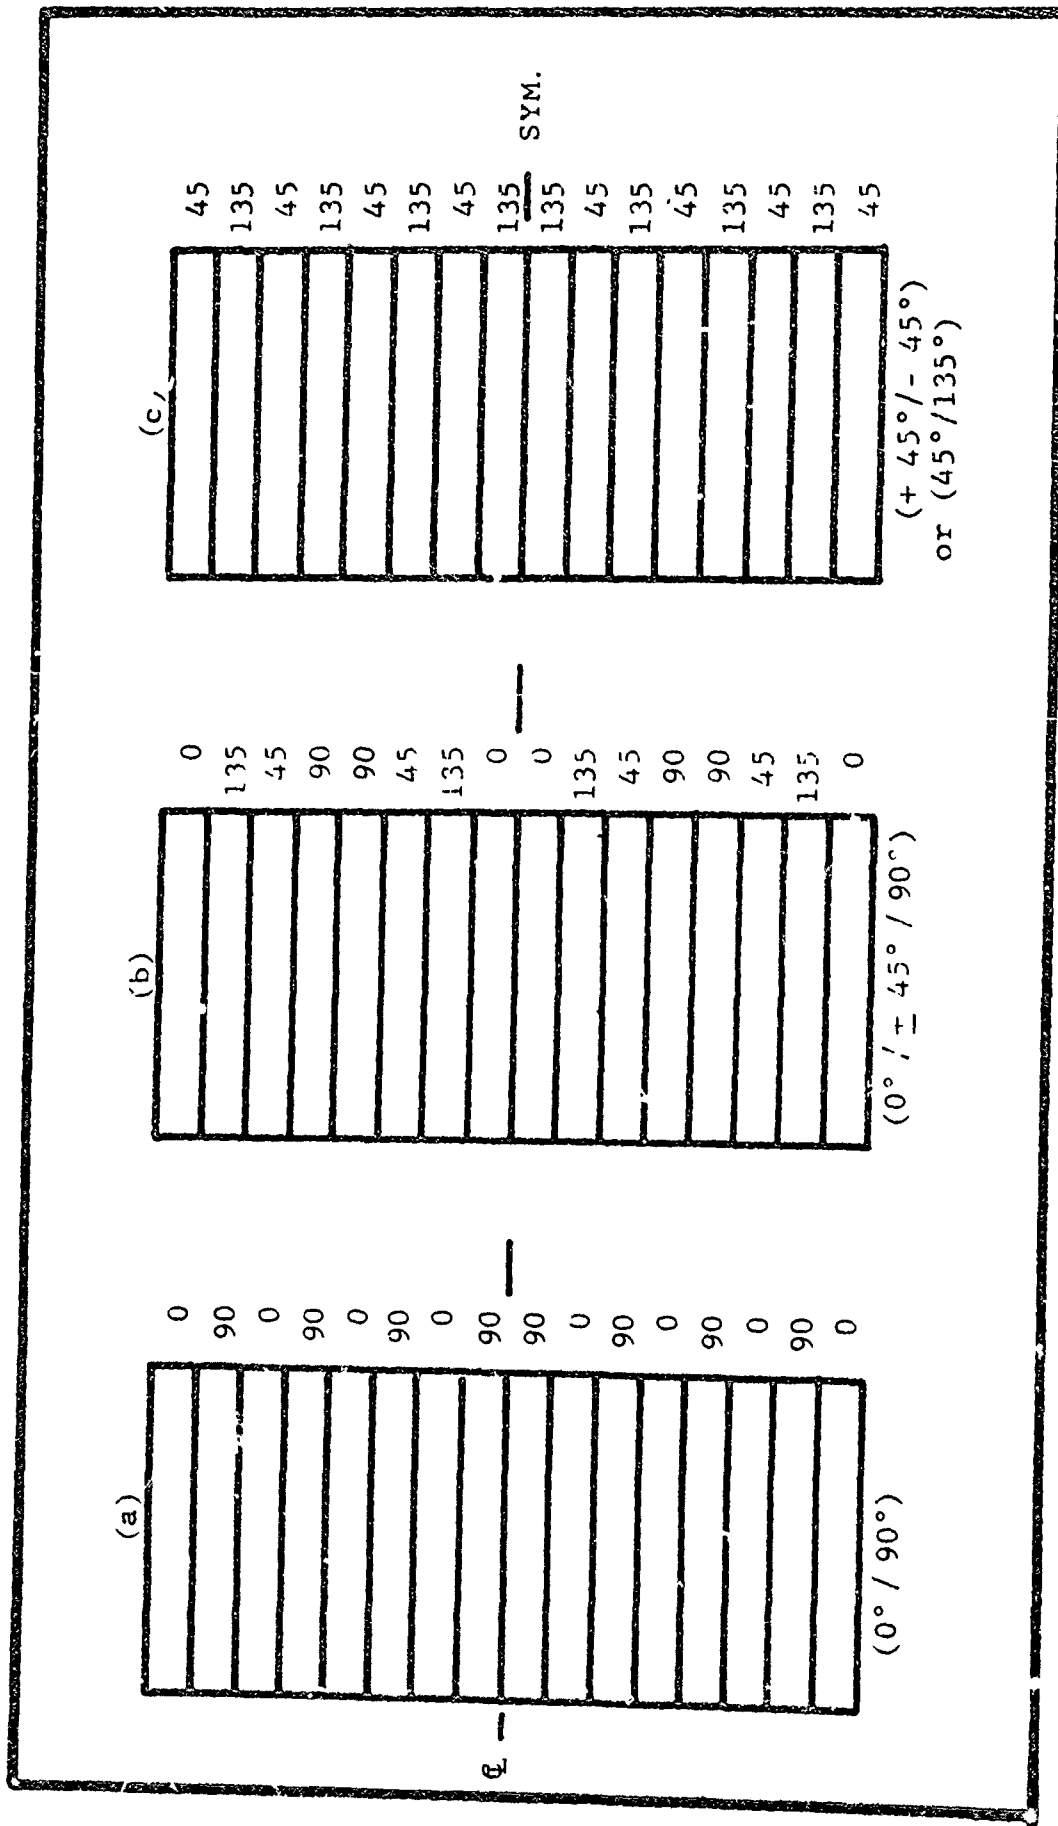
FIG. 1. ORIENTATION DETAILS OF MODMOR II/NARMCO 5206  
PREPEG LAY-UP.

mens required in each category. Where the scrim cloth (104-20 x 20 glass cloth) was employed, it was interleaved between consecutive layers of the graphite prepreg material. The green lay-up was subsequently covered with two bleed cloth layers and finally with a teflon coated glass cloth. Before placing the lay-up in the autoclave, a barrier dam was placed surrounding the whole package to provide the vacuum environment. The cure cycle followed was according to the following schedule:

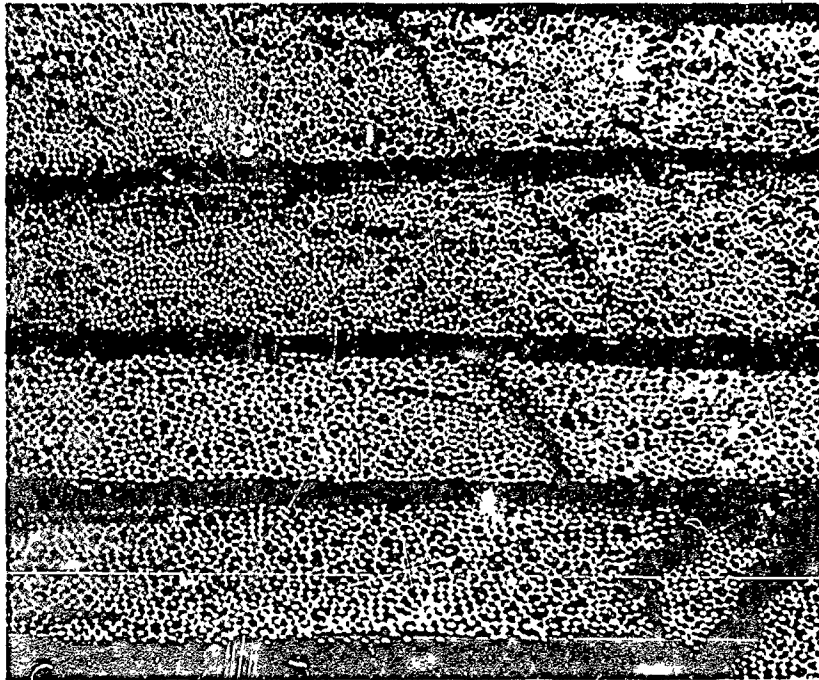
FIG. 7 CROSS SECTIONAL PHOTOMICROGRAPH OF MODMOR II/  
NARMCO 5206 16 PLY COMPOSITE CANTILEVER BEAM  
SPECIMEN SUBJECTED TO FATIGUE ( $R = 0.1$ ) STRESS  
CYCLES AT ROOM TEMPERATURE.

SPECIMEN NO. 7C-12 MAGNIFICATION 100X FIBER  
ORIENTATION  $0^\circ / +45^\circ / 90^\circ$  (WITH SCRIM CLOTH)  
MAXIMUM LOAD 210 LBS. (60.4% OF ULTIMATE)  
NO. OF STRESS CYCLES 100,000

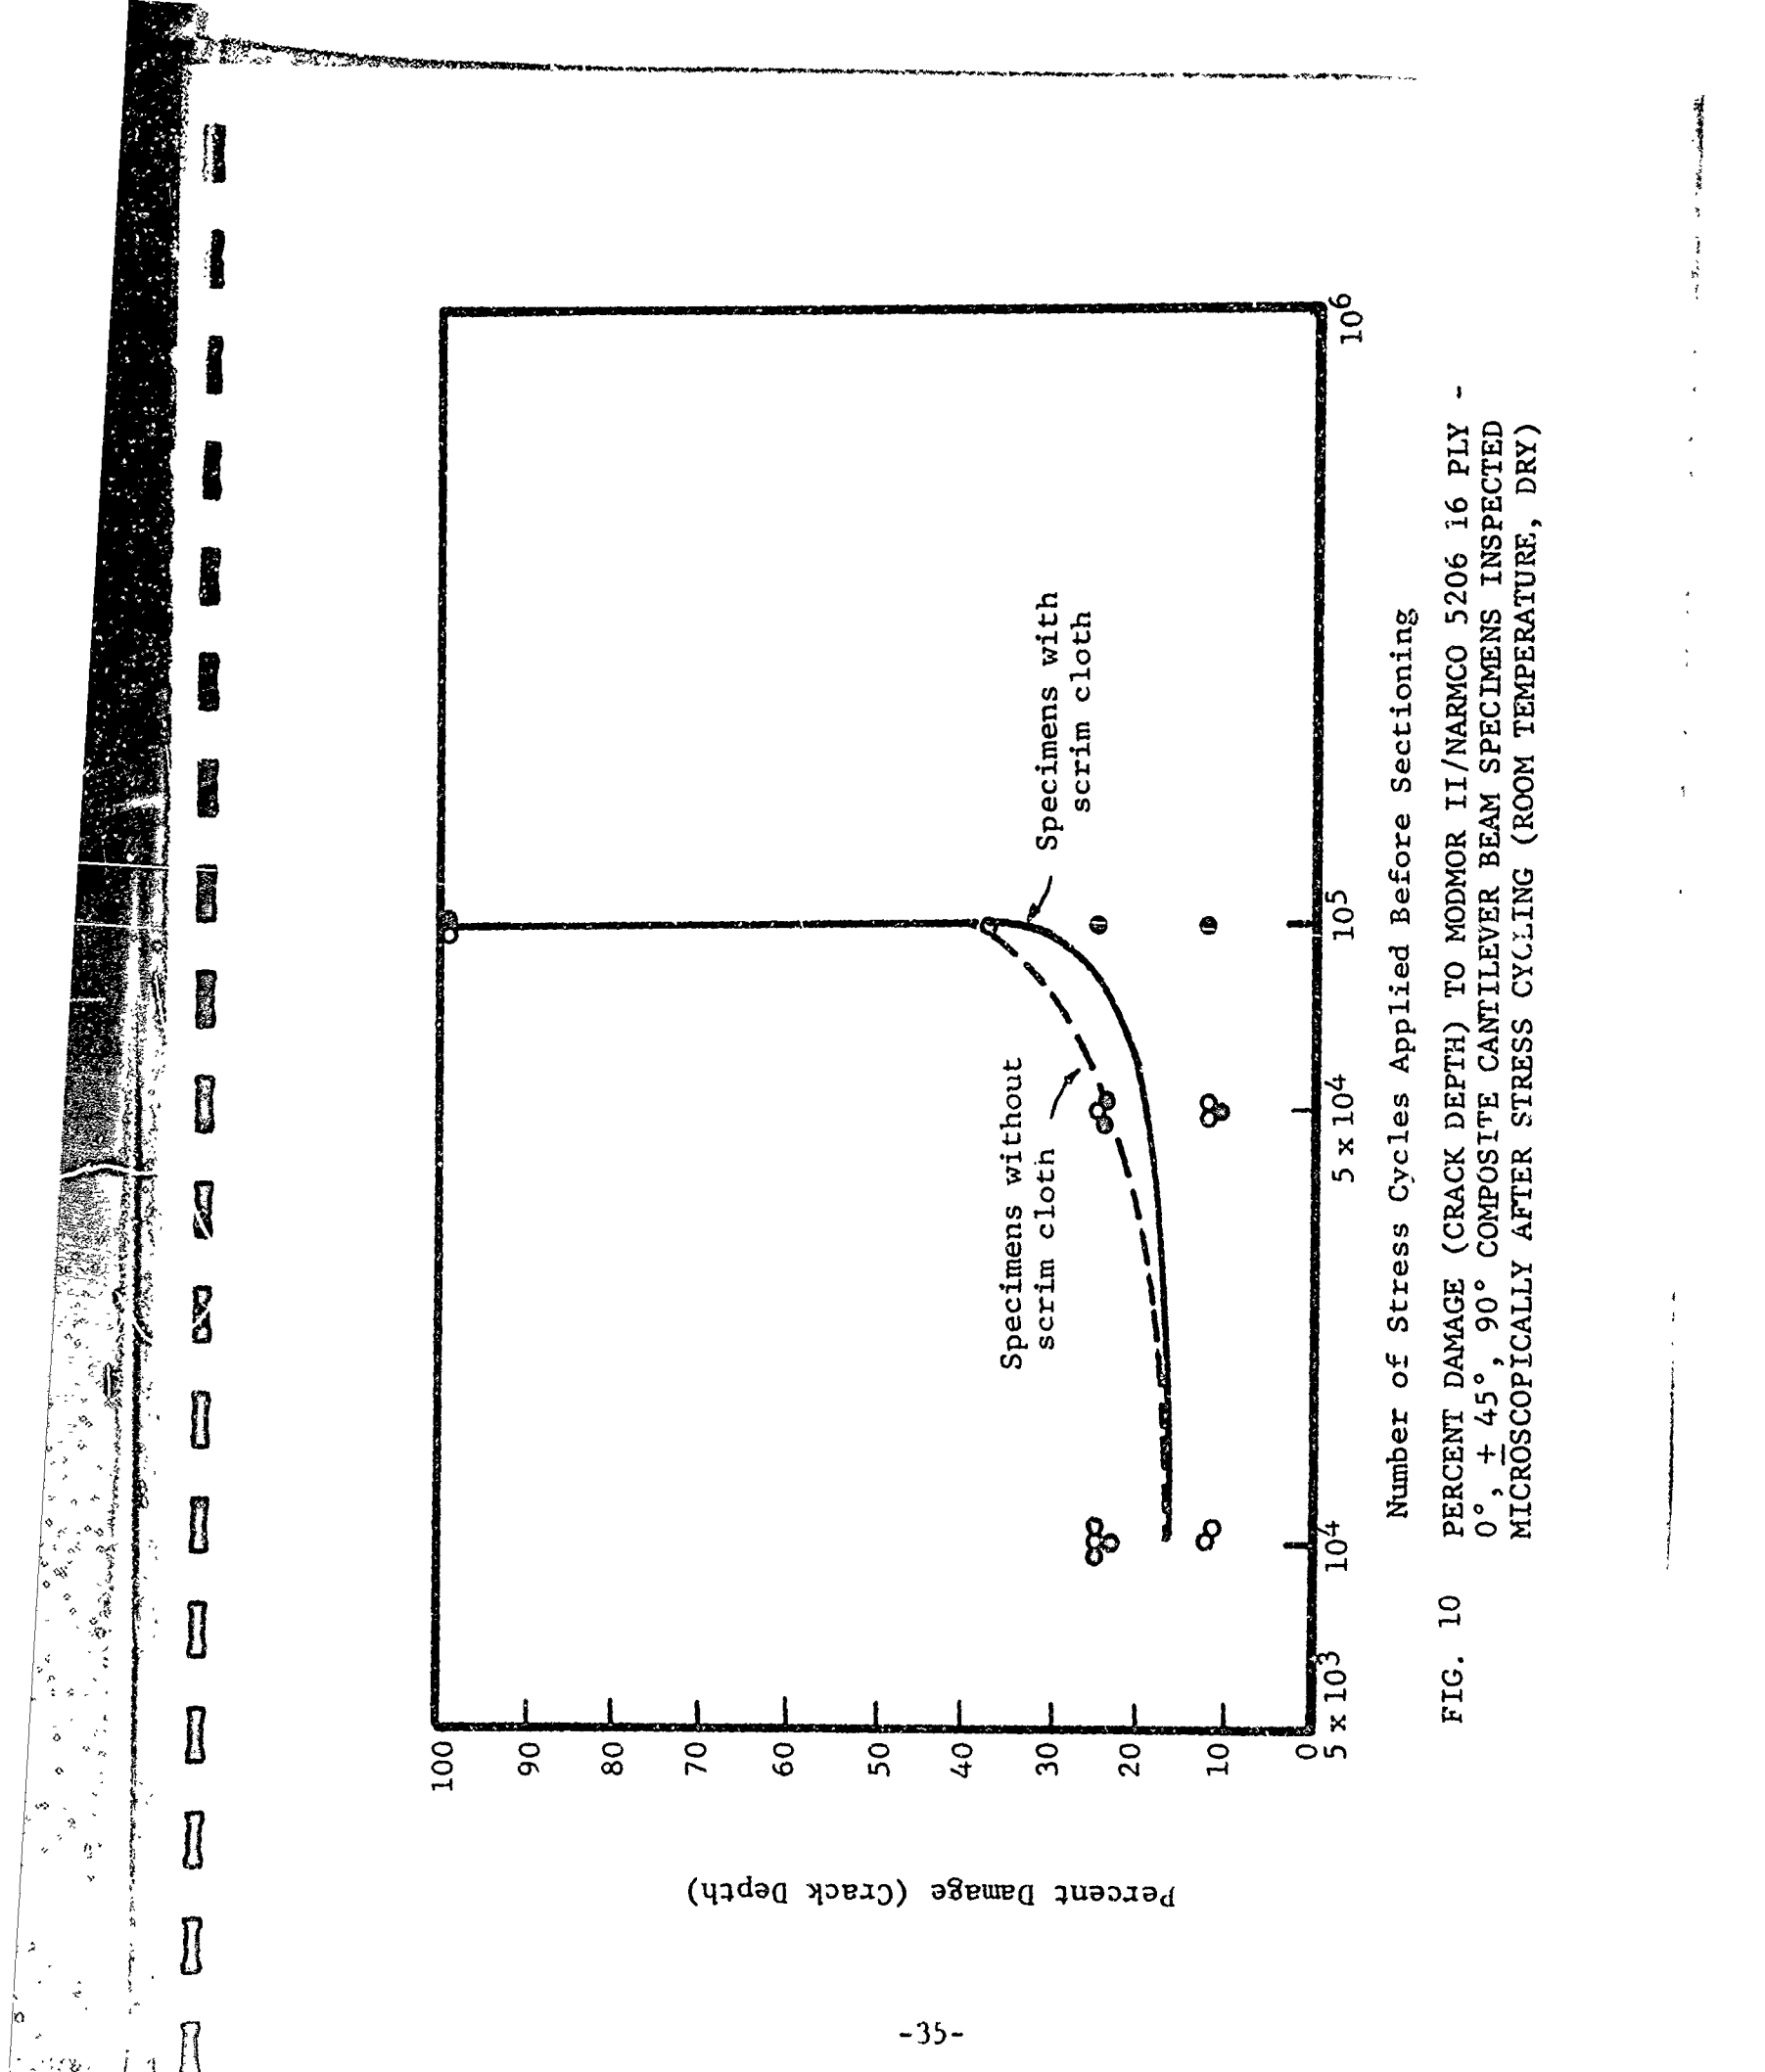
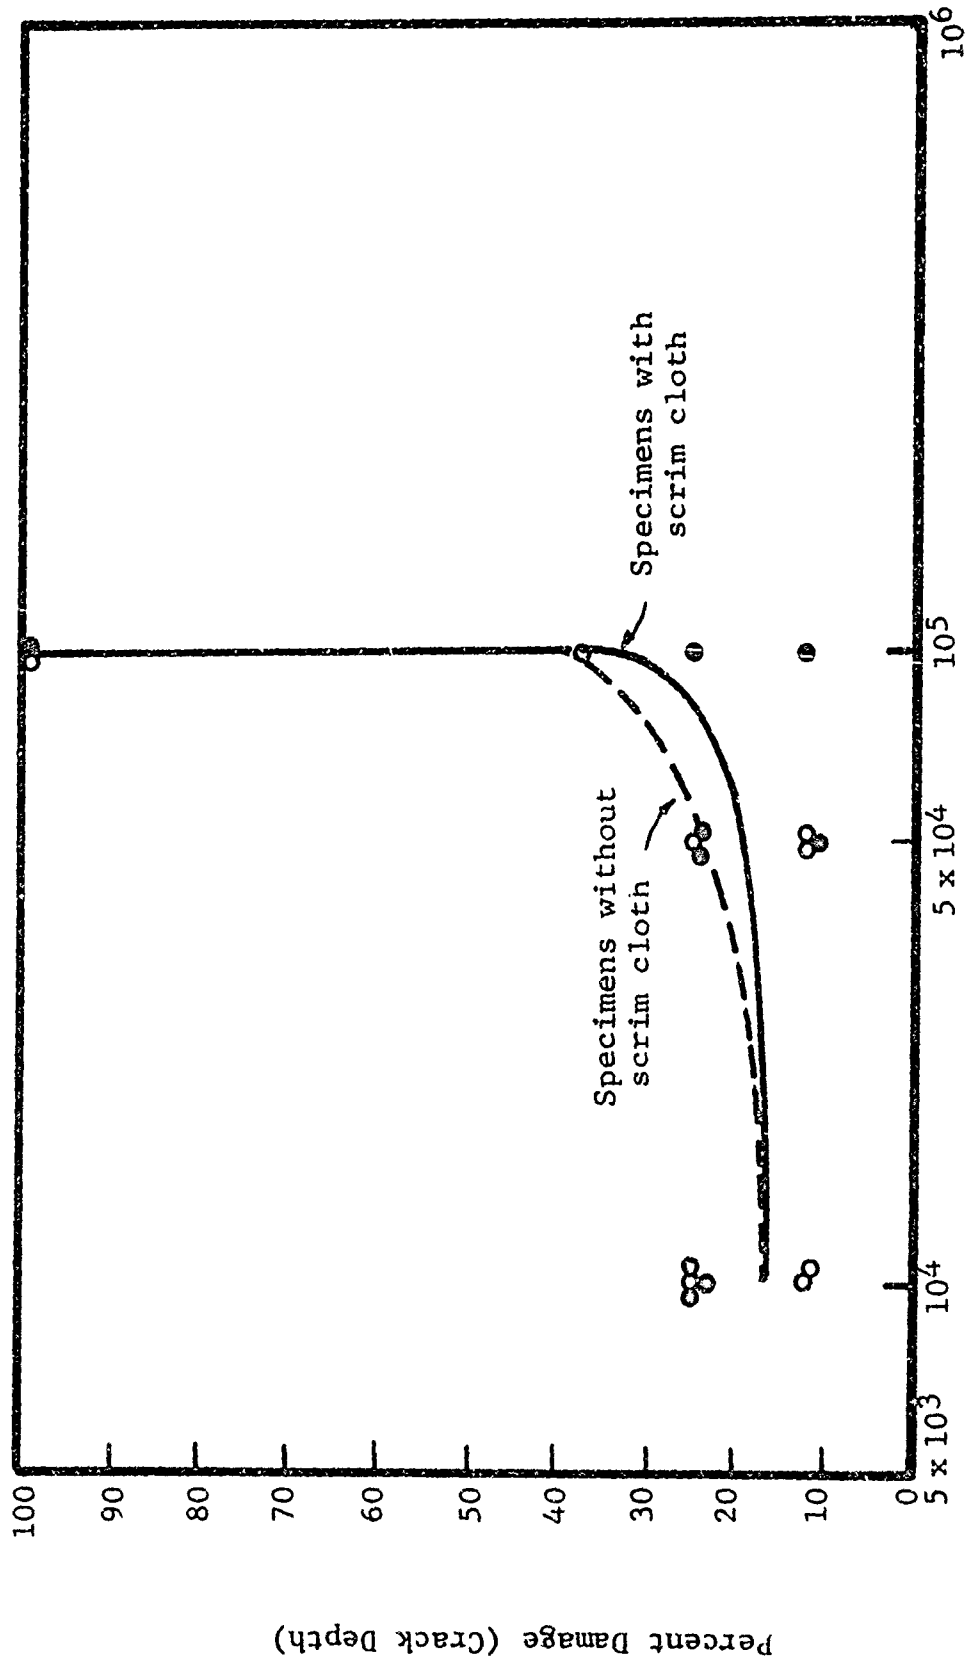
Number of Stress Cycles Applied Before Sectioning

FIG. 10 PERCENT DAMAGE (CRACK DEPTH) TO MODMOR II/NARMCO 5206 16 PLY -  
0°, + 45°, 90° COMPOSITE CANTILEVER BEAM SPECIMENS INSPECTED  
MICROSCOPICALLY AFTER STRESS CYCLING (ROOM TEMPERATURE, DRY)

There is scatter apparent in the data because of discontinuous way in which the cracks penetrate plies. Laminate cracking occurs in stages, from ply to ply, following borders of tows and lamina interfaces rather than continuously as in the case of homogeneous material and thus intermediate stages of damage are not apparent.

It should be noted also that the crack depth in the cross section of the beam at the support does not give an indication of the total area in which cracking has taken place. Thus the total energy required to produce all the crack surfaces has not been accounted for in simple crack depth measurements.

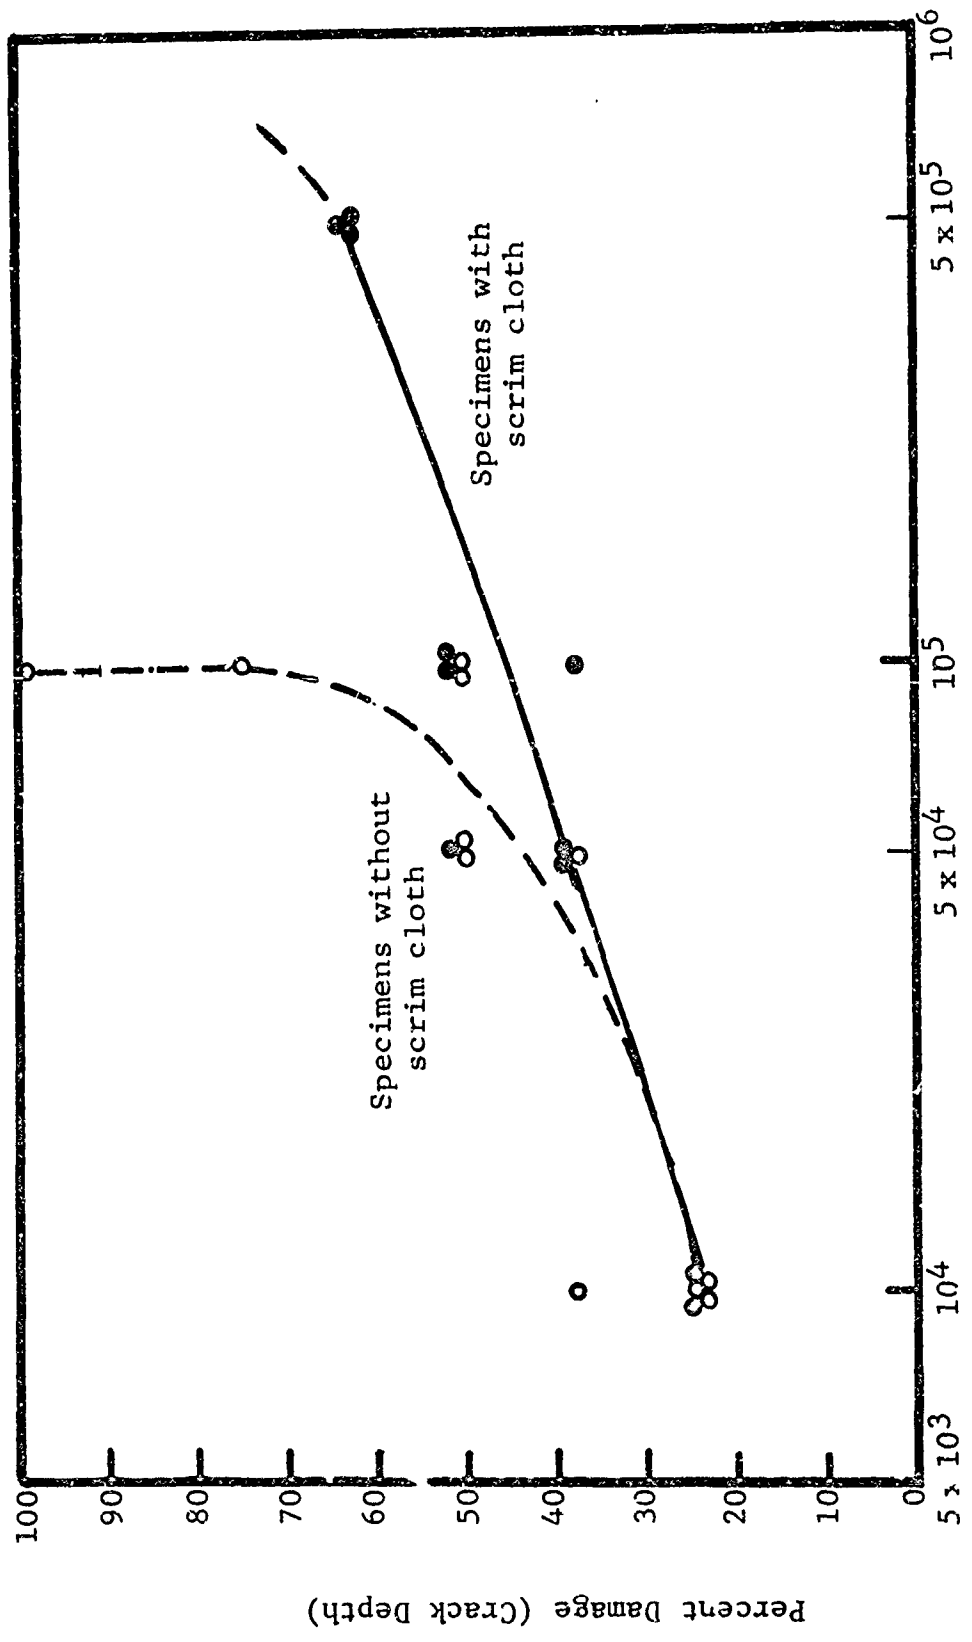
FIG. 11 Number of Stress Cycles applied before Sectioning  
 PERCENT DAMAGE (CRACK DEPTH) TO MODMOR II/NARMCO 5206 16 PLY -  
 45°, 135° COMPOSITE CANTILEVER BEAM SPECIMENS INSPECTED  
 MICROSCOPICALLY AFTER STRESS CYCLING (ROOM TEMPERATURE, DRY)

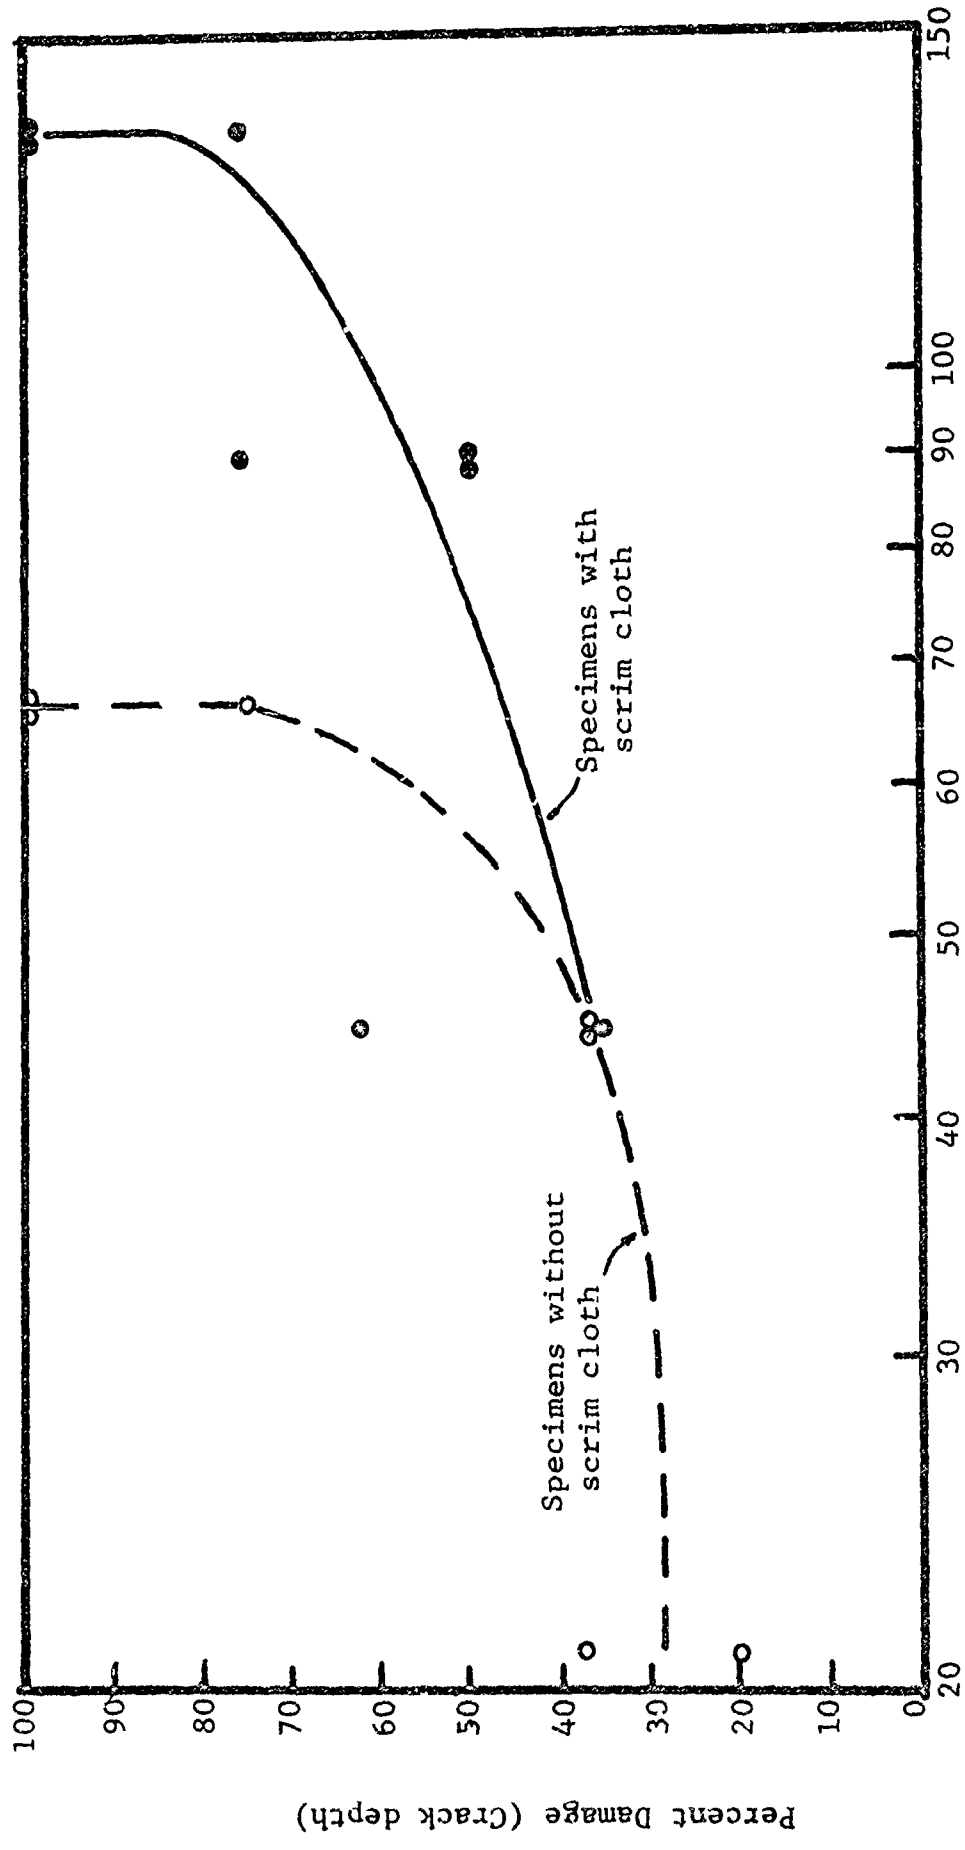
FIG. 12 Number of Fatigue Load Sequences applied before Sectioning  
 PERCENT DAMAGE (CRACK DEPTH) TO MODMOR II/NARMC0 5206 16 PLY - 45°, 135°  
 COMPOSITE CANTILEVER BEAM SPECIMENS INSPECTED MICROSCOPICALLY AFTER SEQUEN-  
 TIAL LOAD FATIGUE (R = 0.1) STRESS CYCLING (ROOM TEMPERATURE, DRY.)

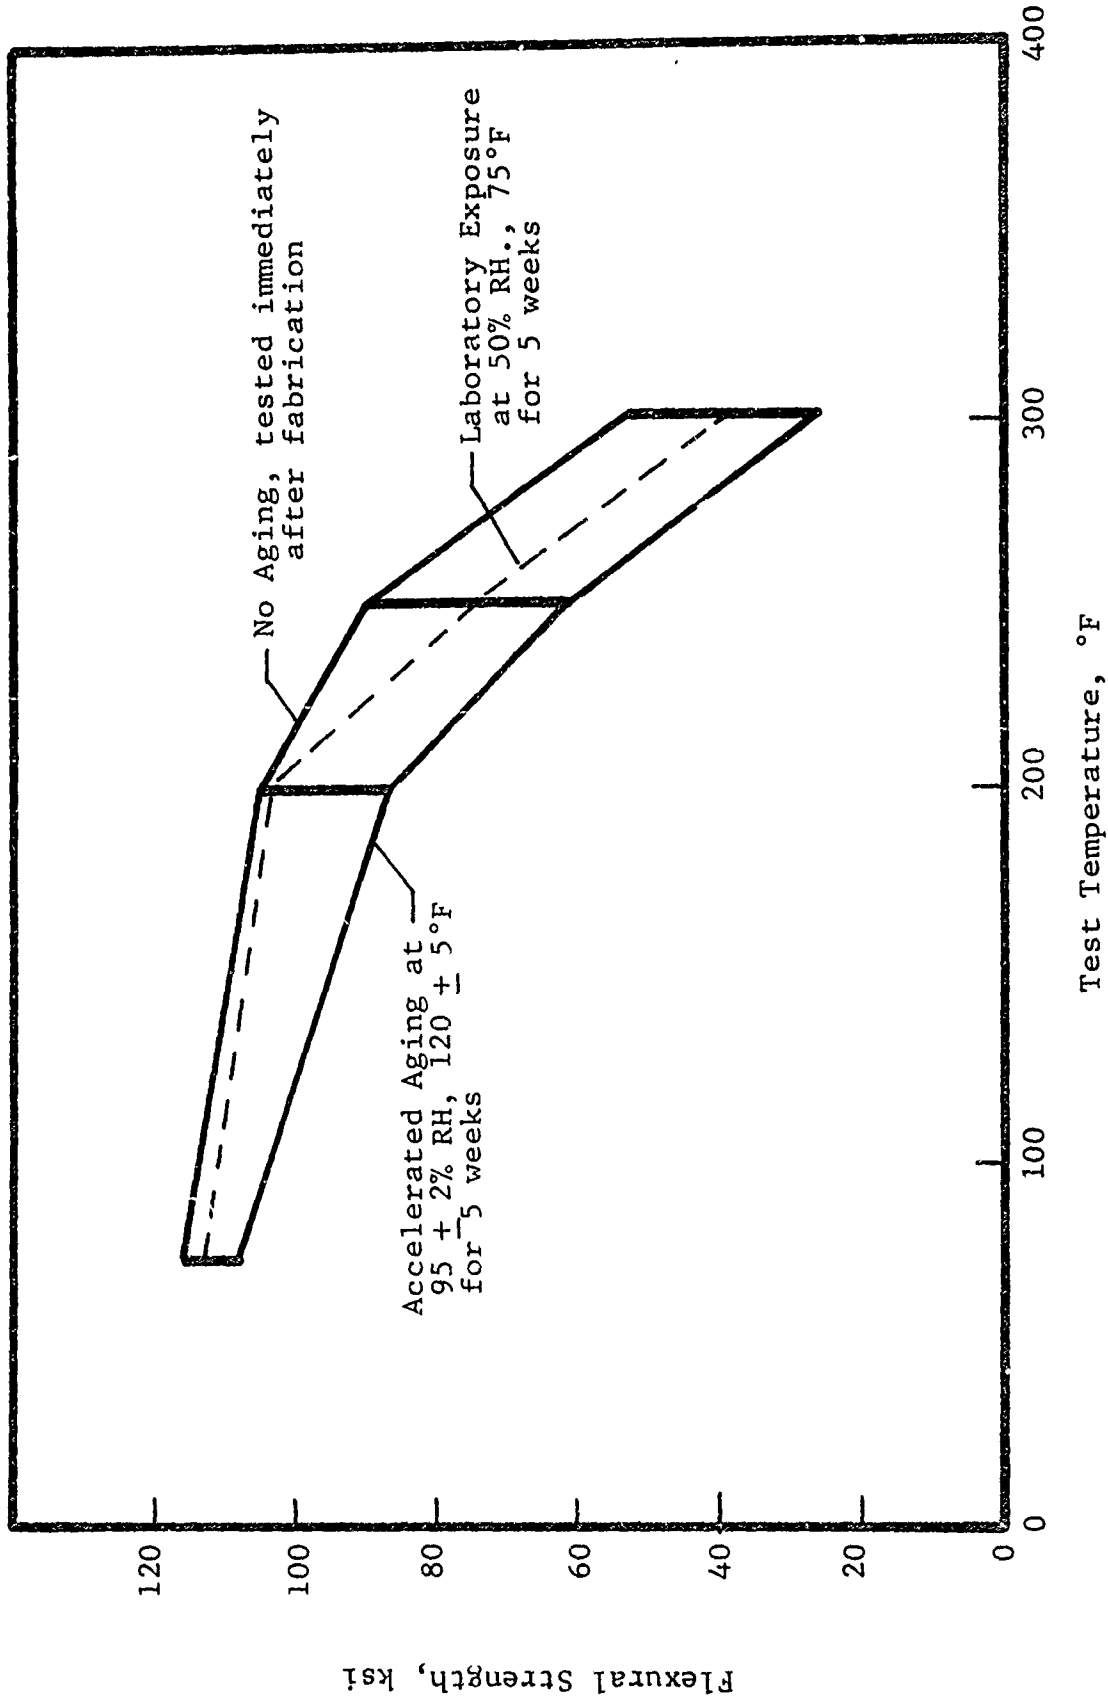
FIG. 14 FLEXURAL STRENGTHS OF MODMOR II/NARMCO 5206 COMPOSITES, 16 PLY - 0°, 90° PLY ORIENTATION

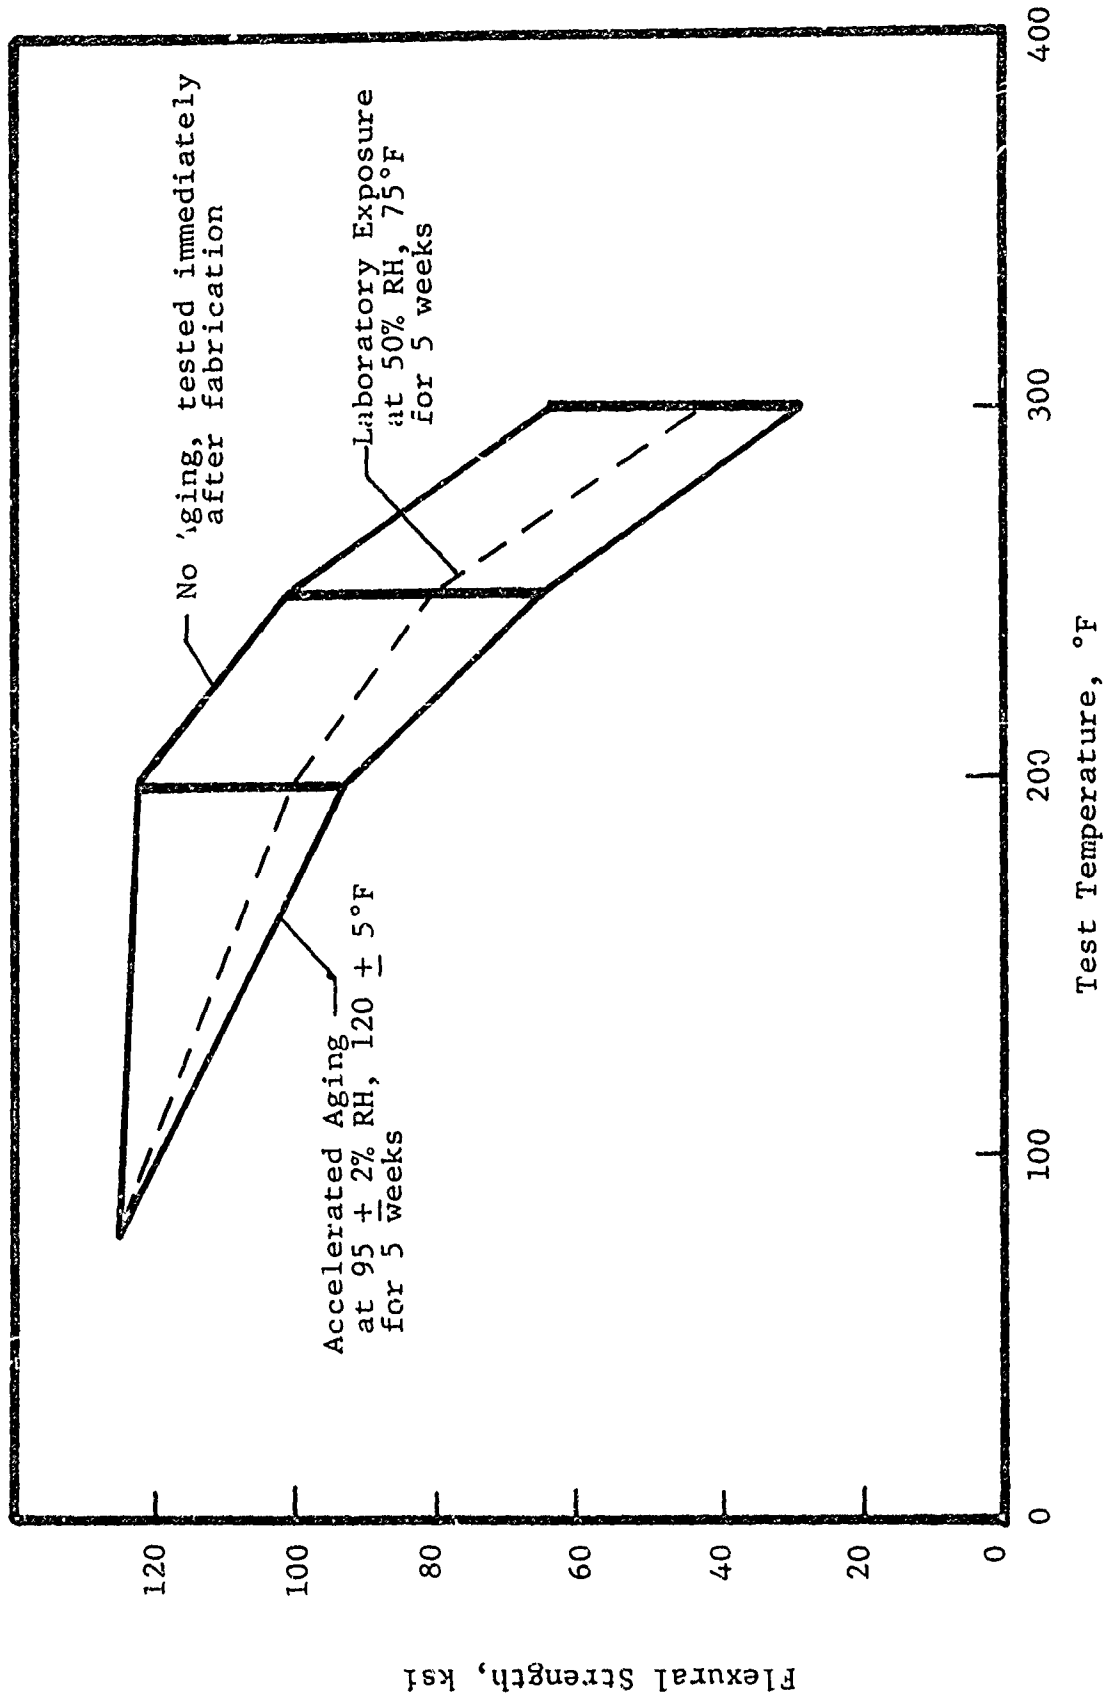
FIG. 15 FLEXURAL STRENGTHS OF MODMOR II/NARMO 5206 COMPOSITES,  
16 PLY - 0°, 90° PLY ORIENTATION (WITH SCRIM CLOTH)

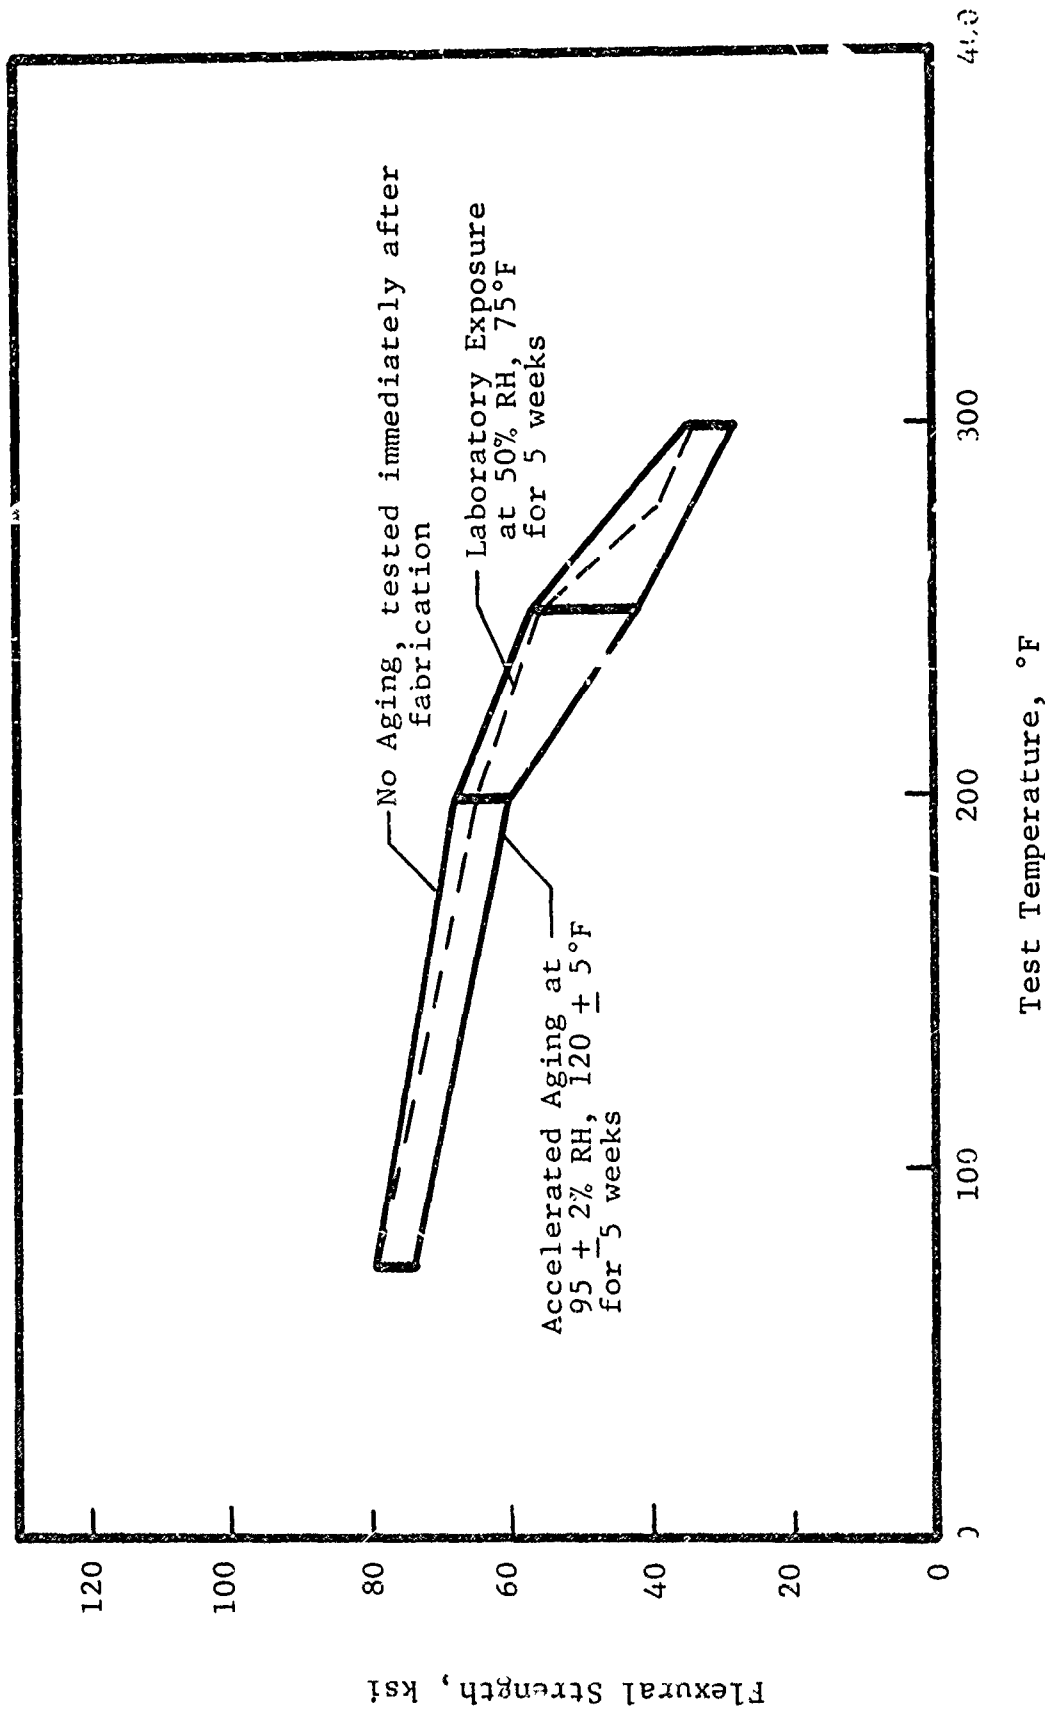
FIG. 16 FLEXURAL STRENGTHS OF MODMOR II/NARMCO 5206 COMPOSITES,  
 16 PLY - 0°, 90° ± 45° PLY ORIENTATION

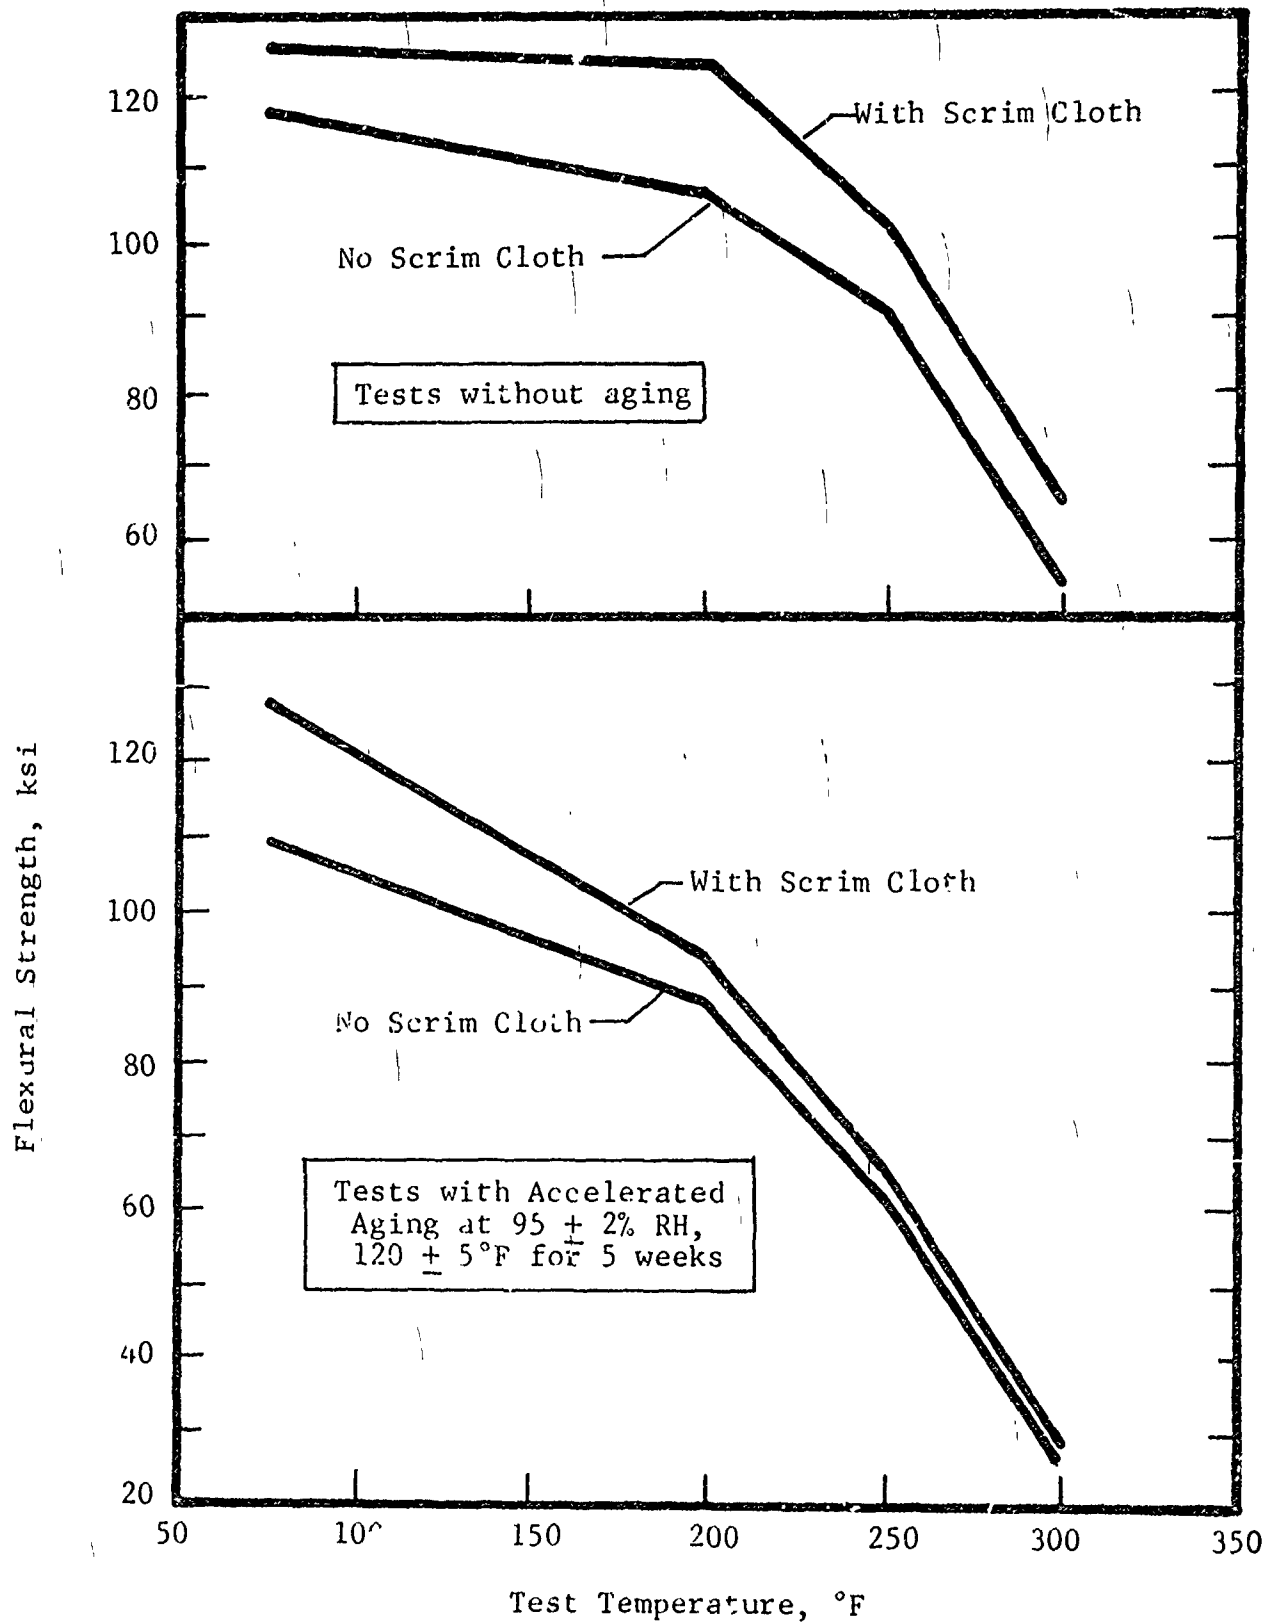
FIG. 17 FLEXURAL STRENGTHS OF MODMOR II/NARMCO 5206 COMPOSITES, 16 PLY - 0°, 90°, PLY ORIENTATION

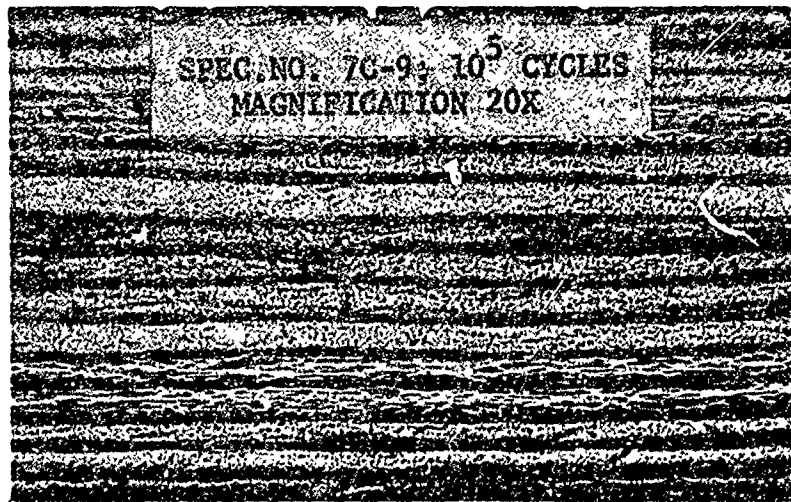
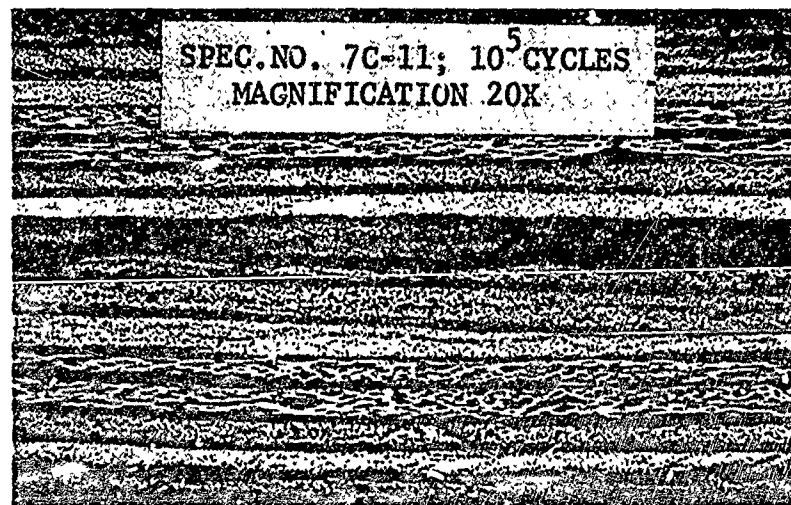
FIG. A-6 CROSS SECTIONAL PHOTOMICROGRAPHS OF MODMOR II/NARMCO 5206 PREPREG 16 PLY - 0°/ + 45°/90° (WITH SCRIM CLOTH) COMPOSITE CANTILEVER BEAM SPECIMENS SUBJECTED TO VARIOUS FATIGUE STRESS CYCLES AT R = 0.1 (MAX. LOAD/CYCLE = 210 LBS), ROOM TEMPERATURE, DRY.

A series of photomicrographs was obtained (Fig. A-1 through A-13 presented in Appendix "A") at various percentages of the average life at a given stress level. The crack patterns were analyzed and a plot of the percent damage, fraction of crack depth (defined or as the number of plies through which the cracks have penetrated) versus the number of stress cycles applied before sectioning of the specimen for both laminate constructions. These damage plots were made for the two fiber orientations are shown in the Figures 10 and 11. The results are not particularly informative regarding the relative performance of composites with scrim cloth interlayers.

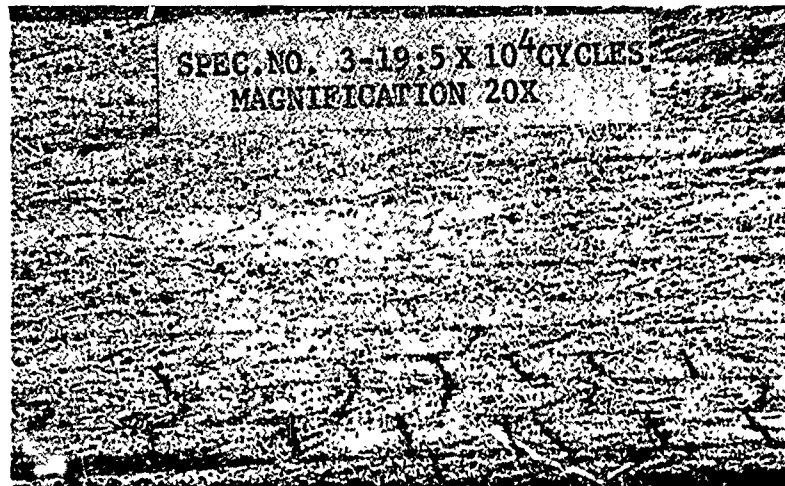
FIG. A-8 CROSS SECTIONAL PHOTOMICROGRAPH OF MODMOR II/NARMCO 5206 PREPREG 16 PLY -  $45^\circ/135^\circ$  COMPOSITE CANTILEVER BEAM SPECIMENS SUBJECTED TO VARIOUS FATIGUE STRESS CYCLES AT  $R = 0.1$  (MAX. LOAD/CYCLE = 168 LBS), ROOM TEMPERATURE, DRY.

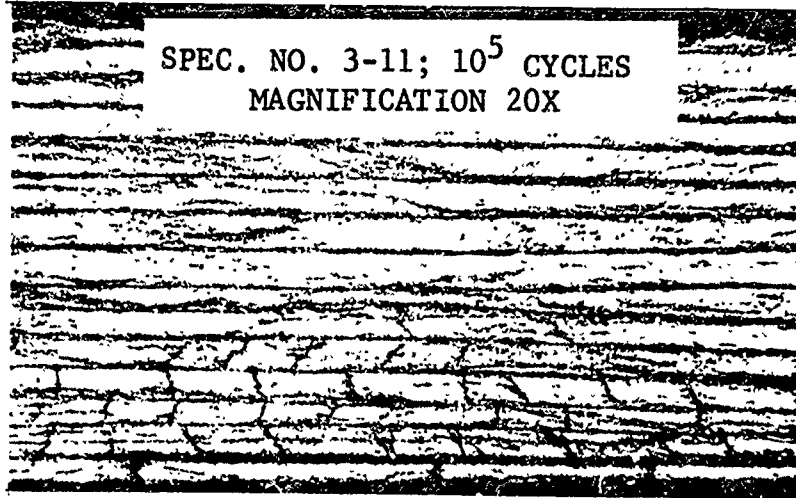
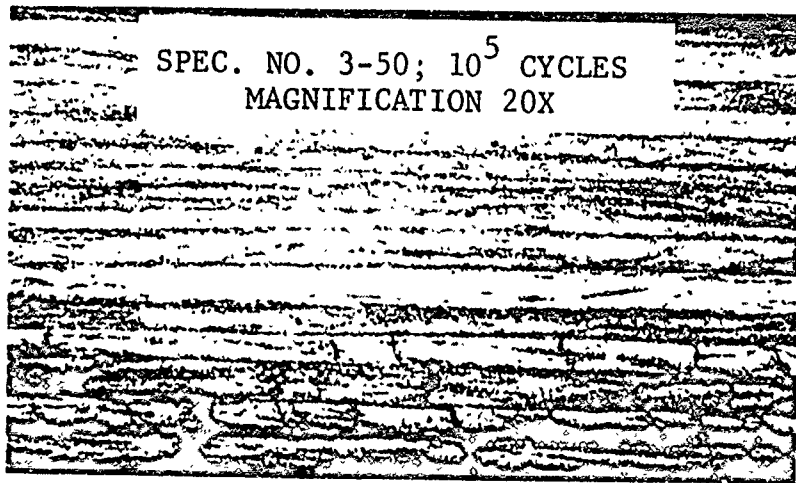
FIG. A-9 CROSS SECTIONAL PHOTOMICROGRAPHS OF MODMOR II/NARMCO 5206 PREPREG 16 PLY -  $45^\circ/135^\circ$  COMPOSITE CANTILEVER BEAM SPECIMENS SUBJECTED TO VARIOUS FATIGUE STRESS CYCLES AT  $R = 0.1$  (MAX. LOAD/CYCLE = 168 LBS), ROOM TEMPERATURE, DRY.
