FATIGUE BEHAVIOR  
OF GRAPHITE COMPOSITES

Final Report  
(9 Feb. 1971 to 8 Feb. 1972)  
February, 1972

IIT RESEARCH INSTITUTE

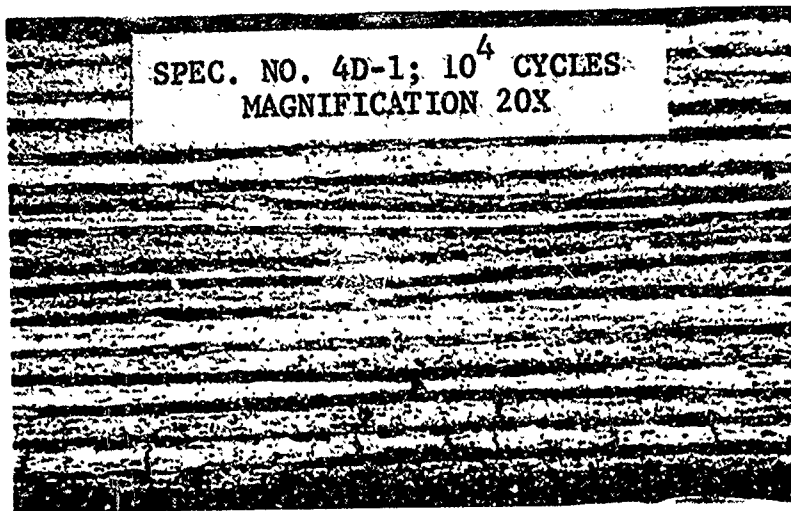
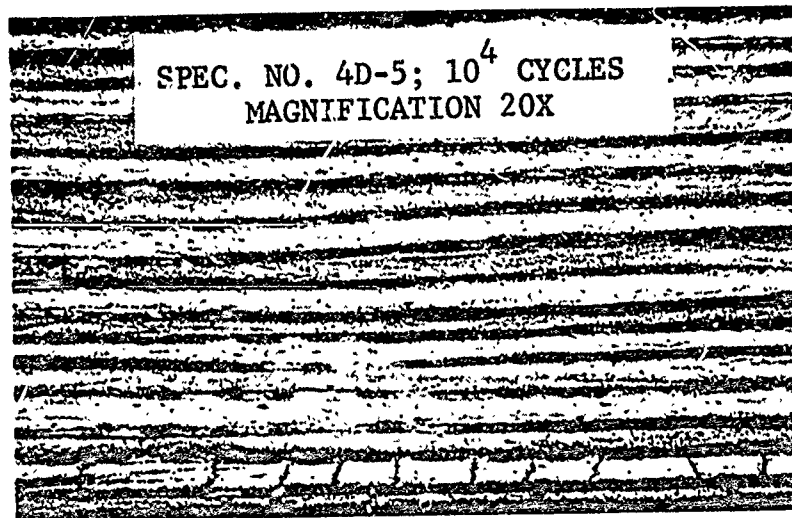
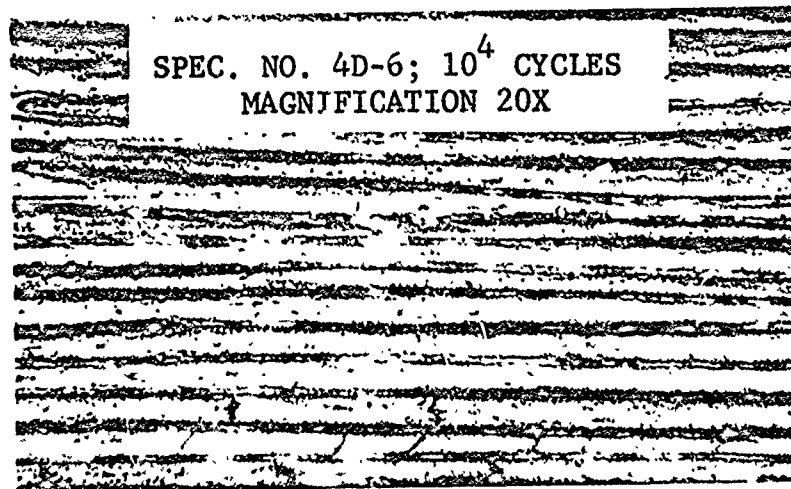
FIG. A-10 CROSS SECTIONAL PHOTOMICROGRAPHS OF MODMOR II/NARMCO 5206 PREPREG 16 PLY - 45°/135° (WITH SCRIM CLOTH) COMPOSITE CANTILEVER BEAM SPECIMENS SUBJECTED TO VARIOUS FATIGUE STRESS CYCLES AT R = 0.1 (MAX. LOAD/CYCLE = 174 LBS), ROOM TEMPERATURE, DRY.

A series of photomicrographs was obtained (Fig. A-1 through A-13 presented in Appendix "A") at various percentages of the average life at a given stress level. The crack patterns were analyzed and a plot of the percent damage, fraction of crack depth (defined or as the number of plies through which the cracks have penetrated) versus the number of stress cycles applied before sectioning of the specimen for both laminate constructions. These damage plots were made for the two fiber orientations are shown in the Figures 10 and 11. The results are not particularly informative regarding the relative performance of composites with scrim cloth interlayers.

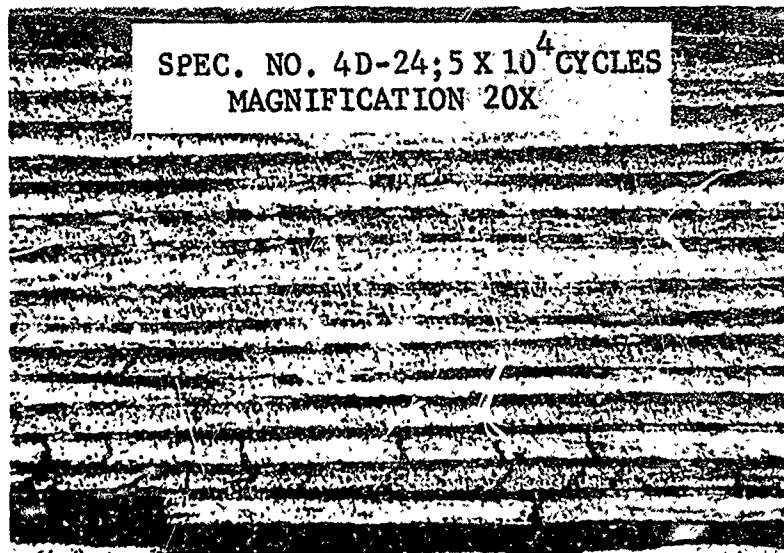
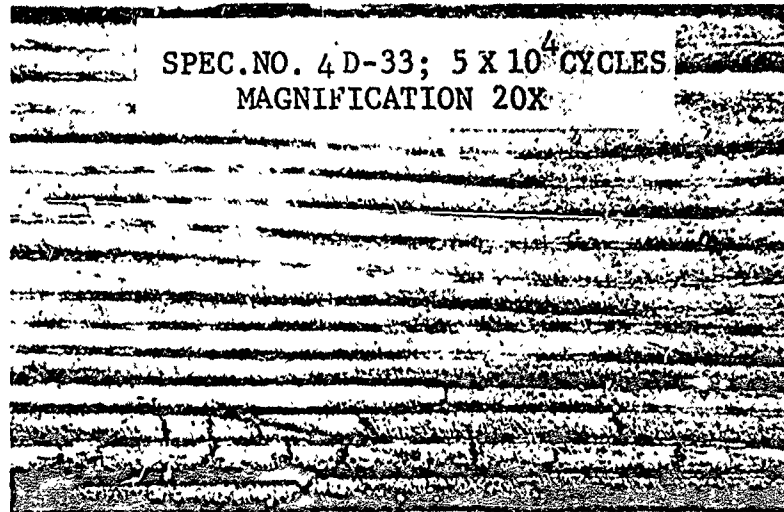
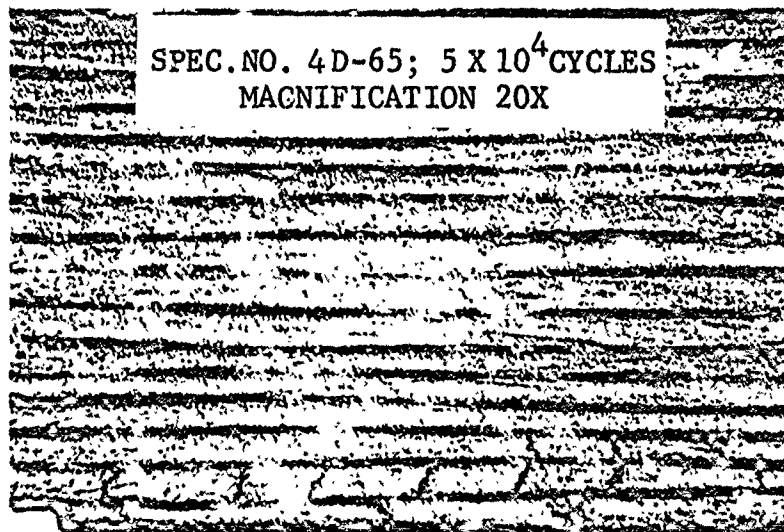
FIG. A-11 CROSS SECTIONAL PHOTOMICROGRAPHS OF MODMOR II/NARMCO 5206 PREPREG 16 PLY -  $45^\circ/135^\circ$  (WITH SCRIM CLOTH) COMPOSITE CANTILEVER BEAM SPECIMENS SUBJECTED TO VARIOUS FATIGUE STRESS CYCLES AT  $R = 0.1$  (MAX. LOAD/CYCLE = 174 LBS), ROOM TEMPERATURE, DRY.

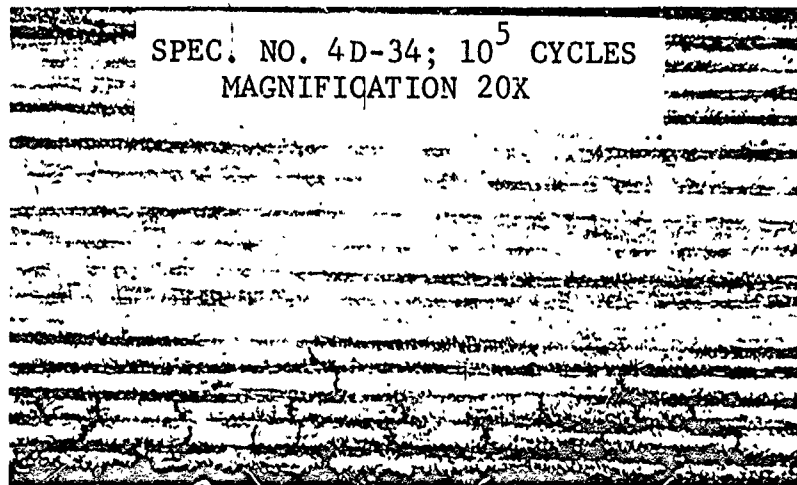
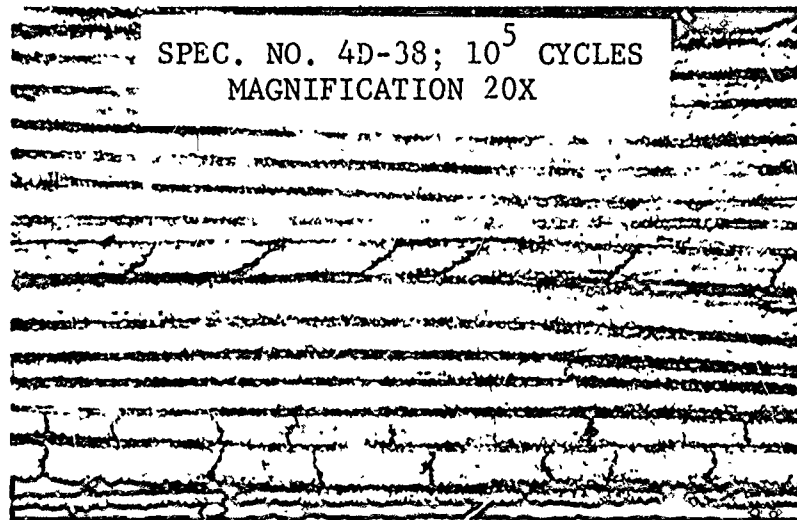
FIG. A-12 CROSS SECTIONAL PHOTOMICROGRAPHS OF MODMOR II/NARMCO 5206 PREPREG 16 PLY -  $45^{\circ}/135^{\circ}$  (WITH SCRIM CLOTH) COMPOSITE CANTILEVER BEAM SPECIMENS SUBJECTED TO VARIOUS FATIGUE STRESS CYCLES AT  $R = 0.1$  (MAX. LOAD/CYCLE = 174 LBS), ROOM TEMPERATURE, DRY.

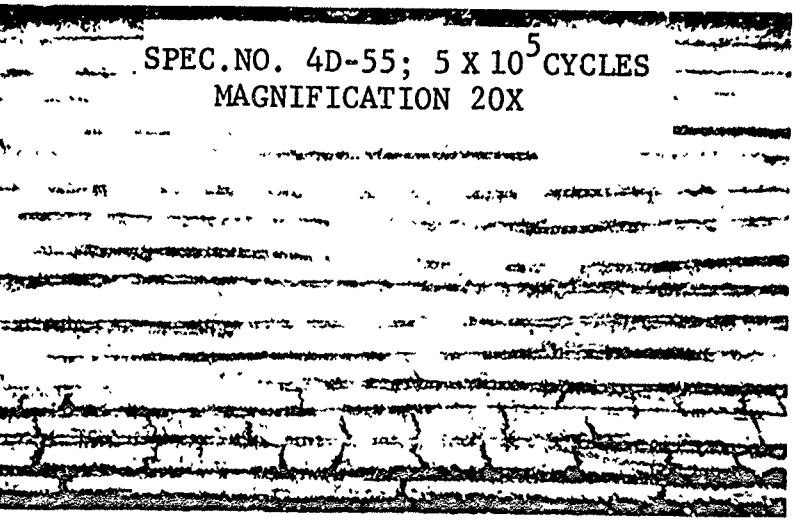
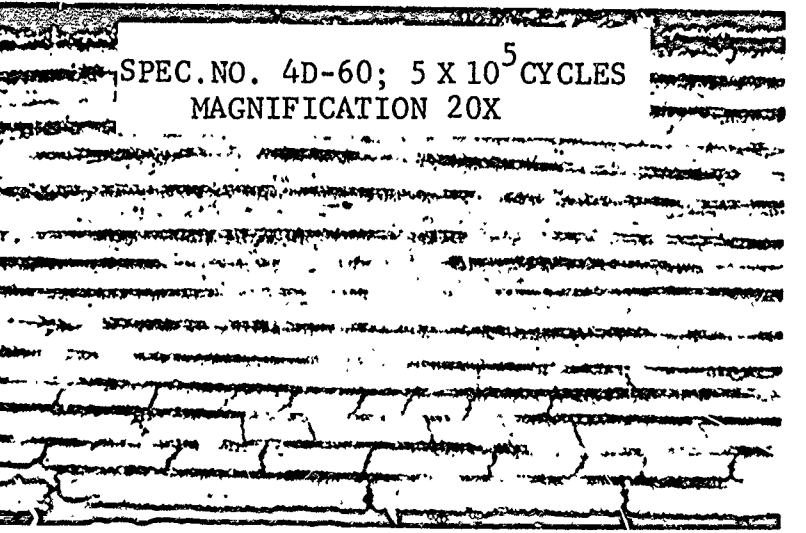
FIG. A-13 CROSS SECTIONAL PHOTOMICROGRAPHS OF MODMOR II/NARMCO 5206 PREPREG 16 PLY - 45°/135° (WITH SCRIM CLOTH) COMPOSITE CANTILEVER BEAM SPECIMENS SUBJECTED TO VARIOUS FATIGUE STRESS CYCLES AT R = 0.1 (MAX. LOAD/CYCLE = 174 LBS), ROOM TEMPERATURE, DRY.

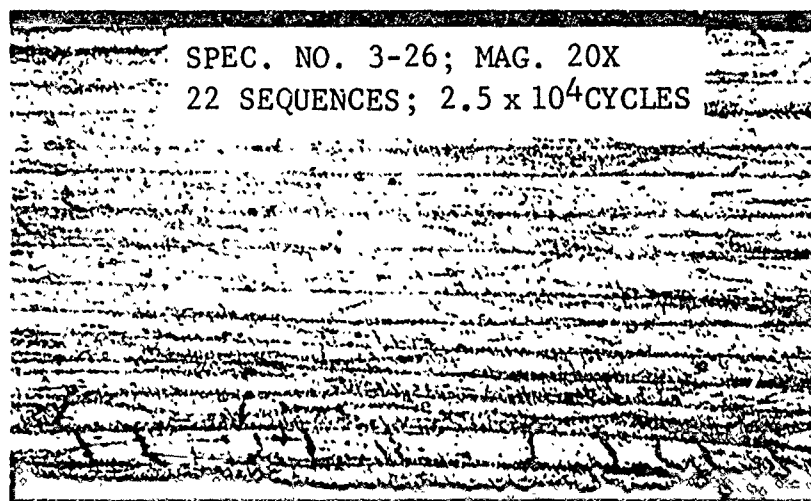
FIG. B-1 CROSS SECTIONAL PHOTOMICROGRAPHS OF MODMOR II/NARMCO 5206 PREPREG 16 PLY -  $45^\circ$ ,  $135^\circ$  COMPOSITE CANTILEVER BEAM SPECIMENS SUBJECTED TO VARIOUS FATIGUE ( $R = 0.1$ ) LOAD SEQUENCES AT ROOM TEMPERATURE

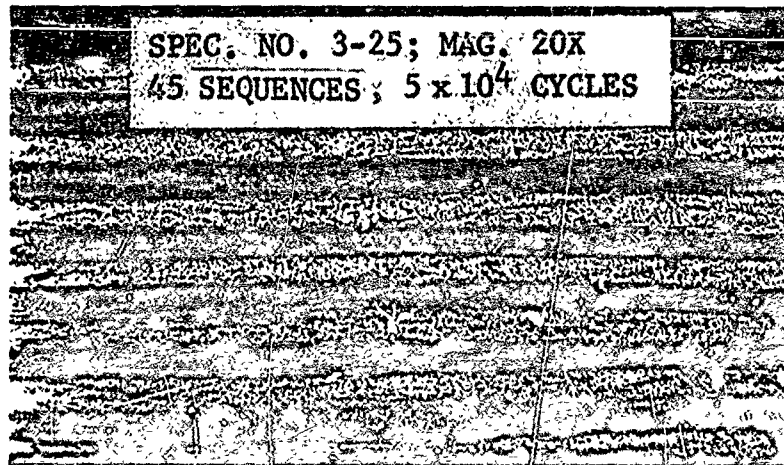
FIG. B-2 CROSS SECTIONAL PHOTOMICROGRAPHS OF MODMOR II/NARMCO 5206 PREPREG 16 PLY - 45°, 135° COMPOSITE CANTILEVER BEAM SPECIMENS SUBJECTED TO VARIOUS FATIGUE ( $R = 0.1$ ) LOAD SEQUENCES AT ROOM TEMPERATURE

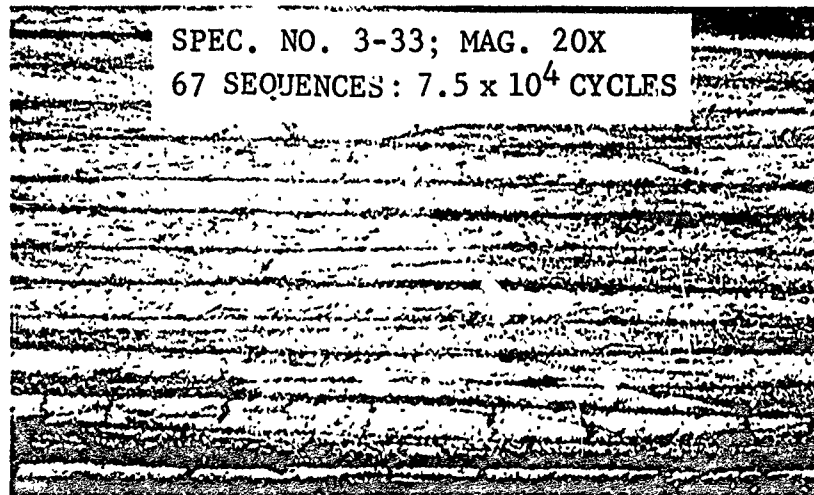
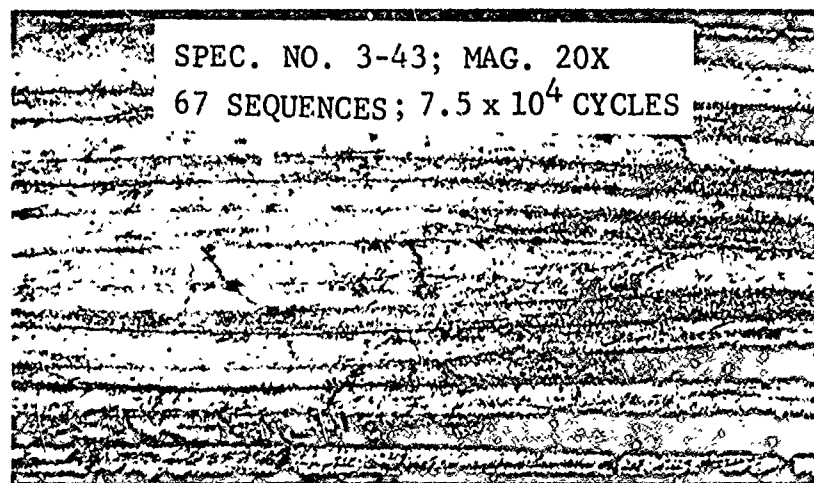
FIG. B-3 CROSS SECTIONAL PHOTOMICROGRAPHS OF MODMOR II/NARMCO 5206 PREPREG 16 PLY -  $45^\circ$ ,  $135^\circ$  COMPOSITE CANTILEVER BEAM SPECIMENS SUBJECTED TO VARIOUS FATIGUE ( $R = 0.1$ ) LOAD SEQUENCES AT ROOM TEMPERATURE

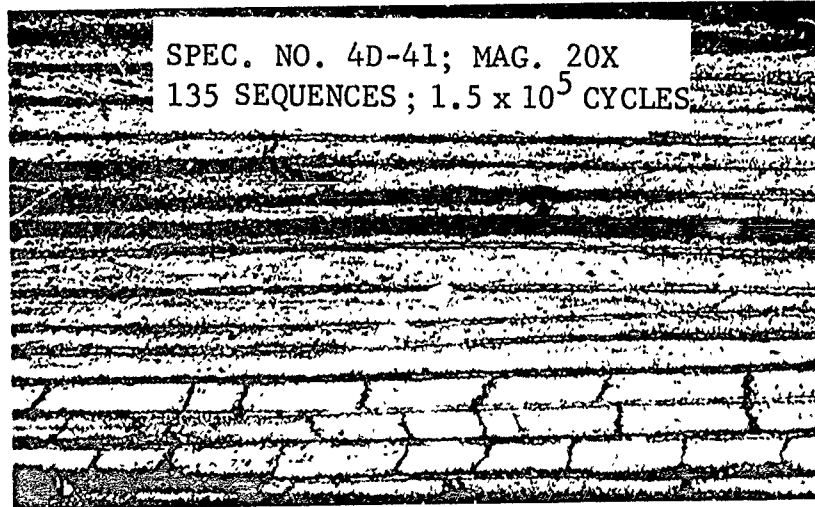
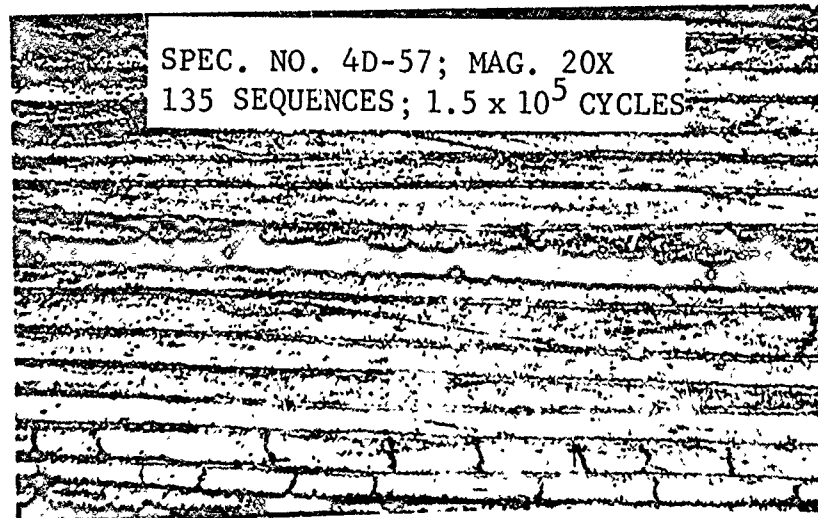
FIG. B-6 CROSS SECTIONAL PHOTOMICROGRAPHS OF MODMOR II/NARMCO 5206 PREPREG 16 PLY -  $45^\circ$ ,  $135^\circ$  (WITH SCRIM CLOTH) COMPOSITE CANTILEVER BEAM SPECIMENS SUBJECTED TO VARIOUS FATIGUE ( $R = 0.1$ ) LOAD SEQUENCES AT ROOM TEMPERATURE

Specimen No.	No. of Spectrums	No. of Cycles	Figure No.
4D-2	45	50,000	B-4
4D-11	45	50,000	B-4
4D-22	90	100,000	B-5
4D-27	90	100,000	B-5
4D-28	90	100,000	B-5
4D-35	135	150,000	B-6
4D-41	135	150,000	B-6
4D-57	135	150,000	B-6
