FINAL REPORT ON
JOINING TECHNIQUES FOR FABRICATION OF
HIGH-TEMPERATURE SUPERALLOY BLADES

C. G. NESSLER
Pratt & Whitney Aircraft
Division of United Aircraft Corporation

TECHNICAL REPORT AFML-TR-71-237
DECEMBER 1971

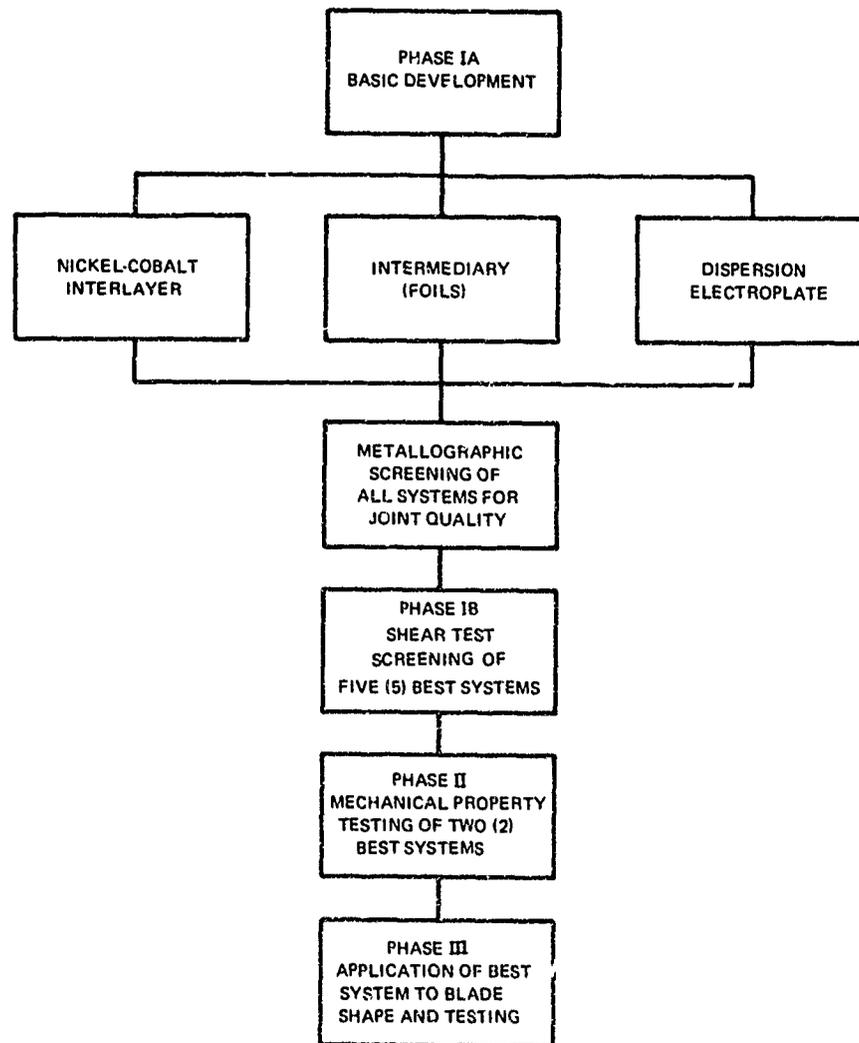
Figure 1 Summary Flow Chart of Superalloy Joining Development

The program was conducted in three sequential phases as shown in Figure 1. Phase IA was directed at interlayer and intermediary development and determination of welding parameters through metallography. Phase IB involved shear testing of selected joints from Phase IA. The best joints from Phase I were tested during Phase II to determine tensile, stress rupture, and thermal fatigue strengths. During Phase III the application of the better systems to an actual blade were accomplished, and the joint fit accommodation and thermal fatigue resistance were evaluated.

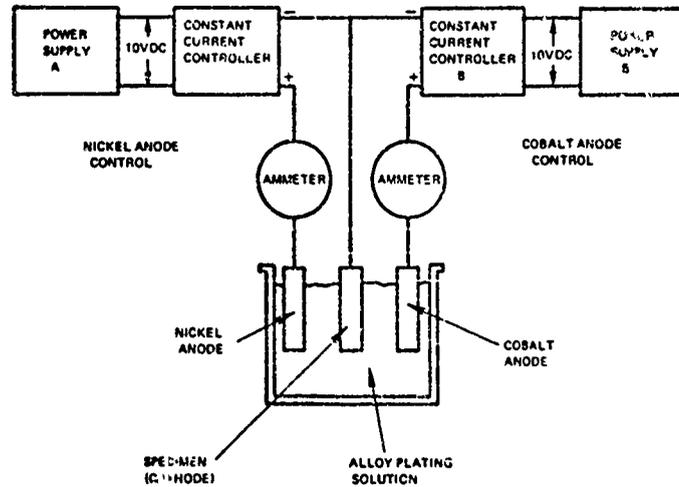
Figure 2 Electroplating Schematic Diagram

The general setup for nickel-cobalt electroplating is shown schematically in Figure 2. Proportioning the total anode current between the separate nickel and cobalt anodes controls the corrosion rate of each anode which maintains the nickel-cobalt equilibrium ratios in the bath; deposition rate on the cathode is determined by the total current.

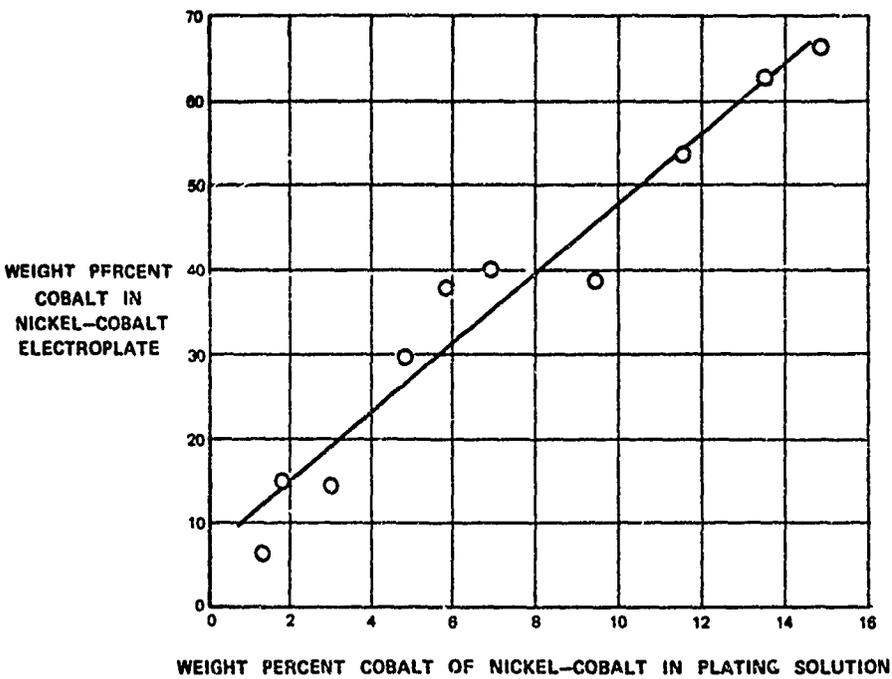
TOTAL METAL CONTENT: 1.0 GRAM EQUIVALENT PER LITER (1.0 NORMAL)
 AMMONIUM CHLORIDE: 27 GRAMS PER LITER
 BORIC ACID: 27 GRAMS PER LITER
 CURRENT DENSITY: 28-32 ASF
 TEMPERATURE: 118-122°F
 PH (ELECTROMETRIC): 4.5-5.0

Figure 3 Electroplating Curve Showing Plating Composition as a Function of Bath Composition

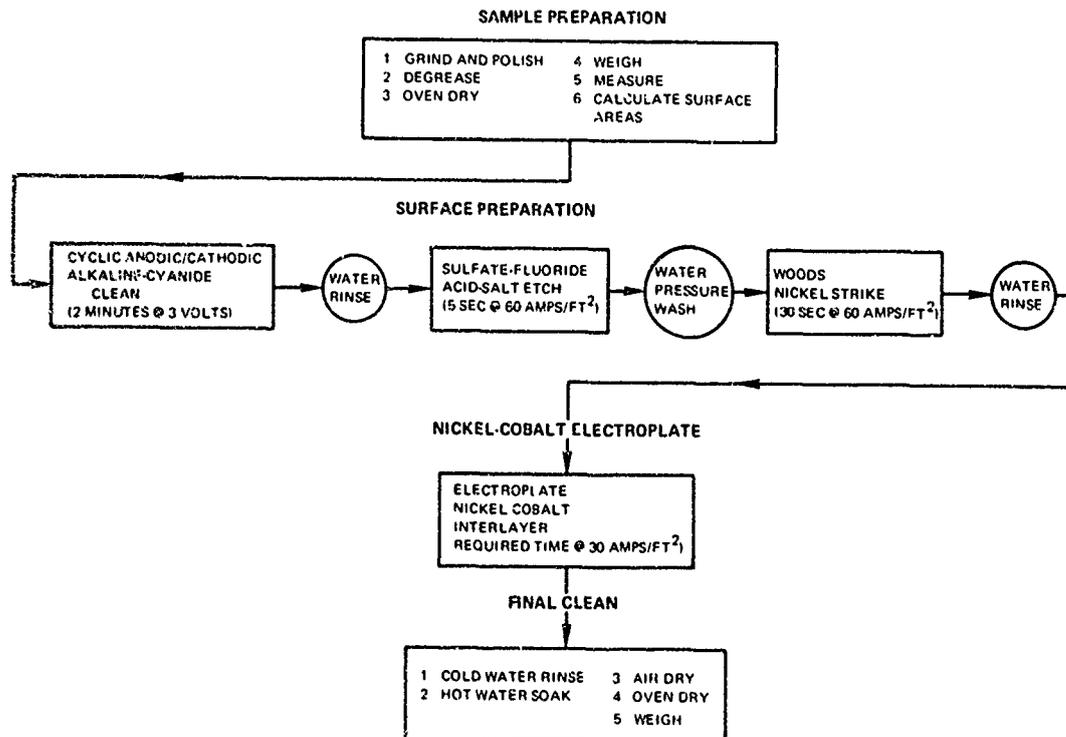
Figure 4 Plating Sequence for Electroplated Nickel-Cobalt Alloy on PWA 1422 Material

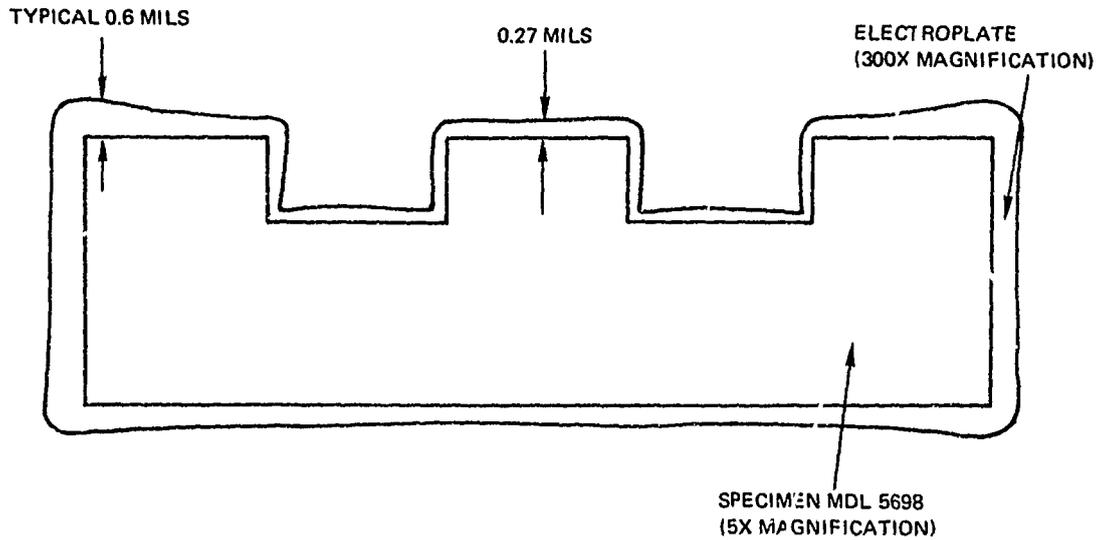
Figure 5 Typical Electroplate Distribution on a Specimen Plated With an Average of 0.38 Mils of Nickel-Cobalt

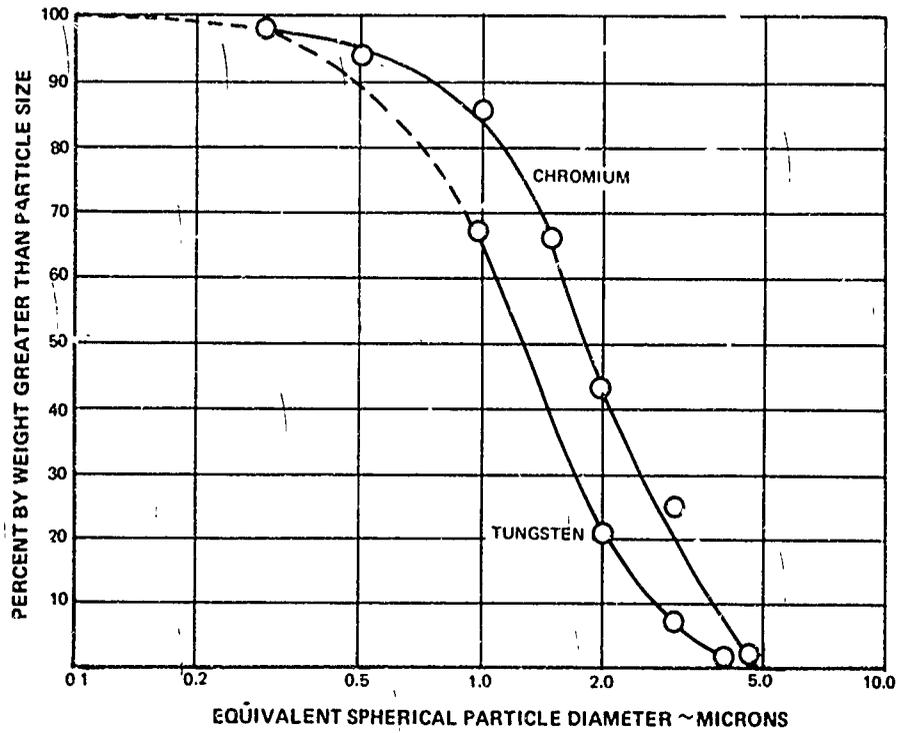
Figure 7 Particle Size Distribution of Elemental Tungsten and Chromium Dispersant Powders

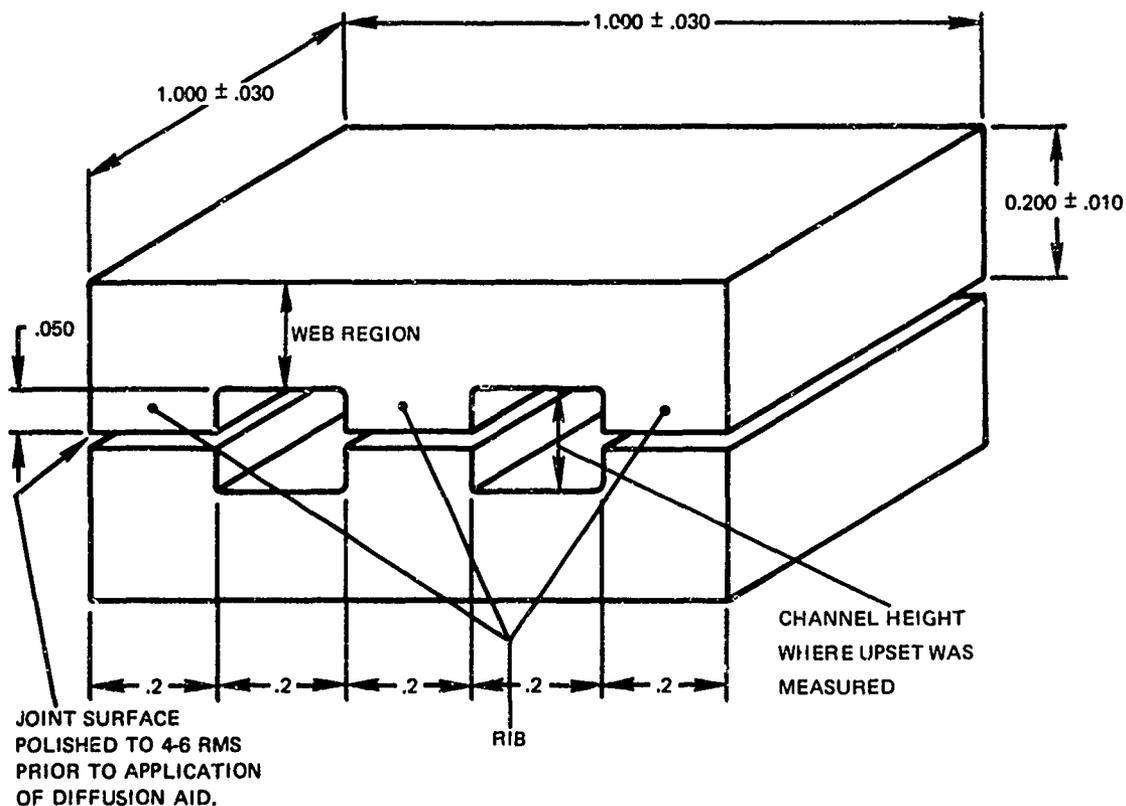
Figure 9 Sketch of 1 x 1 Inch Diffusion Welding Specimen

Since this program was intended to develop joining systems for a specific end product, a split superalloy turbine blade, it was appropriate to deviate from the conventional use of a flat specimen to the choice of a ribbed specimen which somewhat simulates the construction of an airfoil (see Figure 9). This choice introduced the following variables and restraints: (1) as-cast dimensional variables in un-machined areas, (2) variation in electroplating thickness across the ribs, (3) cracking and collapse of the specimen in areas away from the joint, limiting the applied pressure and deformation, and, (4) edge and notch effects were readily visible.

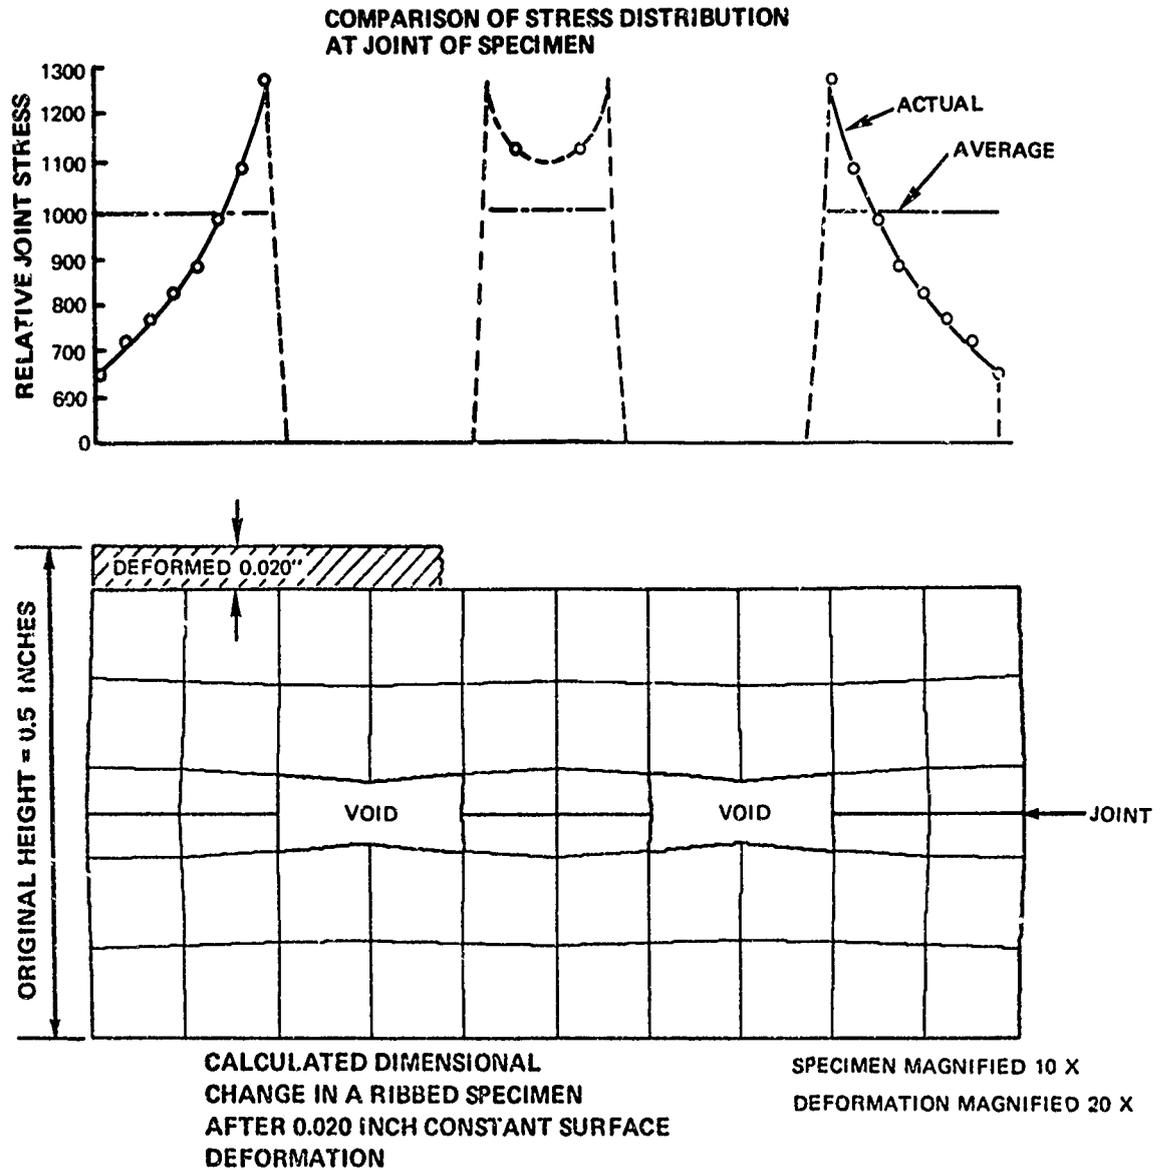
Figure 10 Finite Element Stress Analysis

Since the joint design was considerably different from that of a plain flat specimen, the stress distribution and deformation within the ribbed specimen were analyzed by a finite element plastic stress analysis. The graphic mathematical model output is shown in Figure 10.

In the example shown (Figure 10), the specimen was subjected to constant deformation of the external surfaces, thereby simulating the condition encountered in this program when static pressure dies were used. (Similar results occur when isostatic pressure is simulated.) The stress distribution within the joint varied significantly from the calculated average value based on area and applied force. In real parts, inevitable asymmetry and misalignment can further accentuate the variation in both stress and deformation. Although not represented here, significant stresses were also existent in the base metal over the internal channels. This cursory analysis indicated that since specimen and joint design are consequential factors, diffusion welding parameters developed on flat specimens may not be readily transferrable to real parts. It also indicated that joining systems which are overly sensitive to joint stress and deformation will not be reliable.

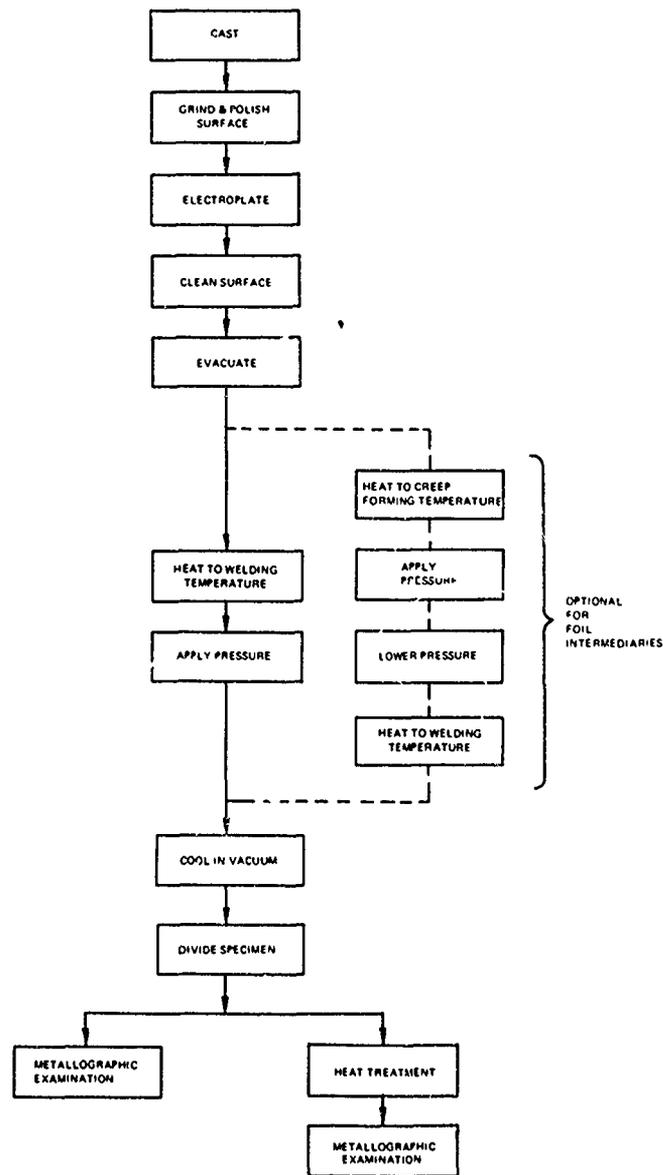
Figure 11 Diffusion Welding Process

The sequence followed in making diffusion welded joints is indicated in Figure 11. After casting, the specimen's faying surface was grit blasted, flat ground for clean-up, and polished with 600 grit paper. After electroplating, the specimens were mated and the external dimensions and the internal rib-cavity space dimensions were recorded. Prior to being placed in the press, the external surfaces of the specimen were coated with a thin aluminum oxide/toluene slurry. The faying surfaces were washed with acetone and methanol and freon dried.

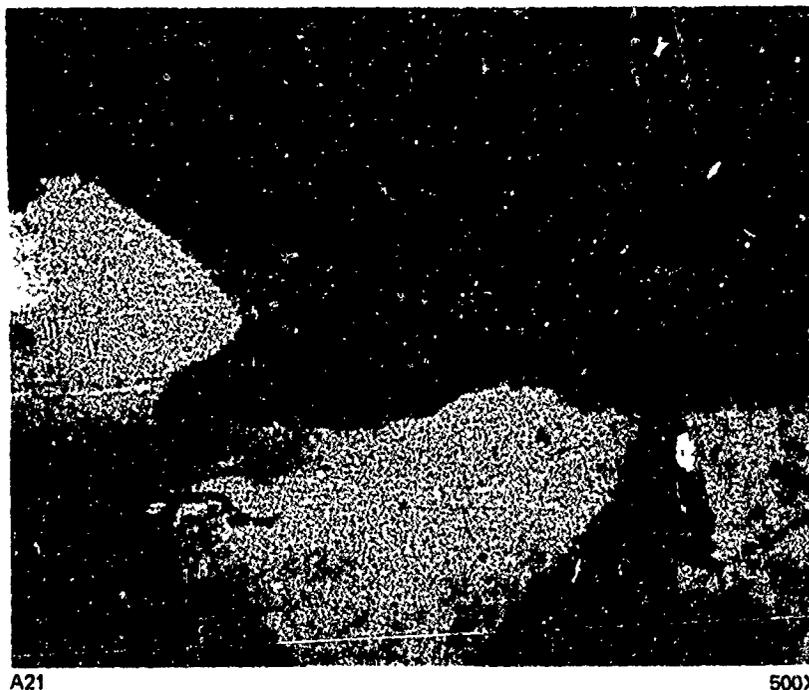
A21

2200°F/280 psi/1 hr
+
2200°F/3 hr.

Figure 17 PWA 1422 Diffusion Welded with a 0.07 Mil Thick Nickel - 30% Cobalt Interlayer Contains a Planar Grain Boundary Interface that is Typical of Inadequate Joint Pressure.

Grain boundary migration is usually limited in diffusion welded joints in cast superalloys. The interface remained planar at the lower welding pressures (see Figure 17), a condition which is known to lead to poor properties. At pressures greater than 500 psi, desirable grain boundary migration occurred; however, there was no significant increase in degree of migration with further pressure increase. A similar lack of response was observed when the pressure was maintained during a welding cycle of four hours. The interfacial grain boundary movement achieved was considered acceptable.

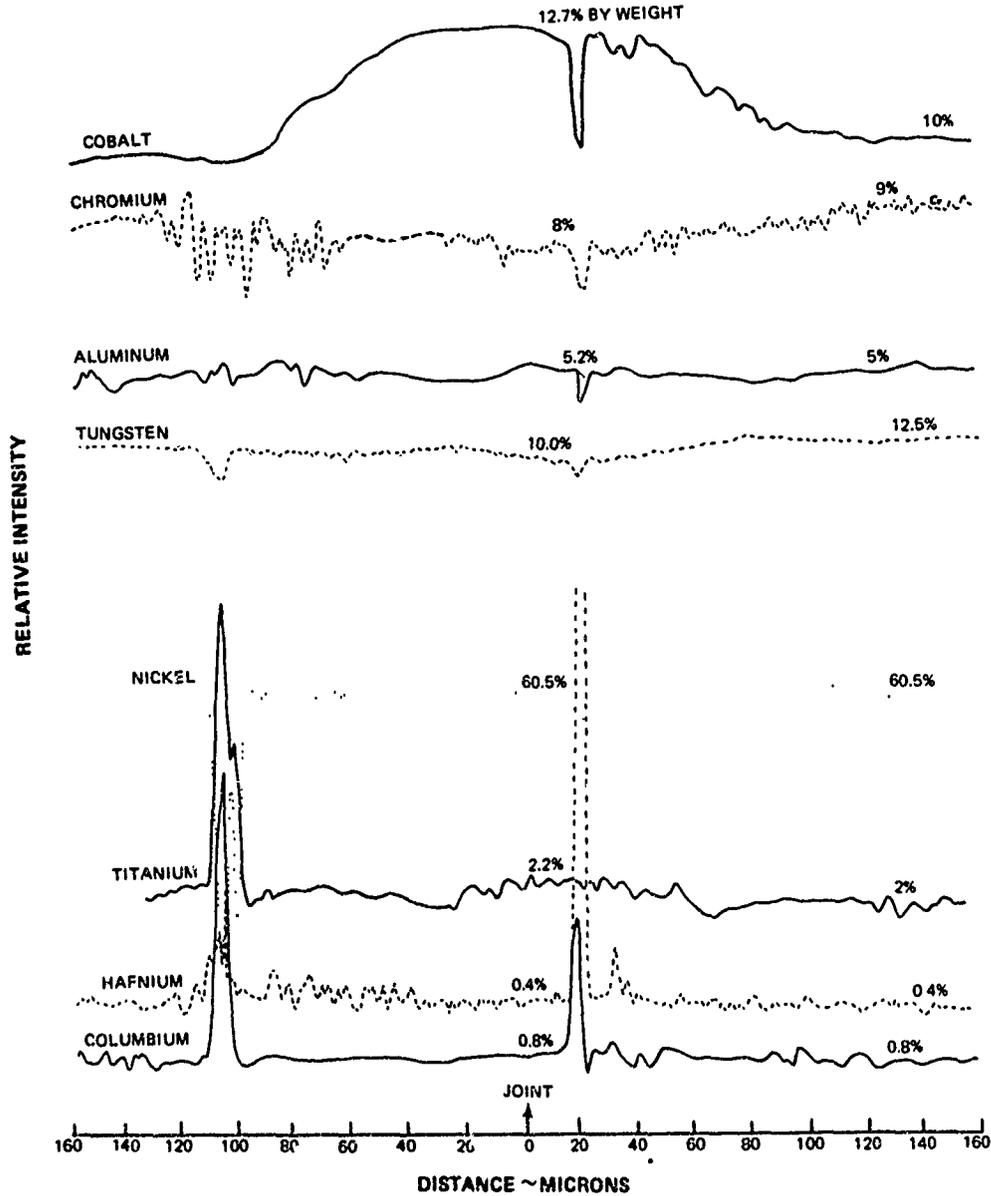
Figure 22 Electron Microprobe Analysis of 0.2 Mil Nickel-25% Cobalt Interlayer Diffusion Weld (2200°F/750 PSI/1 Hr. + 2200°F/3 Hr.). The Joint (See Figure 23b) is Homogeneous with Base Metal Except for Cobalt (Specimen A67H).

Based on the metallographic observations, electron microprobe analyses were made of two welded and heat treated (2200°F/750 psi/1 hr + 2200°F/3 hr) nickel-25 percent cobalt interlayer joints. As shown in Figure 22, homogeneity was largely achieved in a 0.2 mil thick interlayer. Cobalt content was slightly higher, and tungsten content lower, in the joint center compared to the base metal. Metallographic examination showed that the joint was essentially microstructurally homogeneous with the base metal (Figure 23a).

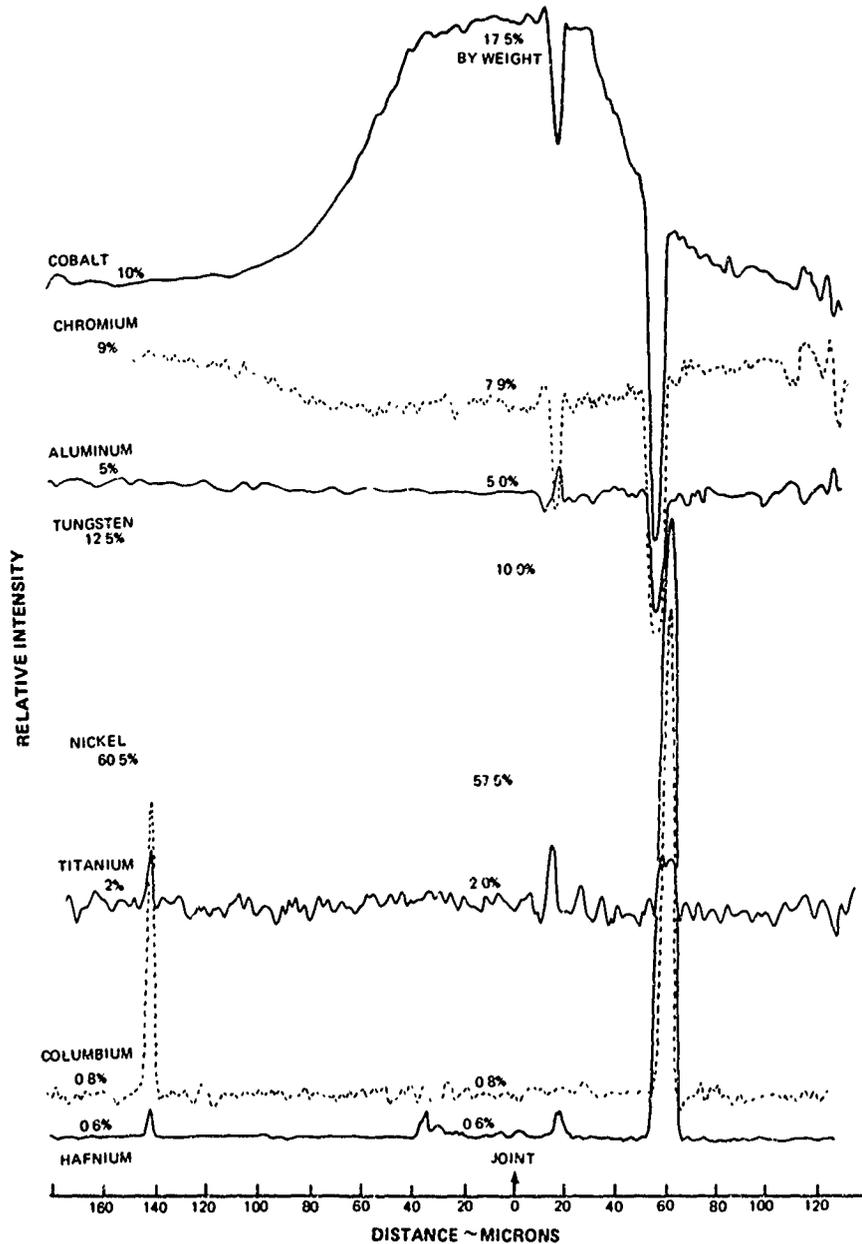
Figure 24 Electron Microprobe Analysis of 0.5 Mil Nickel-25% Cobalt Interlayer Diffusion Weld (2200°F/1000 PSI/1 Hr. + 2200°F/3 Hr.). The Joint (See Figure 23a) is Similar to 0.2 Mil Interlayer Except for Higher Cobalt Content.

By comparison, a 0.5 mil interlayer (Figure 24) had a considerable excess of cobalt in the joint center. Aluminum, titanium, tungsten, and chromium contents were similar to the thinner interlayer, when the joint centers were compared. Despite the similarity in composition, metallography (Figure 23b) indicates the thicker interlayer joint is depleted of gamma prime. Therefore, it can be concluded that excess cobalt has inhibited the formation of gamma prime in the joint by altering the gamma prime solvus locally.

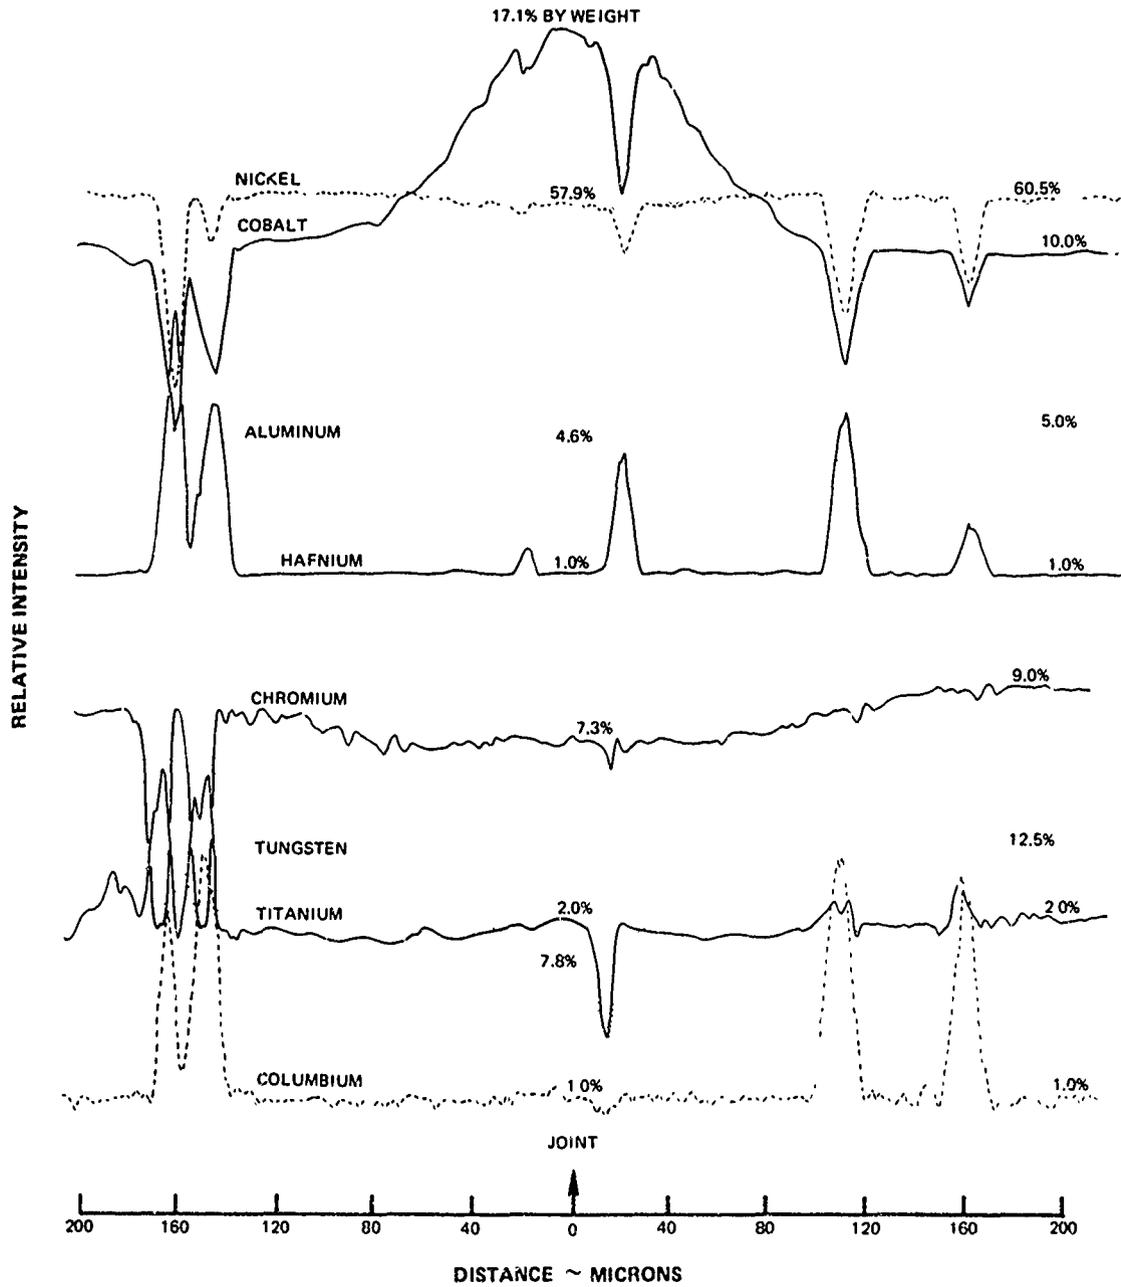
Figure 26 Electron microprobe analysis of 0.5 Mil nickel-20% cobalt interlayer diffusion weld between as-cast PWA 1422 surfaces (2160°F/500 psi/2 hr + 2200°F/2 hr). (See Figure 25).

cobalt joint indicated a lower cobalt content, 14.7 percent, in the joint center. Both analyses showed that tungsten and chromium were somewhat lower than previously in the nickel 25 percent cobalt joint. In view of the small change in cobalt content and the limited probe data, local variations in the base metal probably account for the anomalies.

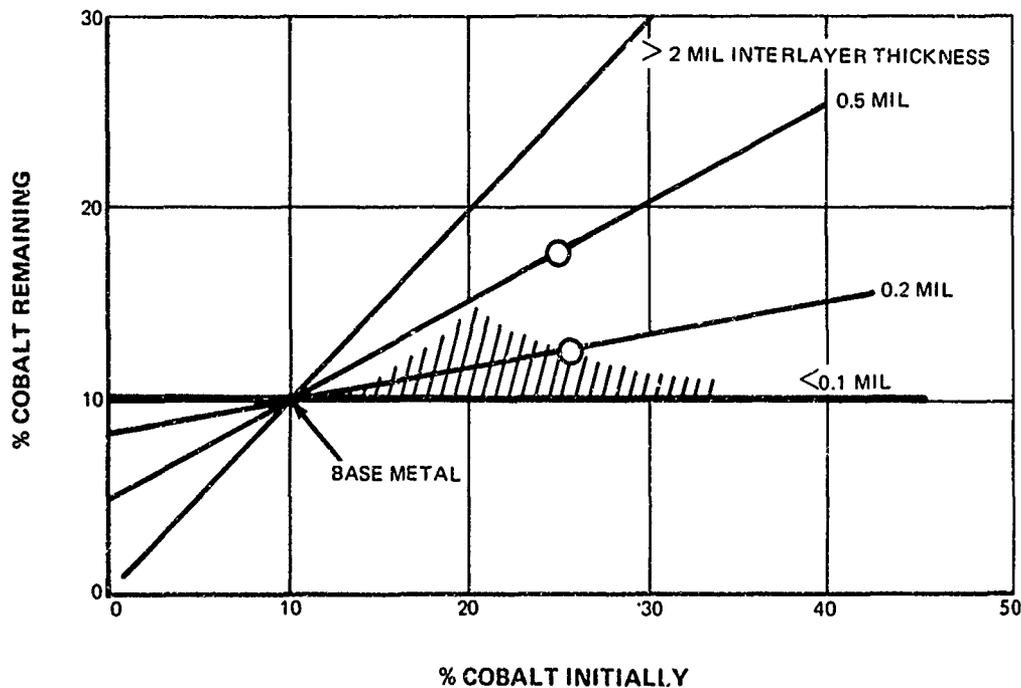
Figure 28 Final Joint Center Cobalt Content as a Function of Initial Interlayer Cobalt Content for Varying Thickness of Interlayer, After Diffusion Weld is Exposed to 2200°F for 4 Hours. Shaded area Represents Metallographically Homogeneous Joints

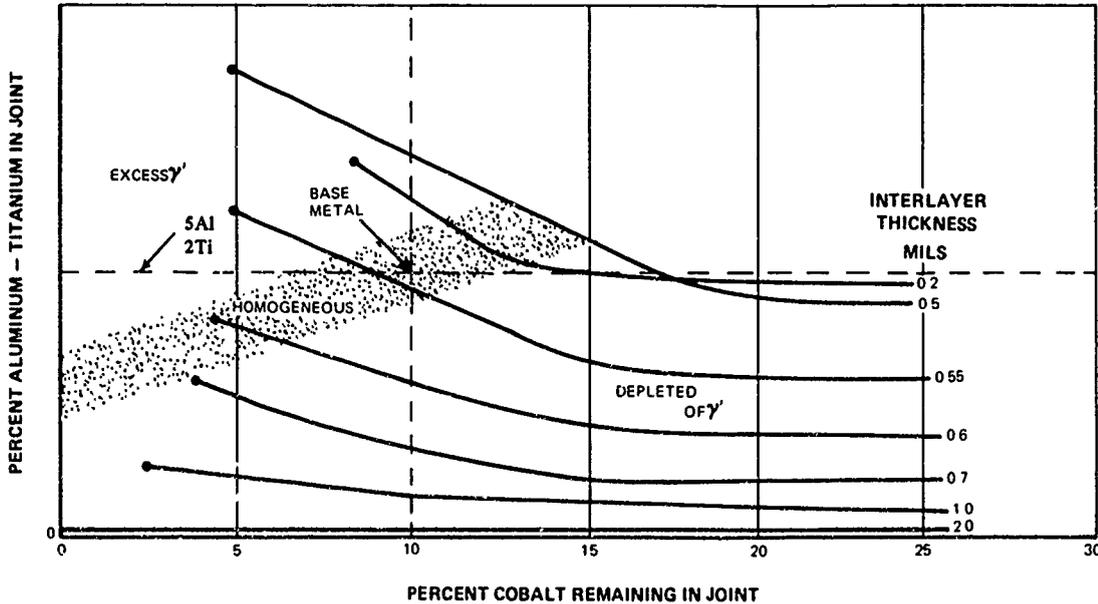
Figure 29 Relationship Between Microstructure and Diffusion Weld Joint Composition and Thickness After 2200°F/4 Hour Exposure. The Percent Cobalt Remaining is Determined From the Initial Interlayer Composition Using Figure 28. For a Given Thickness and Remaining Cobalt Content the Curves Indicate the Amount of Aluminum-Titanium in the Joint Center. Points at the Left End of Constant Thickness Lines Indicate the Percent Cobalt Remaining When a 100% Nickel Interlayer is used Initially.

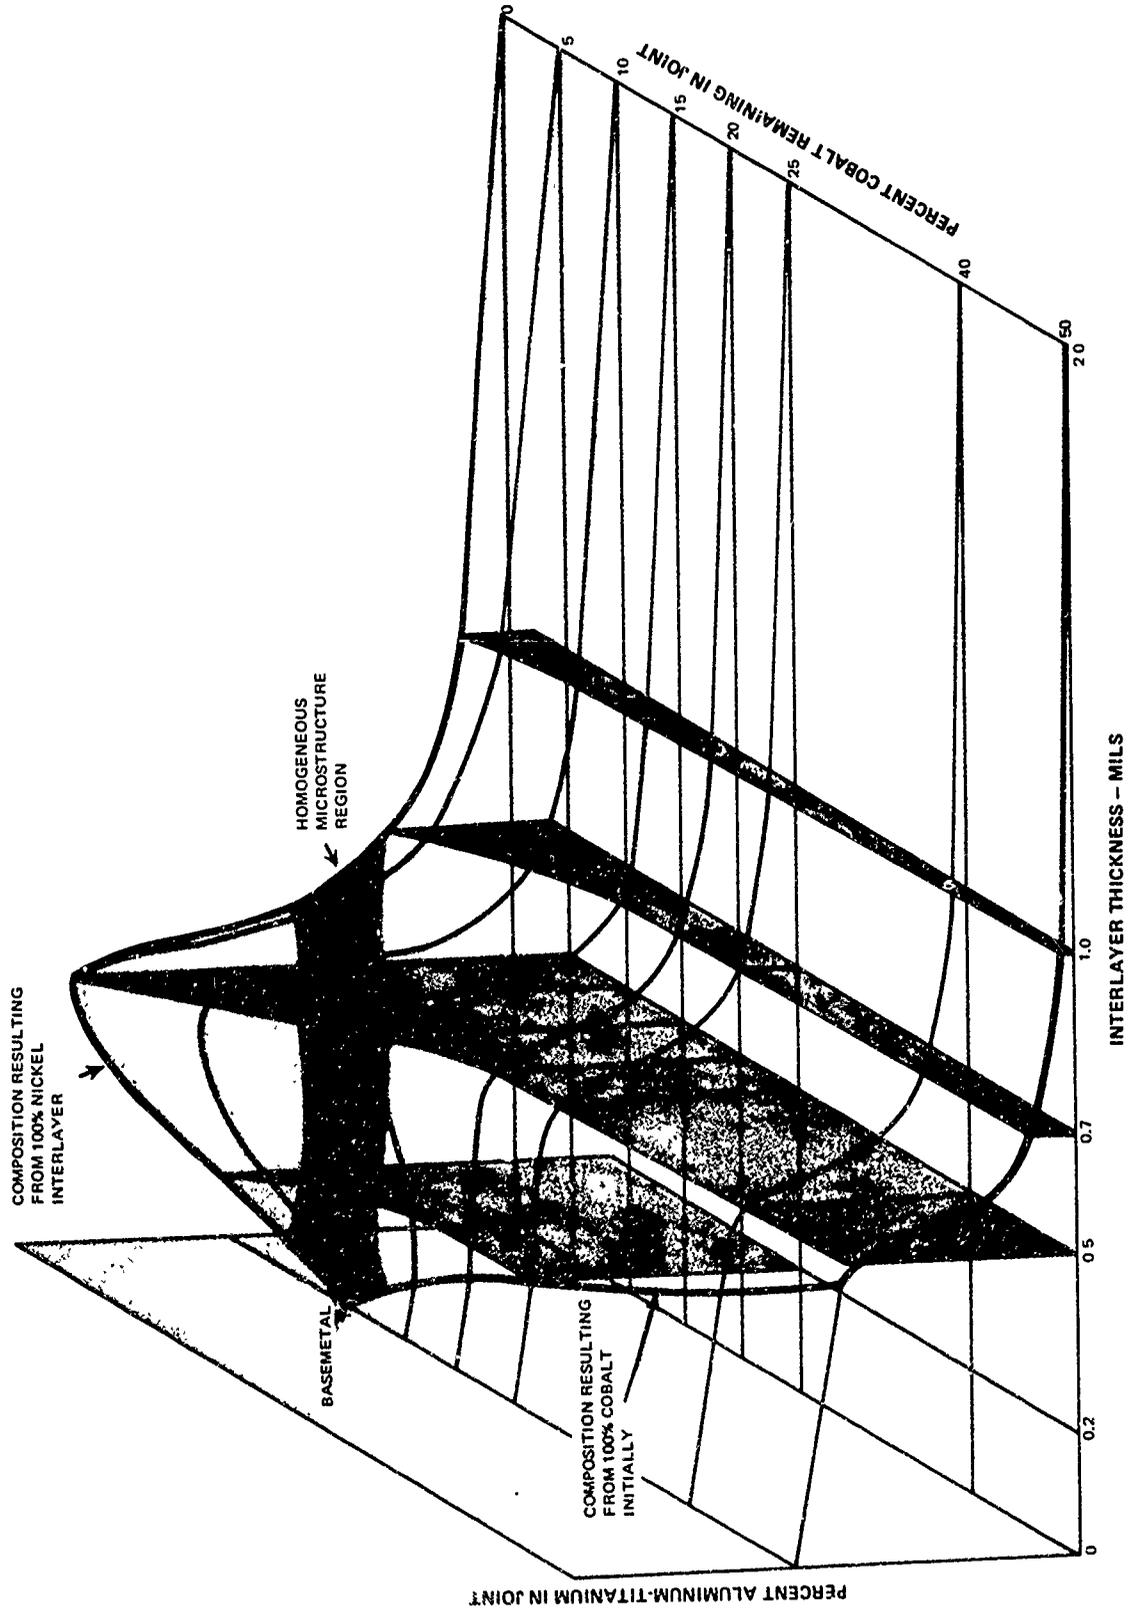
Figure 30 A Three-Dimensional Plot of the Relations Shown in Figure 25, Showing as a Surface the Compositions Which Occur in Diffusion Welds at Varying Interlayer Thicknesses.

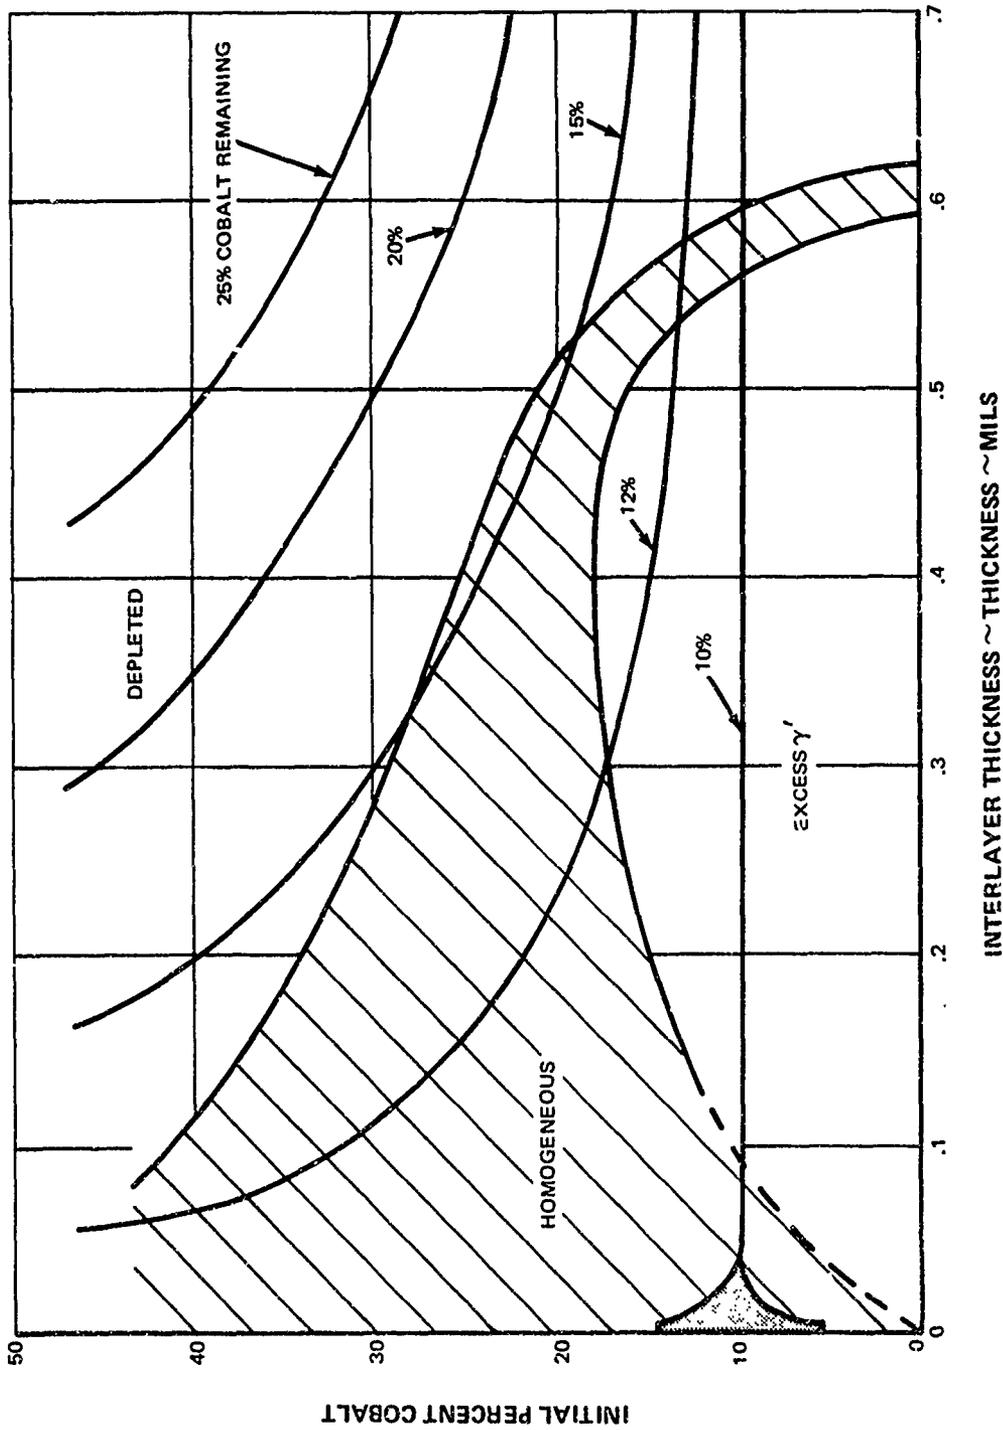
Figure 31 Empirical Relation Between Initial Interlayer Thickness and Composition and Microstructure in a Diffusion Weld After 2200° F/4 Hr. Exposure. Composition Becomes more Critical as Thickness Increases. This Figure Also Relates to Figures 28, 29, and 30.

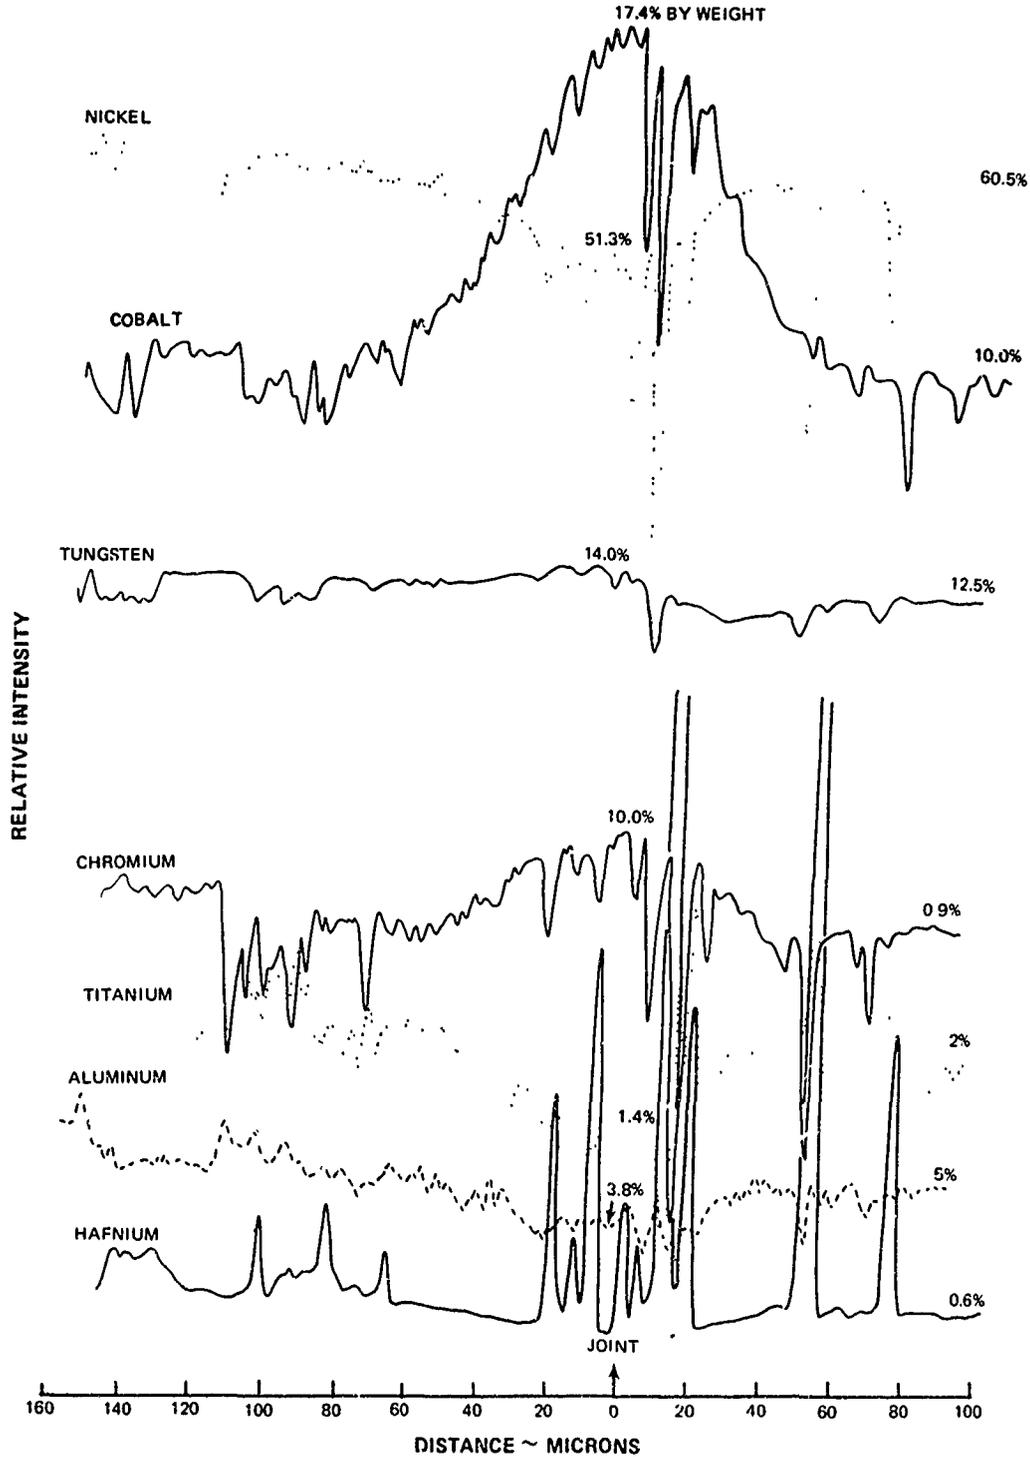
Figure 34 Electron Microprobe Analysis of a 0.5 Mil Dispersion Electroplated Interlayer (49Ni-32Co-9W-10Cr) Diffusion Welded (2200°F/500 PSI/1 Hr. + 2200°F/3 Hr.). The Joint Was Cracked (see Figure 32); Fine Particles Were Identified as Hafnium Rich Oxides. Tungsten and Chromium Have Been Solutioned; Cobalt Content is High.

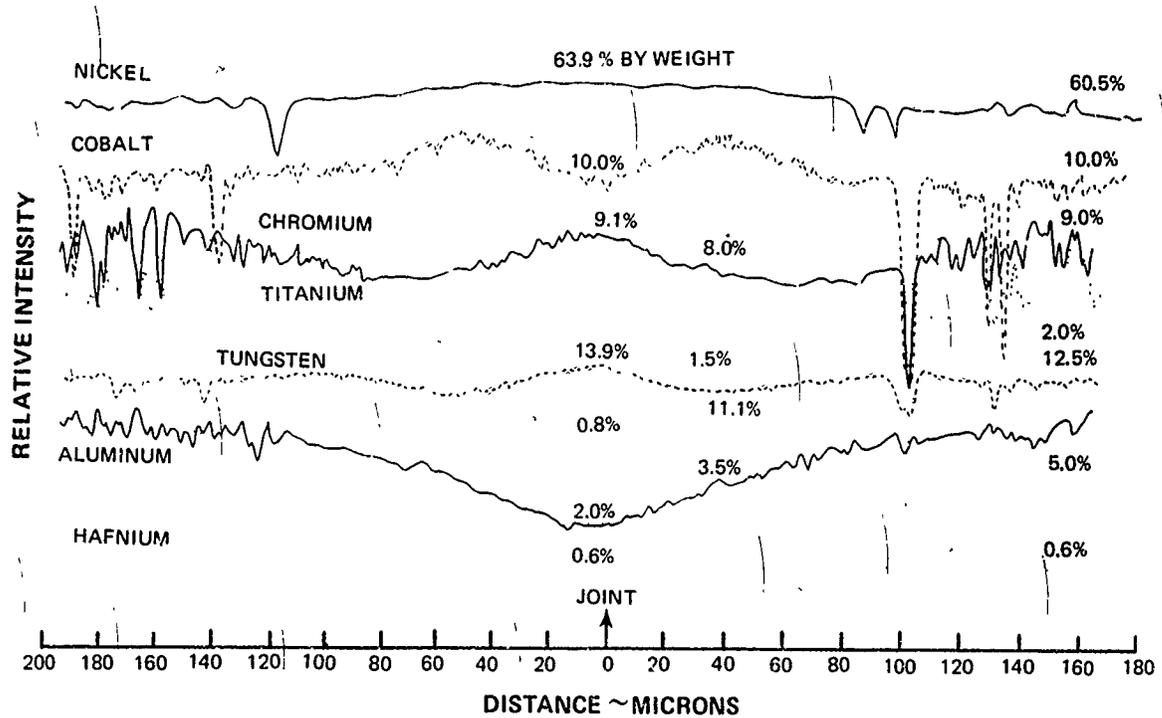
Figure 38 Electron Microprobe Analysis of 3 Mil Foil A Intermediary (68Ni-10Co-9Cr-12W-1Cb) Diffusion Weld (2200°F/500 PSI/1 Hr. + 2200°F/3 Hr.), Also Shown in Figure 3d. Joint Center is Low in Aluminum and Titanium; the 0.2 Mil Nickel-25% Cobalt Interlayer Left Residually High Cobalt on Either Side of the Joint

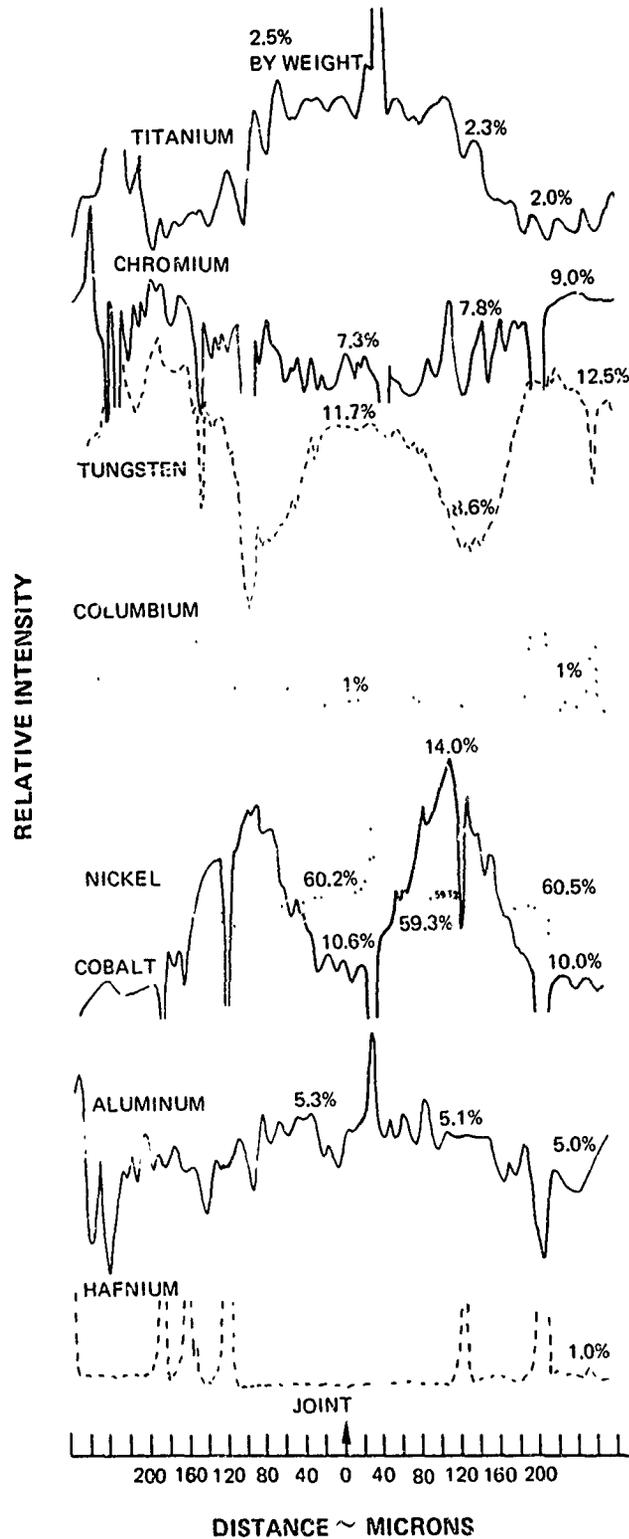
Figure 40 Electron microprobe analysis of an 8 mil Foil B intermediary and 0.5 mil nickel-20% cobalt interlayer diffusion weld between PWA 1422 as-cast surfaces (2170°F/750 psi/2 Hr). Although slightly rich in aluminum and titanium the joint is fairly homogeneous after a two hour cycle.

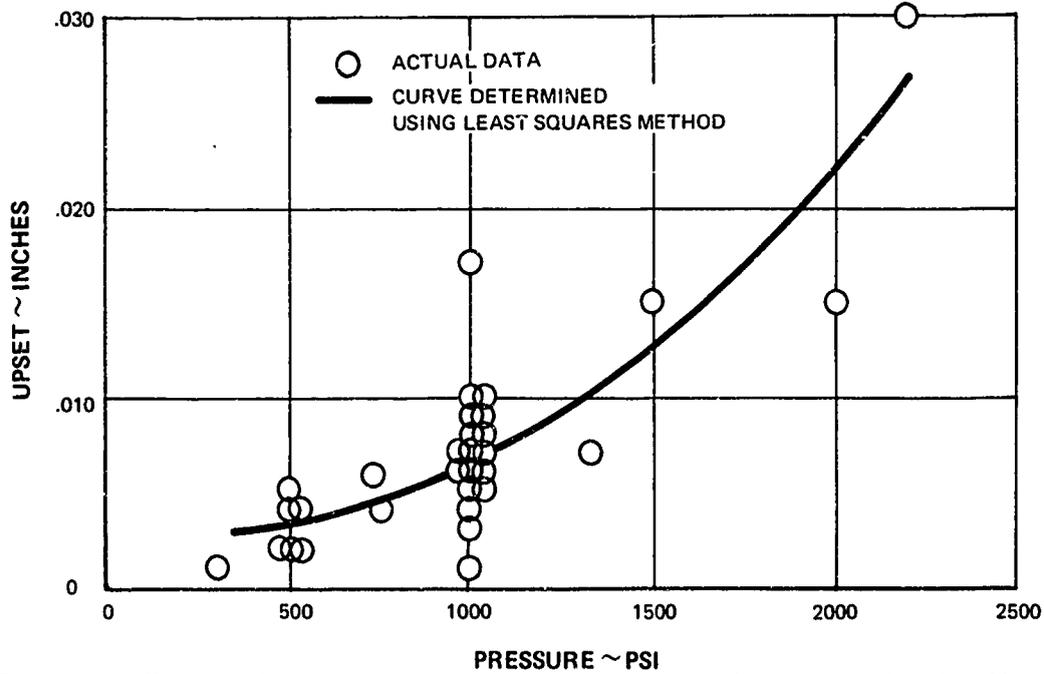
Figure 42 Effect of Pressure on Upset of 1 x 1 Inch Ribbed Specimens After One Hour at 2190-2200°F With Nickel-Cobalt Interlayers
