FINAL REPORT ON
JOINING TECHNIQUES FOR FABRICATION OF
HIGH-TEMPERATURE SUPERALLOY BLADES

C. G. NESSLER
Pratt & Whitney Aircraft
Division of United Aircraft Corporation

TECHNICAL REPORT AFML-TR-71-237
DECEMBER 1971

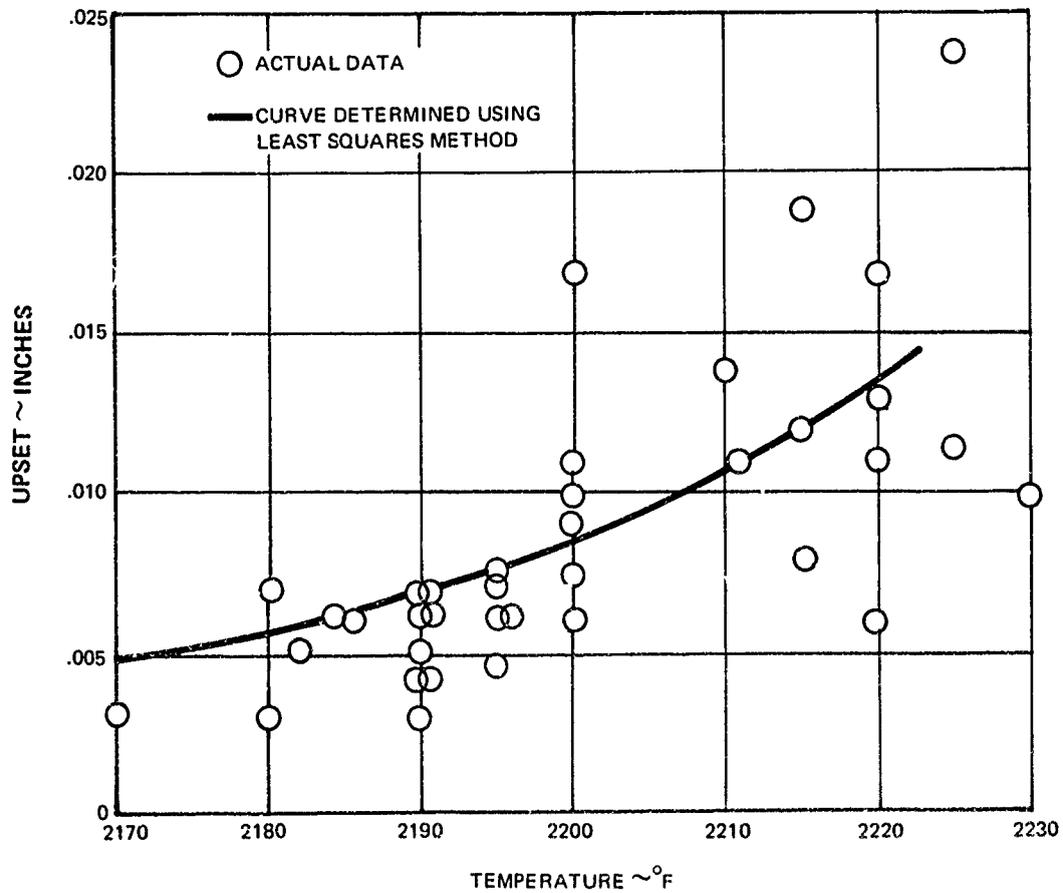
Figure 43 Effect of Temperature on Upset of 1 x 1 Inch Ribbed Specimens After One Hour at 1000 PSI Average Joint Pressure With Nickel-Cobalt Interlayers

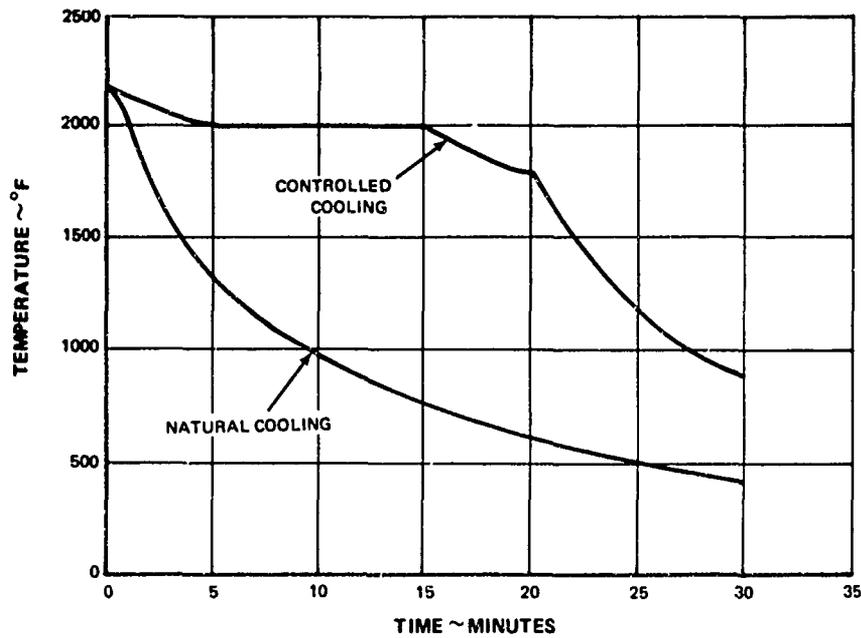
Figure 45 Cooling Rates of 1 X 1 Inch Ribbed Specimens in Diffusion Welding Press

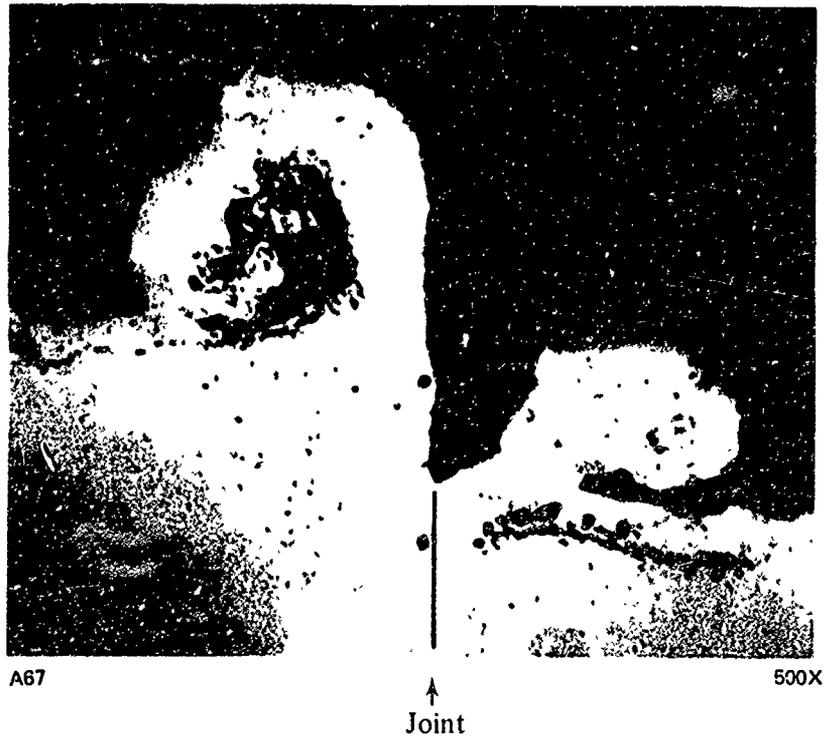
Figure 46 PWA 1422 Diffusion Welded with a 0.5 Mil Nickel - 25% Cobalt Interlayer Shows a Flashing at the Joint Edge that is Believed to be Related to Electroplate Buildup at the Edges and Extrusion During Welding

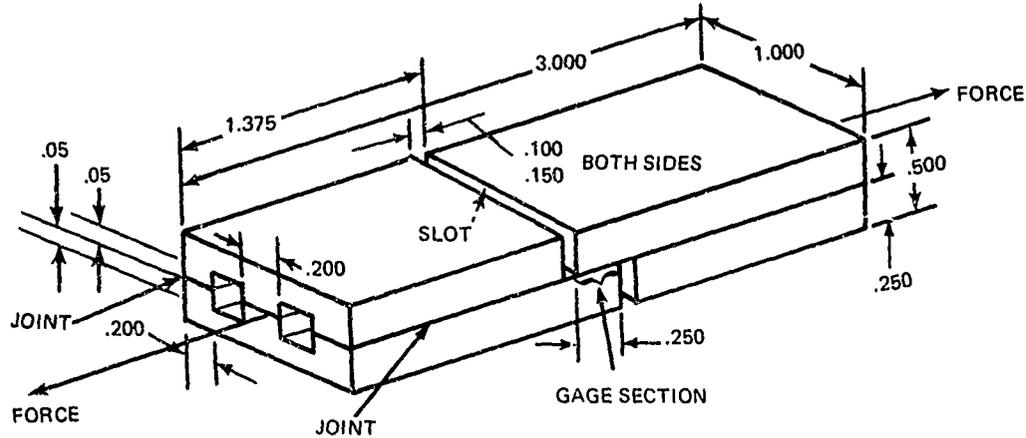
Figure 49 Ribbed Specimen For Evaluating 1800°F Shear Strength Has Internal Dimensions Similar To The 1 x 1 Specimen in Figure 9

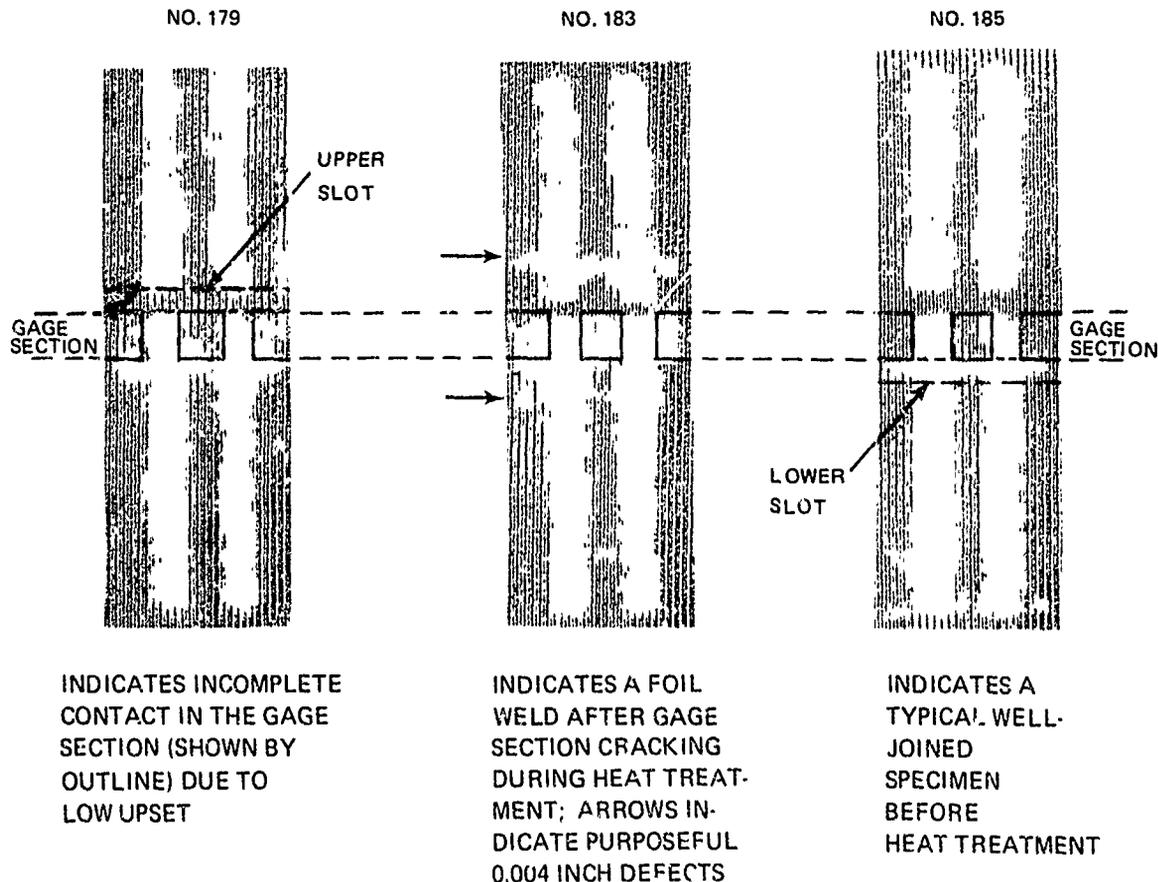
Fig: 52 Typical Ultrasonic C-Scans of 1 x 3 Ribbed Shear Specimens. Slot Region Varies in Appearance Depending on Orientation to Transducer.

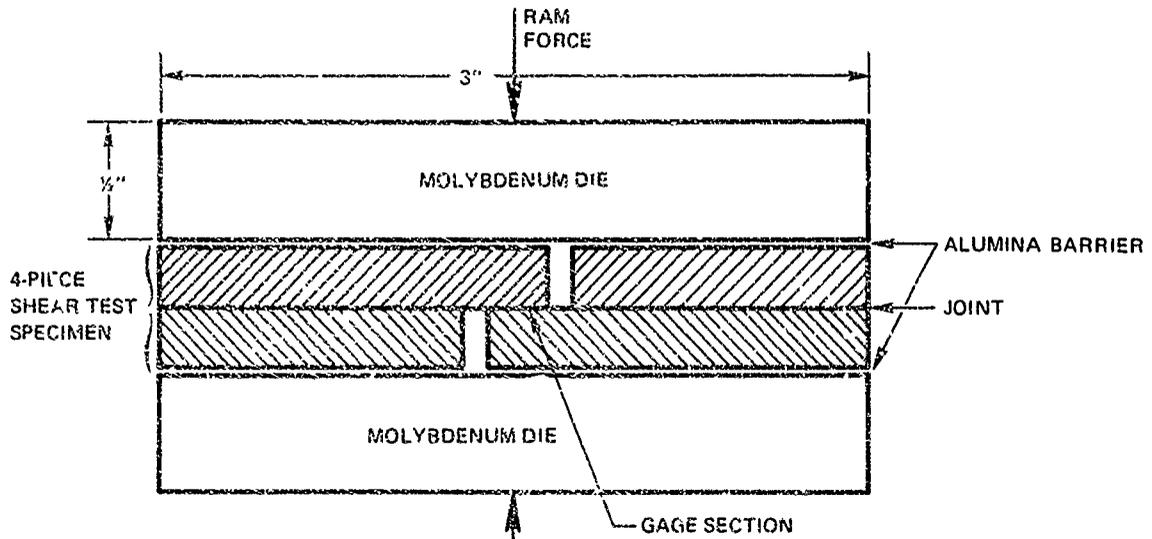
Figure 53 1 x 3 Shear Specimens and Die Configuration Which Often Yielded Gage Section Fractures After Welding.

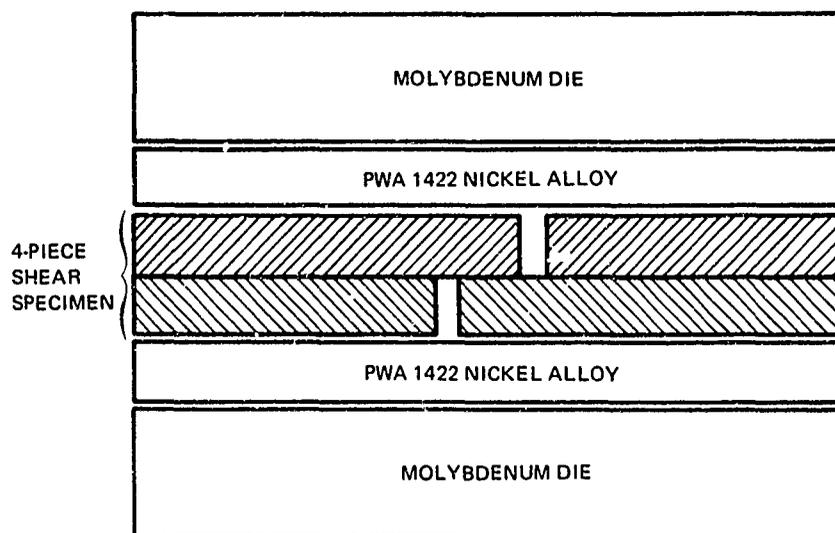
Figure 55 Modified Welding Die Configuration Which Alleviated Gage Section Failure At The End of Welding Cycle

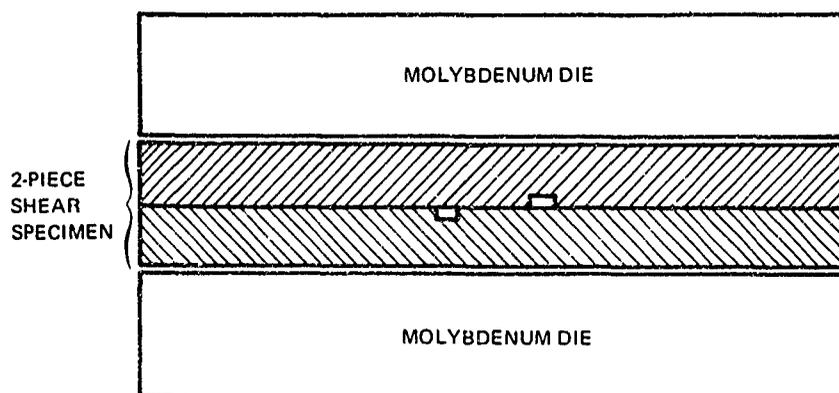
Figure 56 Modified Shear Specimen Configuration Which Avoids Localized Gage Section Stress; Full Slots Are Machined After Welding.

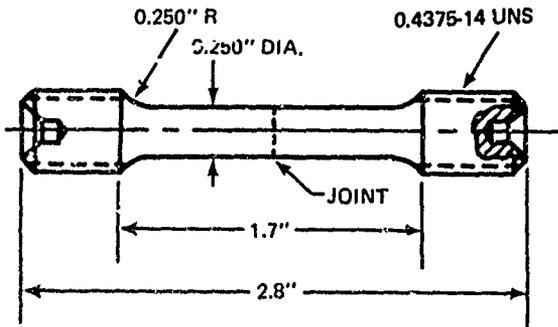
Figure 58 MDL 2351 Tensile Specimen

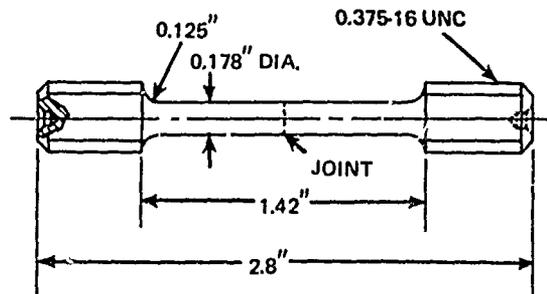
Figure 59 MDL 4528 Stress Rupture Specimen

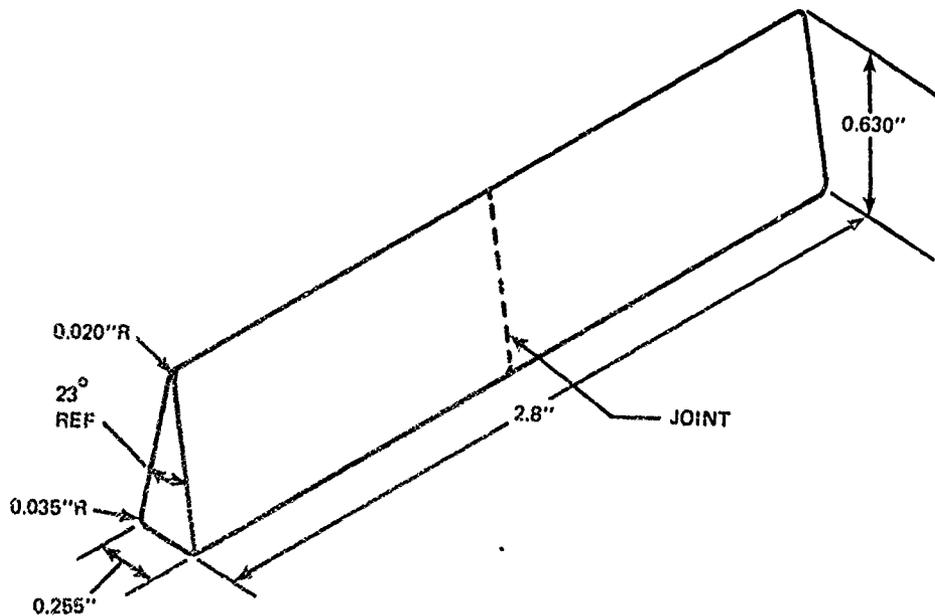
Figure 60 Thermal Fatigue Specimen Machined From Rectangular Block

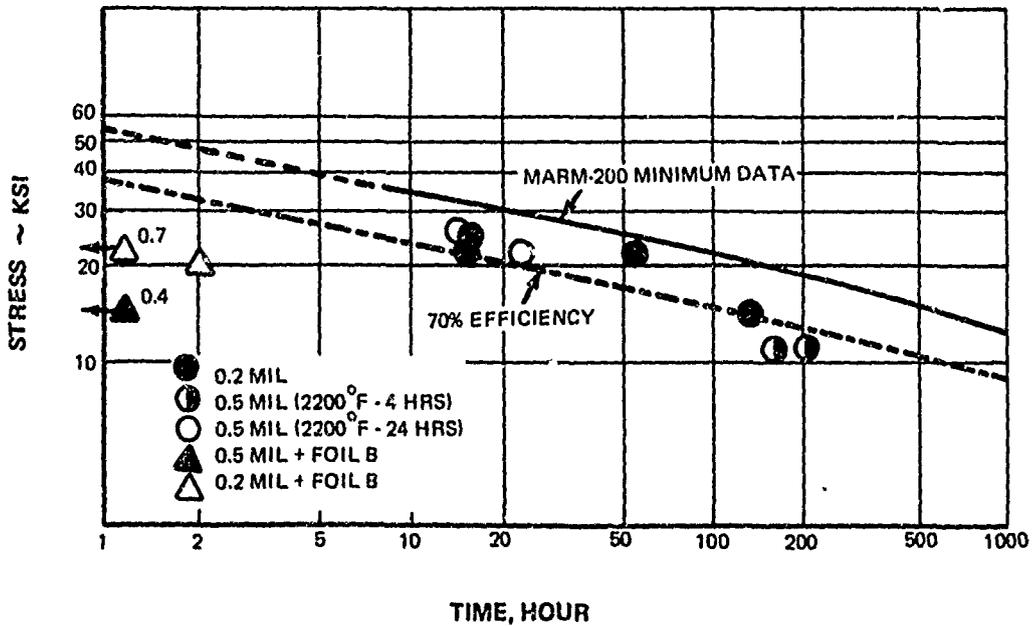
Figure 61 1800°F Stress Rupture Strength of Ni-20Co Interlayer Diffusion Welds of PWA 1422

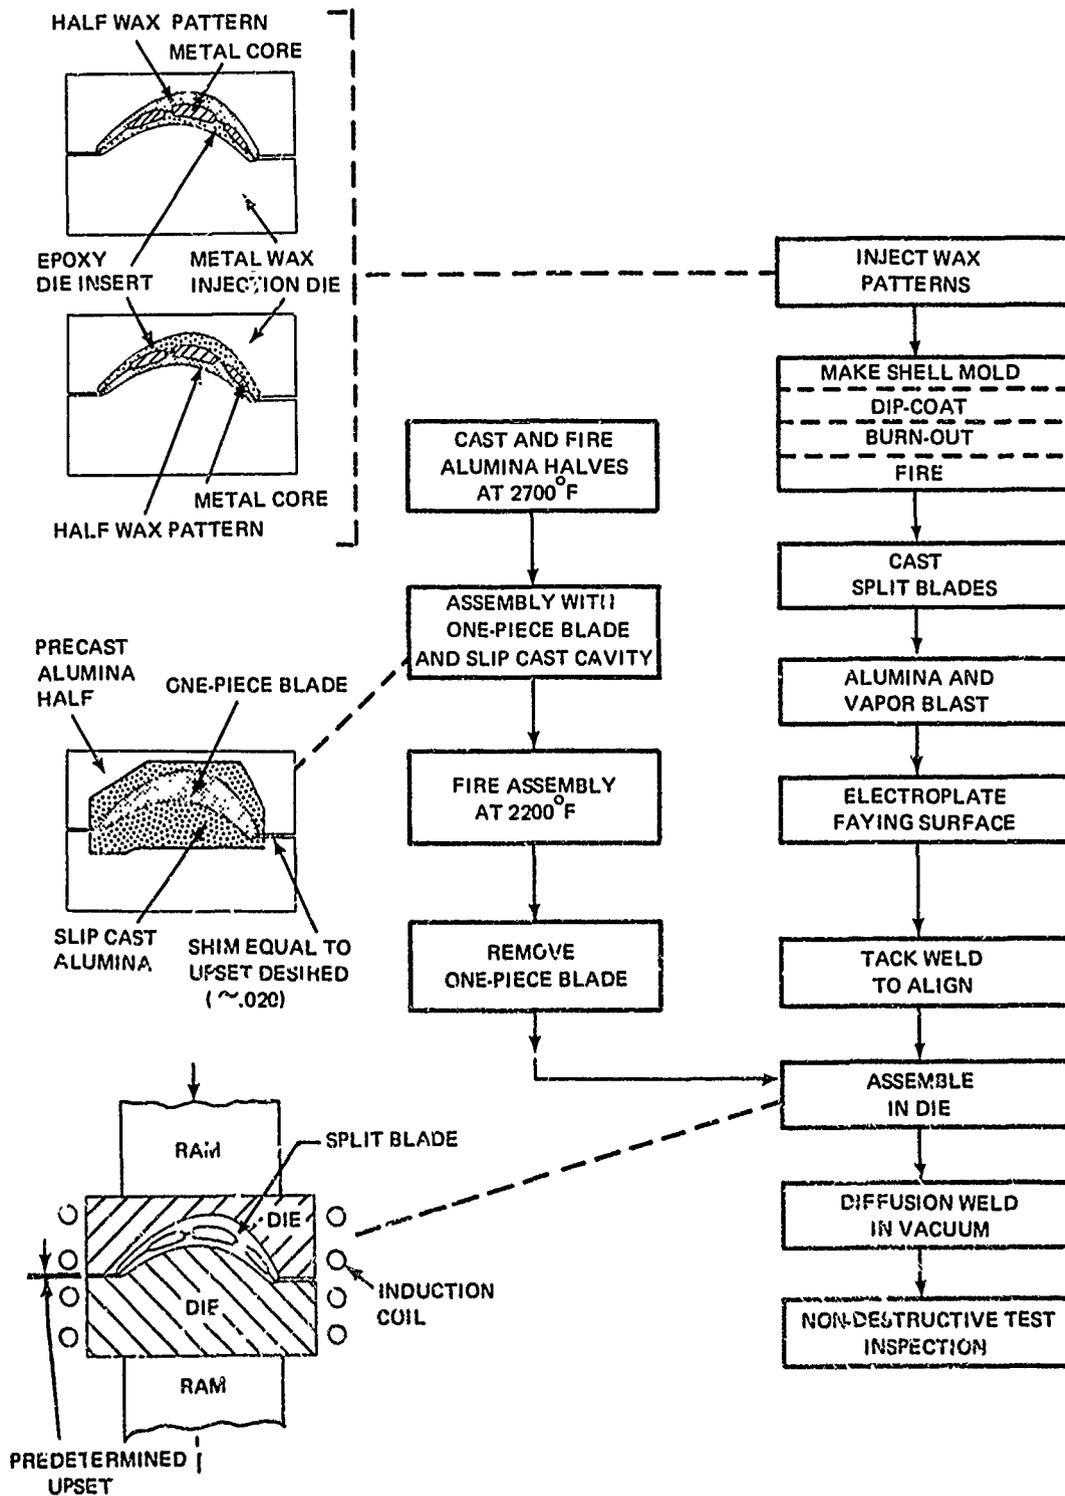
Figure 62 Split Blade Diffusion Welding Flow Chart

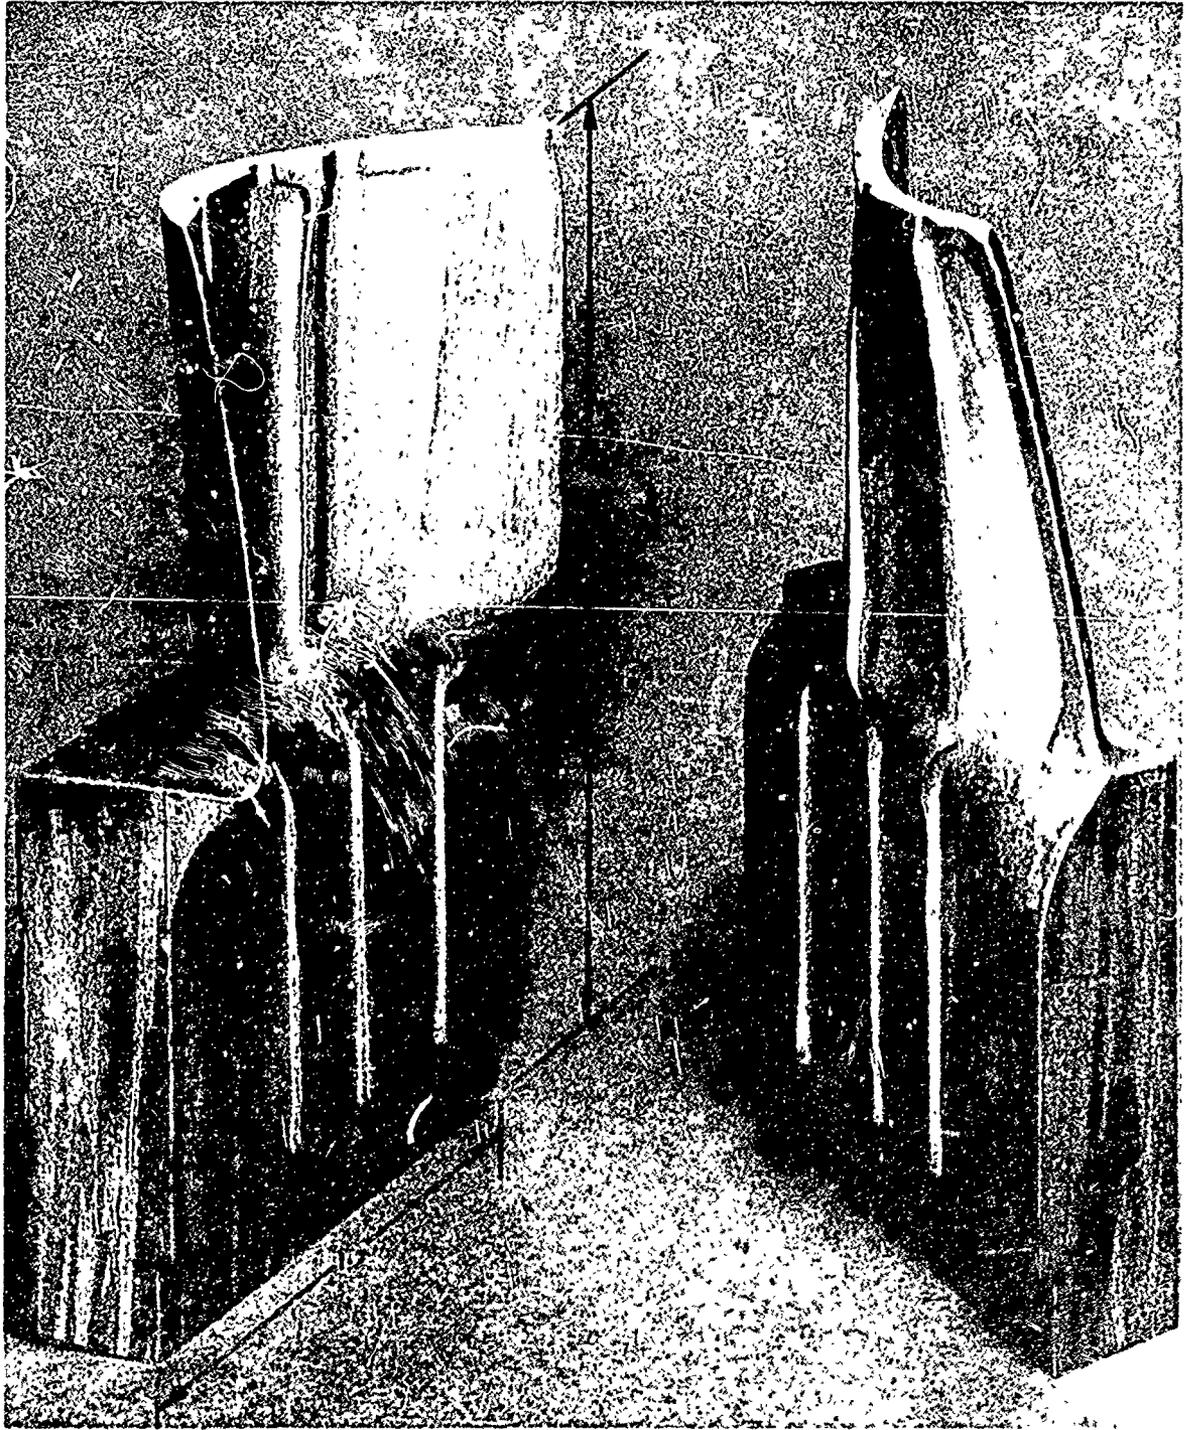
Figure 63 As-Cast, Alumina Blasted, and Etched PWA 1422 Blade Halves Which Were Welded Showing Surface Contour and Finish. The Heavy Root Section is Necessitated by the Directional Casting Process

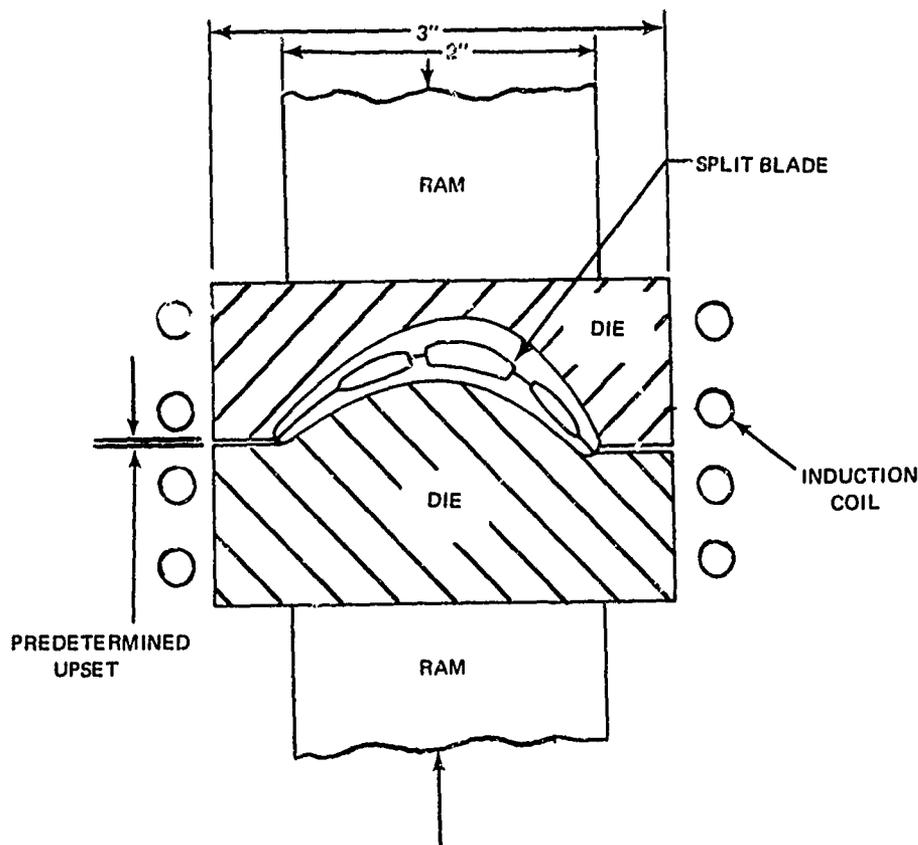
Figure 67 Schematic Diagram of Set-Up for Diffusion Welding Split Blades

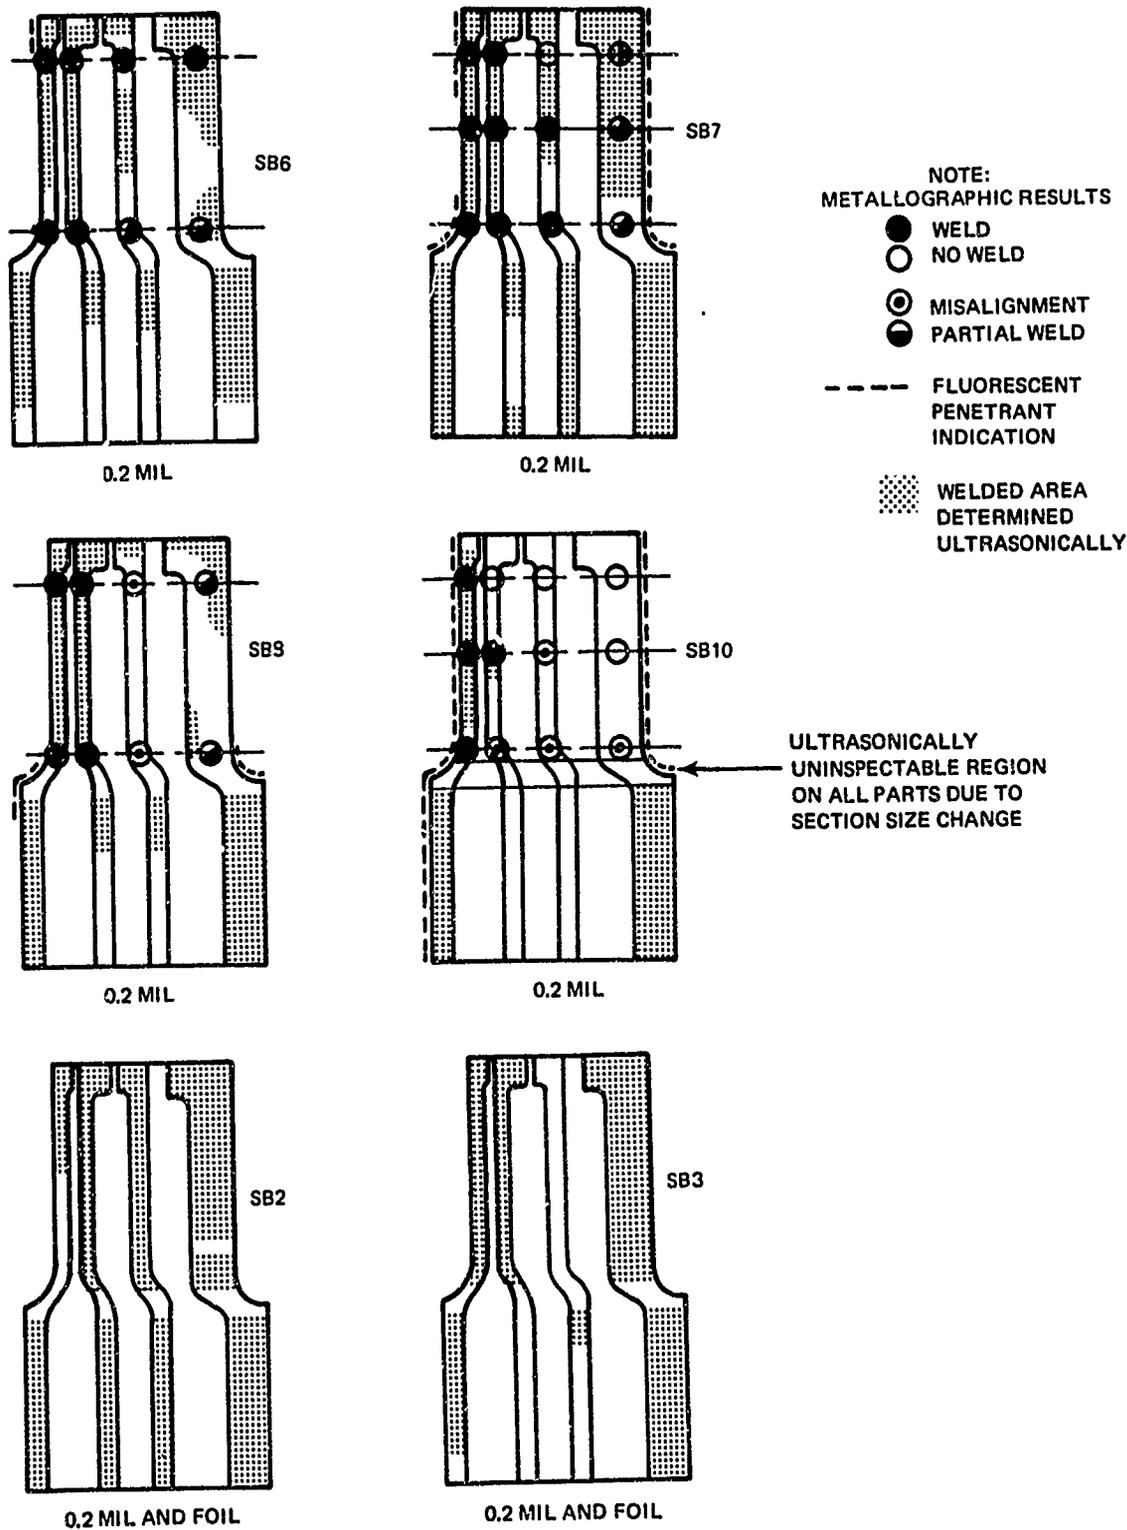
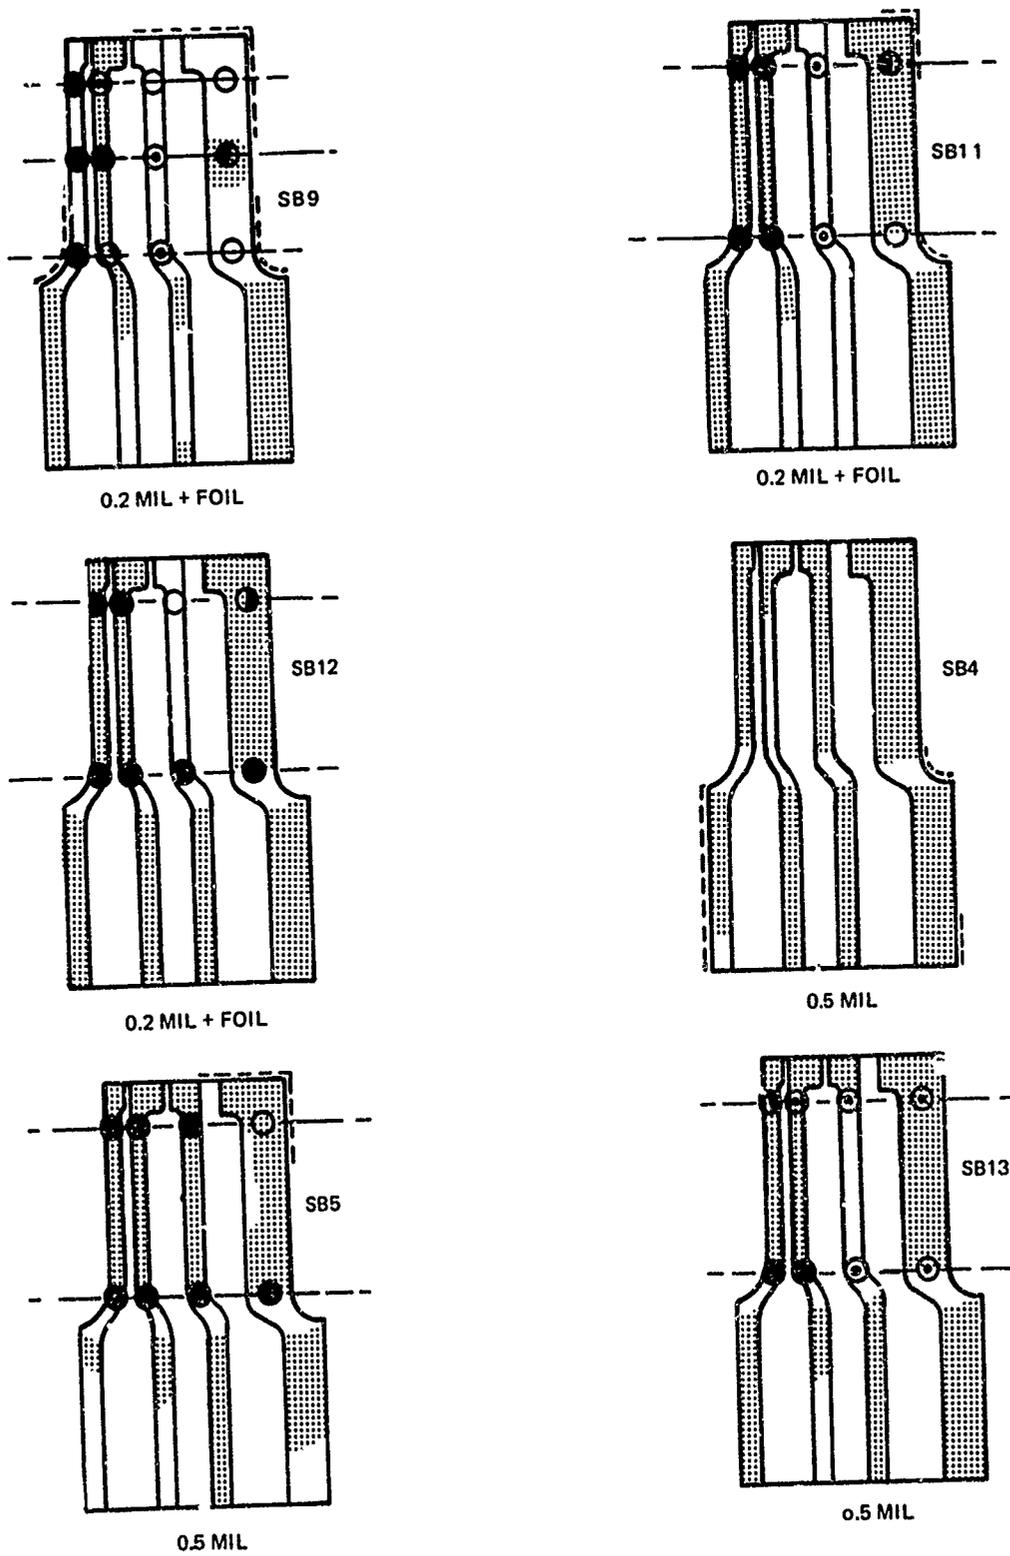
Figure 73 Correlation of Results of Non-Destructive Testing With Metallographically Observed Welding

Figure 73 (Cont'd) Correlation of Results of Non-Destructive Testing With Metallographically Observed Welding

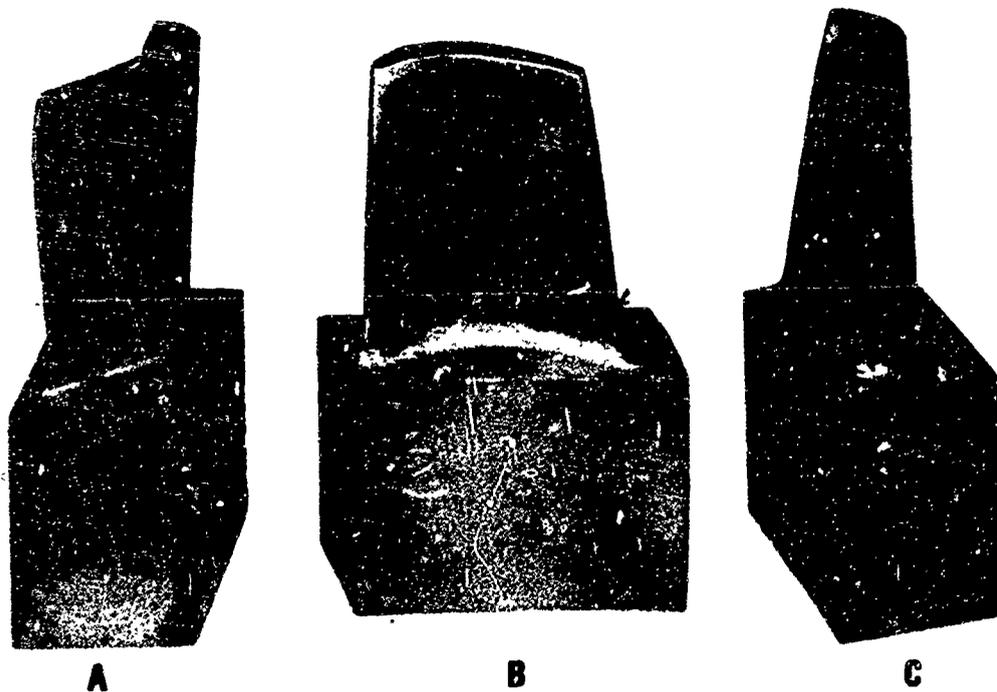
Figure 74 Defects in Diffusion Welded Split Blades: Lack of Fit (A and C) and Localized Melting at Trailing Edge (B).
