THE EFFECT OF FRETTING DAMAGE ON
THE FATIGUE BEHAVIOR OF METALS

Technical Report 1

David W. Hoepfner and Gary L. Goss

LOCKHEED-CALIFORNIA COMPANY • BURBANK
A DIVISION OF LOCKHEED AIRCRAFT CORPORATION

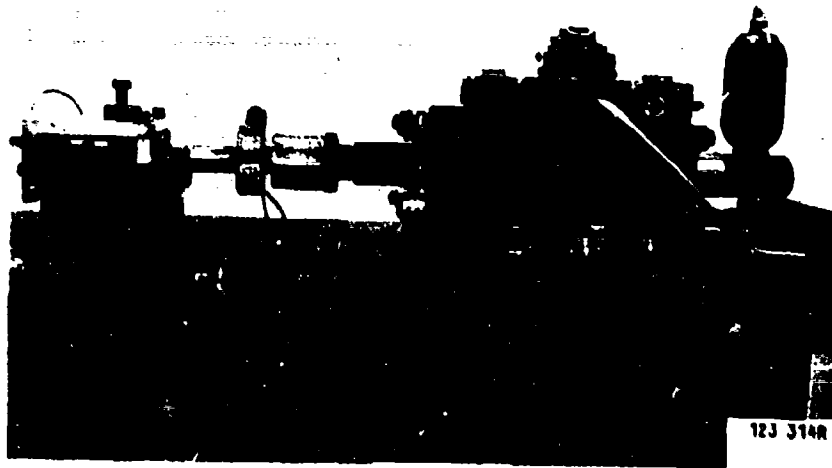
Figure 2. Overall View of the Fretting-Fatigue Test Machine(11)

The basic elements are briefly described here. The fretting-fatigue machine was developed to meet the following requirements:

- (1) A fatigue unit with axial load capability was utilized.
- (2) The mean load, alternating load, normal load, relative surface displacements, friction load, and frequency would be monitored and controlled, as desired, throughout each test.
