## ANNEALED FOIL FATIGUE SENSOR DEVELOPMENT

*ROBERT S. HORNE AND OSCAR L. FREYRE*  
*LOCKHEED-GEORGIA COMPANY*

TECHNICAL REPORT AFFDL-TR-71-127

AIR FORCE FLIGHT DYNAMICS LABORATORY  
AIR FORCE SYSTEMS COMMAND  
WRIGHT-PATTERSON AIR FORCE BASE, OHIO

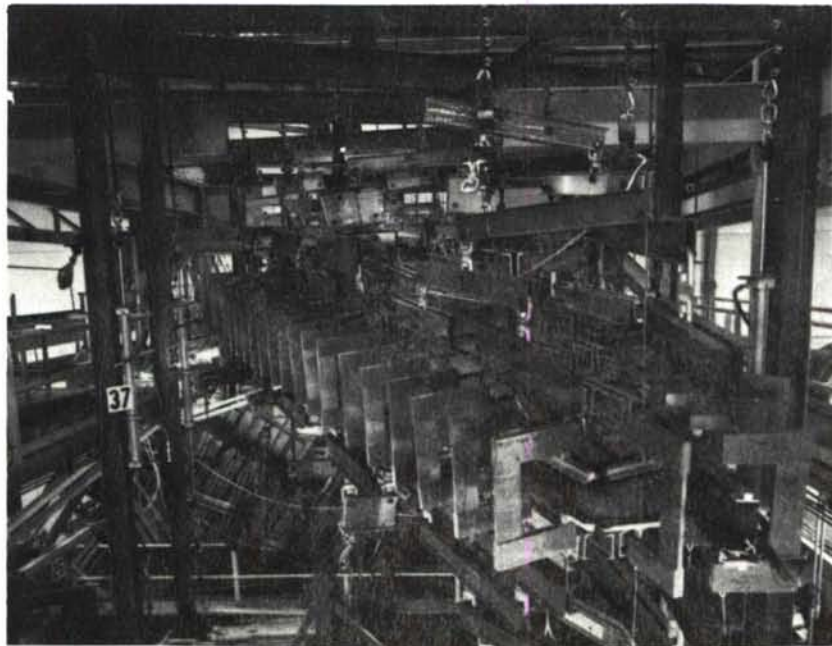
FIGURE 16. LEFT HAND HORIZONTAL STABILIZER AND SURROUNDING TEST FIXTURES. ALL SENSORS INSTALLED ON INTERNAL SURFACES

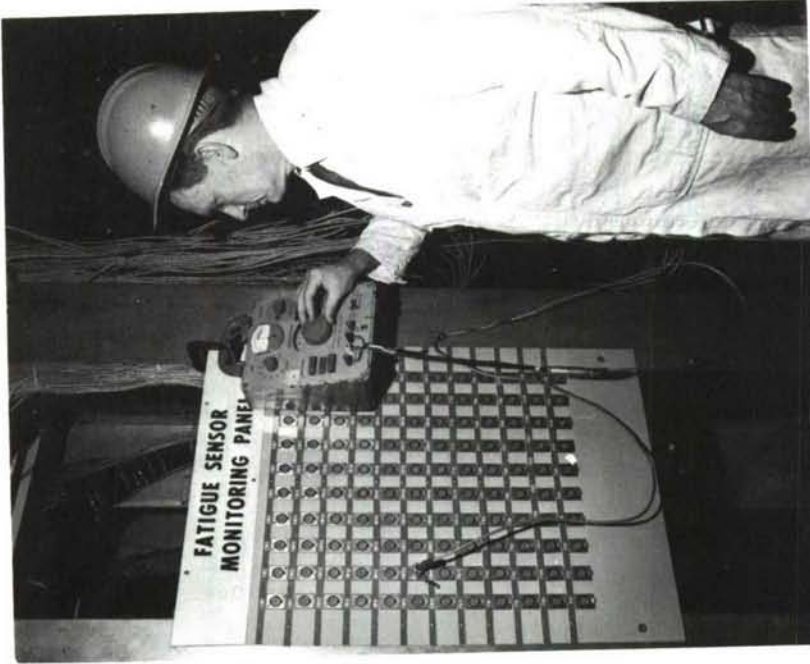
FIGURE 22. SAMPLING OF SENSOR RESISTANCE CHANGE

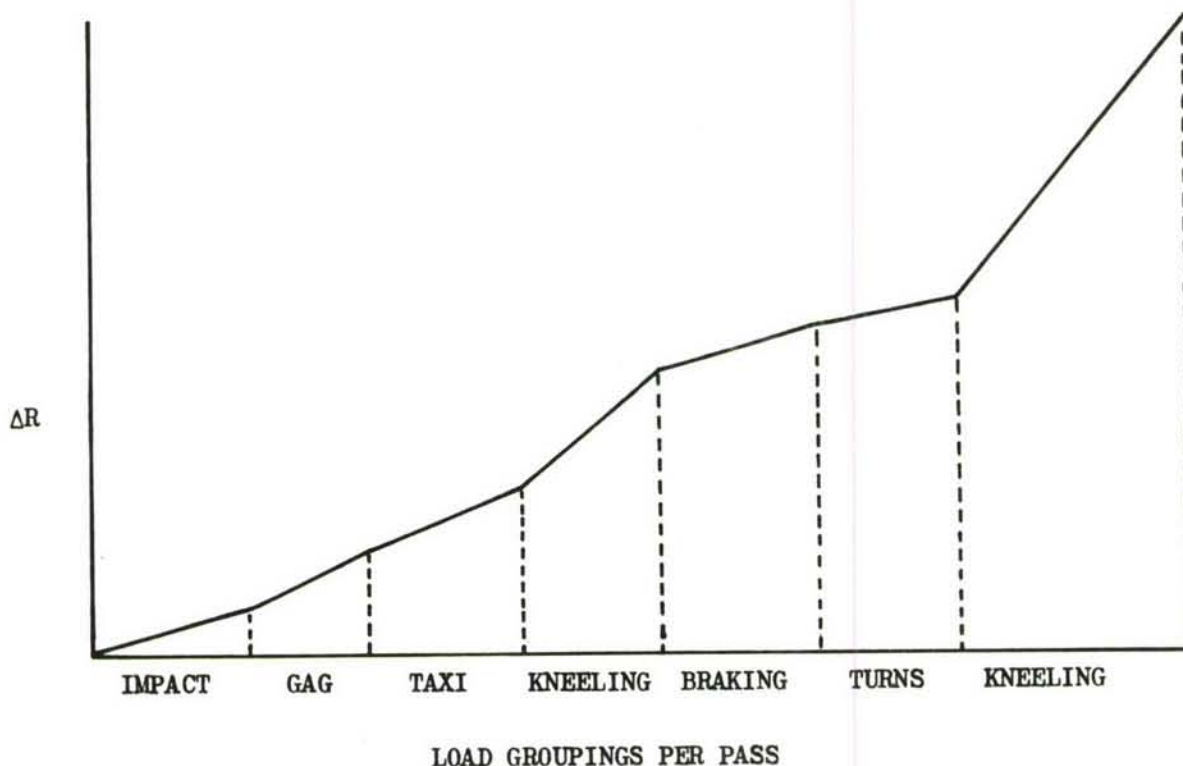
The diagram shown below illustrates the relative anticipated sensor resistance change in response to the basic load sources applied to the C-5A Main Landing Gear fatigue test specimen. The relative severity of each load source must be considered when locating the sensor and selecting its multiplying factor.

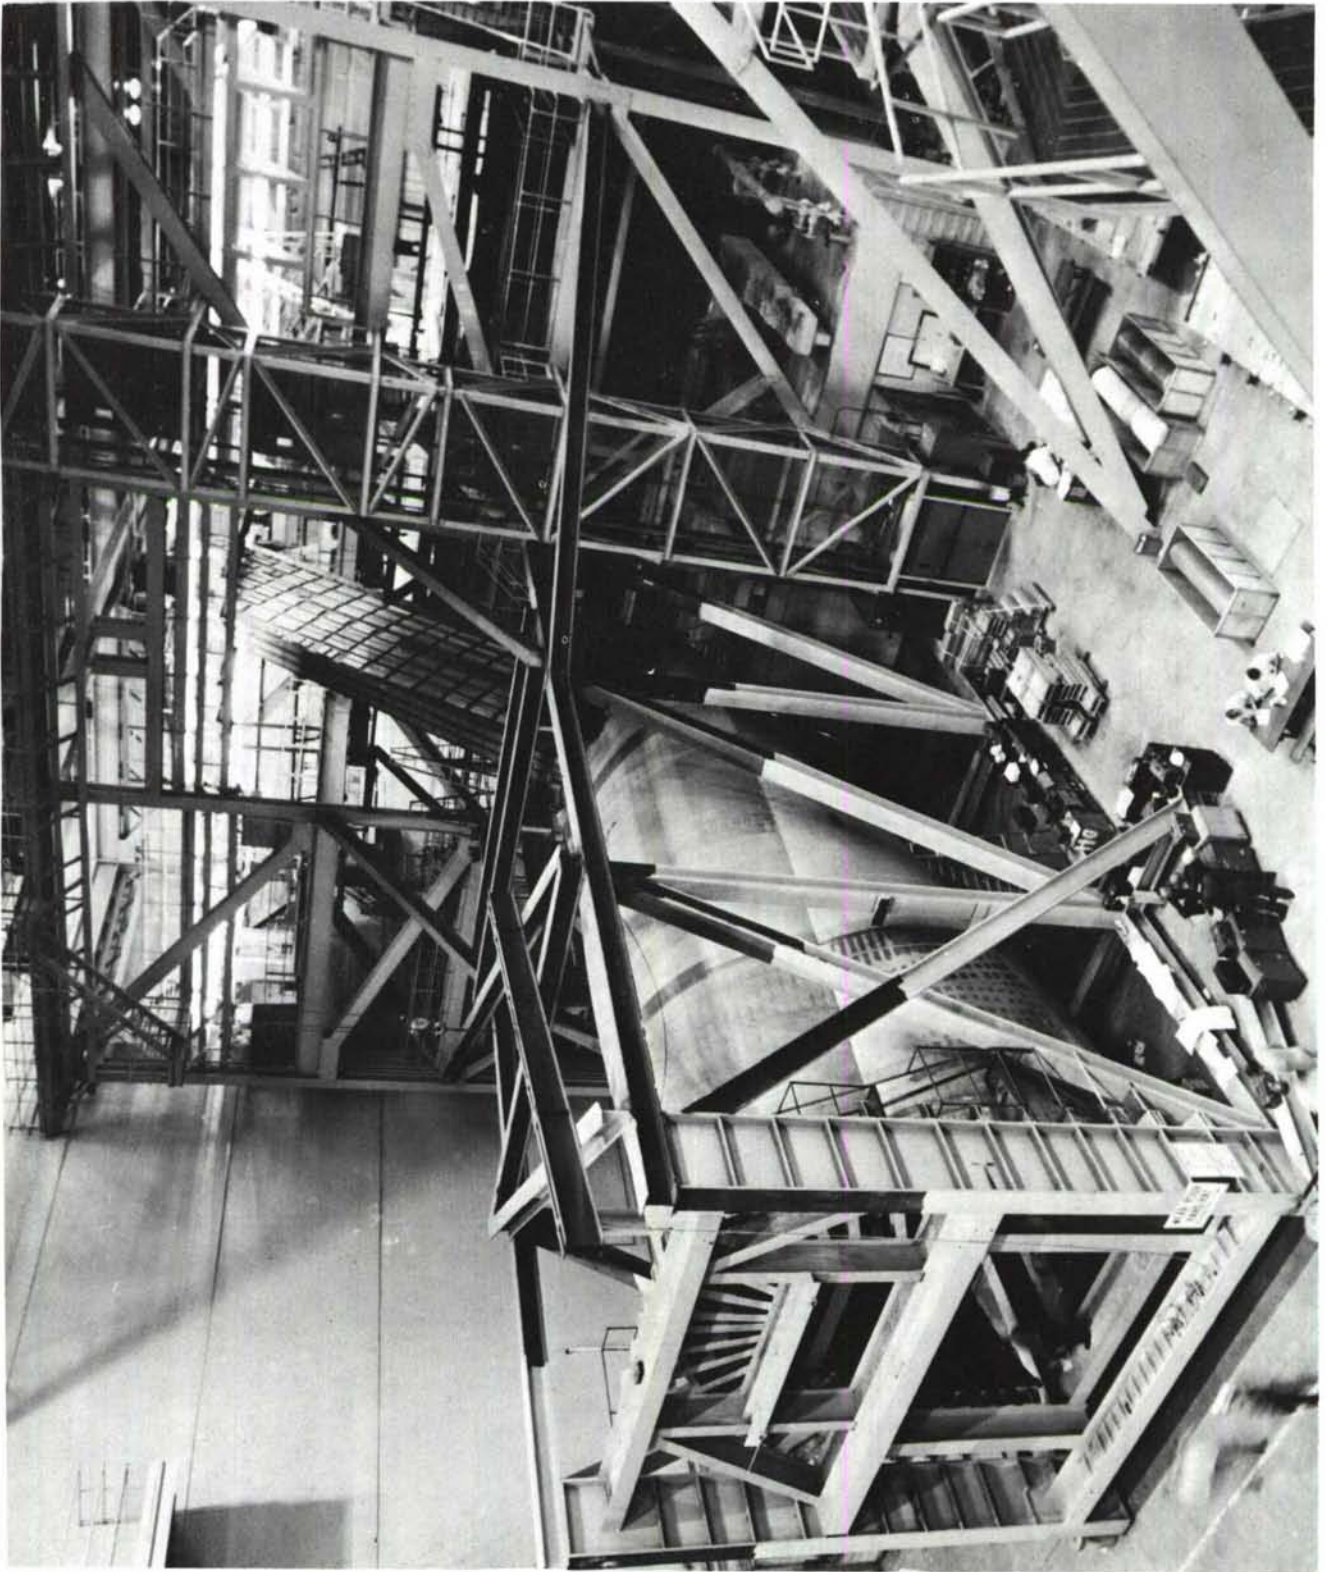
**FIGURE 33.** C-5A AFT FUSELAGE-EMPENNAGE IN TEST FIXTURE PRIOR TO INSTALLATION OF JACKS AND LINKAGE

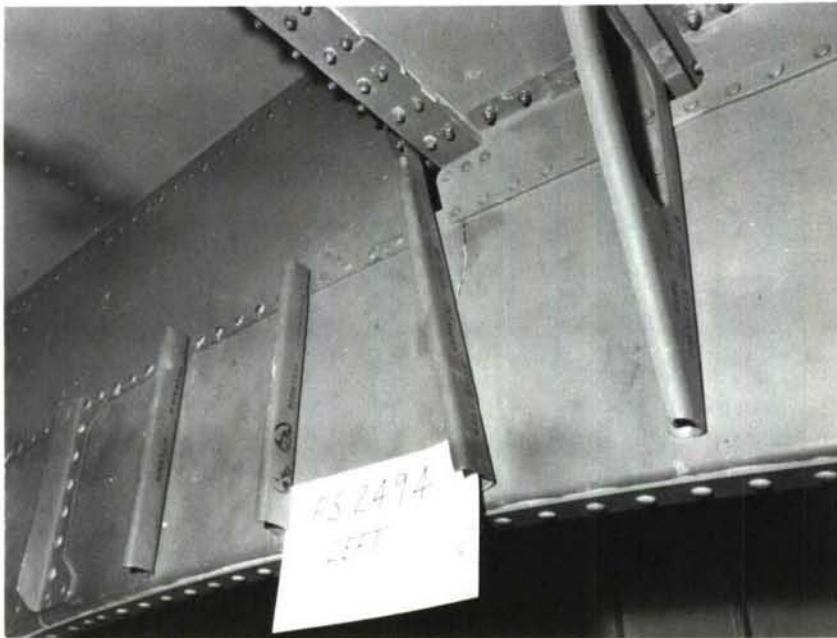
FIGURE 67. FATIGUE DAMAGE AT FUSELAGE FRAME STATION F.S. 2494.  
LOOKING AFT.

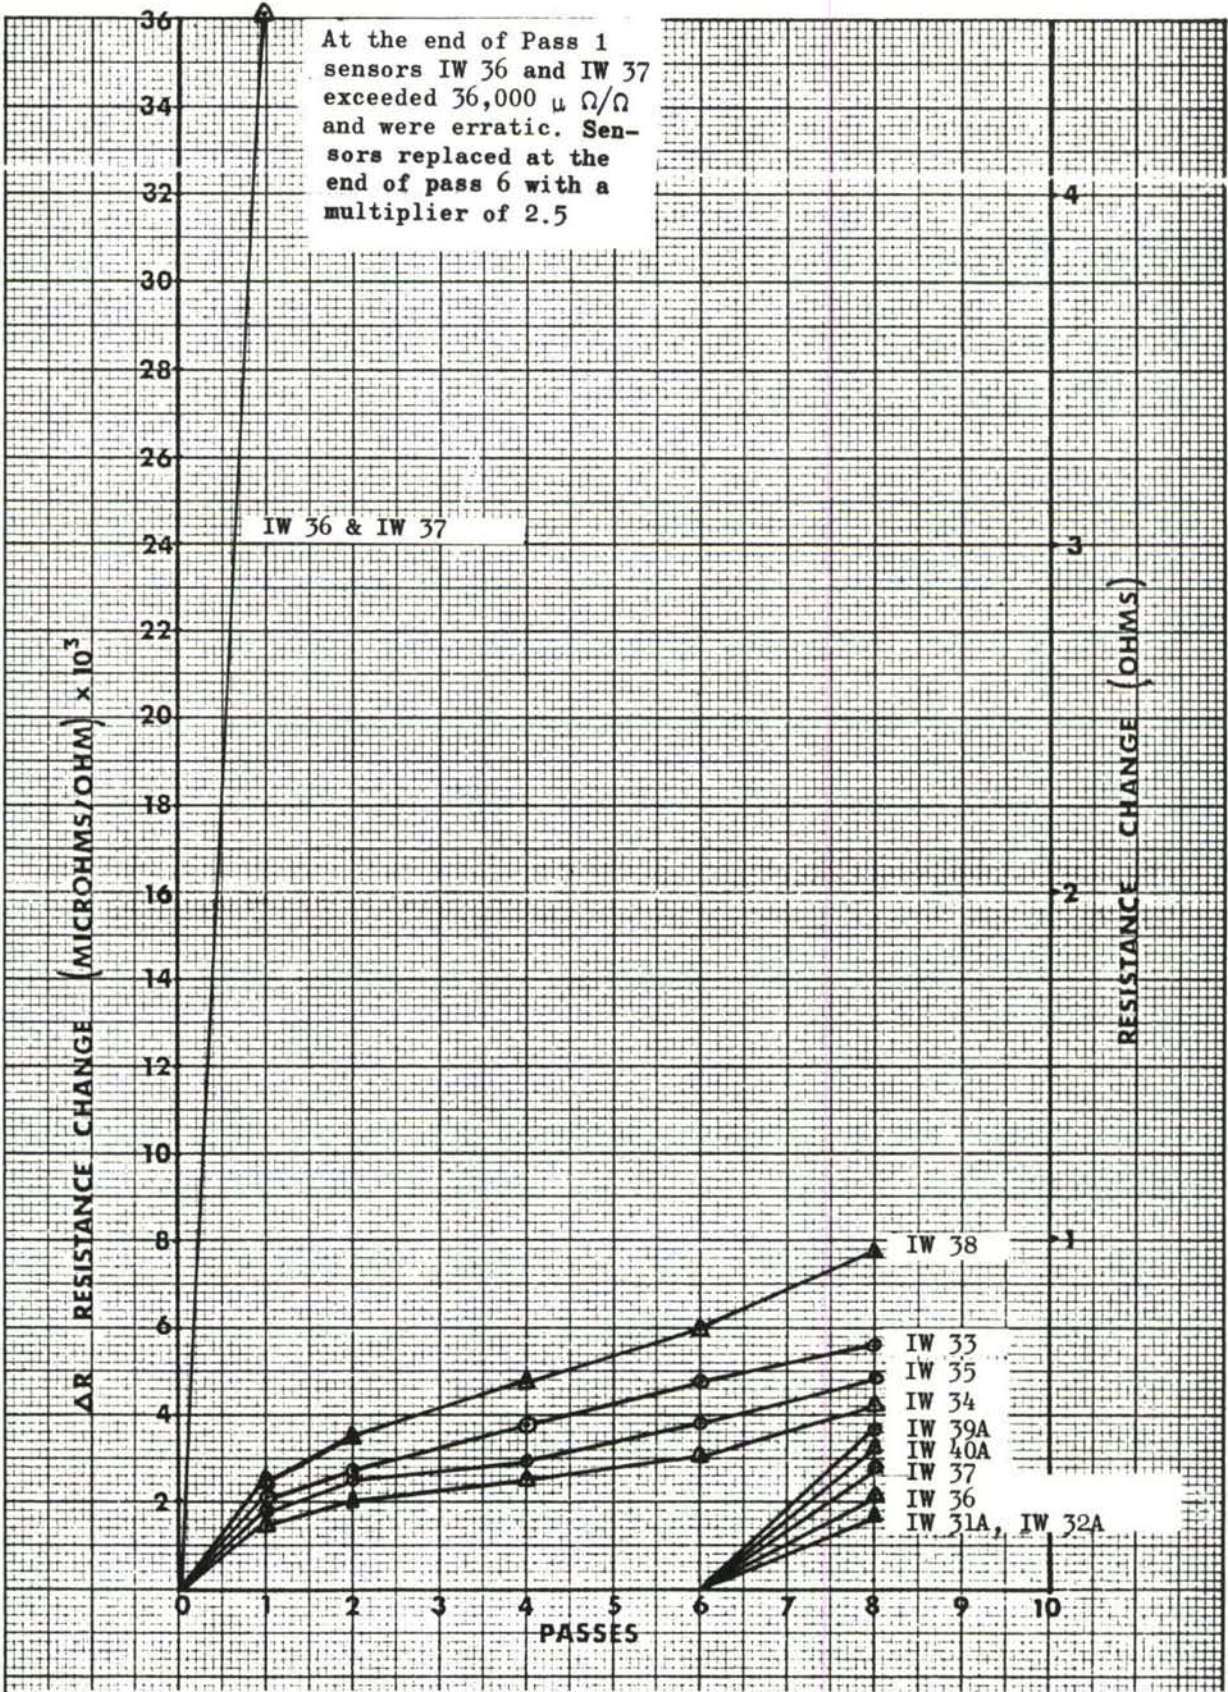
FIGURE 111. SENSOR RESPONSE ON THE LOWER SURFACE INNER WING AT W.S. 577

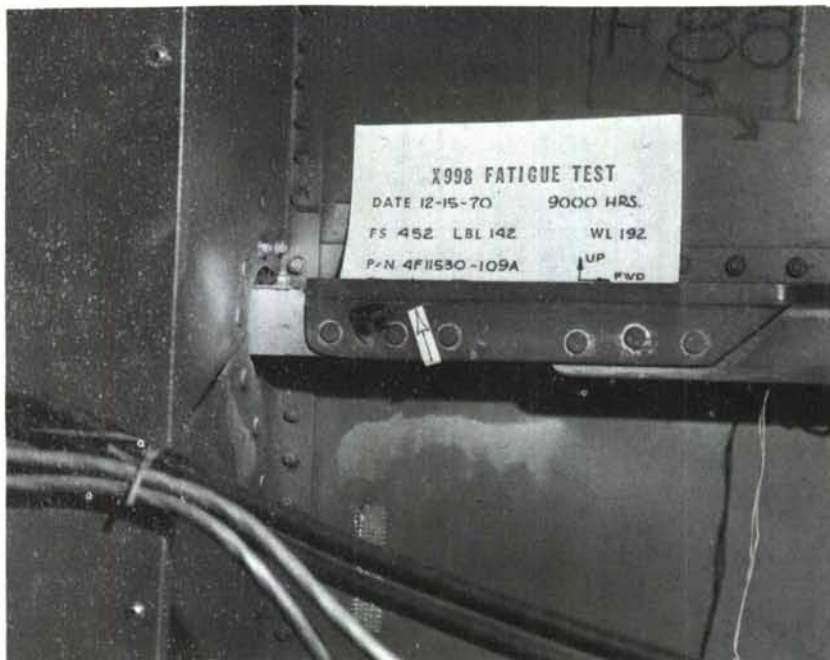
FIGURE 123. FATIGUE DAMAGE AT FUSELAGE STATION 452
