# USAAMRDL TECHNICAL REPORT 72-19

## OIL-STARVATION TEST PROGRAM: EVALUATION OF VASCO-X2 STEEL SPIRAL BEVEL GEARS

### FINAL REPORT

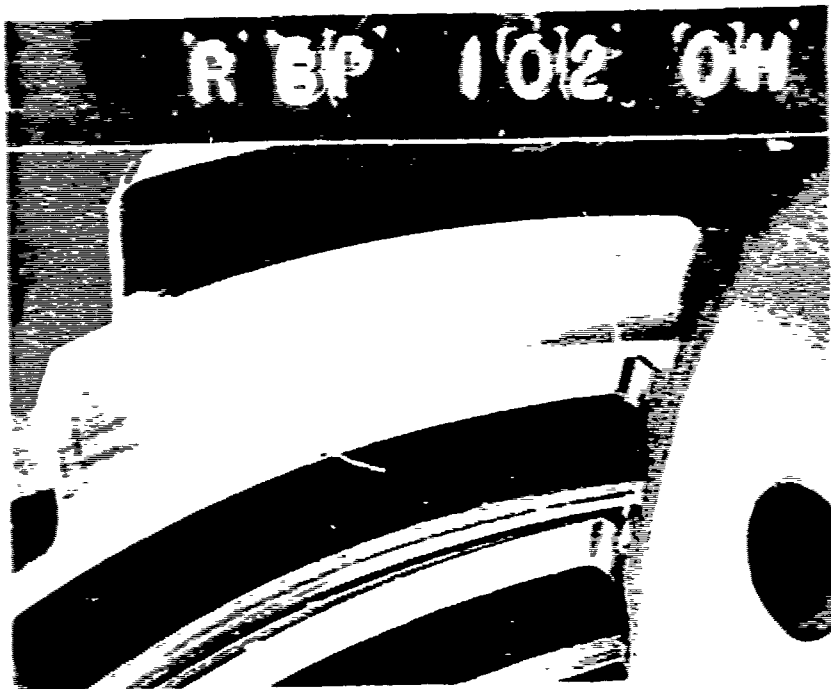
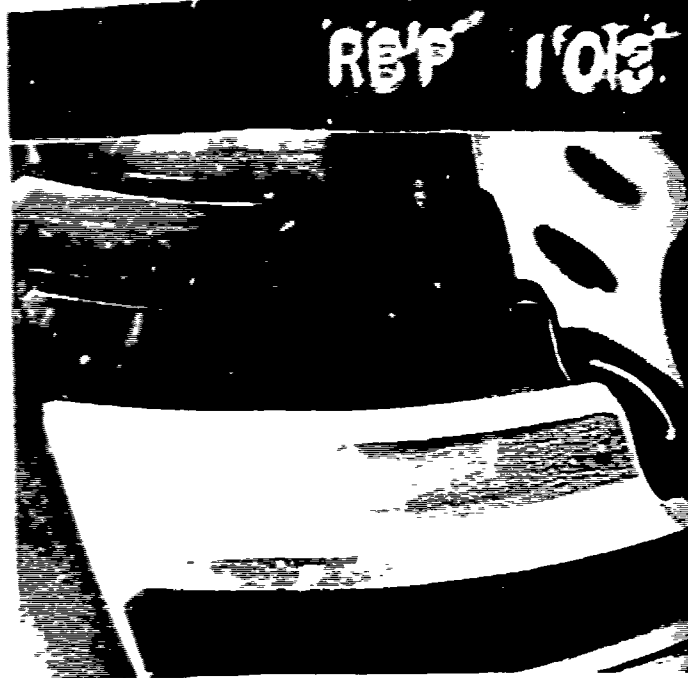
Figure 6. As-Received Condition of Baseline Test Gears (Sheet 1 of 2).

Eight gear sets of each type of steel were reground to remove the tooth surfaces resulting from the previous test program. The physical dimensions resulting from the regrinding process are shown in Table I. Figures 6 and 7 show the as-received condition of the gears prior to testing.

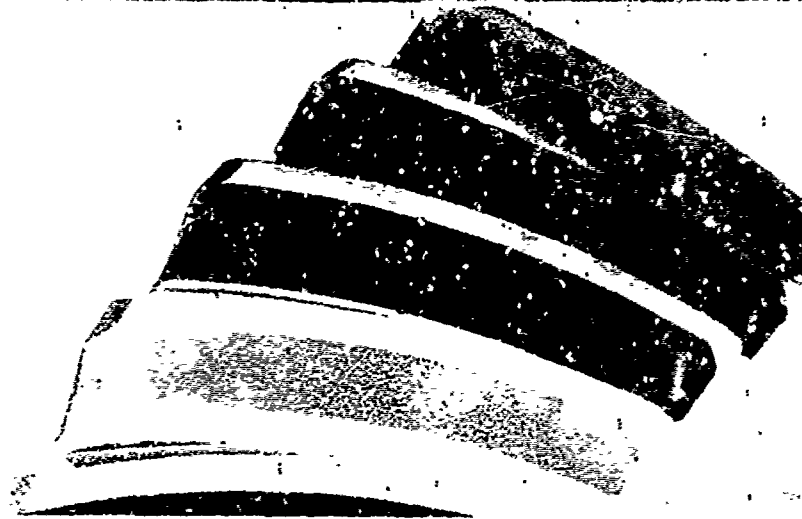
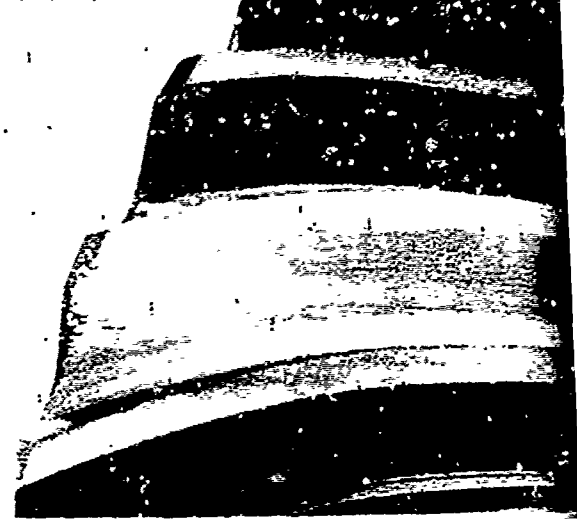
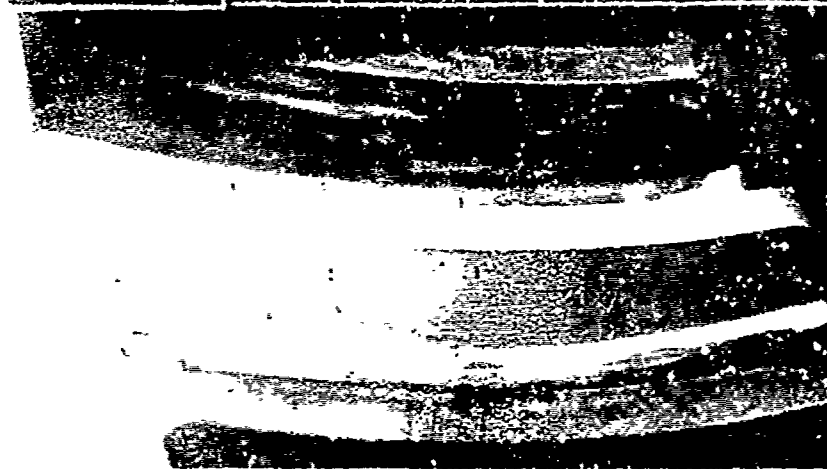
Figure 7. As-Received Condition of VASCO-X2 Test Gears (Sheet 1 of 2).

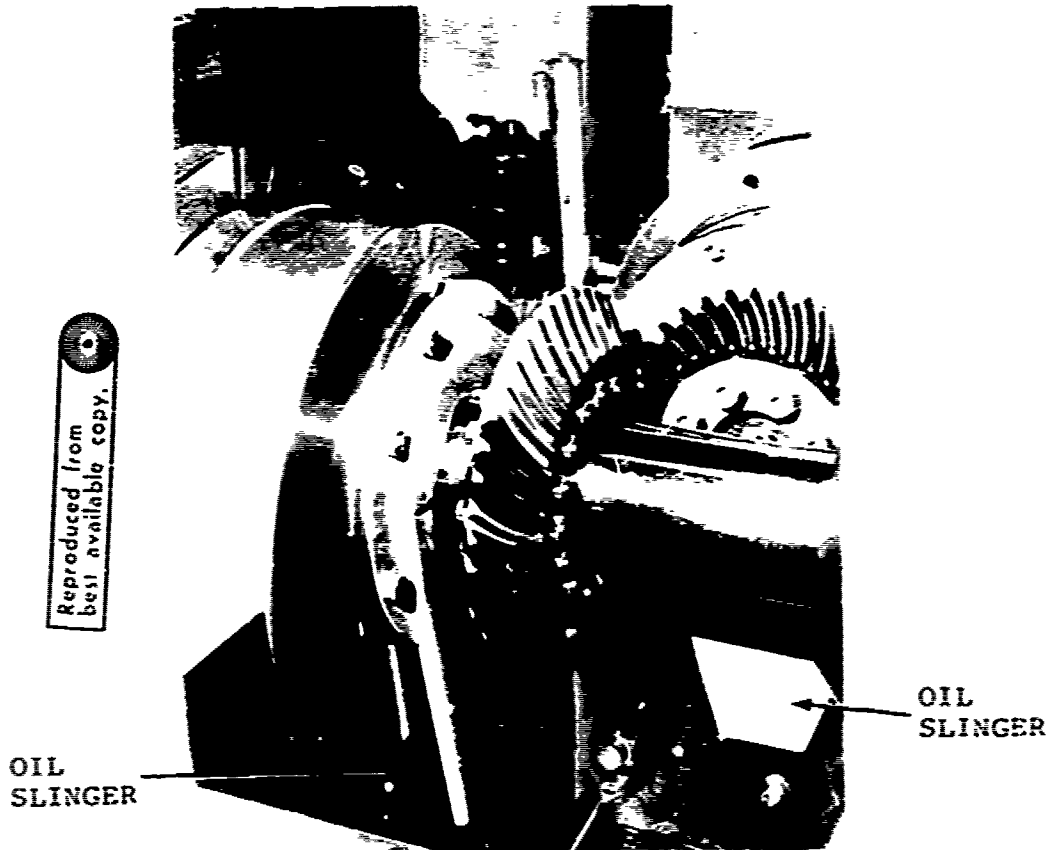
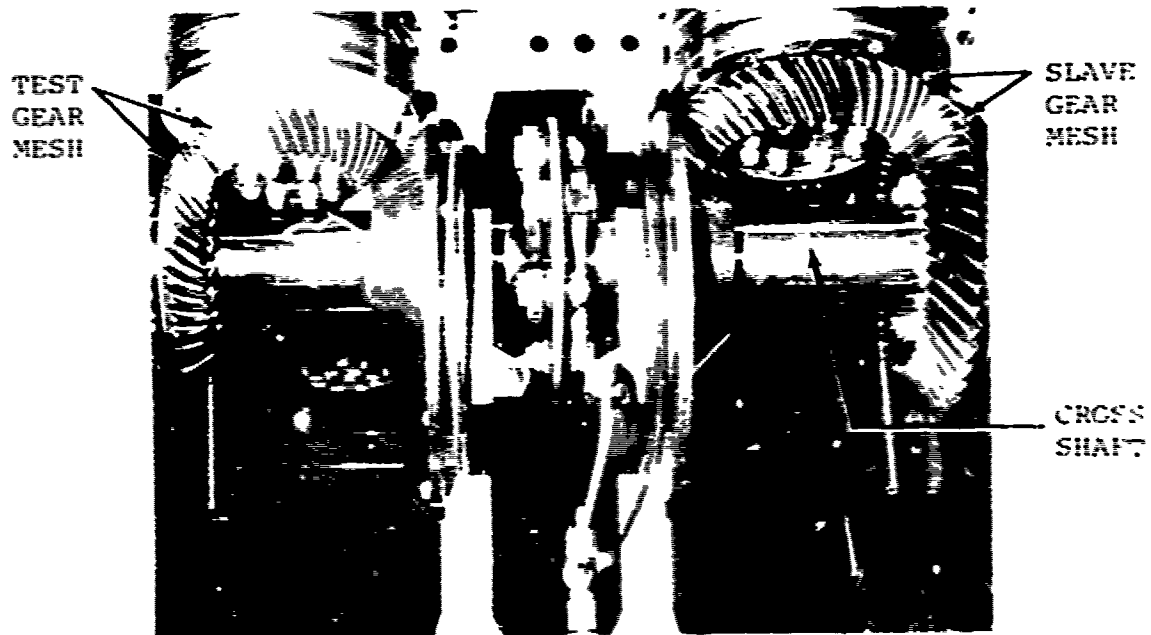
Figure 8. Boeing-Vertol Gear Research Test Stand.

All gear test specimens for this program were evaluated on the Boeing-Vertol gear research test stand located at Villanova University. This test apparatus was specifically designed for research and development programs for spur, helical, and bevel gears. The design incorporates provisions for center distance option, variable speed, and control of oil temperature and oil flow. The system is a regenerative (four-square) design using one gearbox as the slave unit and one gearbox as the test unit. Gear mountings were designed to be rigid and stable under all loading conditions with through-bored housings for maximum accuracy. All gear shafting is supported on ball and roller bearings lubricated by individual oil jets.

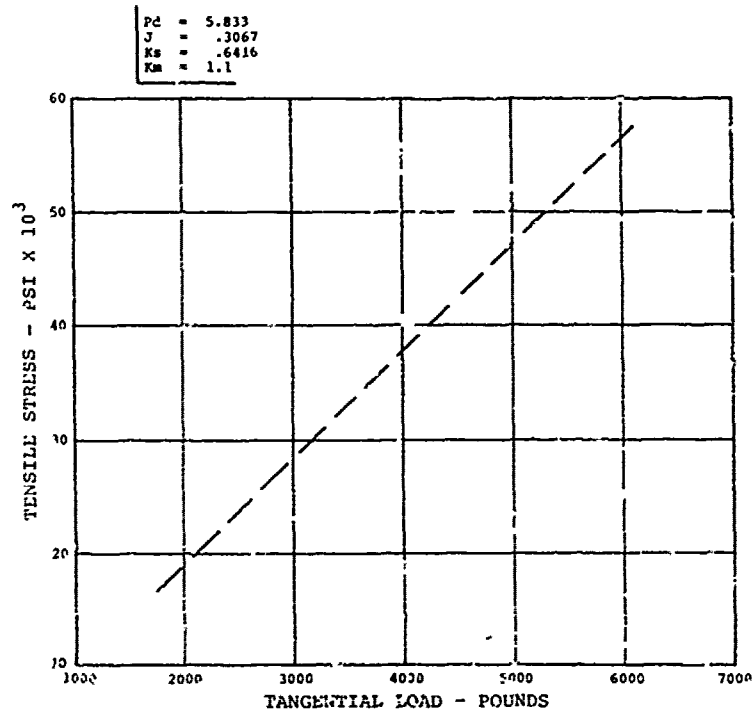
Figure 10. Tensile Stress in Spiral Bevel Test Gears.

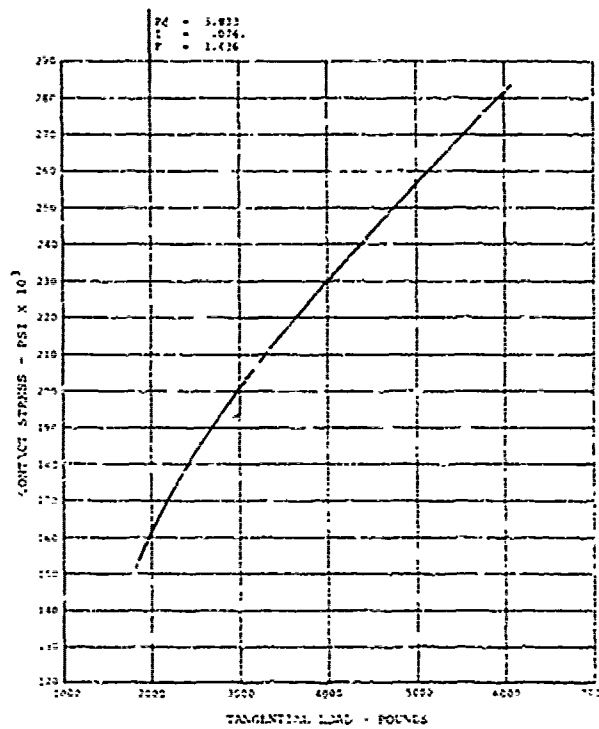
Figure 11. Contact Stress in Spiral Bevel Test Gears.

$$S_c = 2800 \sqrt{\frac{1.1 Wt}{0.6562}} \text{ (see Figure 11)}$$

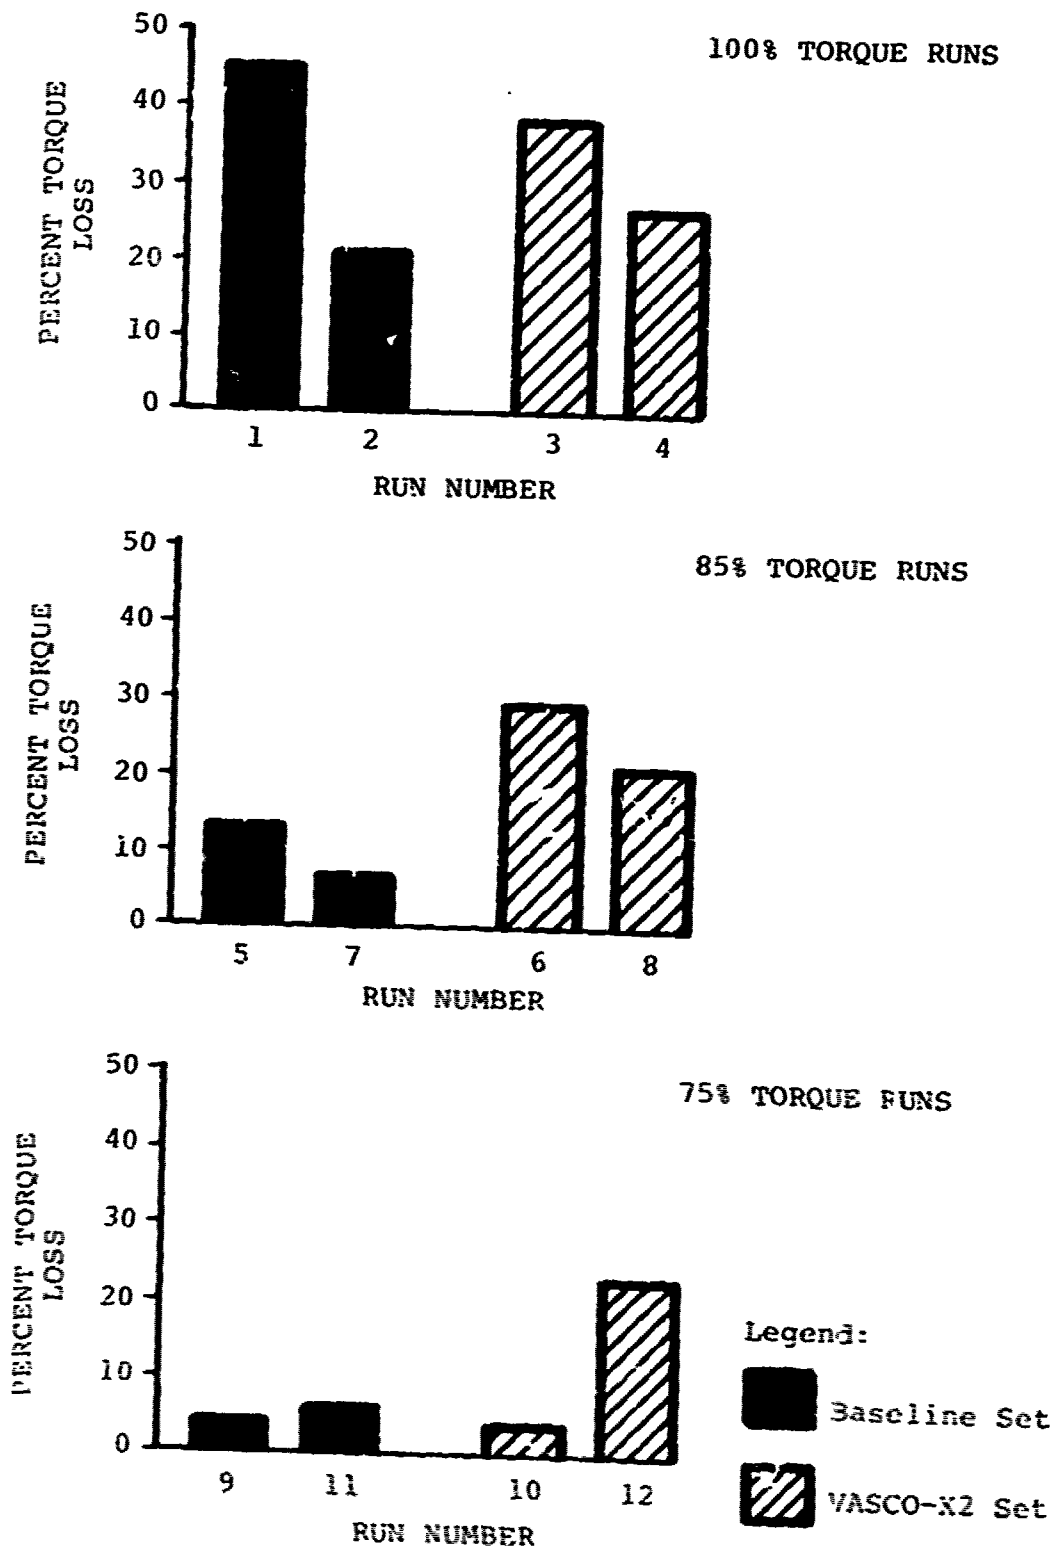
Figure 14. Torque Losses in Nonlubrication Testing.

Pinion-blank temperatures and torque losses (given in Table XI) were checked after each test within minutes of shutdown. Torque losses are attributed to the damage and subsequent wearing away of material from the contacting gear tooth profiles.

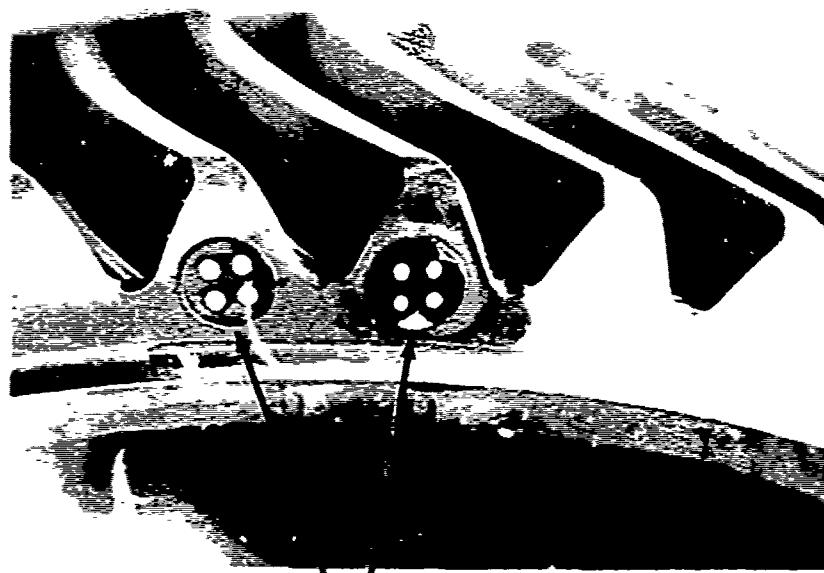
Figure 15. Temperature Gage Installation.

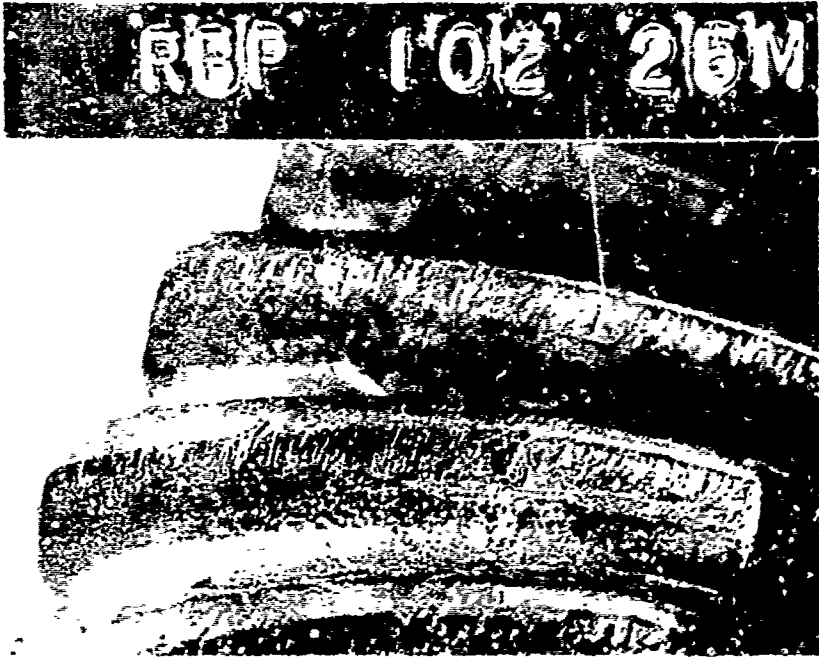
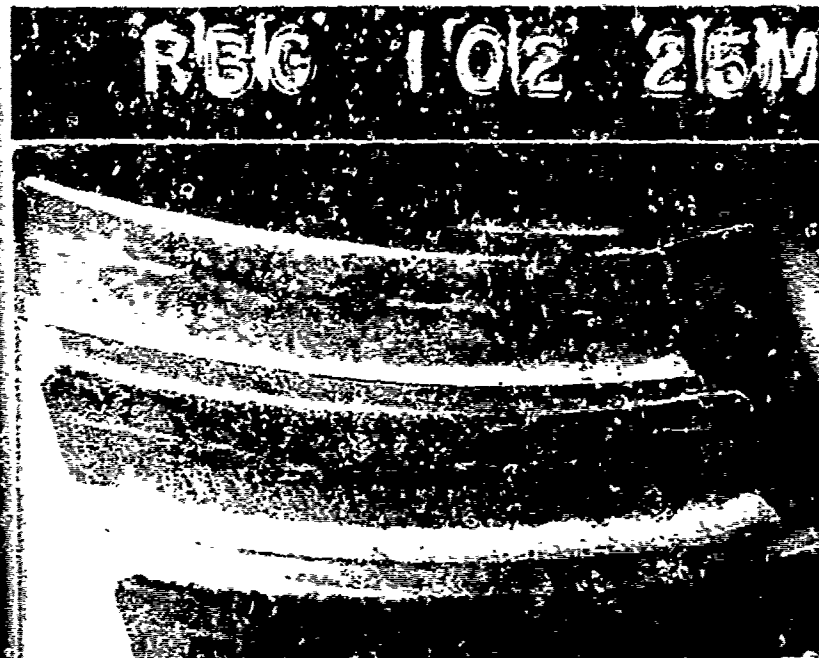
Figure 16. Final Condition of Baseline Test Gears (AISI 9310 Steel) After Nonlubrication Testing (Sheet 1 of 2).

At the conclusion of the nonlubrication testing, the tooth surfaces of both members (pinion and gear) were given a visual inspection. Photographs showing the final condition of the tooth surfaces are given in Figures 16 and 17.

Baseline Gear Set Number 1 - At the end of the run-in tests, the temperature gages were not exposed. After 20 minutes of nonlubrication testing, the vibration signal grew to approximately four times the signal seen at the start of the test run, and the test was ended. The rapid growth in vibration signal occurred in a very short time (seconds), indicating the need for constant visual surveillance of the oscilloscope. Visual inspection of the gear tooth surfaces at the end of nonlubrication testing revealed severe scoring and metal flow, heat discoloration, and pitchline pitting, but no cracks. Metal was transferred from the tips of the teeth on the drive side and

deposited in the fillet root in the form of a metal fin on practically every tooth of the pinion member. The gear member was also heavily scored, but to a somewhat lesser degree than the pinion, with heavy wear indications at the toe end of the driven side. A great deal of metal debris was found in the test housing. This debris was in the form of slivers and splinters. The connecting cross-shaft to the slave bevel gearbox developed heat color stains of light blue, violet, brown, and amber, in that order, coming away from the test gear mesh. Heat stains of comparable colors on 4340 steel (the shaft material) usually indicate a temperature of 650°F to 750°F.

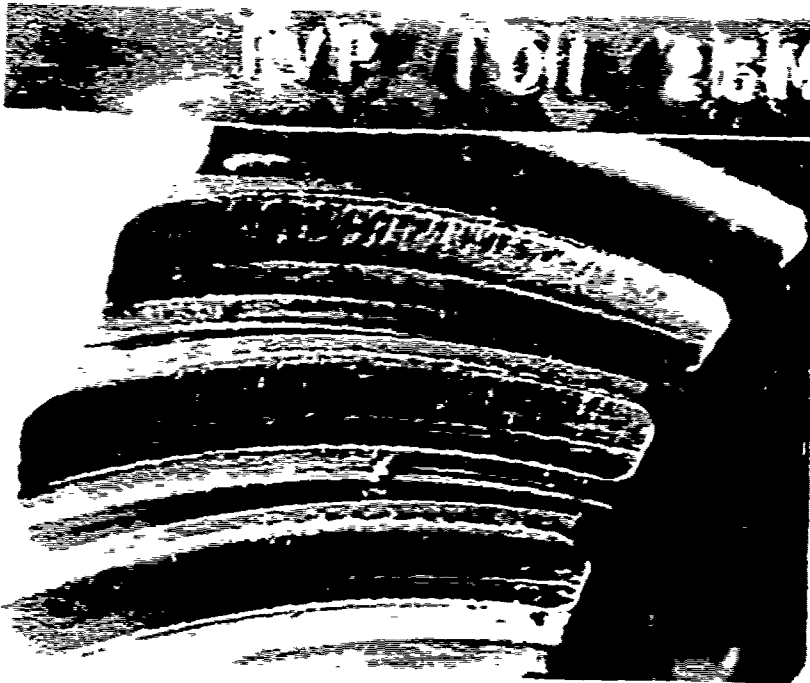
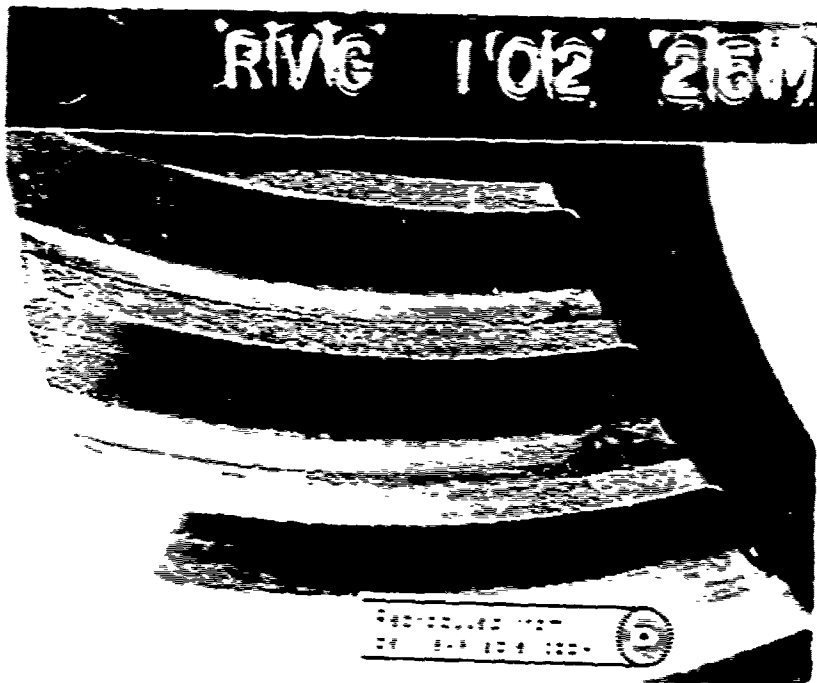
Figure 17. Final condition of VRSCO-X2 Steel Gears After Non-Lubrication Testing (Sheet 1 of 1)

VASCO-X2 Gear Set Number 1 - After the first 50-percent load run-in, inspection of the temperature plate gages indicated that all of the lower temperature and three of the higher temperature dots were exposed. This exposure was believed to be the result of failure of the protective coating and exposure to the lubricating oil.

Visual inspection of the gear tooth surfaces at the end of nonlubrication testing revealed heavy scoring and pitting on the driven side of the pinion member. Scoring and pitting were evident on the driven side of the mating gear member; however, the damage was not as severe when compared to the pinion member. There was no visible evidence of cracks on either member. Contact patterns were visible on the coast side of both members, indicating that the installation backlash was insufficient to counteract thermal expansion during the nonlubrication testing.

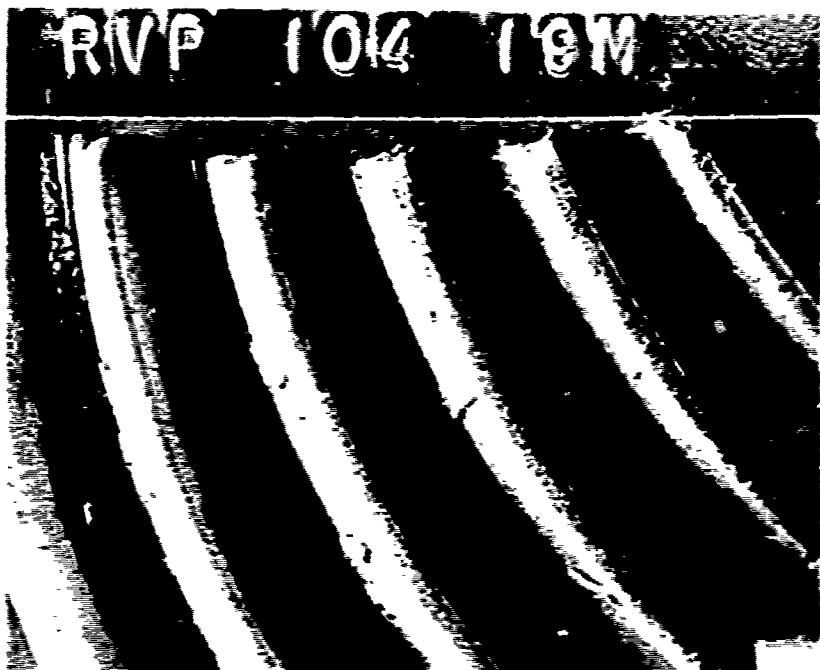
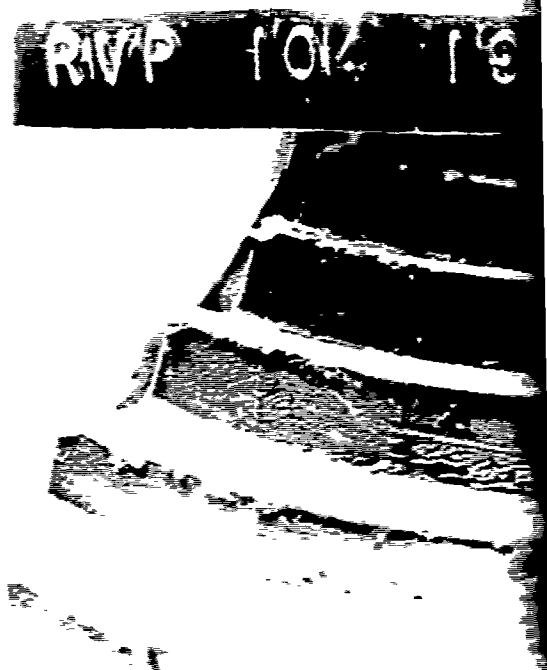
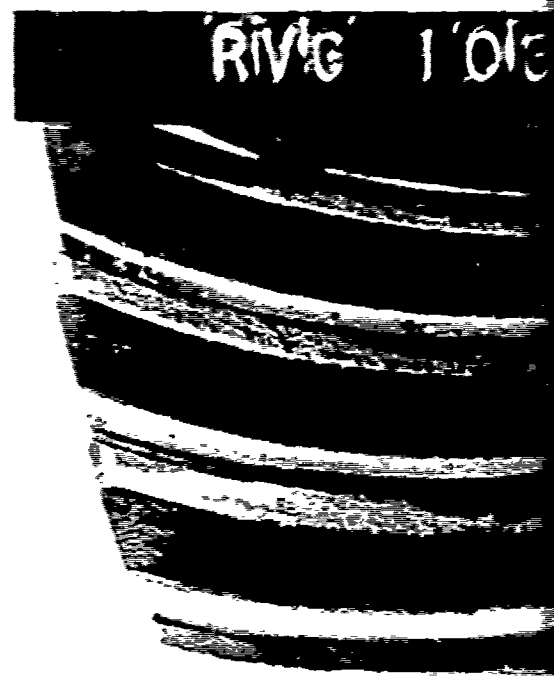
Figure 17 - Continued (Sheet 2 of 3).

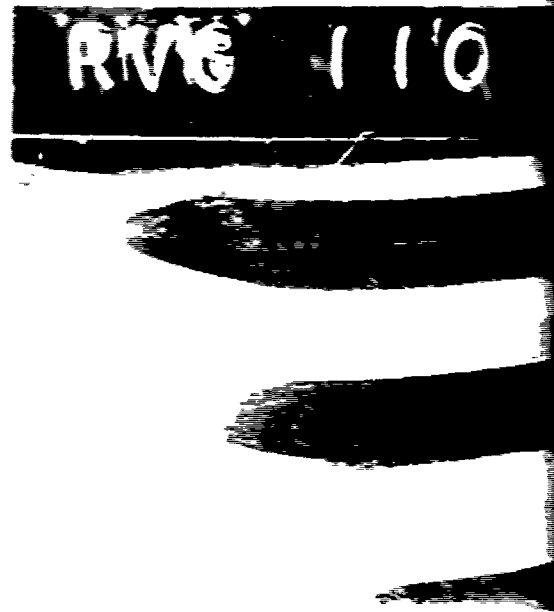
Figure 17 - Continued (Sheet 3 of 3).

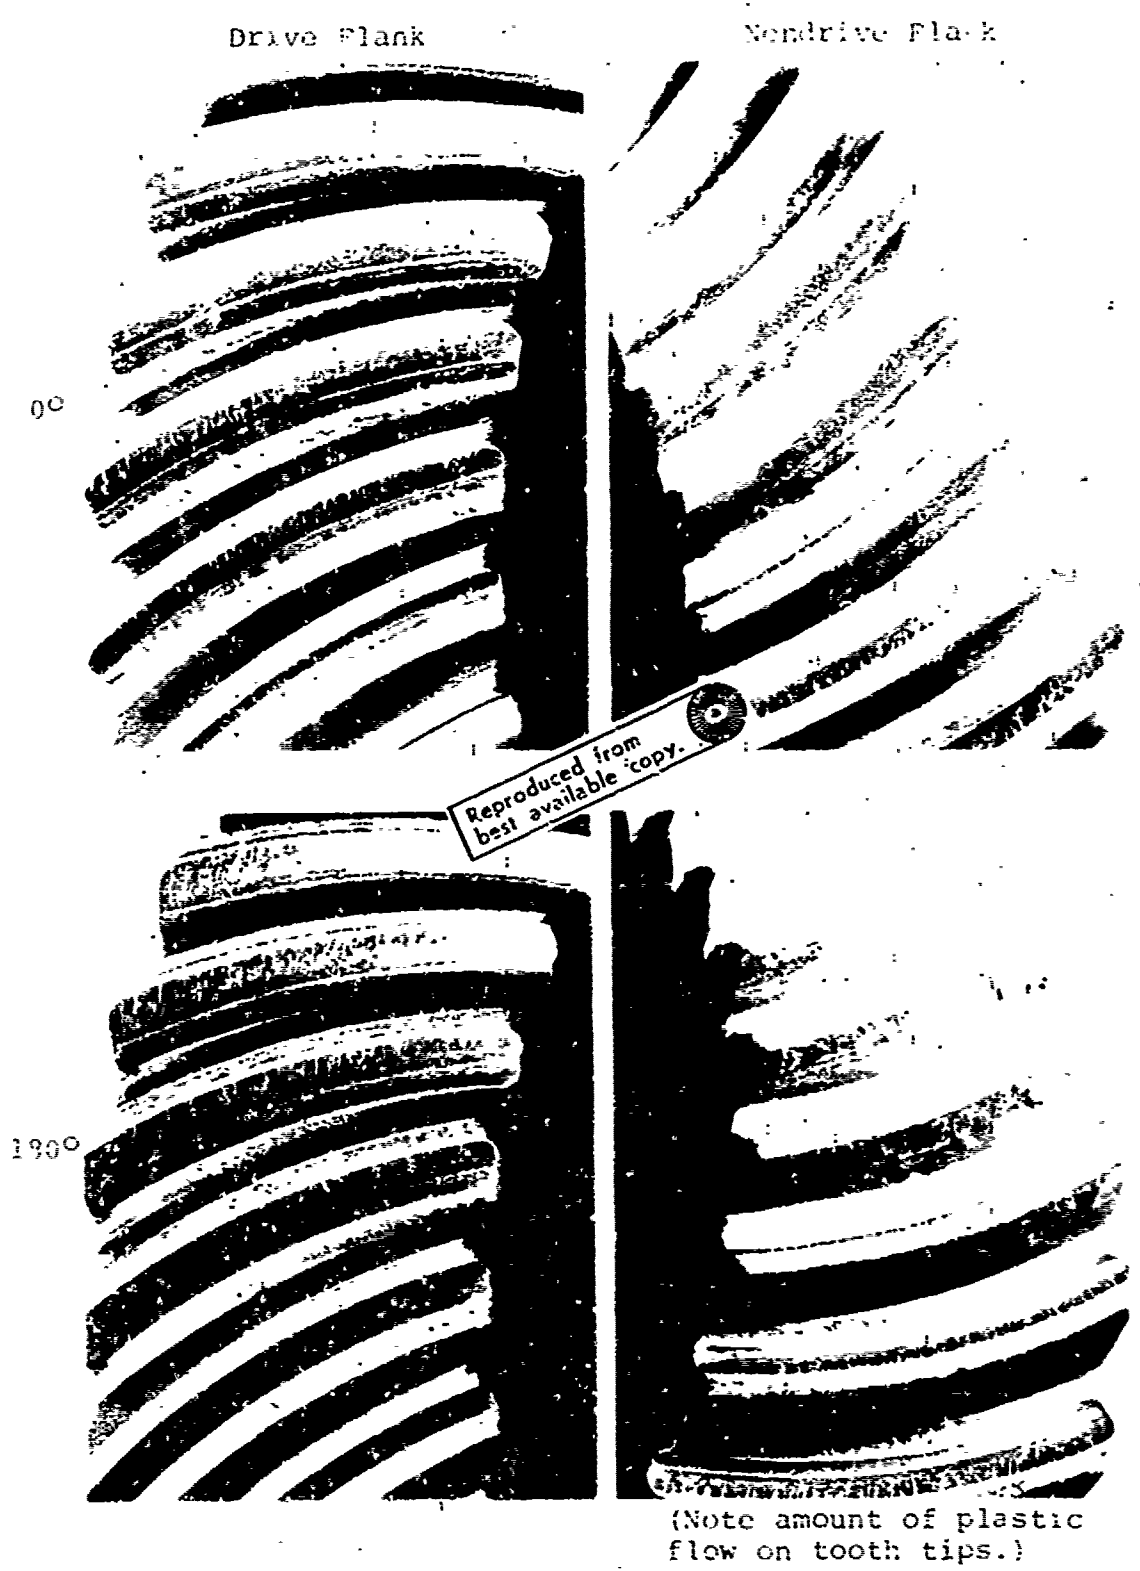
Figure 19. VASCO-X2 Pinion Gear (Al01) After 23 Minutes of Oil Starvation at 100-Percent Load.

In general, the metallurgical examination revealed that both test pinions were subjected to extremely high temperatures. The VASCO-X2 pinion displayed streaks of radial rehardening, shown in Figures 20 and 21, on the drive flank of each tooth. A section taken through one of these localized streaks is shown in Figure 21. It is estimated that this area was subjected to a temperature in excess of 1700°F.

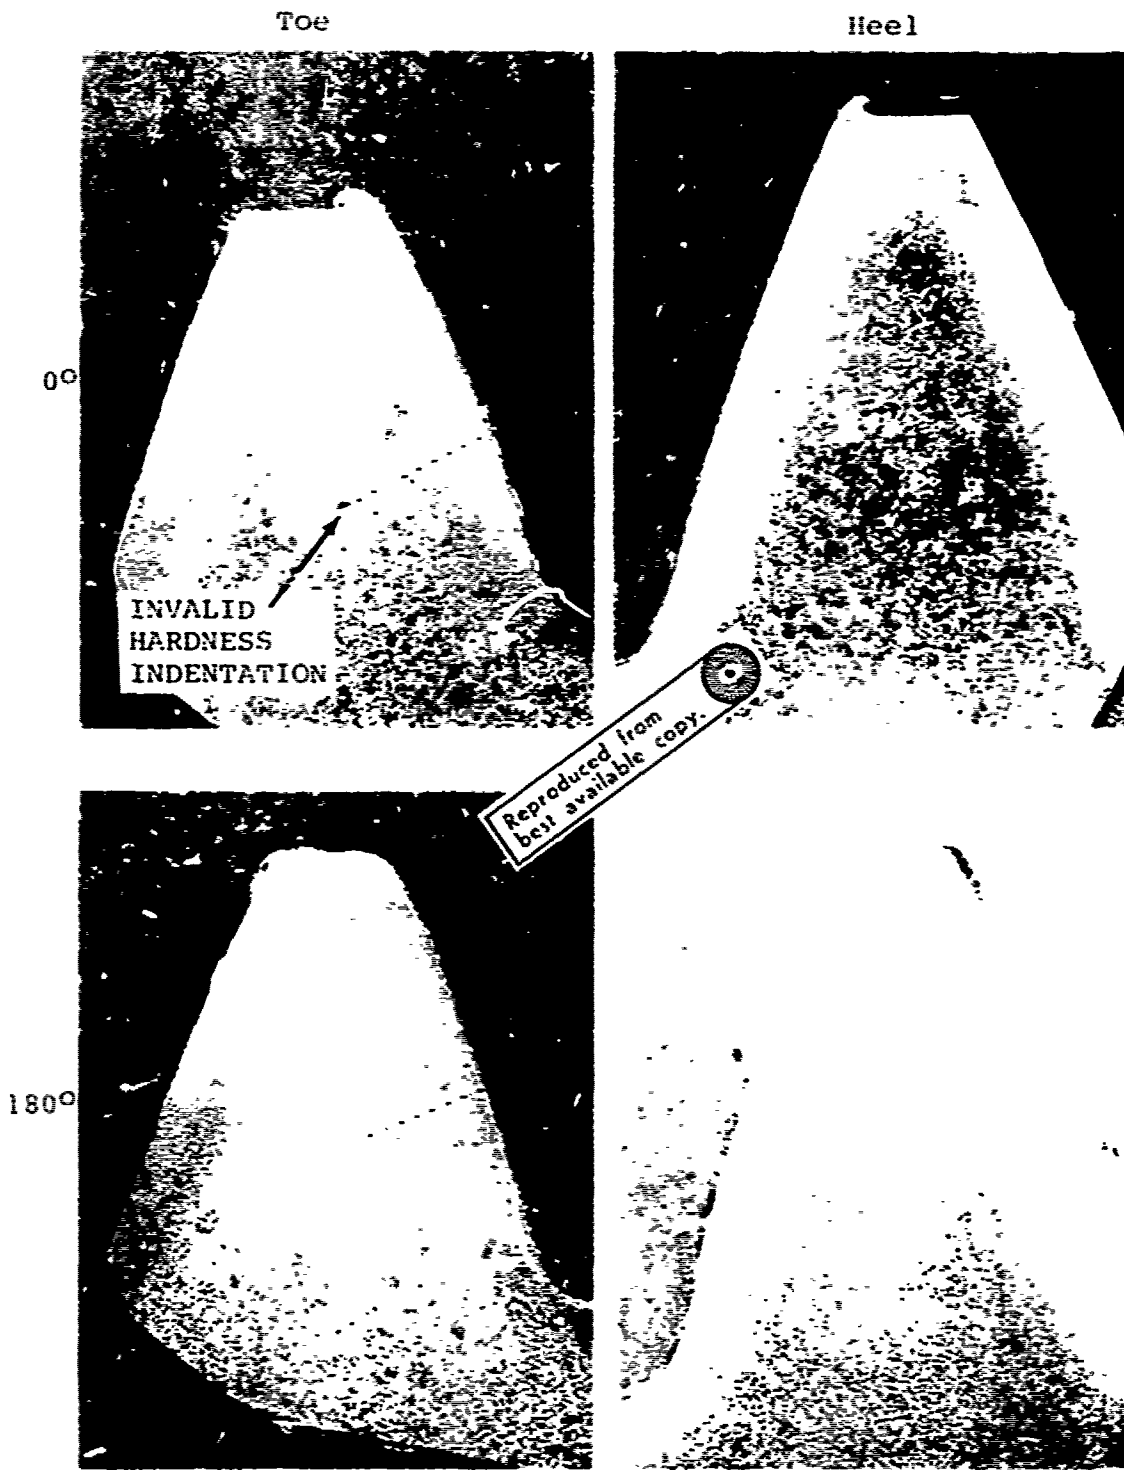
Figure 23. Metallographic Profile of Tooth From VASCO-X2 Pinion Gear (AlCl), Exhibiting Wear and Deformation of Drive Flank Carburized Case (9X).

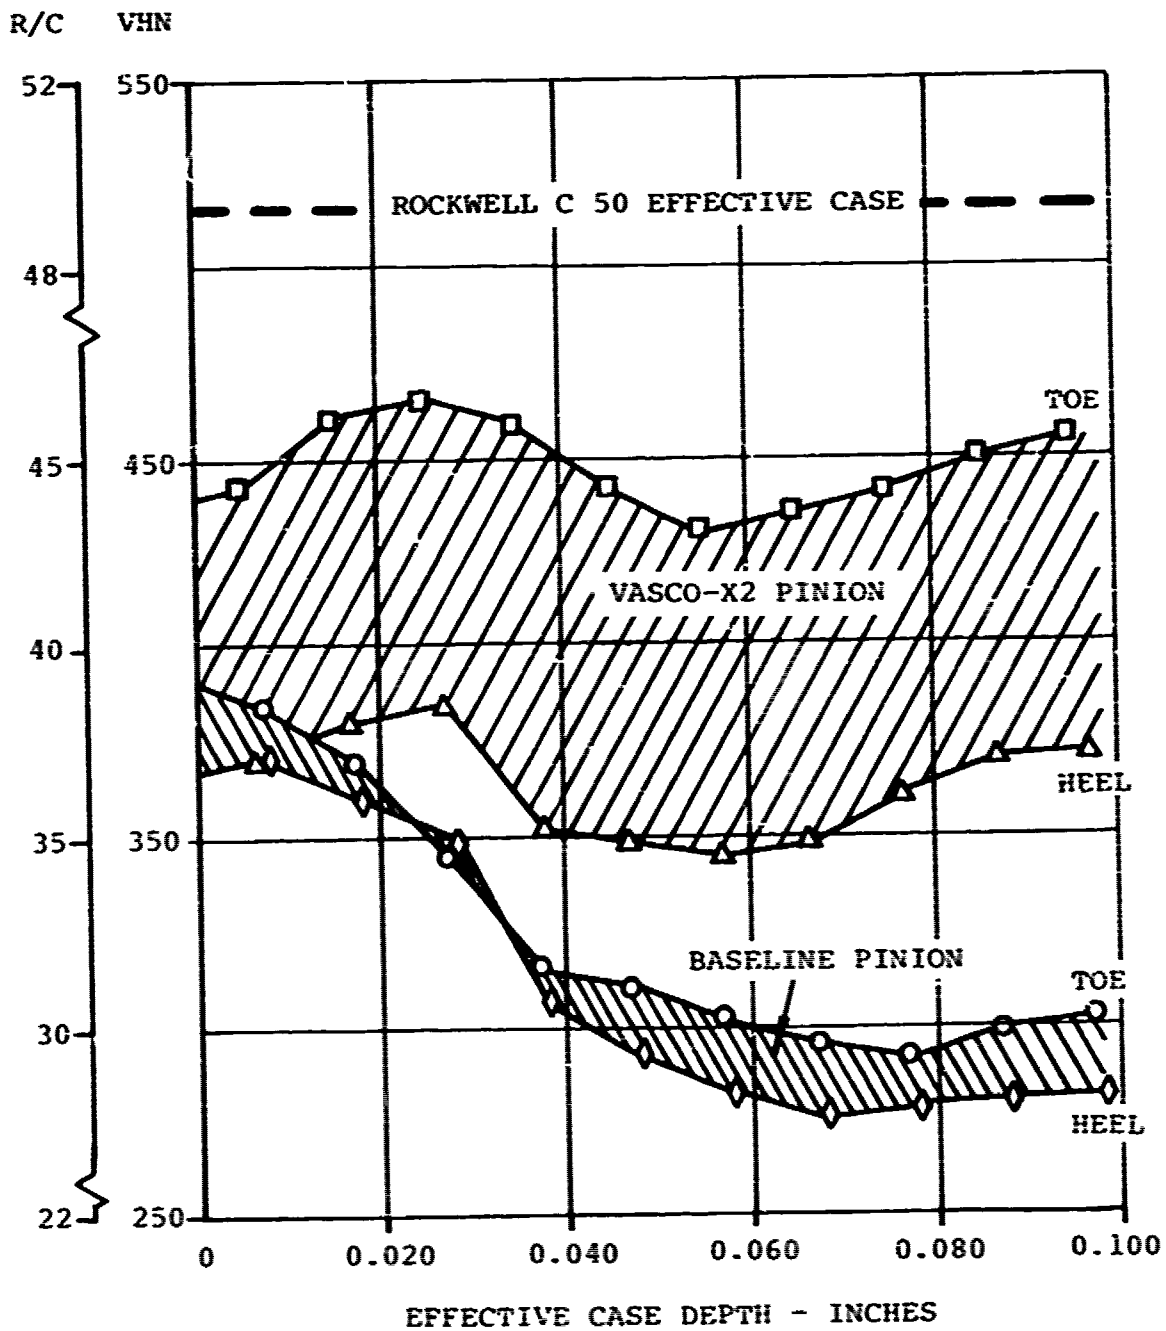
Figure 24. Effective Case Depths and Hardness Traverse Data of Drive Flanks at the 180° Position.

Table XII presents a comparison of hardness along the tooth profile of the two test pinions at the toe and heel positions at two locations 180° apart. This table reveals a higher hardness for the VASCO-X2 pinion along the entire tooth profile and in the tooth core. Figures 22 and 23 present metallographic profiles of the gear teeth. Figure 24 shows effective case dept. of selected positions.
