Corrosive Effects of Solder Flux on Printed-Circuit Boards

AUBREY J. RAFFALOVICH

Abstract - A number of tactical radio sets have been reported inoperable as a result of lead breakage of transistor and quartz crystals. The lead material was a Kovar[®] 1-type iron-nickel-cobalt glass sealing alloy (54 percent Fe-29 percent Ni-17 percent Co). The location and type of fractures indicated that these leads failed by stress-corrosion cracking. Such failures result from the combined effects of mechanical stress and a mildly corrosive atmosphere. The only source of specific corrodent for this type of failure was chloride ions found in residual flux on printed circuitry.

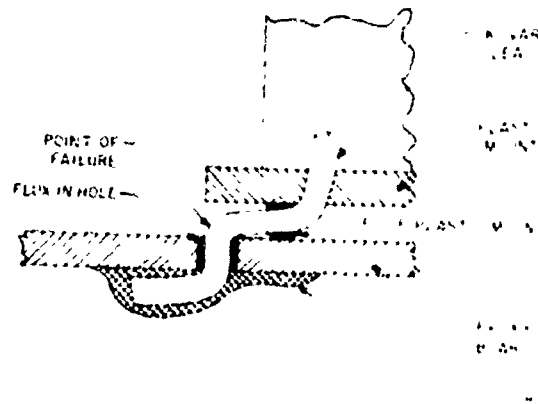
Fig. 5 Mounted 2N2222 transistor
