TECHNICAL REPORT S-72-7

# DEVELOPMENT OF DESIGN CRITERIA AND ACCEPTANCE SPECIFICATIONS FOR PLASTIC FILTER CLOTHS

C. C. Calhoun, Jr.

Conducted by U. S. Army Engineer Waterways Experiment Station  
Soils and Pavements Laboratory  
Vicksburg, Mississippi

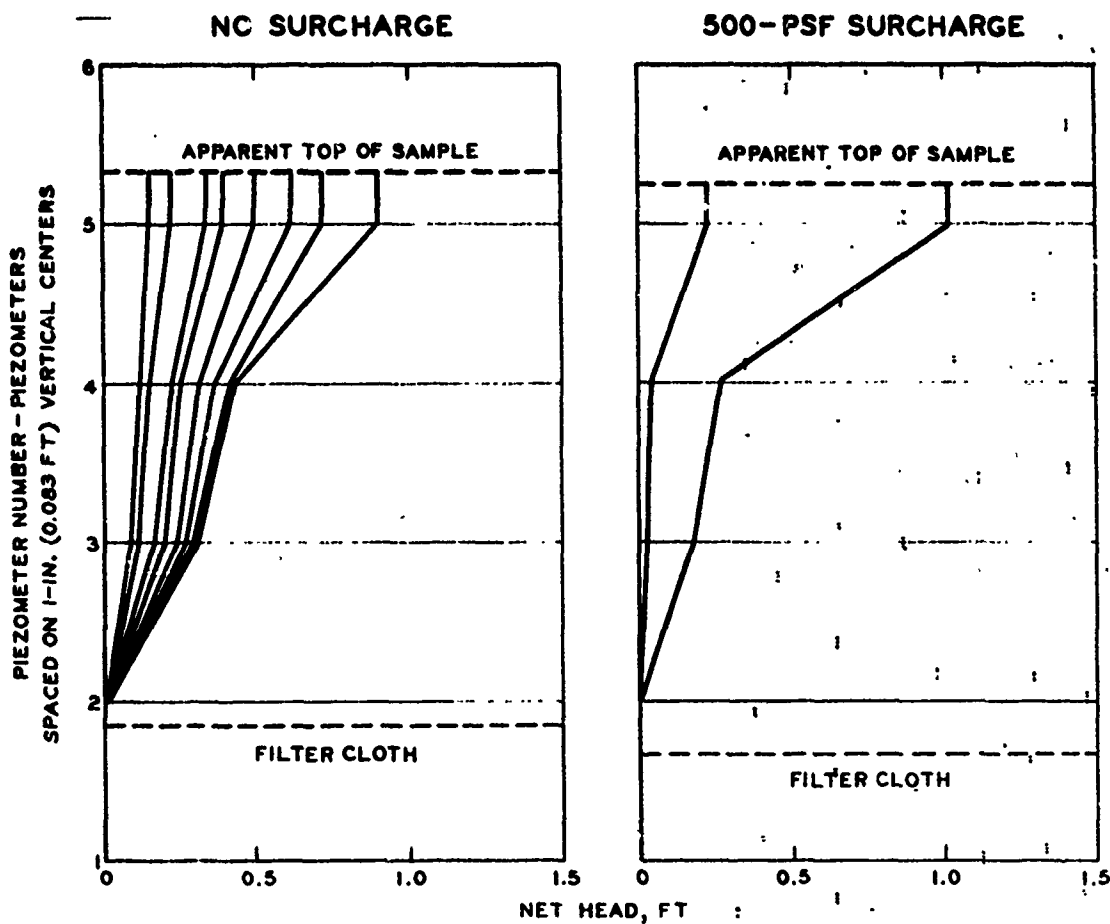
Fig. 10. Head losses through sample and cloth B, test 1

- a. Using F-M sand (test 1). Net heads up to 1-ft water were applied, first under conditions of no surcharge and then under a 500-psf surcharge. Due to high head losses through the base valve, trap, and standpipe, the maximum head differential was only about 1 ft even though the elevation of the constant head reservoir was several feet above tailwater elevation. The Lucite cylinder cracked upon application of 1000-psf surcharge, and the test was discontinued. Sand density after testing was 97.5 pcf in the top 1 in. and 95.7 pcf in the lower 1 in., compared with the initial density after saturation of 95.4 pcf. Plots of head losses through the soil specimen and filter cloth under 0- and 500-psf surcharge are shown in fig. 10. Because of the variation in density of the specimen, it is noted that the head loss throughout the specimen, even with no surcharge applied, was not uniform. Piezometer 2, only 0.2 in. above the filter cloth but adjacent to the aluminum ring on which the filter cloth was affixed, read the same as tailwater.\* There was no indication of sand infiltration through the cloth or piping within the sand specimen during any period of the test (maximum velocity, 0.16 fpm). Sieve analyses of the material taken from the top and bottom of the soil

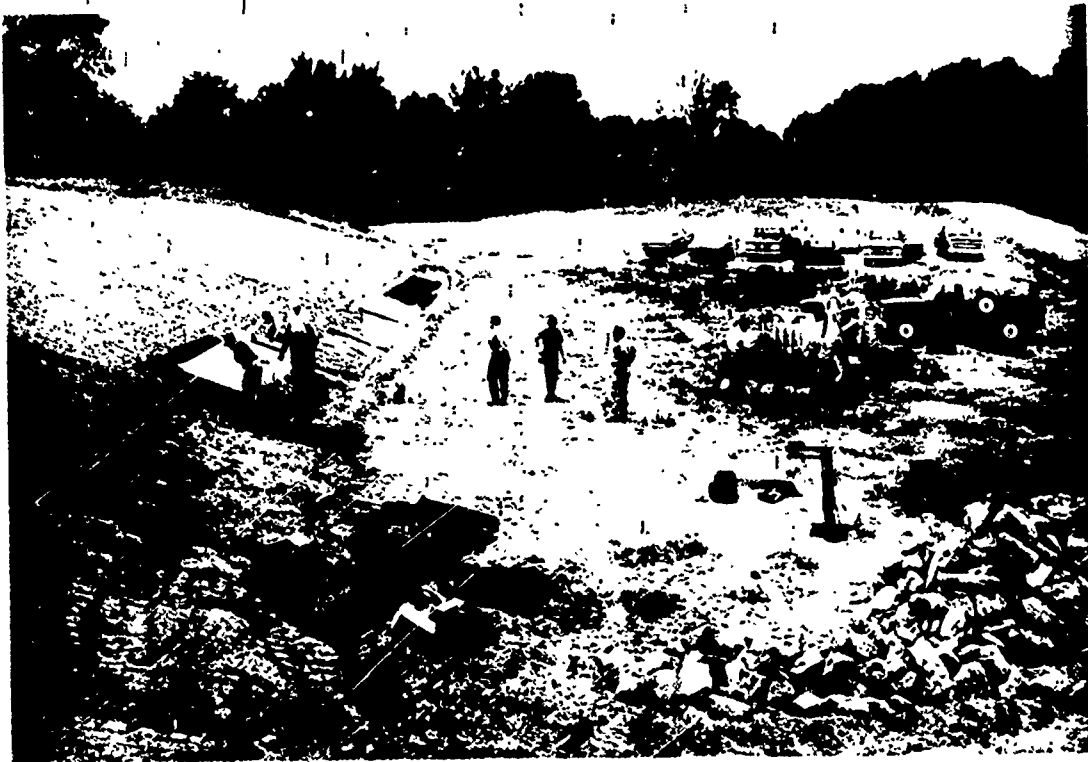
Fig. 33. Overall view of drop test site

46. Fig. 33 shows the test site--a loess bank graded to a 1V-on-3H slope for placement of the cloths. Initially, it was planned to loosen the upper 2 to 4 in. of the slope with a pulvimixer. However, it was found to be difficult for the pulvimixer to operate up and down the slope mixing the material to a uniform depth. Also, the resulting surface was thought to provide much too soft a bed. Consequently, it was decided to simply hand rake the slope before placing the cloths. This provided a smooth uniform bed.

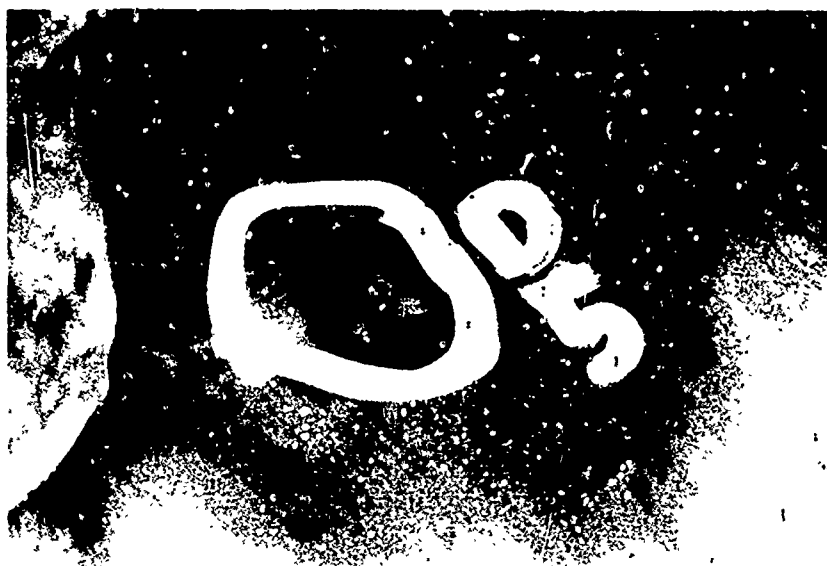
Fig. 38. Cloth D, 1- and 2-in. tears  
after 4.5-ft. drop
