EVALUATION OF INSULATION FOR CRASH FIRE PROTECTION OF NEW FLIGHT RECORDERS

Thomas Rust, Jr
National Aviation Facilities Experimental Center
Atlantic City, New Jersey 08405

SEPTEMBER 1972

FINAL REPORT

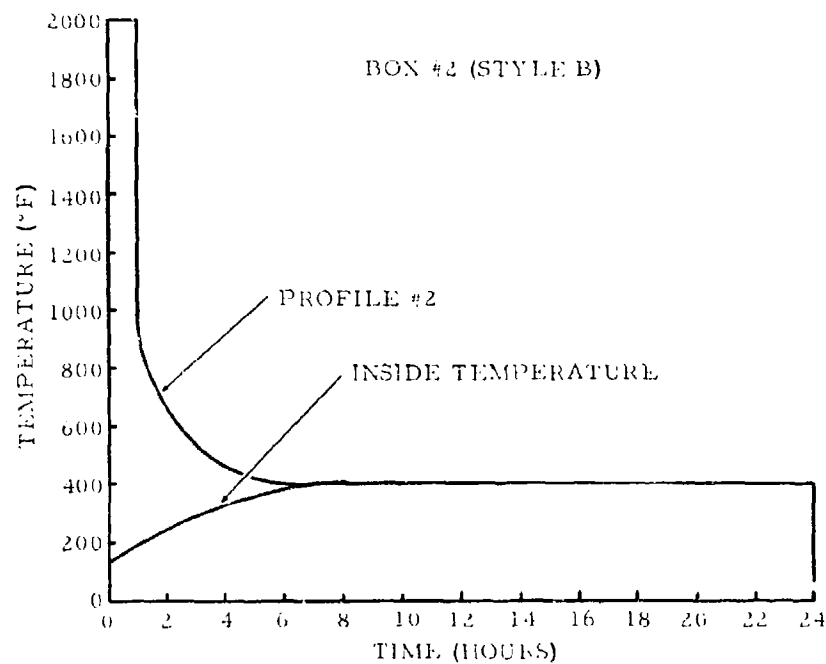
FIGURE 14. TIME-TEMPERATURE HISTORY OF THE ALUMINUM MASS INSIDE BOX NO. 2

The time-temperature histories of the aluminum mass for Boxes 1, 2, and 3 are shown in Figures 13, 14, and 15, respectively. It can be seen that the gelled water of Box No. 1 maintained the aluminum mass at a temperature approximately equal to the boiling temperature of water throughout the test with the exception of the second hour, as shown in Figure 13. Even during this period, the interior temperature was low enough to allow survivability of the polyester tape specimens, as is noted in Table 1. However, Figure 14 shows that the Style B Box No. 2 with the paraffin heat sink material allowed the mass temperature to reach 400°F after 7 hours and was ineffective thereafter. This agrees with the results shown in Table 1 for the polyester tapes which were unplayable after this test. However, the interior temperature was kept low enough to allow the survivability of the steel tape. The Style C Box No. 3 with the stable insulator allowed the aluminum mass temperature to rise to almost 600°F in the first hour, as shown in Figure 15, after which the temperature decreased to about 300°F and then stabilized at 400°F for the remainder of the test. The condition of the tape specimens shown in Table 1 indicates that the interior temperature did not allow the survival of the polyester tapes, but was sufficiently low to allow the steel tape to be readable.

It should be noted as part of Series 1 that, during the transition from full flame coverage to partial flame coverage of Box No. 2 at the 1-hour mark, flames emitting from between the flanges of the two halves of the box were visible. This fact plus the time-temperature history indicates that the paraffin had vaporized within the box but due to lack of oxygen could not burn until the volatiles escaped to the ambient air. This point is quite important in the design of a Style B box since, if air is allowed to enter the interior of the box, burning will take place inside, thus raising the temperature of the interior considerably.

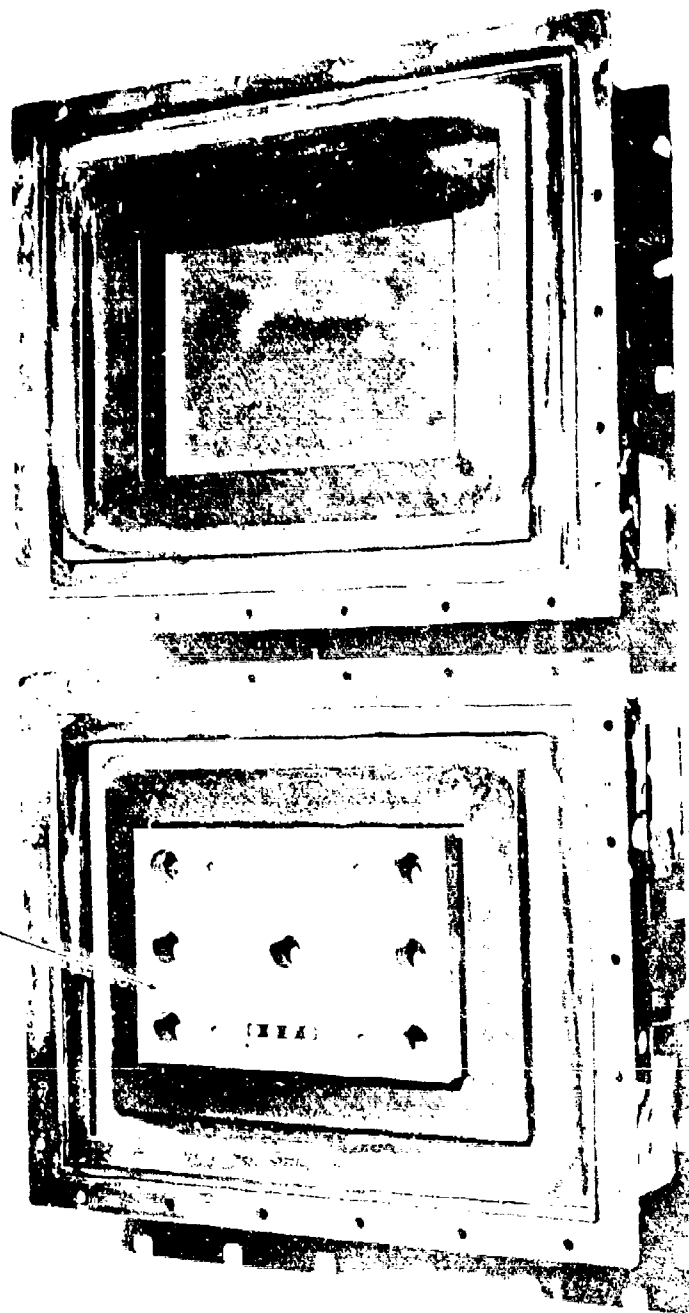
ASBESTOS-COVERED INSIDE THERMOCOUPLE LEADS

FIGURE 18. POST-TEST VIEW OF BOX NO. 3

The results of the Series 1 tests are also shown in Figures 16, 17, and 18 which are post-test views of Styles A, B, and C boxes, respectively. Some of the gelled water is visible in Figure 16, indicating that all of the water was not vaporized. This fact leads to the deduction that Box No. 1 could have protected the tape specimens against a more severe profile. Box No. 2 shown in Figure 17 appears to have some paraffin remaining, indicating that the Style B box could have protected the steel tape from a more severe test profile. Box No. 3 is shown after testing in Figure 18.

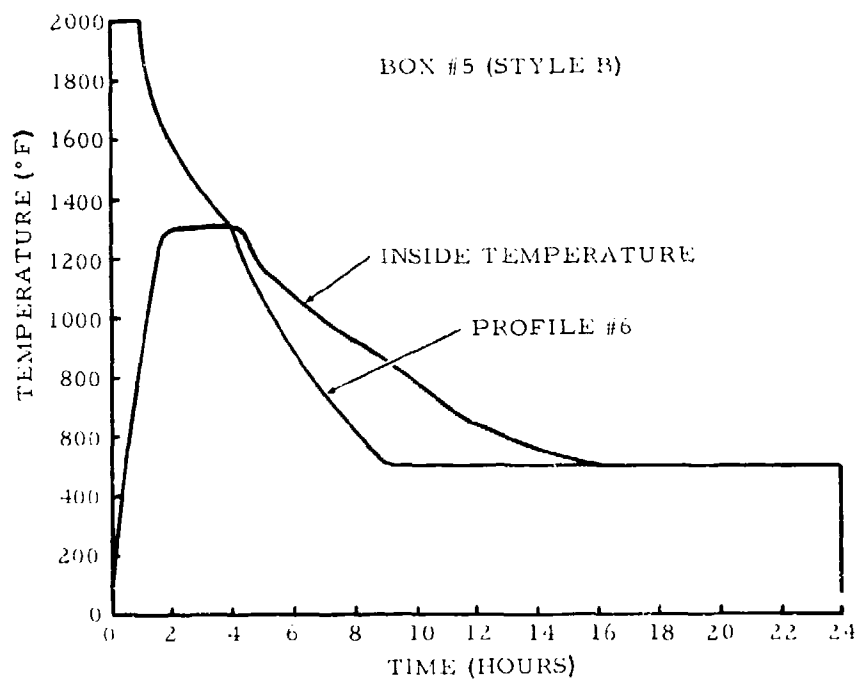
FIGURE 20. TIME-TEMPERATURE HISTORY OF THE ALUMINUM MASS INSIDE BOX NO. 5

It is seen from Figure 20 that the paraffin in Box No. 5 did not give the desired protection since the interior temperature rose steadily to 1300°F at the second hour of the test. As would be expected with internal temperatures of that magnitude, none of the tape specimens was readable (see Table 1) and, in fact, the aluminum mass was partially deformed indicating that it had partially melted during the test. The melting temperature of aluminum is approximately 1200°F.

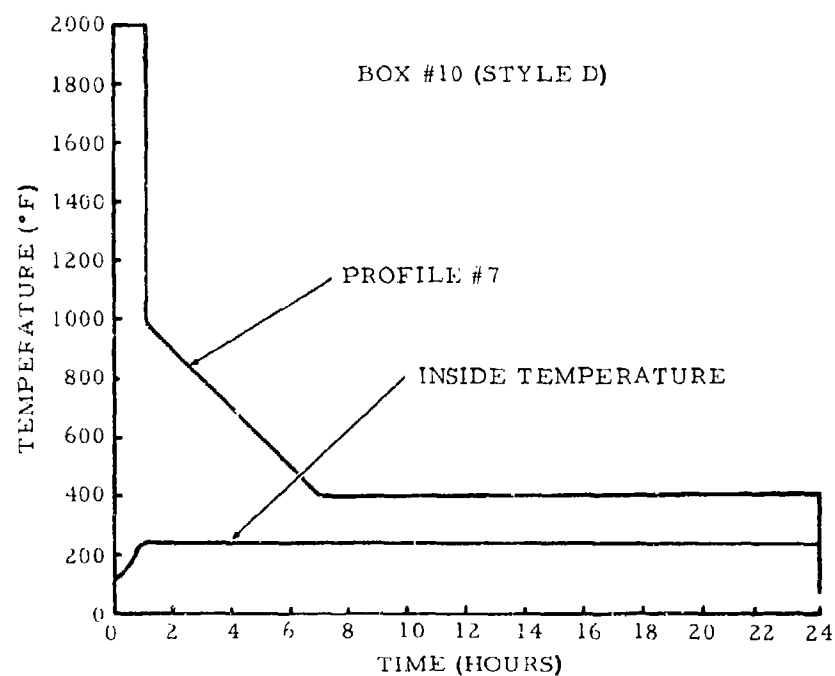
FIGURE 25. TIME-TEMPERATURE HISTORY OF THE ALUMINUM MASS INSIDE BOX NO. 10

It is seen from Figure 25 that the water-evolving material performed satisfactorily as it maintained the internal temperature at 240°F or below throughout the entire test. The results listed for Box No. 10 in Table 1 indicate that all tape specimens were readable, as expected.
