DEVELOPMENT OF CBR DESIGN CURVES FOR AM1 LANDING MAT

MISCELLANEOUS PAPER NO. 4-599

September 1963

U. S. Army Engineer Waterways Experiment Station
CORPS OF ENGINEERS
Vicksburg, Mississippi

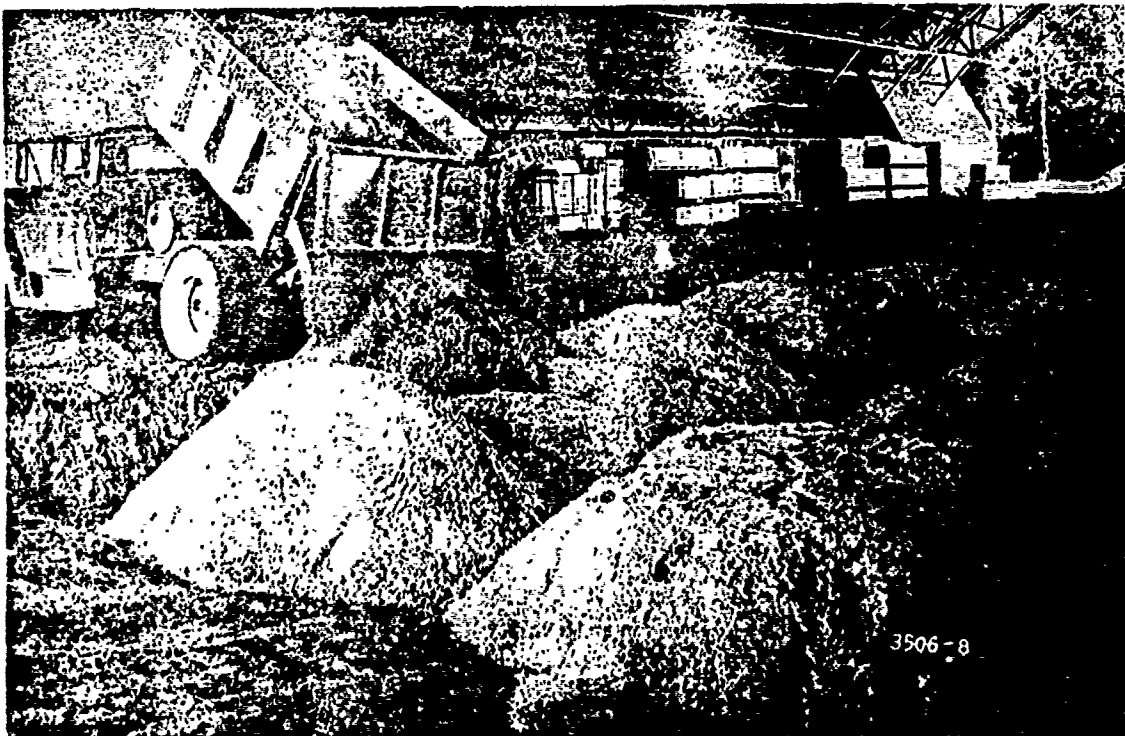
Fig. 4. End-dumping of sand in item 4

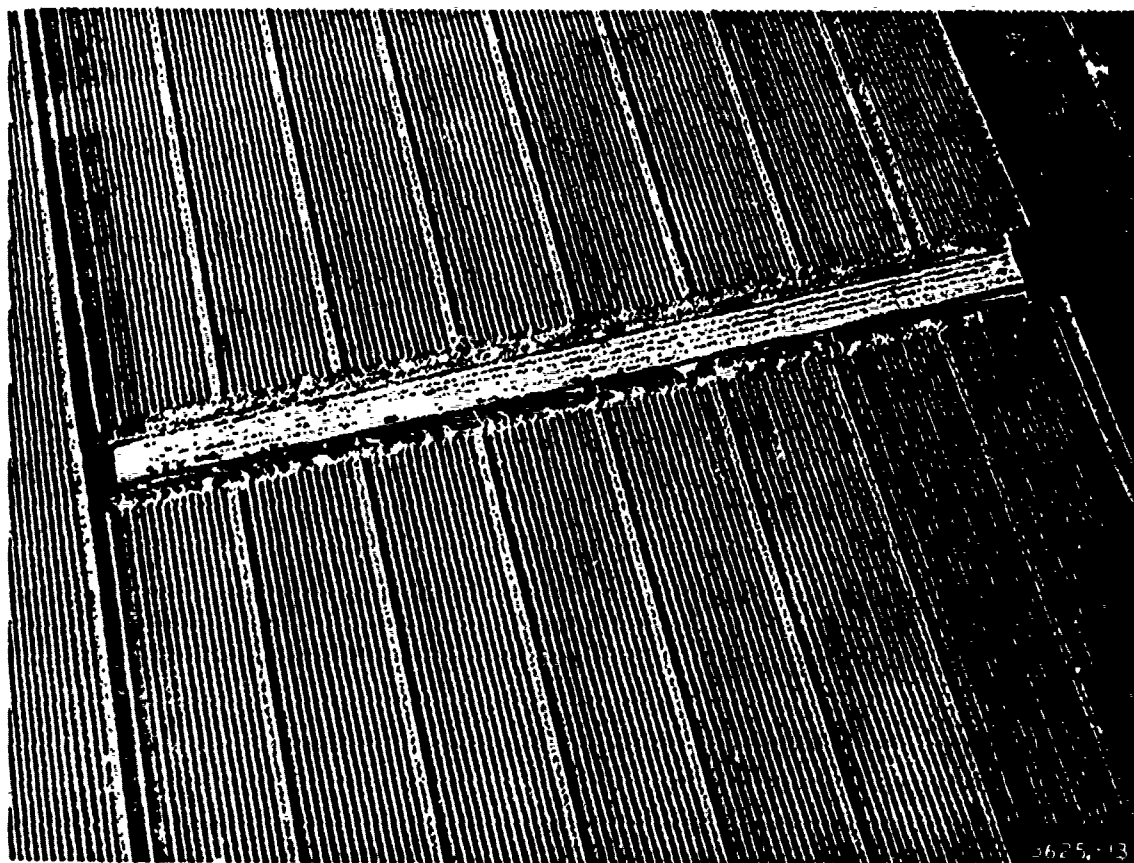
Fig. 10. Cracks at end joint and overlapping corner break in item 1 after 20 coverages of traffic

single-wheel load had no detrimental effects on types 1-a and 1-d mats, except for a minor crack at an end joint of a plank of type 1-d mat.
