RAIN EROSION CHARACTERISTICS OF THERMAL PROTECTION SYSTEM MATERIALS AT SUBSONIC VELOCITIES

Bell Aerospace Company

Air Force Materials Laboratory

TECHNICAL REPORT AFML-TR-72-145

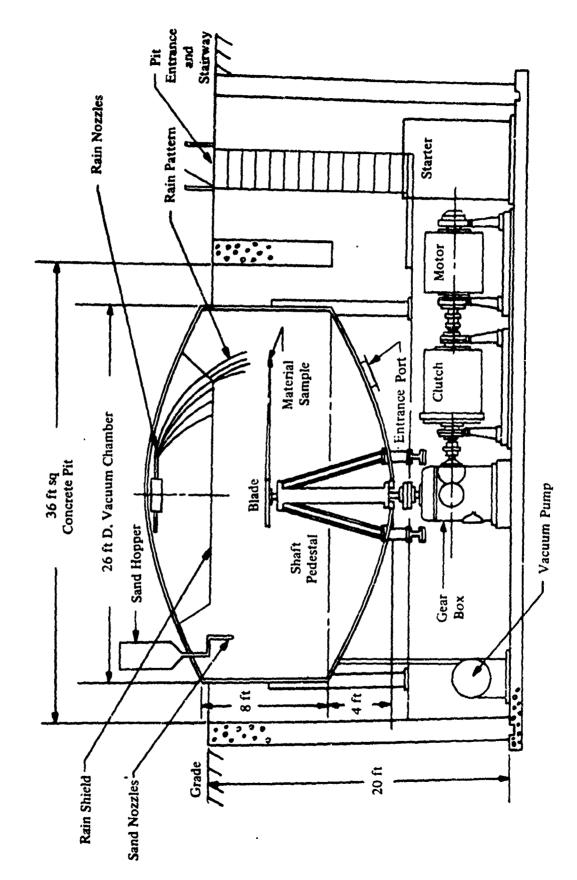
Figure 1. Supersonic Impact Erosion Test Equipment

Figure 1 is a sketch of the general layout of the test apparatus. Figure 2 shows the vacuum chamber with the hatch cover removed. Shown in the right-hand portion of Figure 2 is the 3000 kva, 12,000 to 2,500 volts. 3-phase substation with transformer and primary and secondary switchgear.

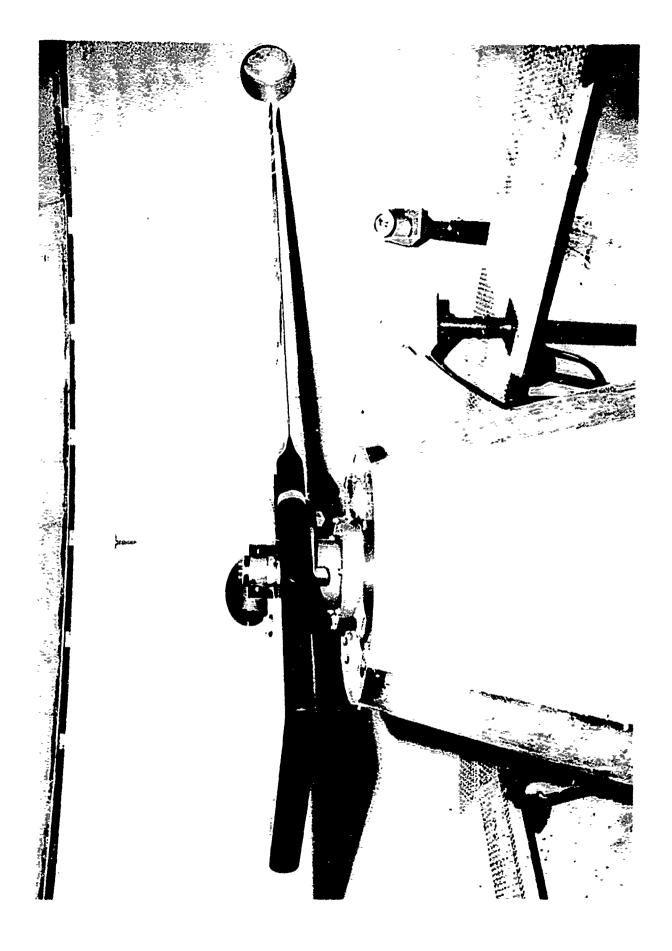
FIGURE 3. COUNTERBALANCED TEST BLADE

The single counter-balanced rotating test blade has a nine-foot radius and is shown in Figure 3. Specimens are attached to the tip of the blade by means of specimen holders.

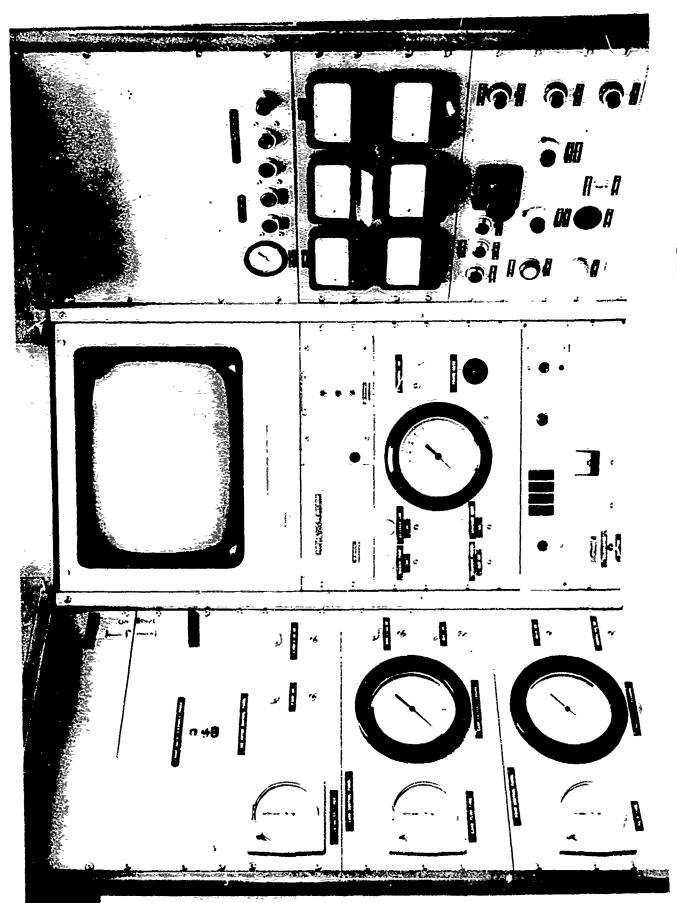
FIGURE 4. CONTROL CONSOLE AND TV MONITOR

The operation of the erosion test apparatus is controlled and monitored on a console as shown in Figure 4, in another building located 250 ft from the test chamber. The control room and test apparatus are separated for safety of operating personnel.

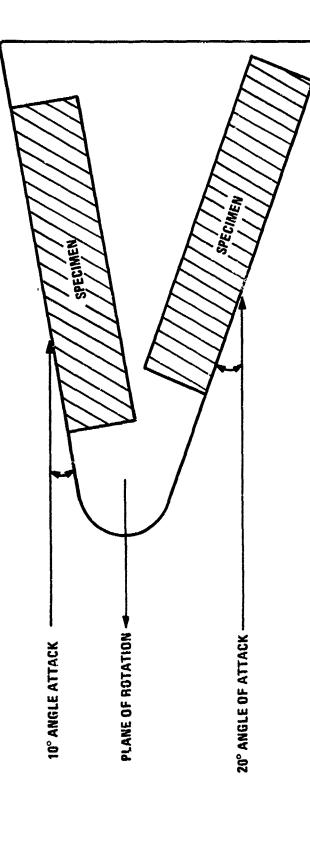
FIGURE 5 - SPECIMEN POSITION FOR 10° AND 20° ANGLE OF ATTACK

Figure 5 illustrates the angle of impact of rain drops.

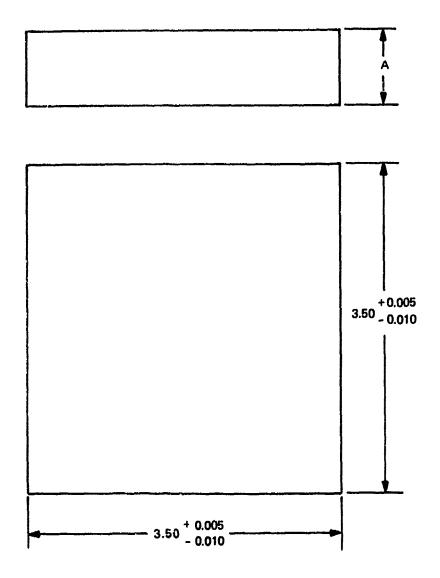
FIGURE 9 - 10° - 20° - 40° EROSION TEST SPECIMENS

Figure 9 gives the dimensions of the test specimens for the ten - twenty - forty degree tests.

Dimension "A" 0.500, 0.563, 0.625, 0.688, 0.750 + 0.005 Thickness as Desired

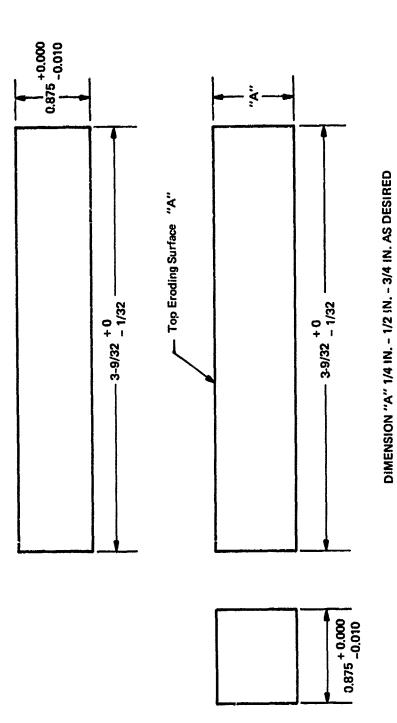
FIGURE 10 - 90° EROSION TEST SPECIMEN

Figure 10 outlines the dimensions required for ninety degree specimens.
