STRESS CORROSION CRACKING OF TITANIUM  
ALLOYS IN METHANOLIC AND OTHER MEDIA

AFML-TR-71-232

TECHNICAL REPORT AFML-TR-71-232

MARCH 1972

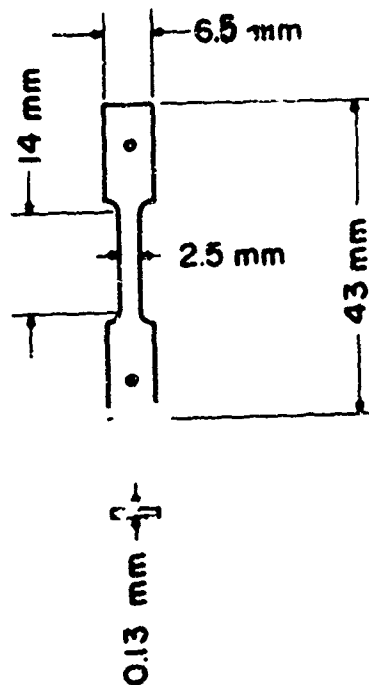
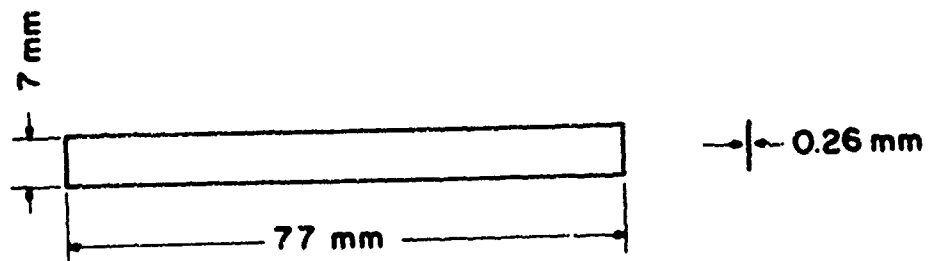
Figure 1a. Specimen Configurations

Tensile Specimen for Straining Electrode Tests

Bend Specimen for Static Tests

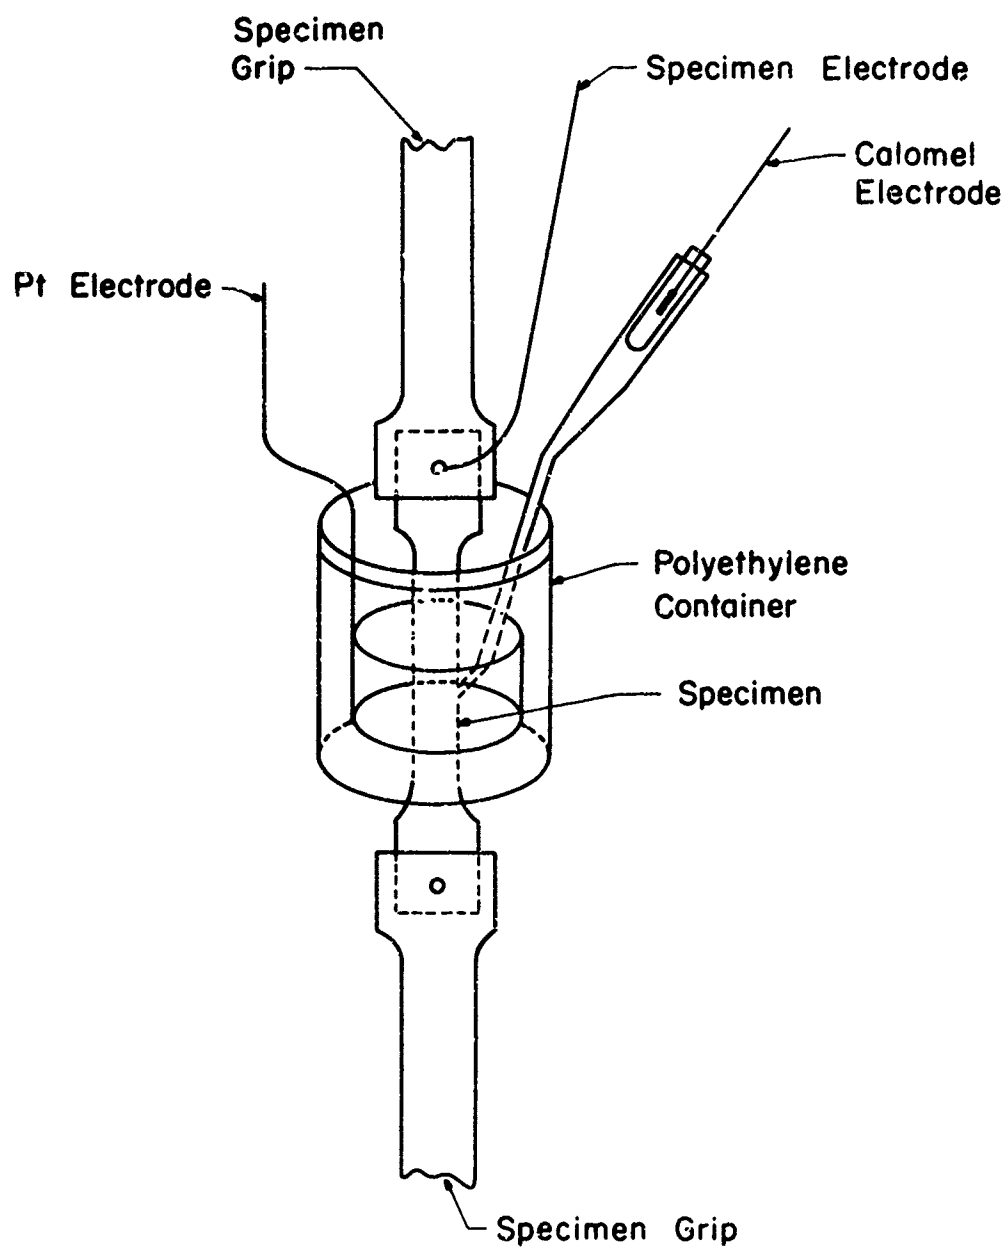
Figure 1b. Cell for Straining Electrode Tests

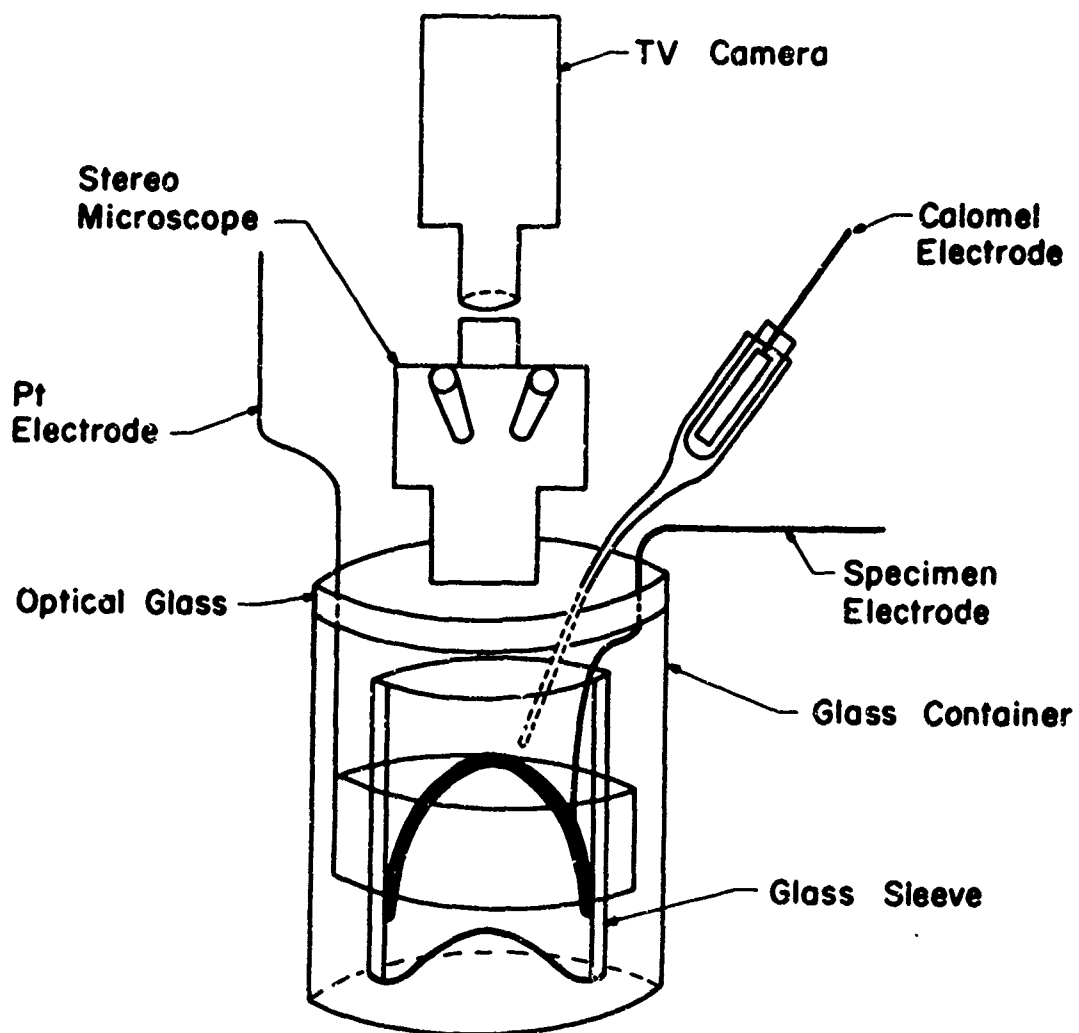
Figure 1c. Cell for Stress Corrosion Bend Tests

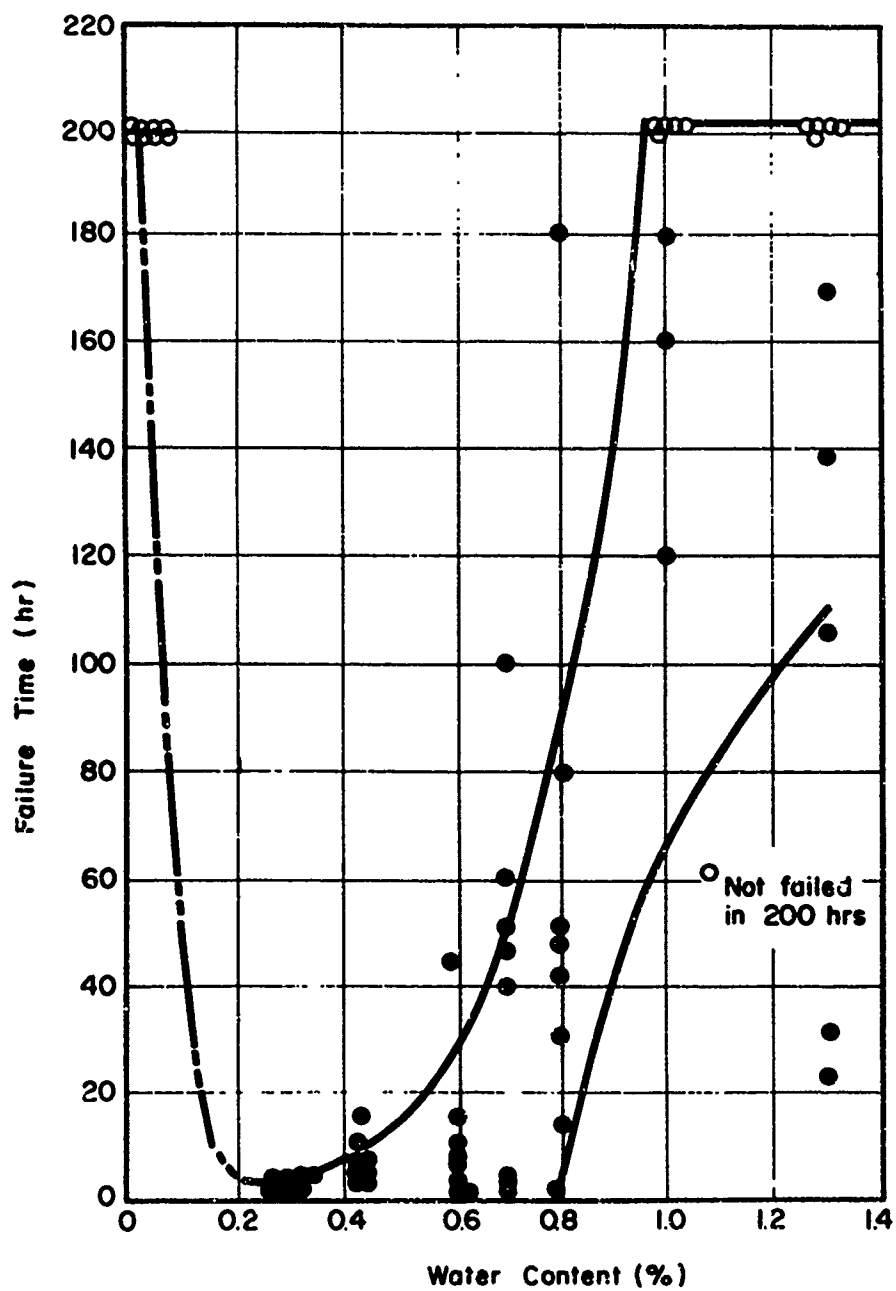
Figure 2a. Failure Time vs Water Content at Corrosion Potential

Figure 2a shows the effect of water content in X w/o  $\text{CH}_3\text{OH}$ -0.17 w/o  $\text{HCl}$ -Y w/o  $\text{H}_2\text{O}$  mixtures upon time to failure of U-bend specimens of Ti-6Al-4V alloy. Similarly, Figure 2b shows the effect of water content upon the ultimate elongation of un-notched dynamically strained tensile specimens of the same alloy (as-received condition). (In these figures, zero water content refers to reagent grade absolute methanol having a water content of about 0.05%, which is taken into account. Fracture behavior in this absolute methanol was not significantly different from that in air.) In both cases, water concentrations in the range 0.3 to 0.6% had the maximum effect, i.e., minimum times to failure and minimum elongation at fracture. Outside this range the fracture behavior

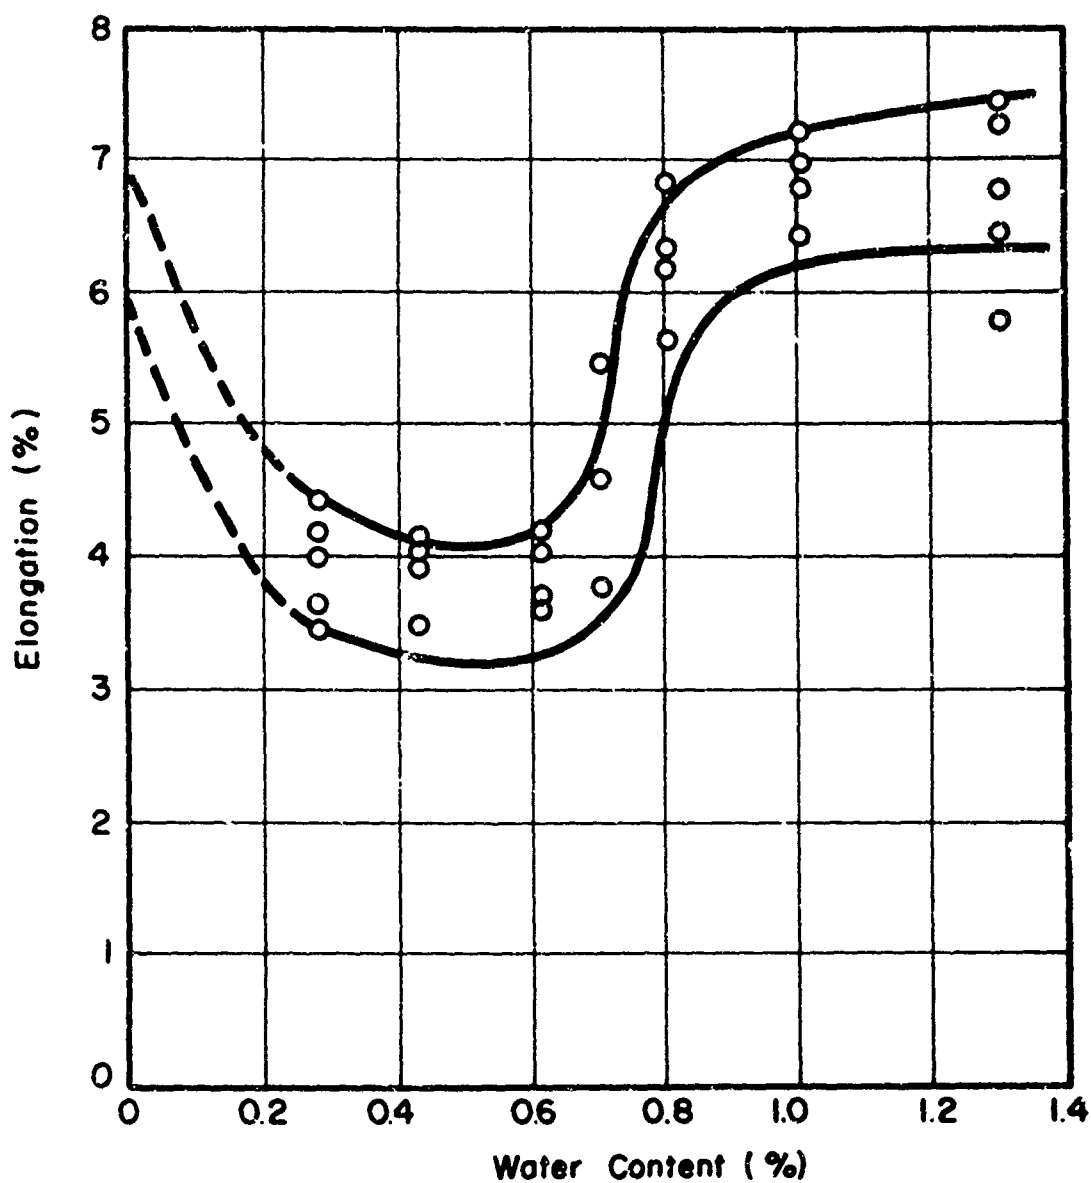
Figure 2b. Elongation vs Water Content:  $\text{CH}_3\text{OH} + 0.166\% \text{HCl} + \text{H}_2\text{O}$  (Tensile Direction Parallel to Rolling Direction; Strain Rate 0.005 cm/min)

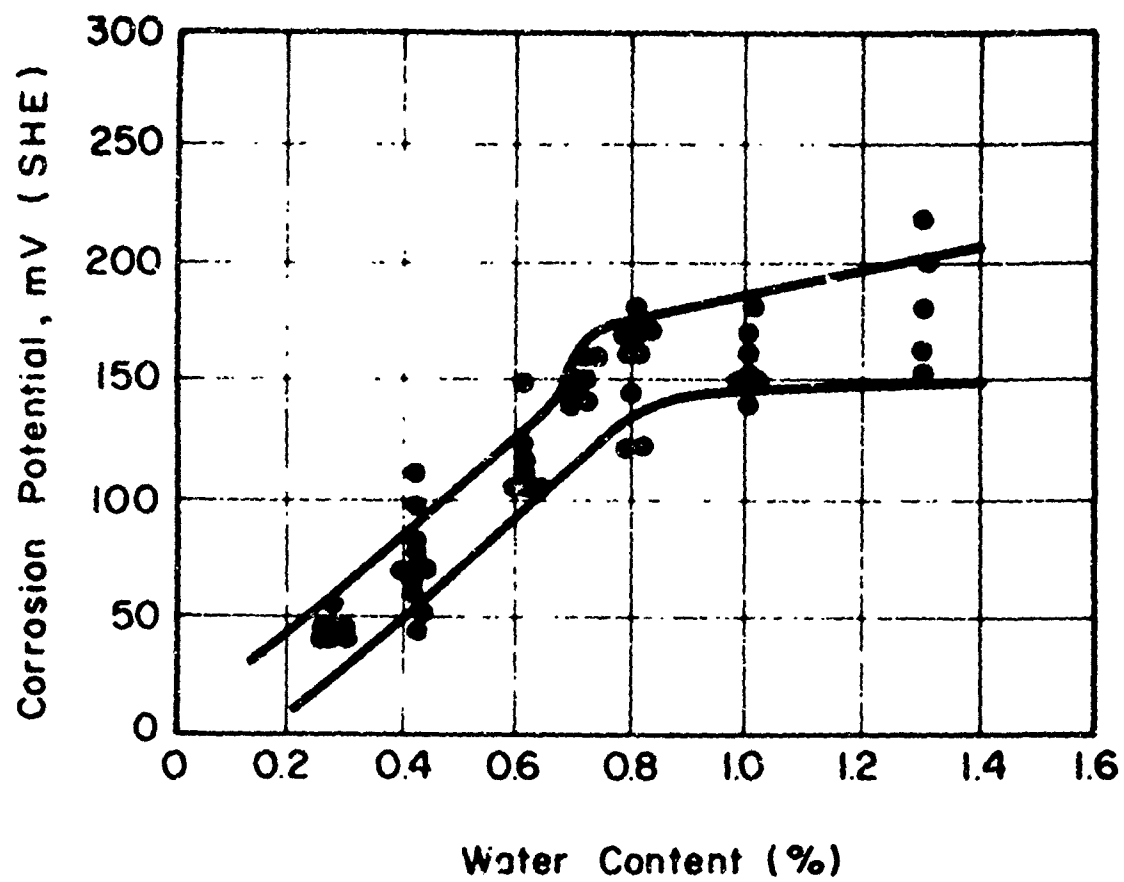
Figure 3. Corrosion Potential vs Water Content;  $\text{CH}_3\text{OH} + 0.166\% \text{HCl} + \text{H}_2\text{O}$  (No Applied Load)

Figure 3 shows the effect of water concentration in the  $\text{CH}_3\text{OH}$ -0.17%  $\text{HCl}$ - $\text{H}_2\text{O}$  mixtures upon the open circuit corrosion potential (SHE) of 6-4 alloy. It can be seen that in the region of greatest stress corrosion cracking (SCC) susceptibility, i.e., 0.2 to 0.6%, the corrosion potential tends to shift in the anodic direction as the water content is increased. Above 0.6% the potential becomes more or less independent of the water content.

above a rather critical value of about 0.8%, the repair or passivation is complete, cracking is inhibited, and the potential becomes independent of water content, again as in Figure 3. On this model it would be anticipated that upon straining the specimen, the anodic current should be increased, due to the creation of defects in the oxide film or to the exposure of fresh metal surface, and the corrosion potential should shift in the cathodic direction. As can be seen in Figures 4 and 5, such a cathodic shift is in fact observed when the water content is above about 0.8% and/or the strain rate greater than 0.1 cm/min. Below these values the corrosion potential shift is in the anodic direction, which is difficult to interpret except perhaps on the basis that the combination of dynamic strain and incompletely passivated surface introduces a new anodic reaction of higher EMF.

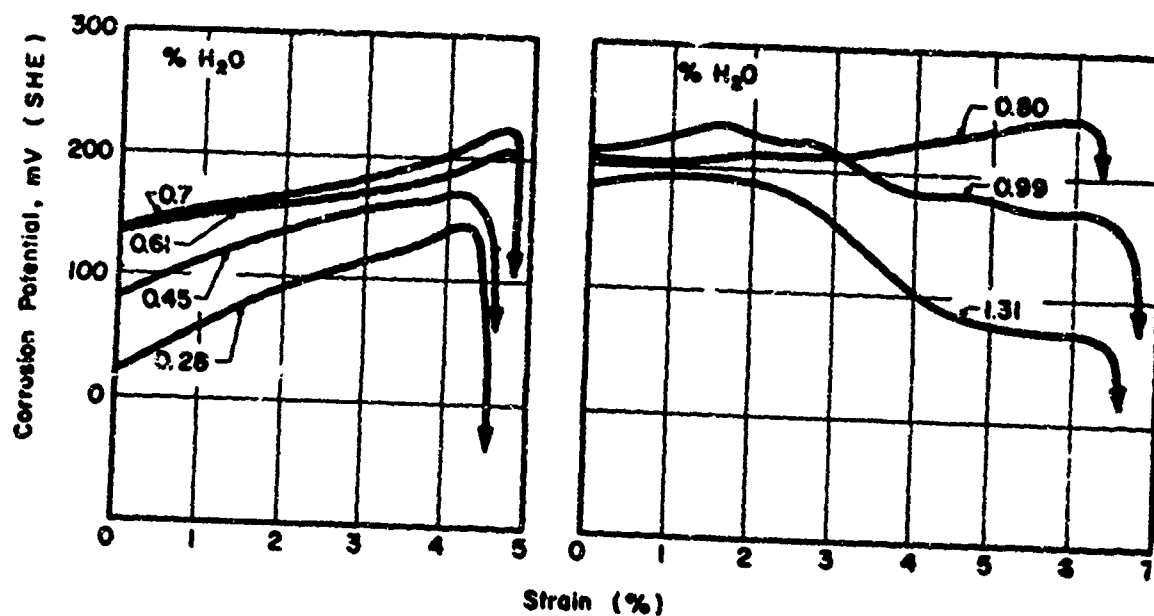
Figure 4. Corrosion Potential vs Elongation in CH<sub>3</sub>OH + 0.166% HCl + H<sub>2</sub>O

Figure 4 illustrates the variation of corrosion potential with elongation of the 6-4 specimen, under tensile loading at 0.005 cm/min (0.36%/min), in solutions having different water contents. Potentials are observed to be altered by strain in the anodic direction at water contents of 0.8% and lower, and in the cathodic direction at higher values.

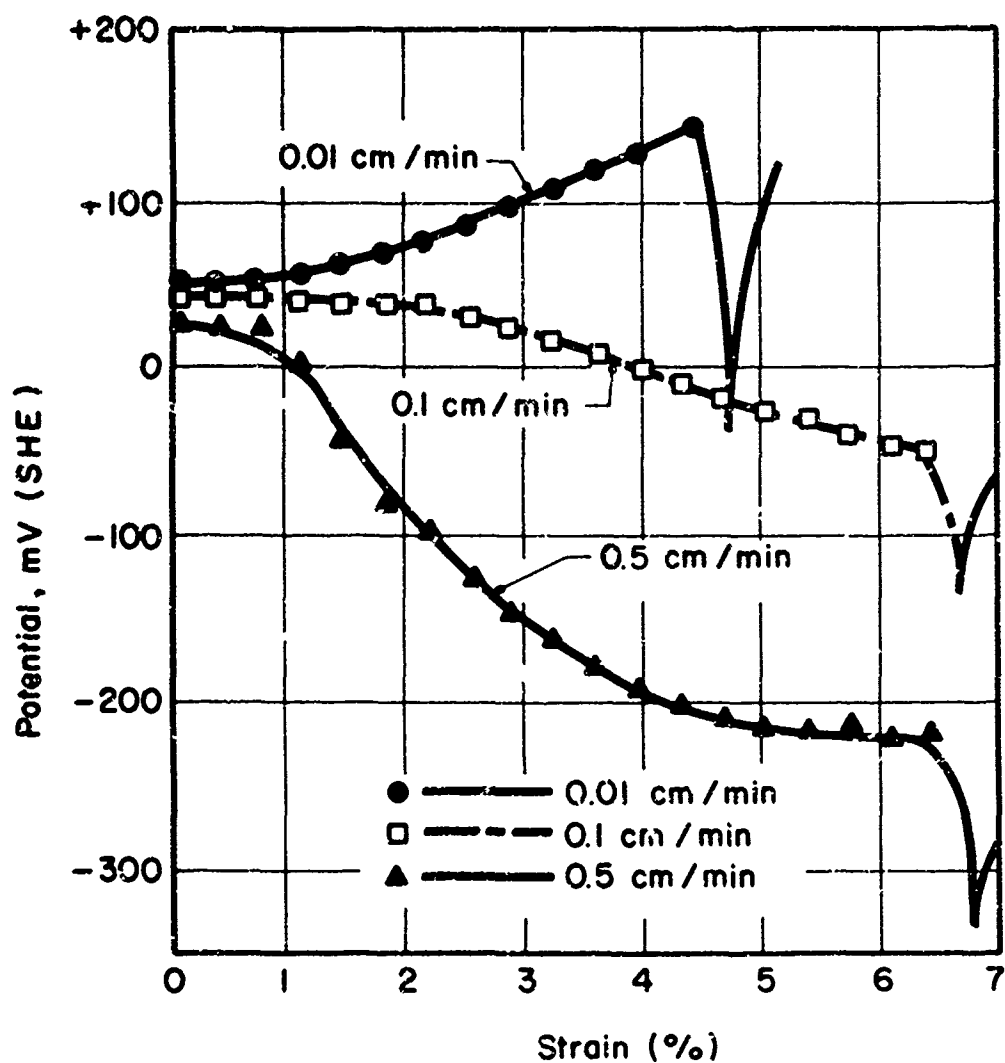
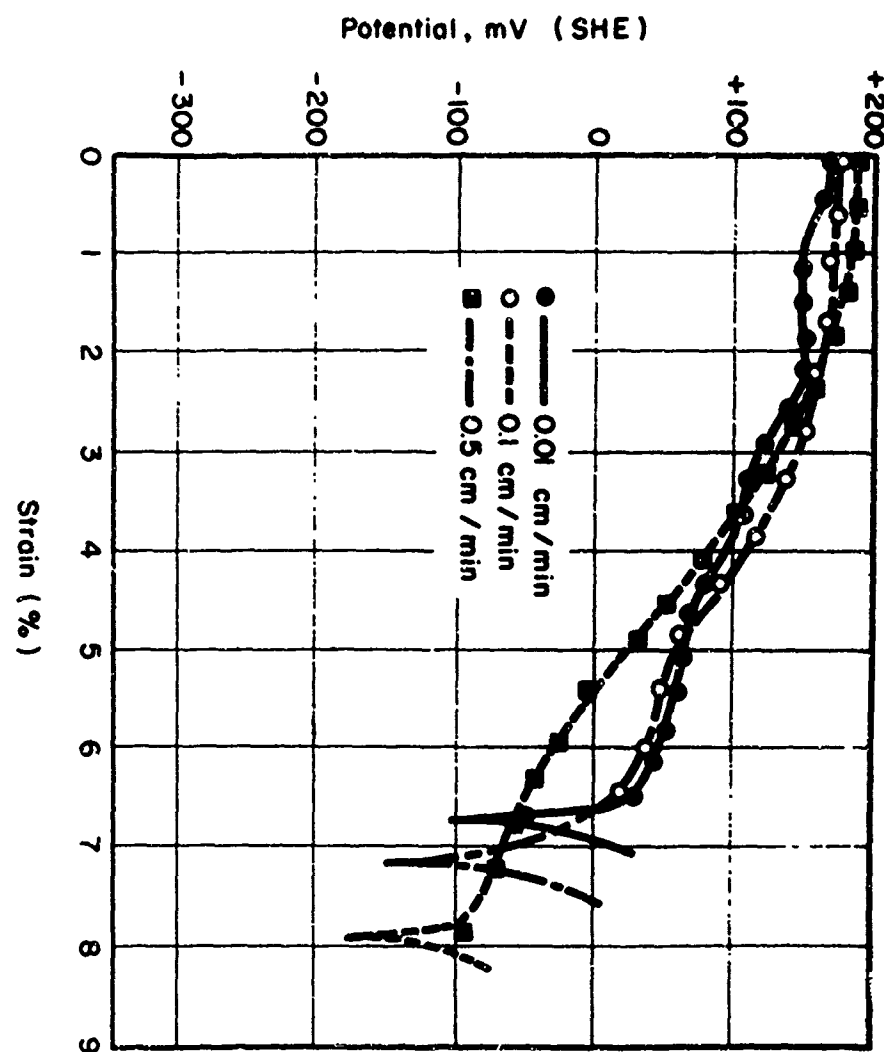
Figure 5a. Effect of Strain Rate on Corrosion Potential vs Strain in  $\text{CH}_3\text{OH} + 0.166\% \text{HCl} + 0.28\% \text{H}_2\text{O}$

Figure 5b. Effect of Strain Rate on Corrosion Potential vs Strain in  $\text{CH}_3\text{OH} + 0.166\% \text{ HCl} + 0.99\% \text{ H}_2\text{O}$

Figures 5 a and b show the effects of straining, at different strain rates, on the corrosion potentials in solutions having water contents of 0.28% and 0.99%, respectively. In the 0.99% solution, the strain rate has little effect on the behavior of the corrosion potential; in the

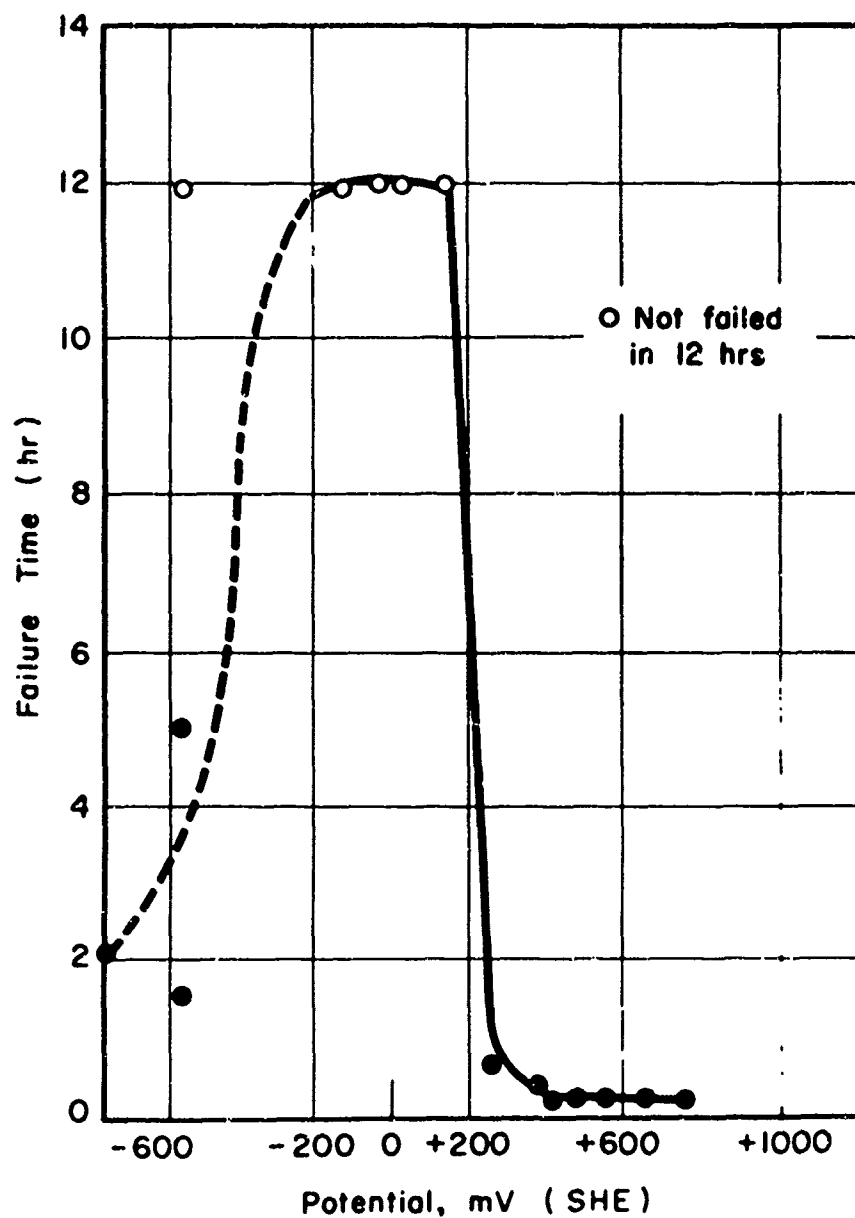
Figure 7. Failure Time vs Polarization Potential in  $\text{CH}_3\text{OH}$  + 0.166%  $\text{HCl}$  + 0.99%  $\text{H}_2\text{O}$

Figure 7 shows the effect of applied anodic and cathodic potentials on the stress corrosion failure times of Ti-6Al-4V U-bend specimens in  $\text{CH}_3\text{OH}$ -0.17% $\text{HCl}$ -0.99%  $\text{H}_2\text{O}$  solutions. Some-what similar measurements have been reported elsewhere (References 5 and 12), but the present results are included here for purposes of comparison and completeness of presentation. Note that while this water concentration of 0.99% would normally prevent cracking, the application of anodic potentials above about 200 mV (SHE) leads to rapid failure. In the potential range from about +200 to -200 mV, the alloy apparently becomes insusceptible to SCC, with susceptibility returning at higher cathodic potentials, around -600 mV.

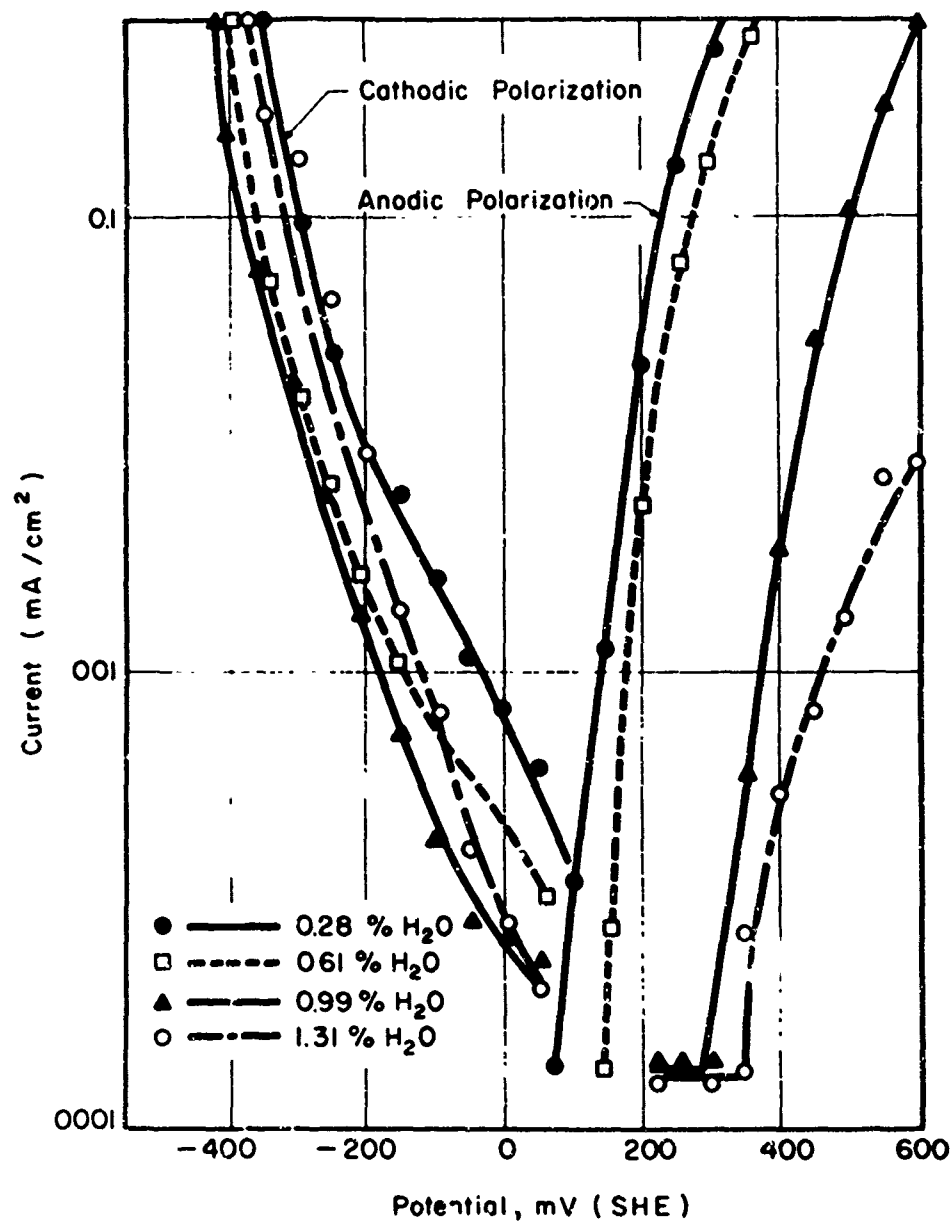
Figure 8. Effect of Water Content on the Polarization Curves in  $\text{CH}_3\text{OH} + 0.166\% \text{HCl} + \text{H}_2\text{O}$  (Scanning rate 25 mV/min)

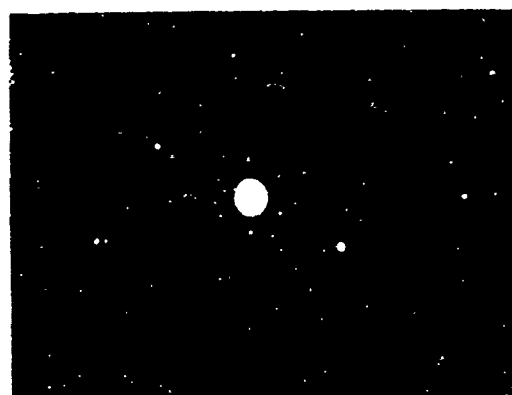
Figure 10. Corrosion Products on External and Fracture Surfaces of Ti-6Al-4V Fractured in  $\text{CH}_3\text{OH} + 0.17\% \text{HCl} + 1\% \text{H}_2\text{O}$  (Carbon Replica; X2,350) (a) External Surface; (b) Fracture Surface; (c) Electron Diffraction Pattern of Corrosion Product ( $\text{TiCl}_3$ )

Under anodic polarization, crack formation takes place by a pitting mechanism. In the case of Ti 6-4 U-bend specimens in  $\text{CH}_3\text{OH}-0.17\%\text{-HCl}-1\%\text{H}_2\text{O}$  water, pits are observed to form at potentials of about +300 mV (SHE), or higher, the number of pits increasing rapidly with potential. Under microscopic observation, cracks are seen to originate at the pits and grow laterally perpendicular to the direction of tensile stress. (See Figure 9.) Fontana, et al. (Reference 25) have reported that in the case of 6-4 alloy in  $\text{CH}_3\text{OH}-\text{H}_2\text{O}-\text{NaCl}$  solutions, the pits originate by selective attack of  $\beta$  grains and along the  $\alpha$ - $\beta$  interface. Fontana (Reference 25) has reported observing, by light microscopy, black corrosion product in the pits, and the present authors have also observed such material both in the pits and on the fracture surfaces, as shown in Figure 10. The corrosion product was identified by electron diffraction as  $\text{TiCl}_3$  (Figure 10).

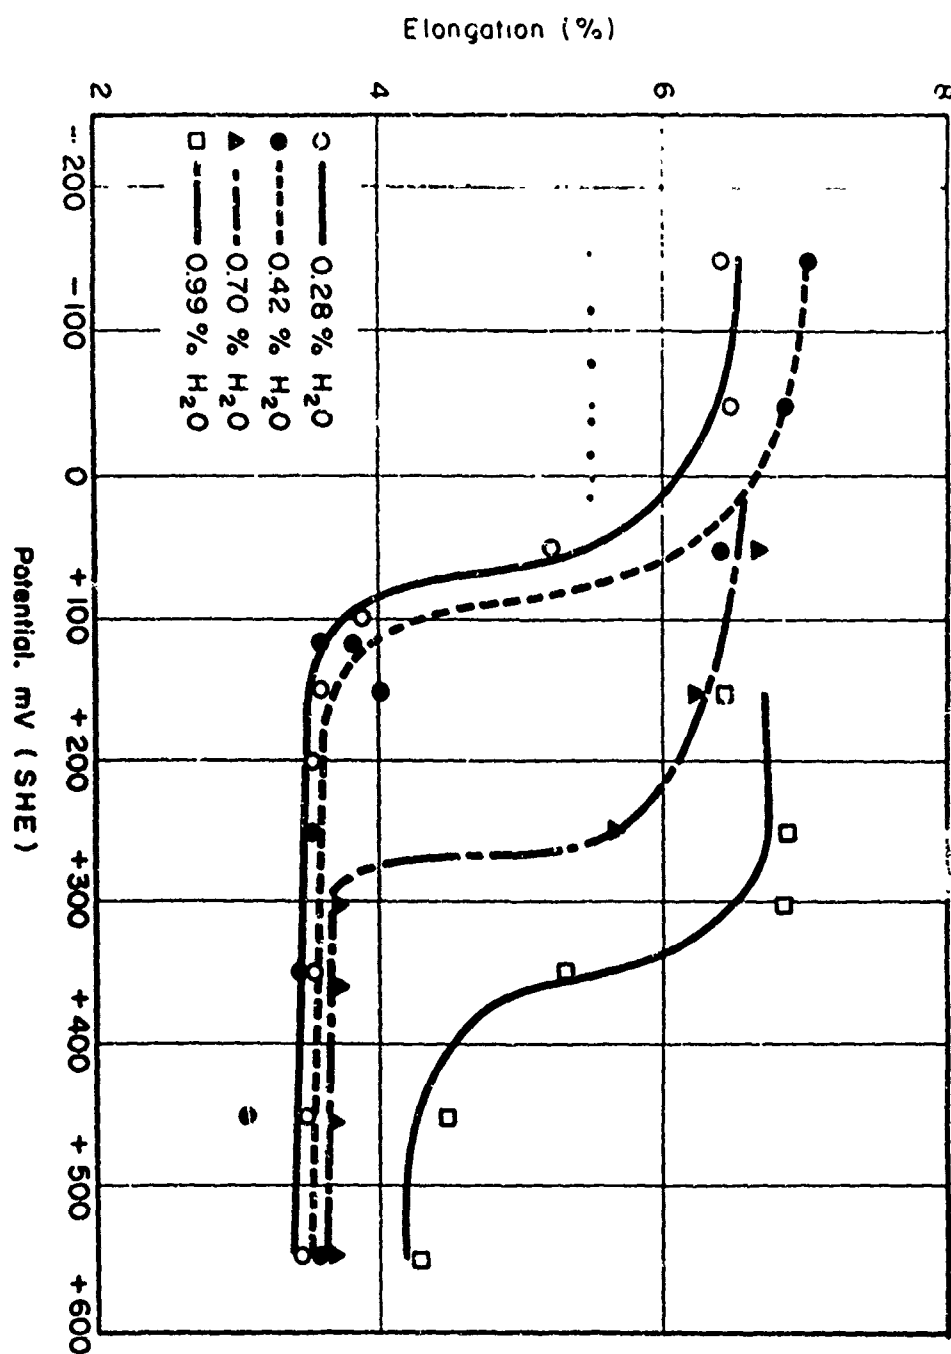
Figure 11. Effect of Polarization Potential on Elongation

of Ti 6-4 are illustrated in Figure 11, for various water concentrations. It can be seen that at any particular water content, there is a fairly definite potential associated with the transition from insusceptible to susceptible, or embrittled, behavior. (The average elongation at fracture in air was about 7%.) As the water content is increased, the transition potential becomes increasingly anodic. In Figure 12, this transition potential is plotted as a function of water concentration for comparison with the corrosion potential (shaded area). At about 0.6 to 0.7% water, the corrosion potential becomes less than the potential necessary to produce embrittlement.

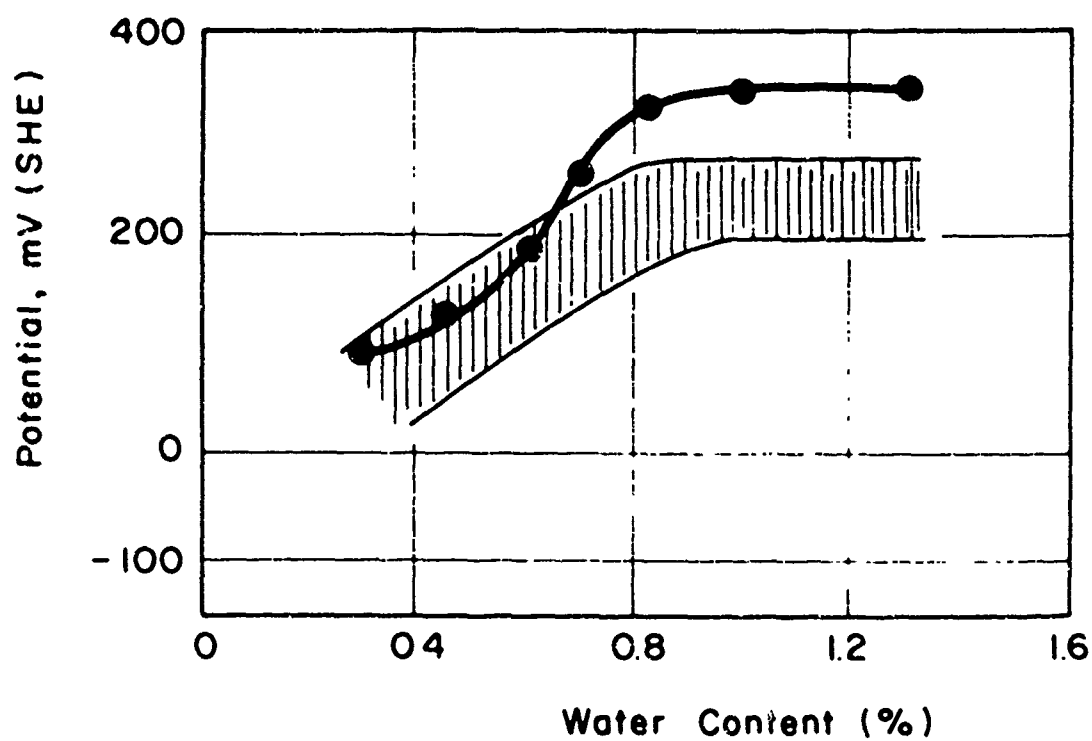
Figure 12. Transition Potential vs Water Content

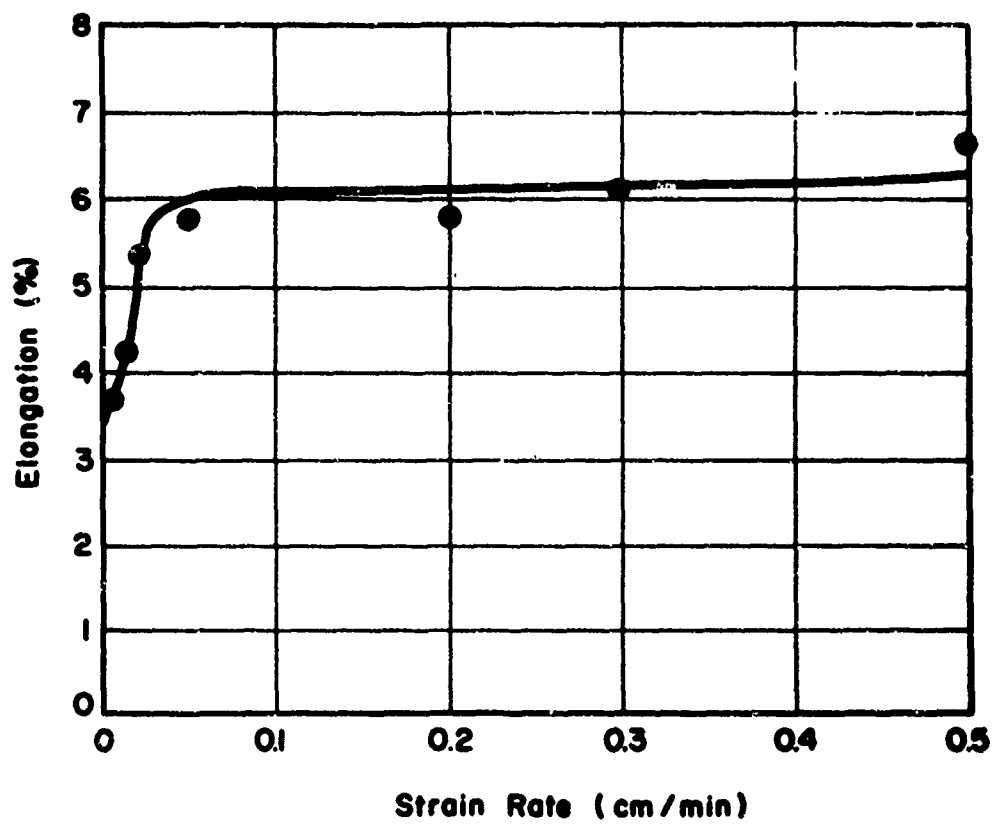
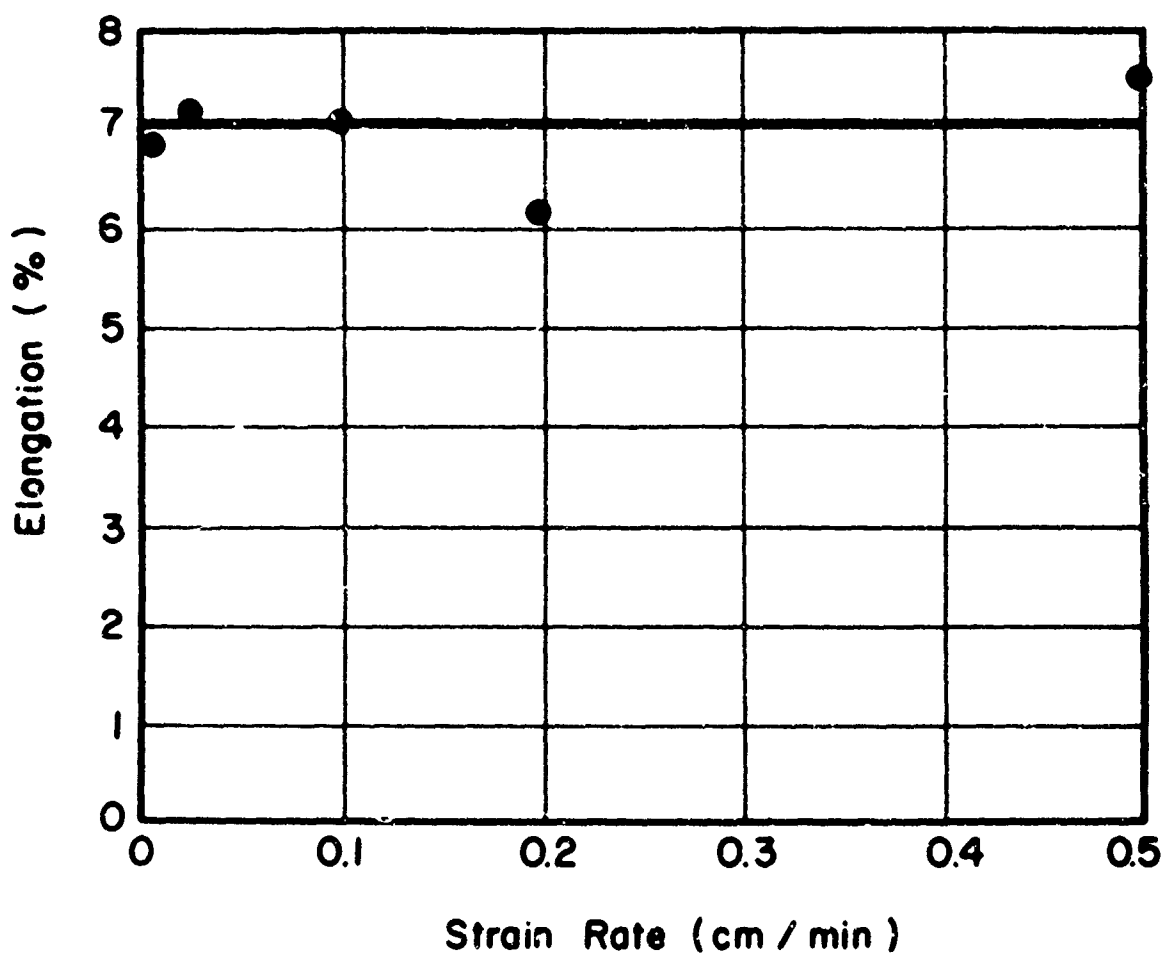
Figure 13a. Effect of Strain Rate on Specimen Elongation at +350 mV (SHE)

Figure 13b. Effect of Strain Rate on Specimen Elongation at +50 mV (SHE)

The effect of strain rate on ultimate elongation, under anodic (+350 mV SHE) and slightly cathodic (+50 mV SHE) polarization relative to the corrosion potential at 0.42% $H_2O$ , is illustrated in Figures 13a and b. At this level of cathodic polarization, the alloy is not embrittled and susceptible to SCC and the normal elongations typical of fracture in air were observed at all the strain rates employed. With anodic polarization and embrittlement, the ultimate elongation is very sensitive to the strain rate, increasing rapidly with rate in the range 0.005 to 0.020 cm/min. Above about 0.050 cm/min, the normal fracture process apparently becomes faster than the stress corrosion cracking, and elongations

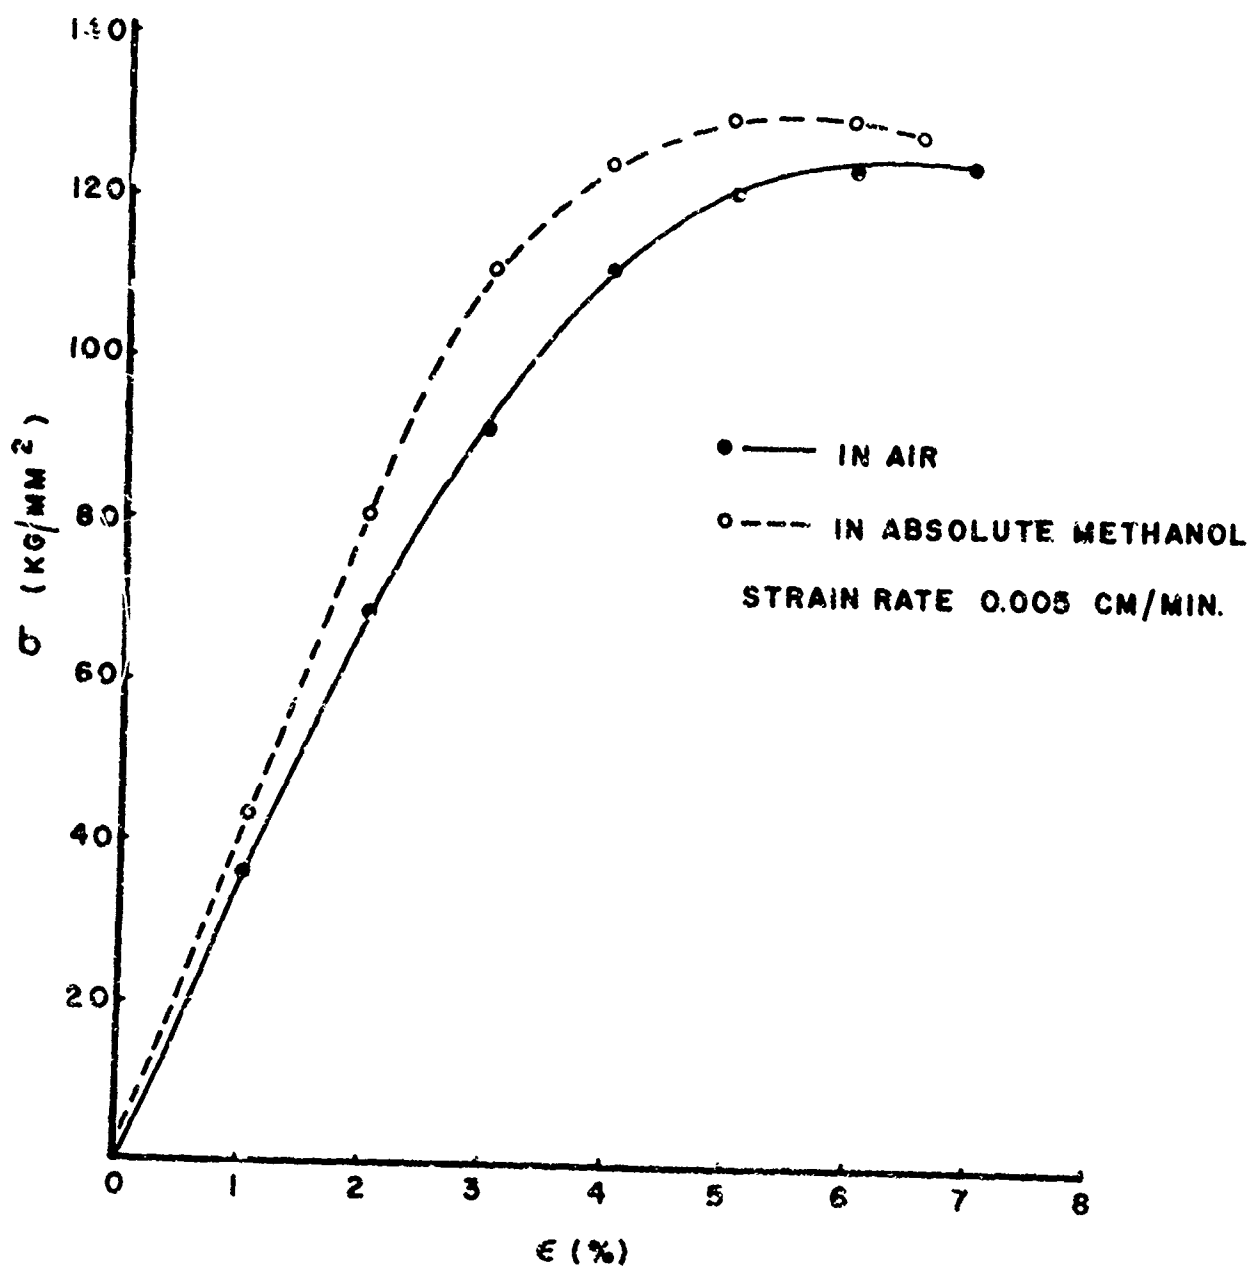
Figure 14. Stress-Strain Curves of Ti-6Al-4V in Air and in Absolute Reagent Grade Methanol (0.015% H<sub>2</sub>O)

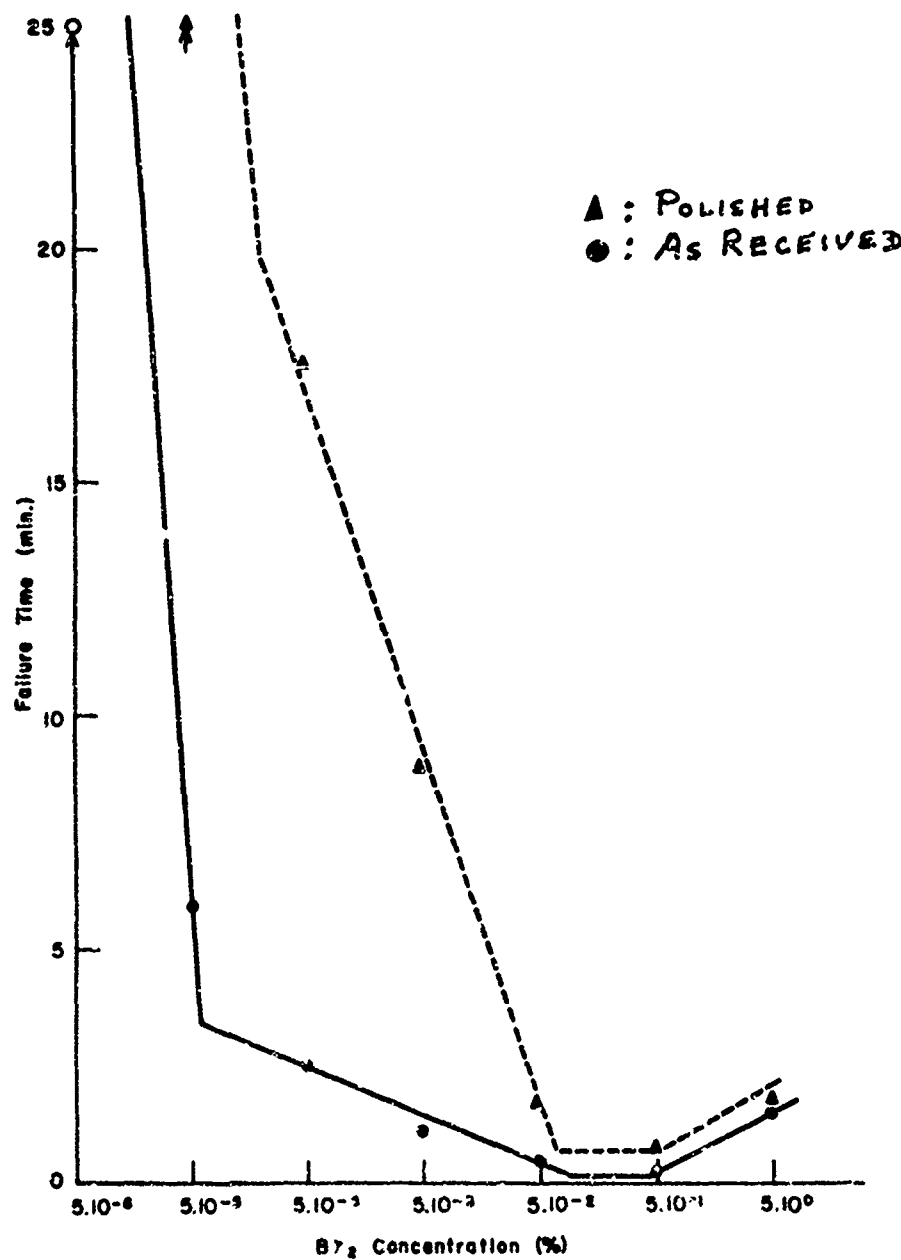
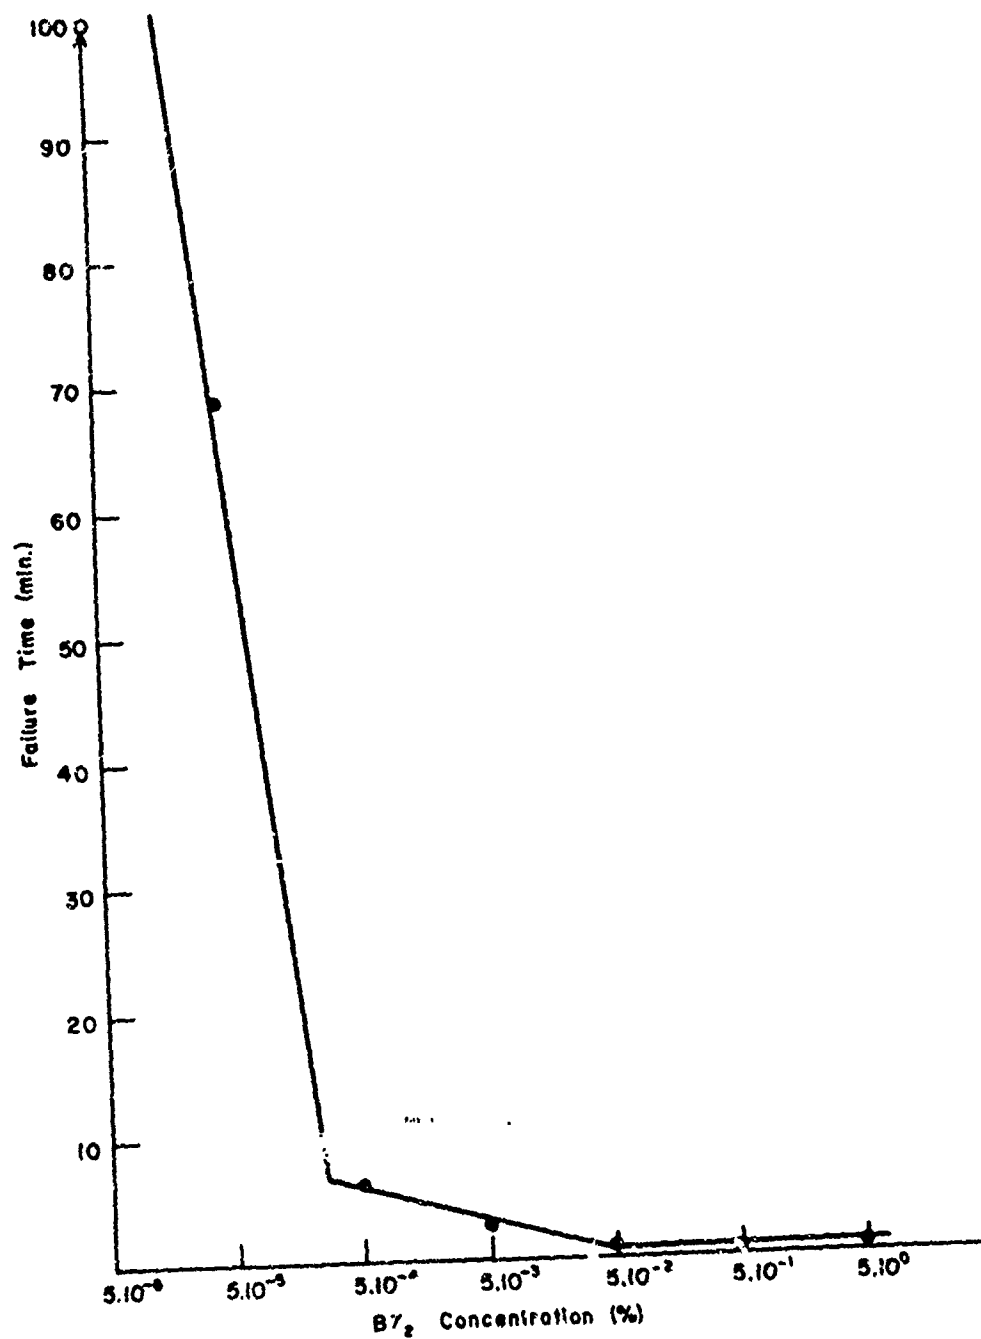
Figure 16a. Failure Time vs Bromine Concentration: Titanium  
 8-1-1

Figure 16b. Failure Time vs Bromine Concentration; Heat-Treated  $\beta$ -III

Failure times in methanol-bromine solutions, as a function of bromine concentration, are shown in Figure 16a for Ti-8Al-1Mo-1V and in Figure 16b for  $\beta$ -III alloy heat-treated to produce all  $\beta$ -phase. Note that bromine concentrations as low as  $5 \times 10^{-5}\%$  (by volume) still produce rapid failures. Also the curve for 8-1-1 shows a minimum at 0.05 to 0.5%. The Ti-6Al-4V and unalloyed titanium show similar tendencies except that failure times are longer and the minima are not conspicuous. The minimum is presumably due to increased general corrosion and crack blunting at higher bromine concentrations. For purposes of comparison, weight loss measurements of Ti 8-1-1 as a function of time were made in the bromine solutions, the results being shown in Figure 17. It is interesting that in the  $5 \times 10^{-5}\%$  solution, a weight loss on the order of a microgram or less per  $\text{cm}^2$  of specimen surface could still cause failure in about five minutes.

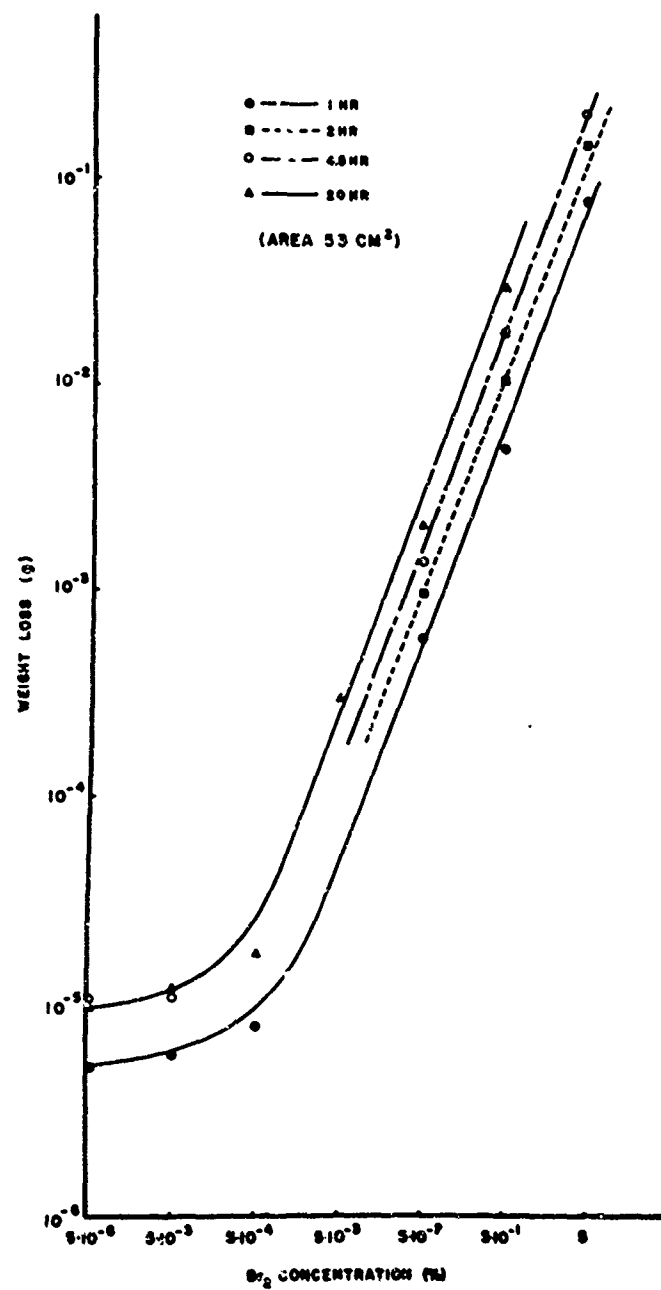
Figure 17. Weight Loss vs Bromine Concentration; Titanium 8-1-1
