STRESS CORROSION CRACKING OF TITANIUM  
ALLOYS IN METHANOLIC AND OTHER MEDIA

AFML-TR-71-232

TECHNICAL REPORT AFML-TR-71-232

MARCH 1972

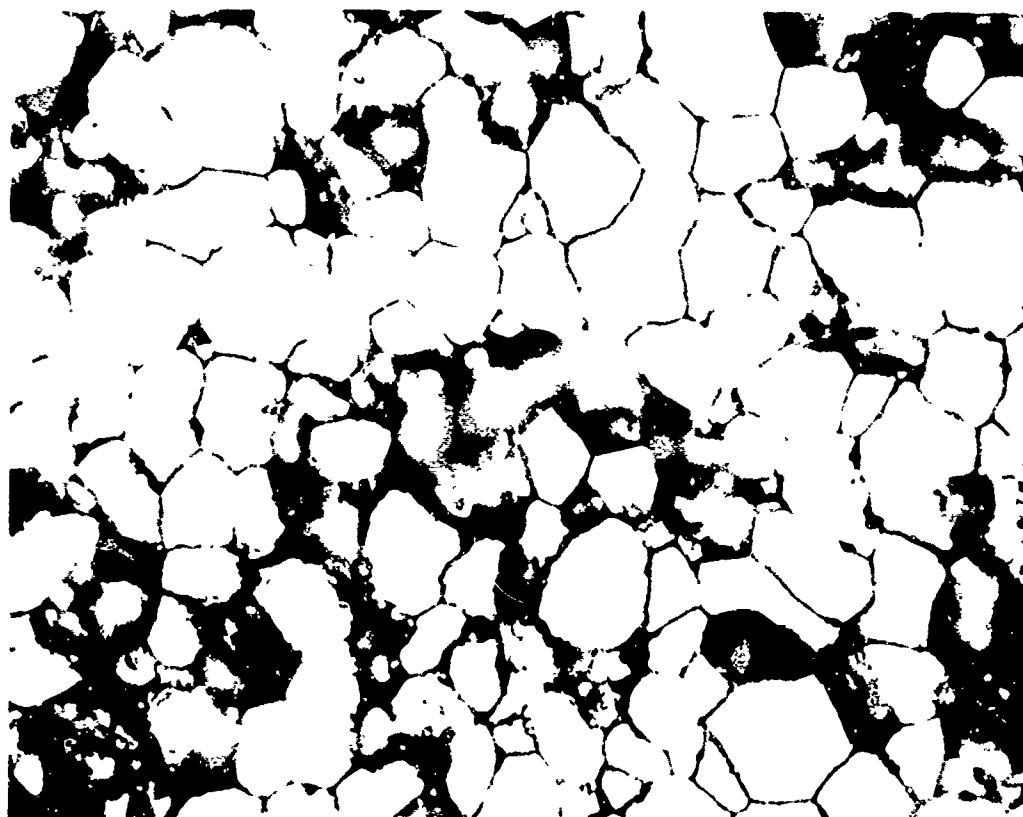
Figure 19. Intergranular Corrosion of Unalloyed Titanium (RMI70) in Bromine-Methanol Solution (1%Br<sub>2</sub>; 68-Hour Exposure; No External Stress; X300)

In the case of unalloyed titanium in the methanol-bromine solutions, the "pure" corrosion reaction with no applied stress is intergranular, as shown in Figure 19. At moderate stress, both the corrosion and the stress corrosion cracking were intergranular. However at higher stresses, a small amount of transgranular cracking was observed.

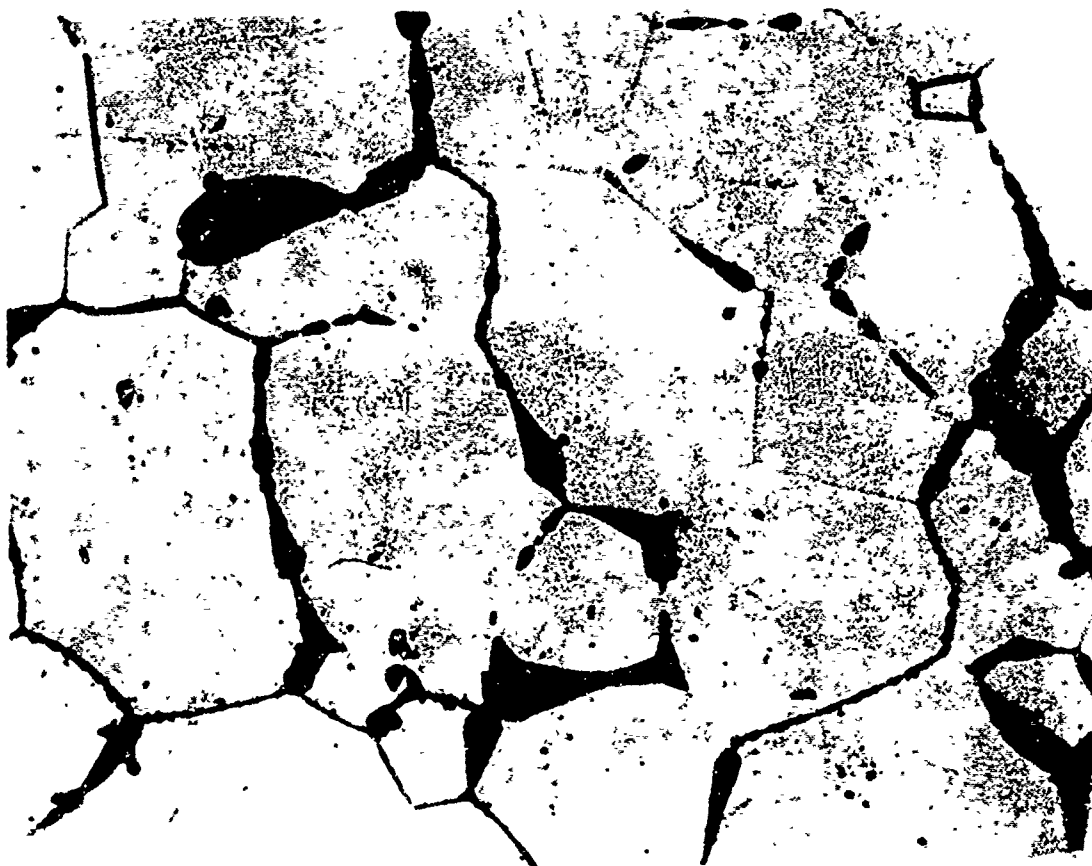
Figure 20. Grain Boundary Corrosion Near Center of Heat-Treated B-III Alloy Specimen in Bromine-Methanol Solution (0.05%Br<sub>2</sub>; 164 Hours; No External Stress; X210)

With  $\beta$ -III alloy heat-treated to produce all  $\beta$ -phase, the corrosion with no applied stress was also intergranular, Figure 20. When stress is applied, the stress corrosion cracking is mixed inter- and transgranular, being mostly

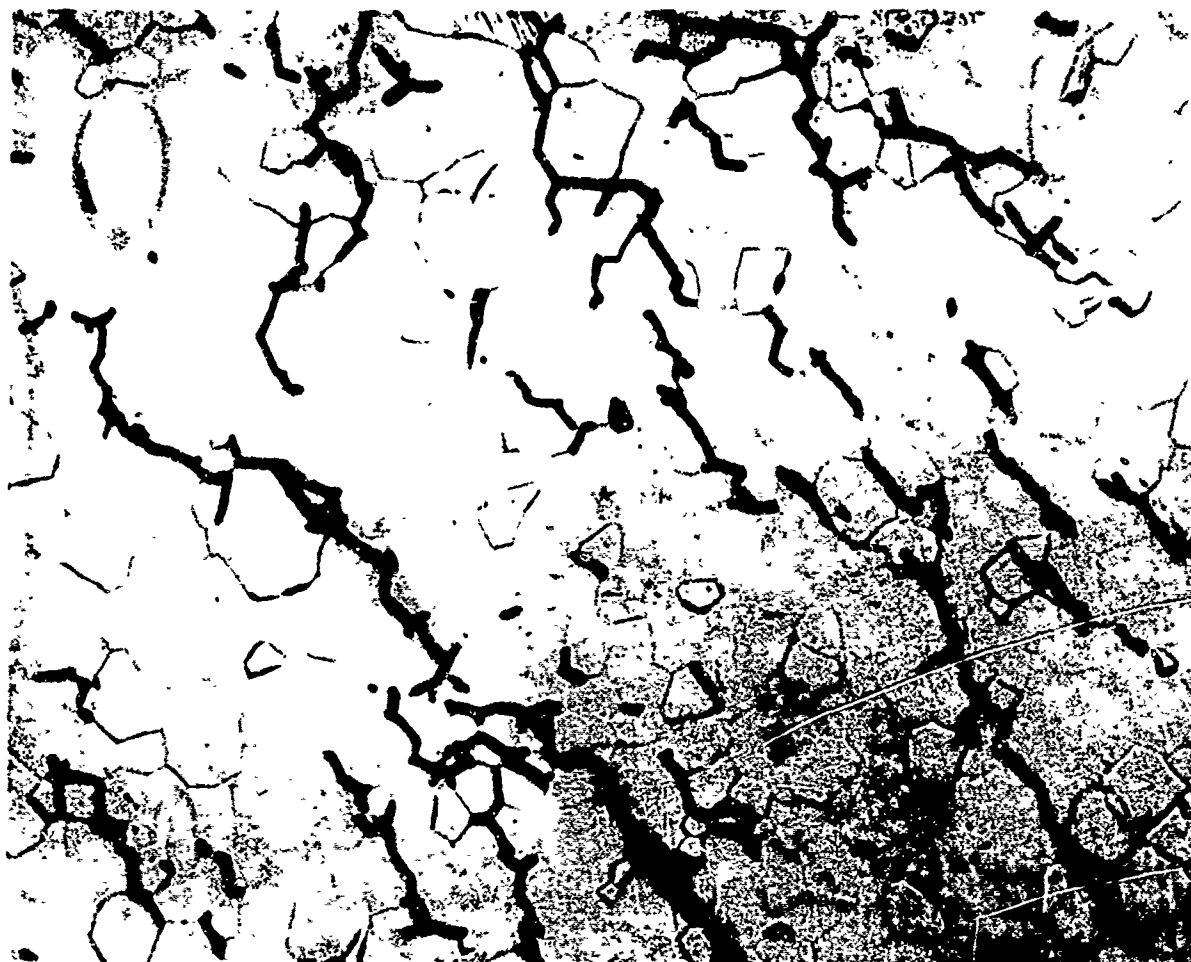
Figure 21. Stress Corrosion Cracking of Heat-Treated  $\beta$ -III Alloy in Bromine-Methanol Solution ( $0.5\% \text{Br}_2$ ; X50)

intergranular when the bromine concentration is 0.5% or greater (Figure 21). At lower bromine concentrations the stress corrosion cracking appears to be largely transgranular, as illustrated in Figures 22 and 23. The stress corrosion cracking of heat-treated  $\beta$ -III is also mixed inter- and transgranular in methanol-hydrochloric acid-water mixtures as shown in Figure 24.

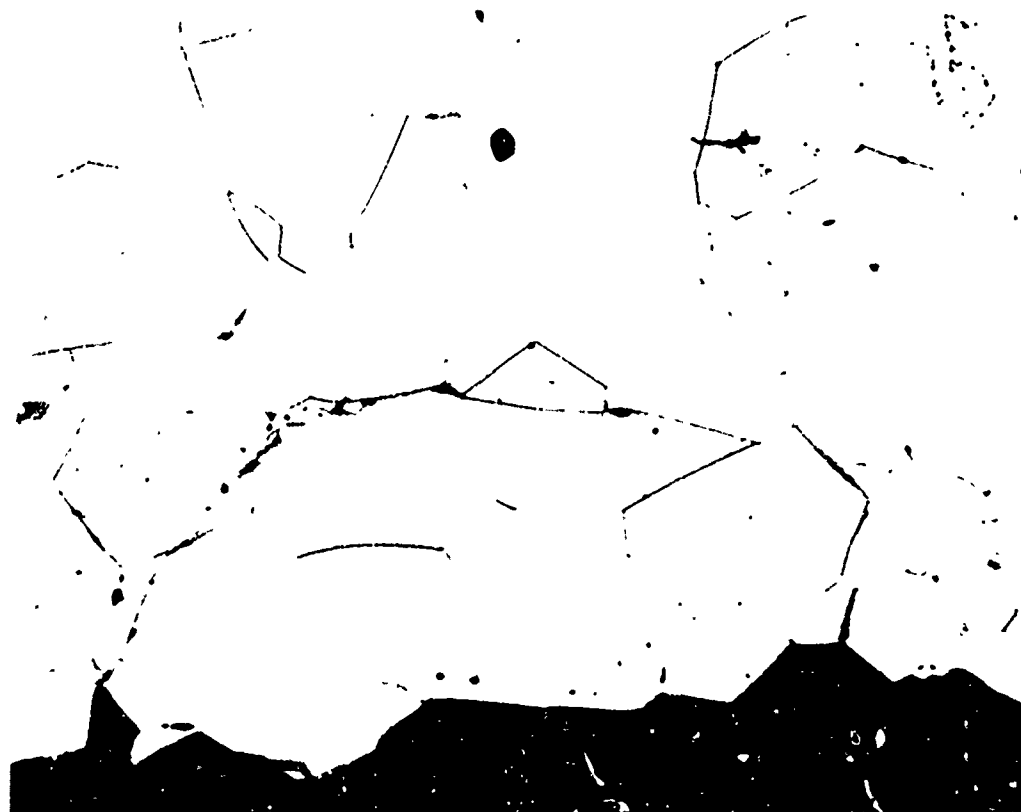
Figure 22. Stress Corrosion Cracking From Residual Stress at Edge of  $\beta$ -III Specimen ( $0.05\%Br_2$ ; X150)

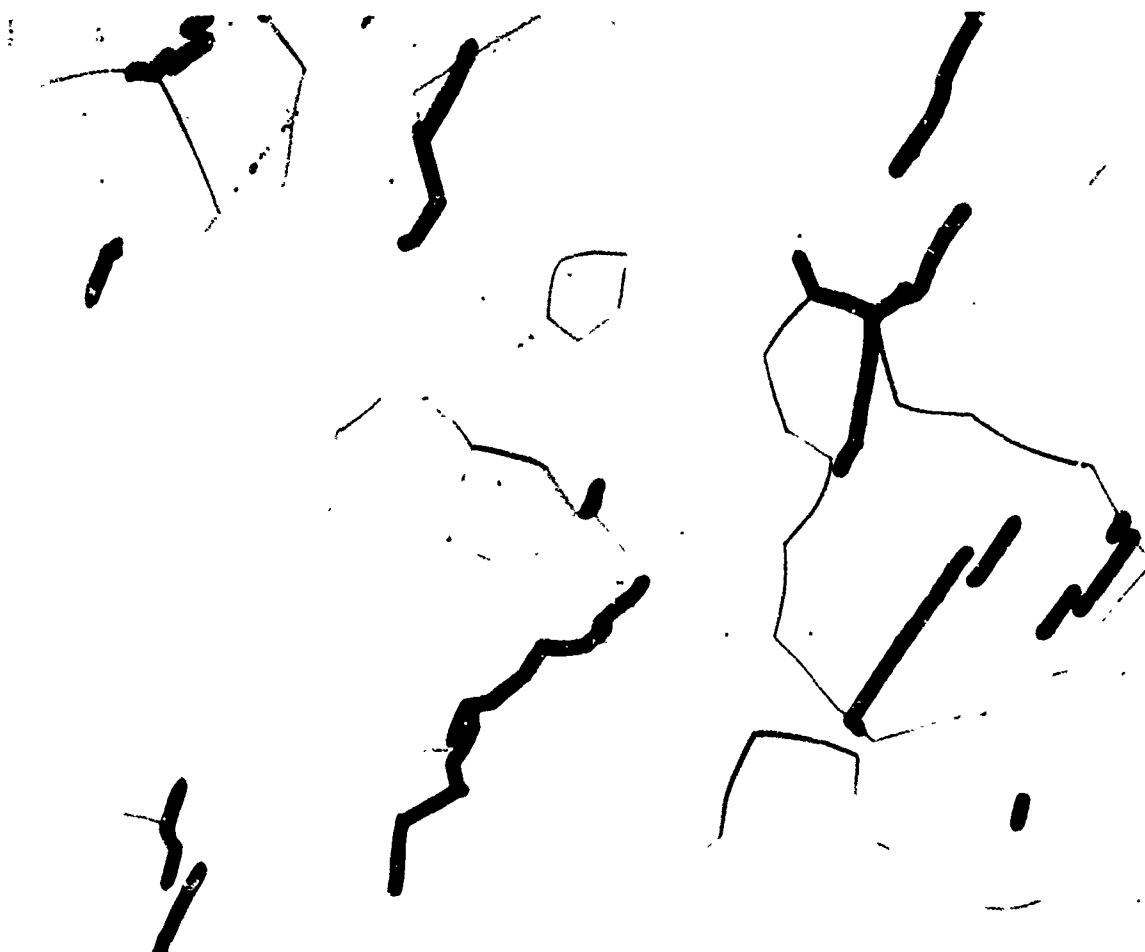
Figure 24. Stress Corrosion Cracking of Heat-Treated 8-III Alloy in  $\text{CH}_3\text{OH} + 0.17\%\text{HCl} + 0.28\%\text{H}_2\text{O}$  (X100)
