UH-1 TEST BED PROGRAM. VOLUME I.

USAAVSCOM TECHNICAL REPORT 72-19

UH-1 TEST BED PROGRAM

CONTRACT DAAJ01-70-C-0828 (P3L)
NORTHROP CORPORATION ELECTRONICS DIVISION
RESEARCH PARK, PALOS VERDES PENINSULA, CALIFORNIA

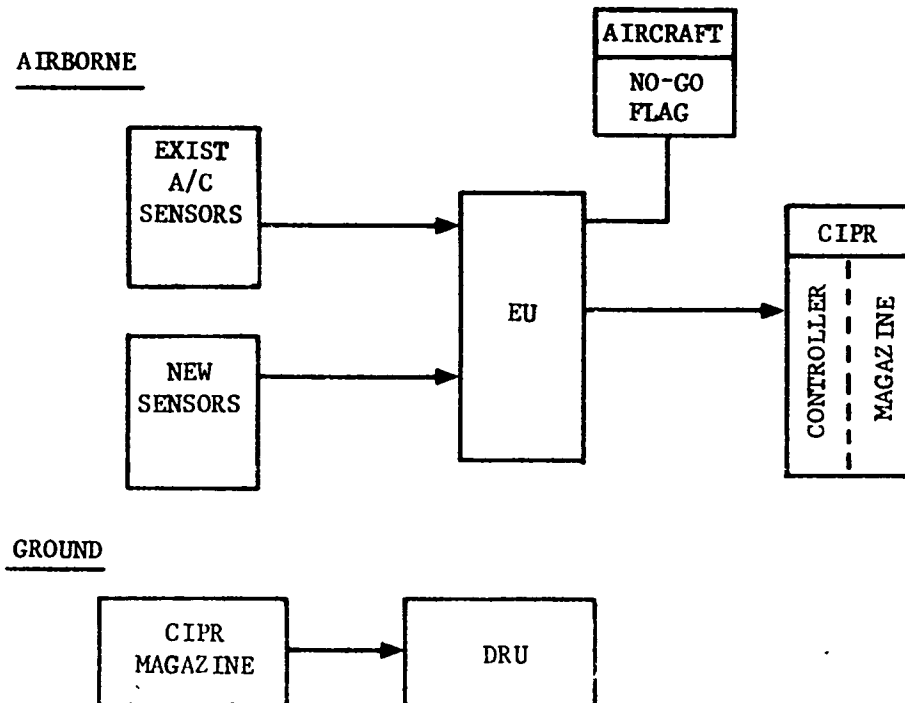
The basic airborne system is composed of an Electronics Unit (EU), a Continuous Inflight Performance Recorder (CIPR), and both new and existing aircraft sensors. Accumulated maintenance data is recovered from the airborne system by use of the Data Recovery Unit (DRU). Figure 3-1 depicts in block form the relationship of the major parts of the system.

FIGURE 3-1 SYSTEM BLOCK DIAGRAM

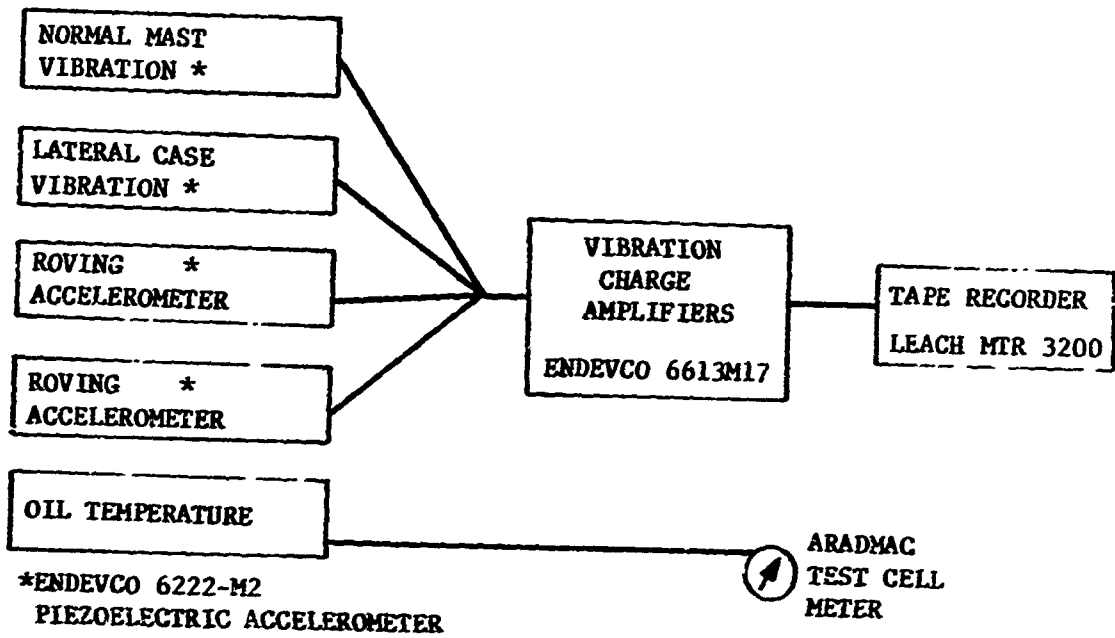
FIGURE 5-2 TRANSMISSION TEST CELL INSTRUMENTATION BLOCK DIAGRAM

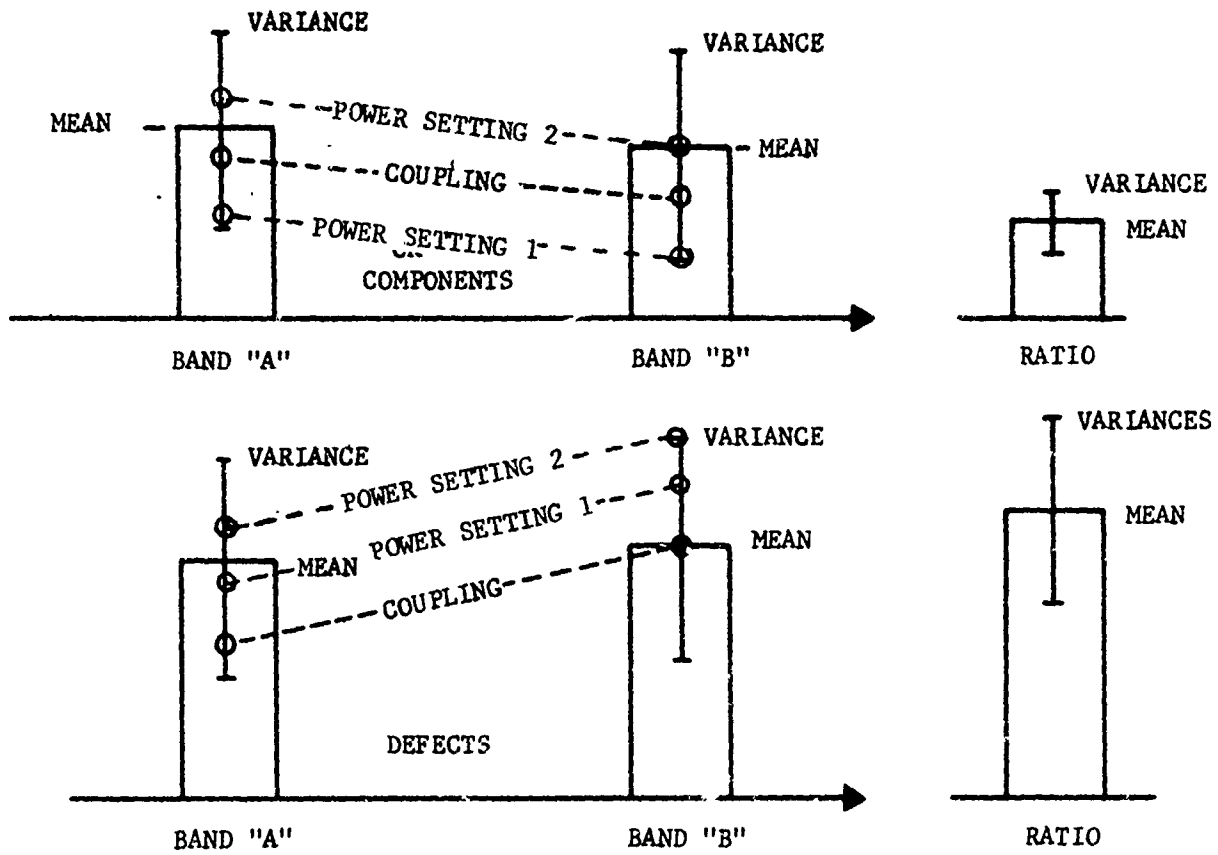
FIGURE 7-9 COUPLING EFFECTS
