# **Wear Resistant Coatings for Titanium Alloys**

**fretting fatigue of uncoated Ti-6Al-4V**

**General Electric Company**

AFML-TR-71-212

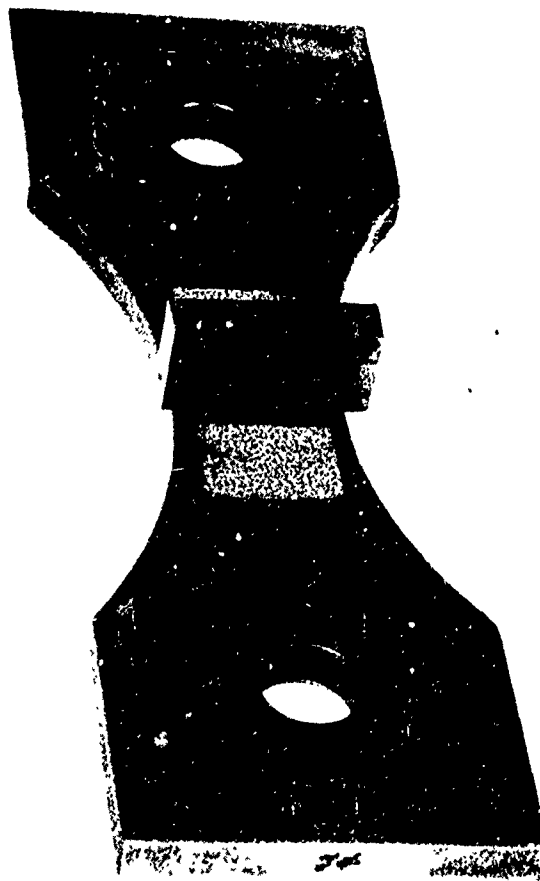
Figure 12. Specimen and Shoe Combination for High Pressure Sliding Wear Test

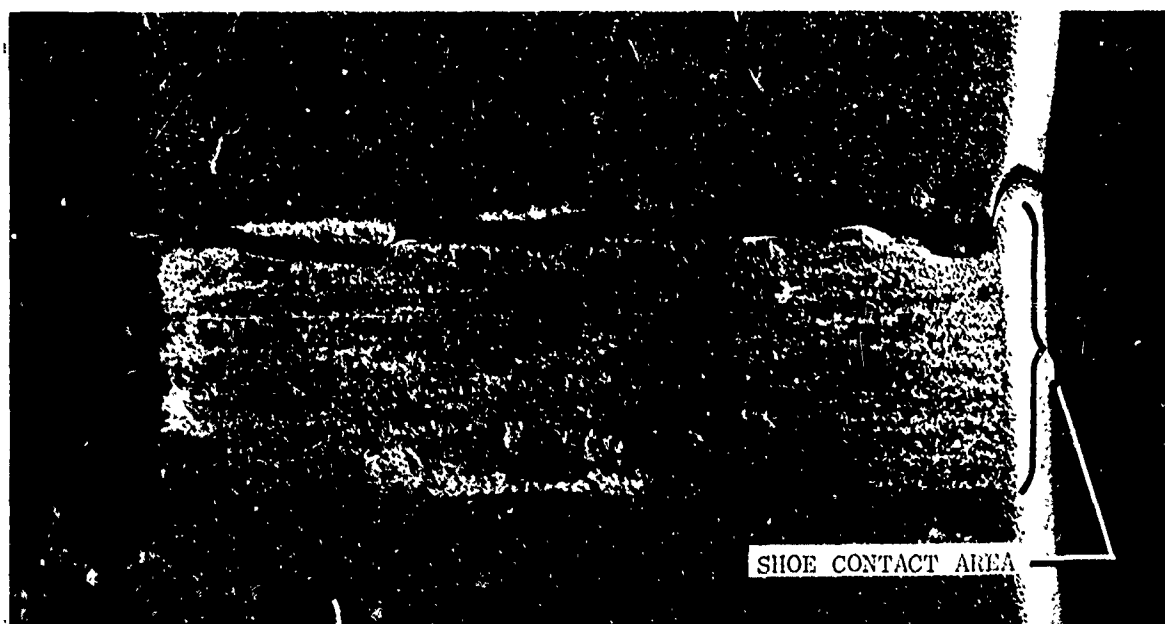
**Figure 17.** Fretting Fatigue Specimen 48 Tested Under 5,000 PSI Shoe Contact Pressure at 20,000 PSI Mean Tension and 60,000 PSI Alternating Bending Stress to  $9.4 \times 10^4$  Cycles. Upper Photograph Illustrates the Fretted Area where the Shoe was in Contact. Origins Visible in the Lower Photograph Show the Initiation of Failure from Surface Damage at the Edge of the Shoe Contact Area. (6X)

Figures 16, 17, and 18 illustrate the typical surface appearance of fretting fatigue specimens tested under 500, 5000, and 75,000 psi, respectively. Visually

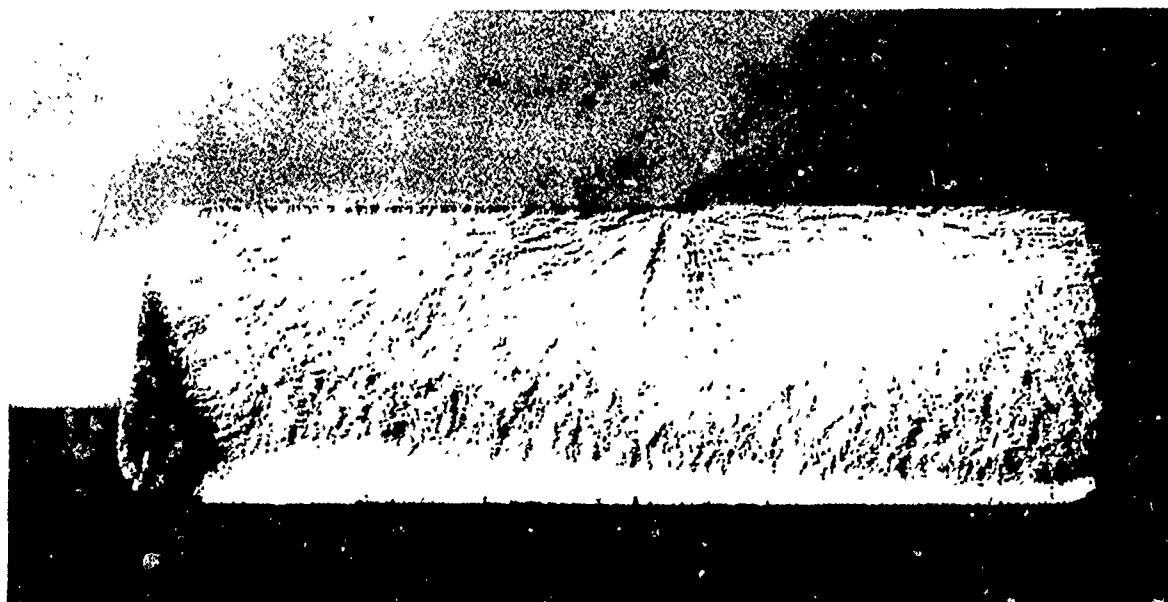
Figure 18. Specimen 60 Tested Under 75,000 PSI Shoe Contact Pressure. Upper Photograph Illustrates the Mild Appearing Fretted Area where the Shoe was in Contact. Origins Visible in the Fracture Face Show the Initiation of Failure from Surface Damage. Detail of the Wear Damage is Shown in Figure 20. (6X)

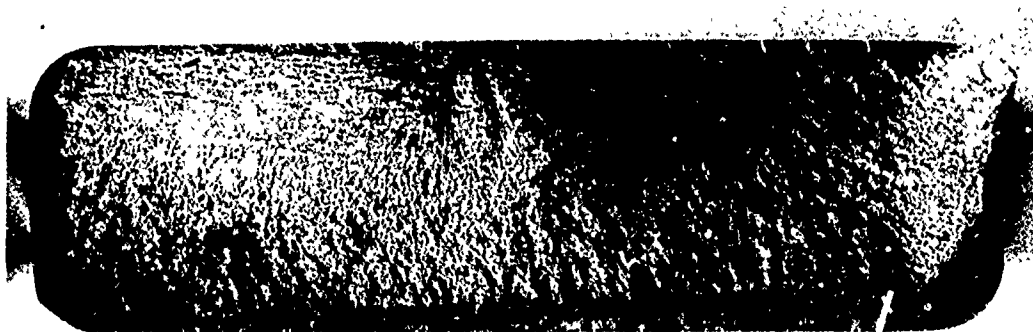
Figure 20. Composite SEM and Macro photographs of Specimen Surface. Specimen Surface was Illustrated Previously in Figure 19. Fracture Face in the Origin Reveal the Surface. Figure 19 Previously Illustrated Typical Metallurgical Features. Typical Shot-Peened Surface in a Nonfretted Area.

Figure 20 is a series of SEM photographs of Specimen 60 illustrated previously in Figure 18. Figure 20A shows a macrophoto of the single major origin. Figure 20B shows the origin in perspective with the fracture edge and the dimpled peened texture of the specimen surface (part of the shoe contact area during test). Successively detailed views of the origin in Figures 20C and 20D reveal no readily discernable primary site of failure. Nonetheless, they show the fretted band from shoe contact along the fracture edge. In the center view it

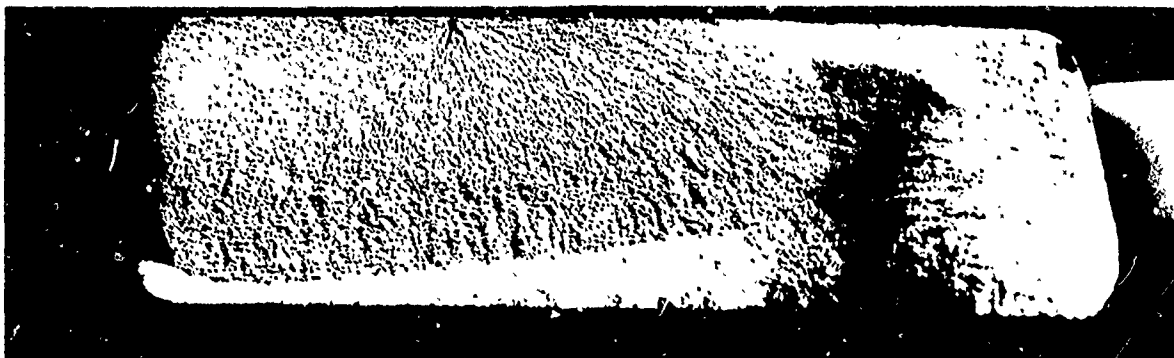
Figure 33. Specimen 38 Illustrating the Galling Wear and Fatigue Fracture Pattern After Testing Under 10,000 PSI Contact Pressure and 5-Mil Stroke.

Figure 33 illustrates Specimen 38, its wear shoe and fracture face. It was tested in the 10,000 psi contact pressure series with a 5-mil stroke. The shoe exhibits many scoured-out pits while the specimen wear surface shows an accumulation of debris. A detail of Specimen 39 in Figure 34 shows that it consists mainly of pits, smeared debris, and isolated areas of original peened

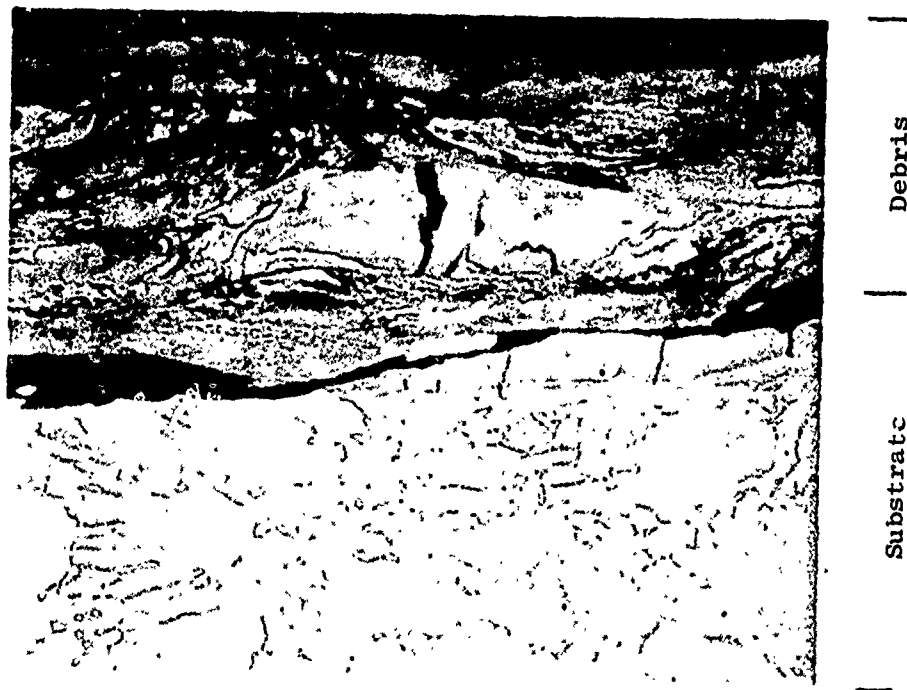
Figure 36. Metallographic Section of Specimen 38  
Showing Wear Debris Layer in Substrate  
Pit. (Mount 1917, Neg G6305, 1000X)
