LIGHTWEIGHT GEARBOX DEVELOPMENT FOR  
PROPELLER GEARBOX SYSTEMS APPLICATIONS  
POTENTIAL COATINGS FOR TITANIUM ALLOY  
GEARS

Richard A. Hirsch

**Detroit Diesel Allison Division  
General Motors Corporation  
Indianapolis Operations**

**TECHNICAL REPORT AFAPL-TR-72-90**

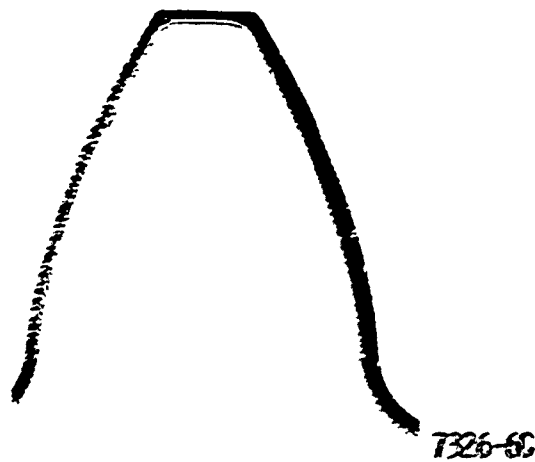
Figure 60. Tooth plate thickness macro section.
